### 3. Planning Background:

## 4. Historical Context

## **5. Details of Proposals for Reuse**

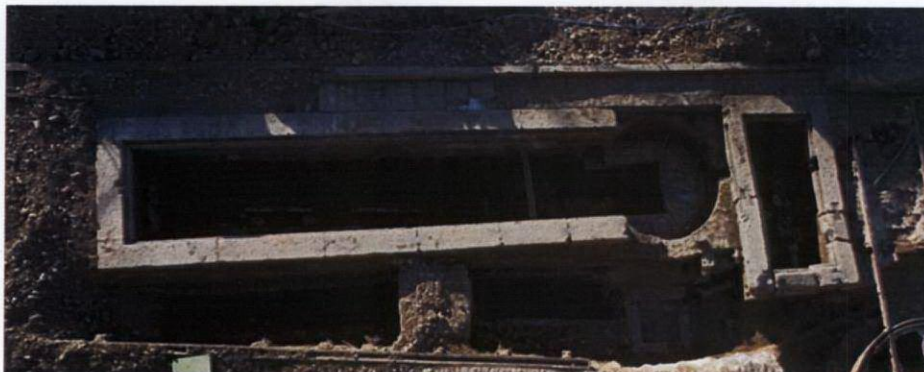
Image 1: View of Crane Base 1

The surviving crane base consists of two rectangular forms: a larger one orientated on an east-west axis; and a smaller one orientated north-south. These abut a central circular section (see Image 1 below) While the granite coping stones have survived on the two rectangular sections, the coping is absent from the circular chamber, perhaps because the stones were robbed after the structure fell out of use.

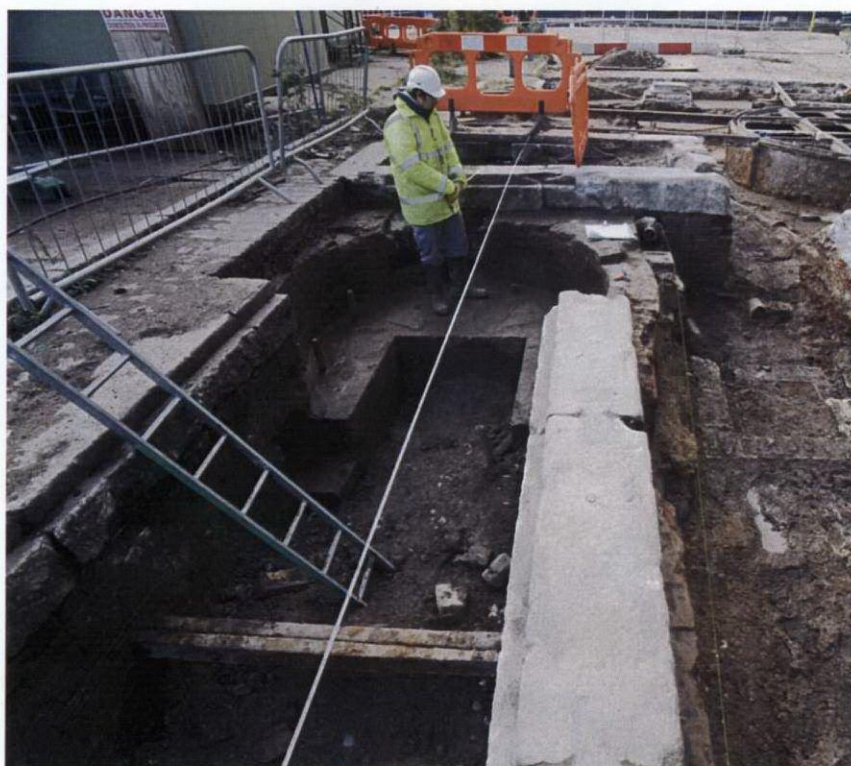
**Image 2:** Detail photo of Crane base 1 looking west

The remaining coping stones sit on brick foundations. Brick foundations also remain connected with the central circular section, and this section also features sandstone blocks at its base. Masonry floors have been uncovered in both rectangular sections, both at approximately 1.5m below the top of coping level (see Image 2).

In terms of function it is suggested that the circular section may have housed the turning mechanism, with metal fixings potentially for the crane being uncovered during the archaeological investigations (and visible in Image 2). The smaller western rectangle probably formed the machine house possibly for the turning mechanism. Metal hydraulic pipes and cast iron water pipes were found in this location. The exact purpose on the larger rectangle is unknown although it may have housed the hydraulic pistons providing the power to lift the hook.

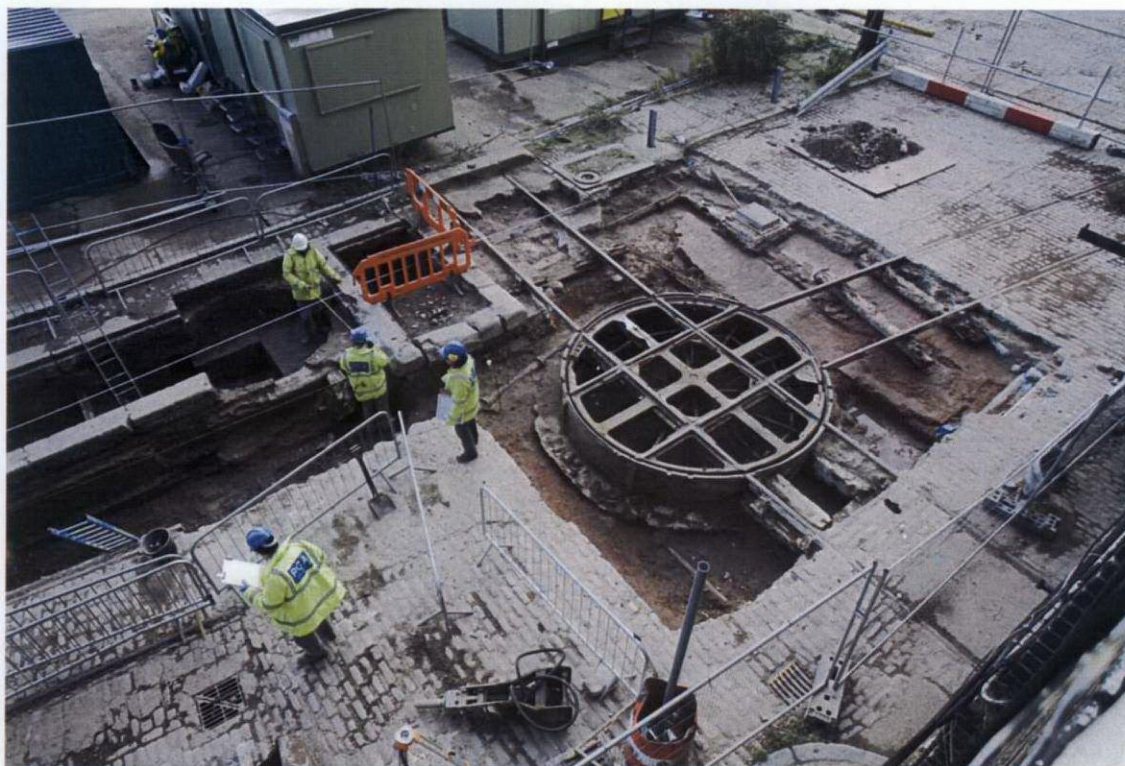
Image 3: The relationship of Crane base 1 and Turntable B

The remains of Turntable B and Crane Base 1 were found next to one another (Image 3.) Documentary evidence suggests that there was a strong relationship between the function of the cast-iron turntable and crane. Wagons would be loaded on the basin-

side (Railway Line J) and then shunted into the Western (Down) Transit Shed (via Railway Line 1); this required the wagons to be turned through 90° on the turntable. It should be noted that the rails of Railway Line 1 (1.36m) were of a different gauge to those of Railway Line J (surviving rails to the west of Turntable B were 1.40m in gauge).

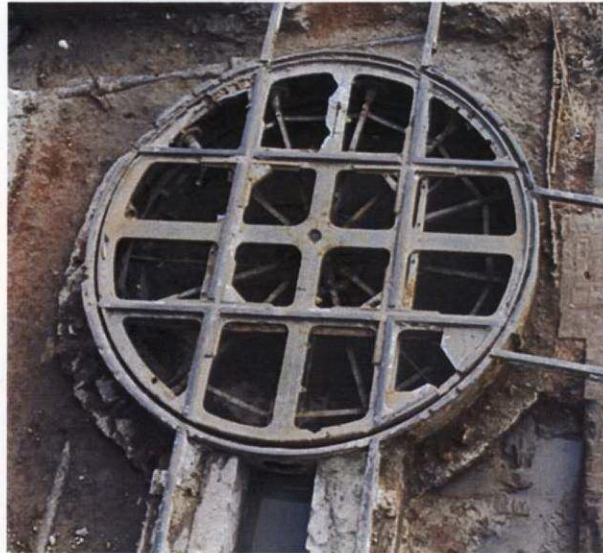
**Image 4:** Turntable B details

The turntable itself was 3.66m in diameter (approximately 12') and the design followed Charles Heard Wild's patented of 1847. It is likely that the turntable was manufactured by Ransomes and May of Ipswich and delivered to the King's Cross Goods Yard in 1850.

The turntable was composed of a reinforced the outer drum and a revolving mechanism consisting of spokes with circular metal wheels attached to the end. A full description of the turntables operation can be found within the report titled *Feasibility Study into the Restoration of Turntable B* which can be found in Appendix 3. The turntable is composed of both cast- and wrought-iron elements. The larger elements (outer drum, top-surface and wheels) would most likely be form of cast iron while the smaller elements are probably of wrought-iron construction.

From an initial visual inspection it is not envisaged that any cast iron components will need to be repaired. Of the wrought-iron elements cracks and splits have been noted in several members which may require repair, and there is evidence of significant corrosion in places. However the extent of repairs required will not be known definitively until the sweep blast is completed.

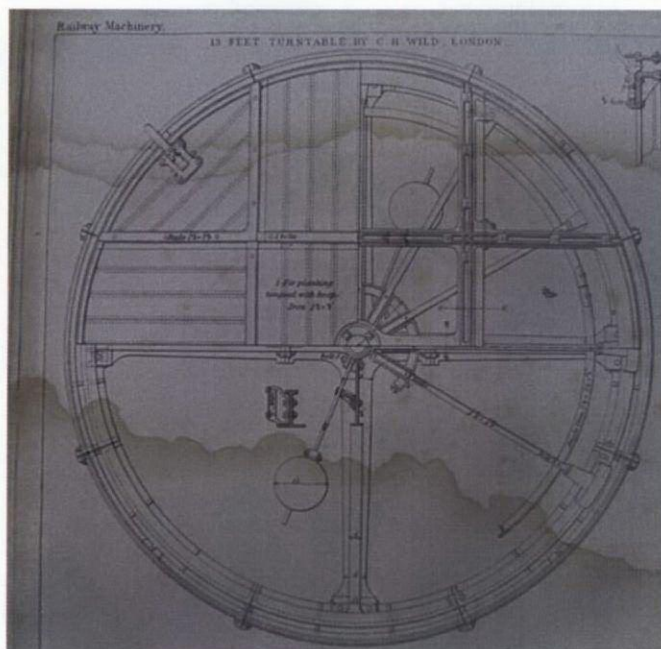
**Image 5:** Wild's Patent Turntable; image taken from D K Clark, Railway Machinery, 1855. as referenced in Smith, T. (2009)

The top surfaces of Wilds patented turntable were panelled with wooden planks (see image 5 below; although it should be noted that the version shown is a larger type with counterbalance weights).

- There is some dispute as to whether wooden blocks are the historically correct surface finish. Records suggest that the original surface of Wilds Patented Turntables were covered in planks rather than blocks (see Image 5 reproduced in Section 4 of this document). As such it is felt that the use of planks, orientated to match the available historical evidence, would be appropriate.

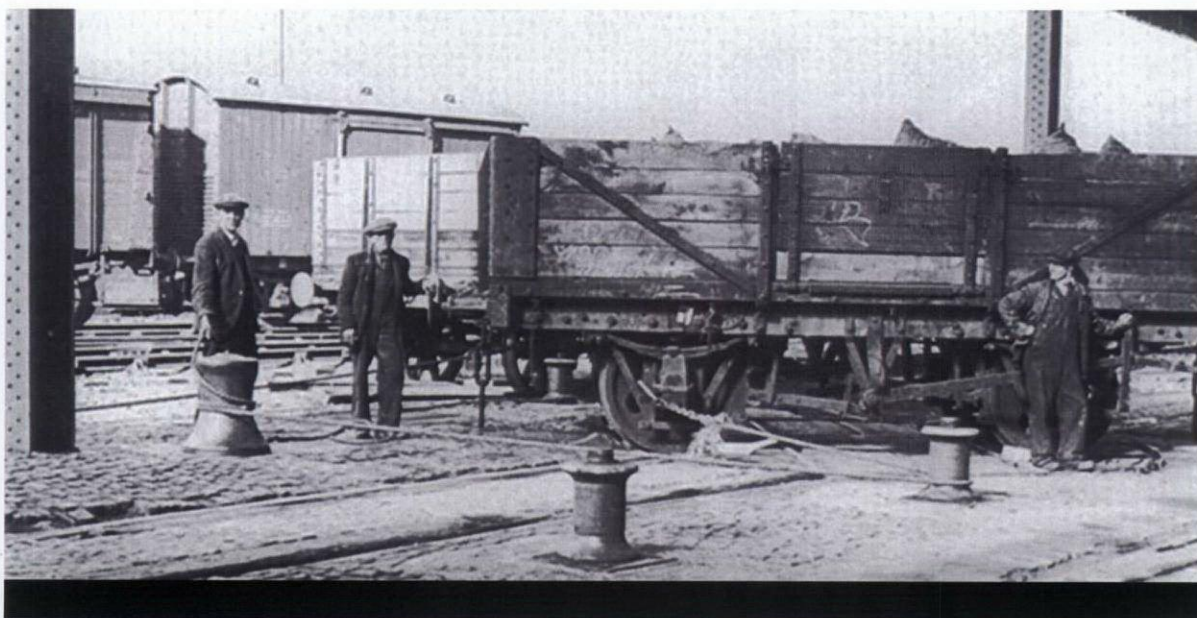
Hydraulic capstan shunting was introduced to the Goods Yard after August 1881. It is likely that Capstan B was installed at around this time. Documentary evidence from the early 1930s suggests that the exterior capstans may have been used both to rotate the adjacent turntable (see image 6) and to assist with the shunting of wagons.

Unfortunately as can be seen from image 7, the capstan box was the only element of capstan B which was found on site.

**Image 6:** An example of a capstan (and associated fairleads) rotating a wagon turntable. Photo location unknown.

**Image 7:** Capstan Box B as found

The Capstan B box is to be reintroduced into the public realm in the location from which it was removed. Unfortunately the box is the only element of Capstan B which was found on site; the whereabouts of the hydraulic mechanism and capstan itself (i.e. the spindle) is unknown.

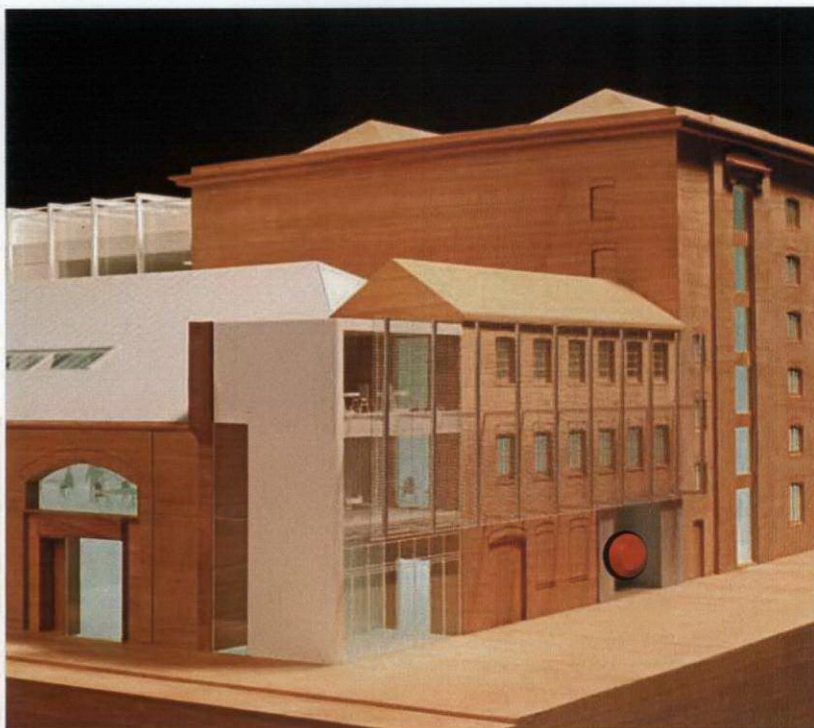
**Image 8:** Outline model of the West Granary Office with retail entrance marked.

The heritage items will be located directly to the south of the West Granary Office, with Turntable B located in front of one of the main doors into one of the Western Transit Shed retail unit (see drawing LD9736 and image 8). The cluster will also be on the desire line for pedestrians wishing to access Stables (nee Transit) Street. As such is expected to be significant foot fall within the area.

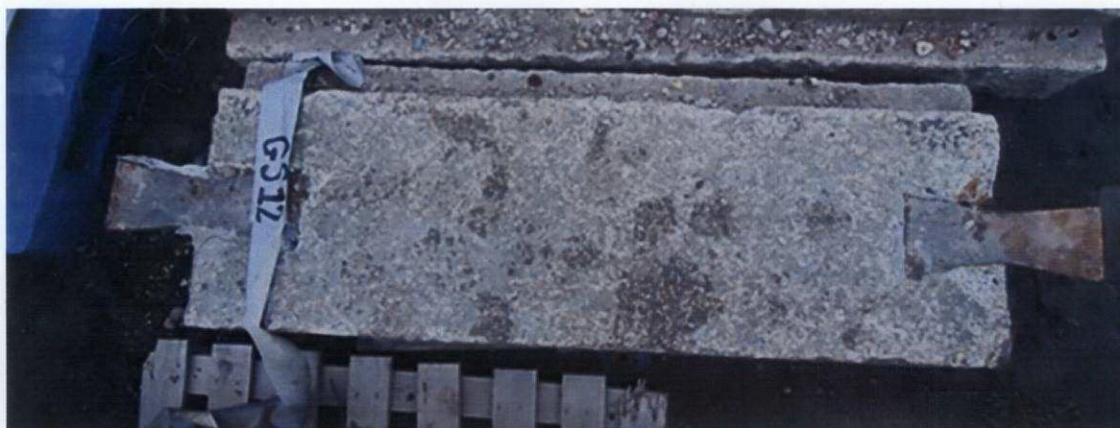
**Image 9:** Detail Image of Existing Crane Base Coping Stone

The surviving coping stones are generally free from damage, being relatively rectangular in section (see image 9). As such the hard landscaping can be brought

tight and flush to the coping stones, with a slightly recessed mortar joint to the edge. The inner lower lip of the coping stone will be covered by reclaimed setts; although the coping stone will not be damaged.

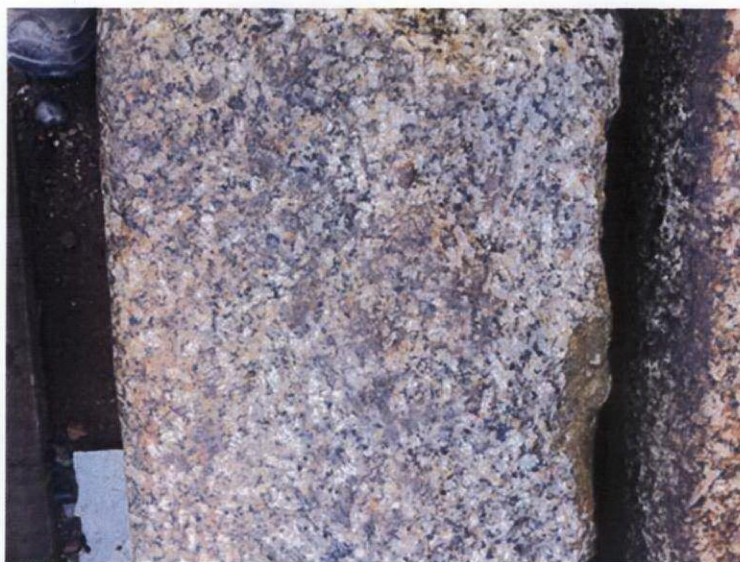
**Image 10:** Detail Image of site won granite kerbs

A small number of the coping stones have suffered surface damage and/or are cracked (see Appendix 4) and to introduce them into the hard landscaping 'as-found' would leave significant trip hazards within the public realm, particularly where the edges have been rounded. As such repairs will be undertaken to a limited number of stones; the methodology for which can be found in Appendix 6. Where infill material is required, site-won granite kerbs will be used (see image 10). This will be fixed via a combination of dowel (where possible) and mortar. The mortar surround will make the area of contemporary repair apparent, but the use of a sympathetic material will prevent the crane base as a whole appearing aesthetically like a patchwork.

Where the coping stones are missing from the central, circular section the idea of installing replacement copings was considered. These could also be fashioned from site-won granite kerbs. However this was not considered particularly honest given the scale of the contemporary insertion required. Rather the proposal is to use an obviously contemporary material – porphyry - to outline the central section of the crane base. This mirrors the strategy used with respect to the canal basin outline which runs around the square; a similar historic feature which is echoed in the hard landscaping utilising contemporary materials.

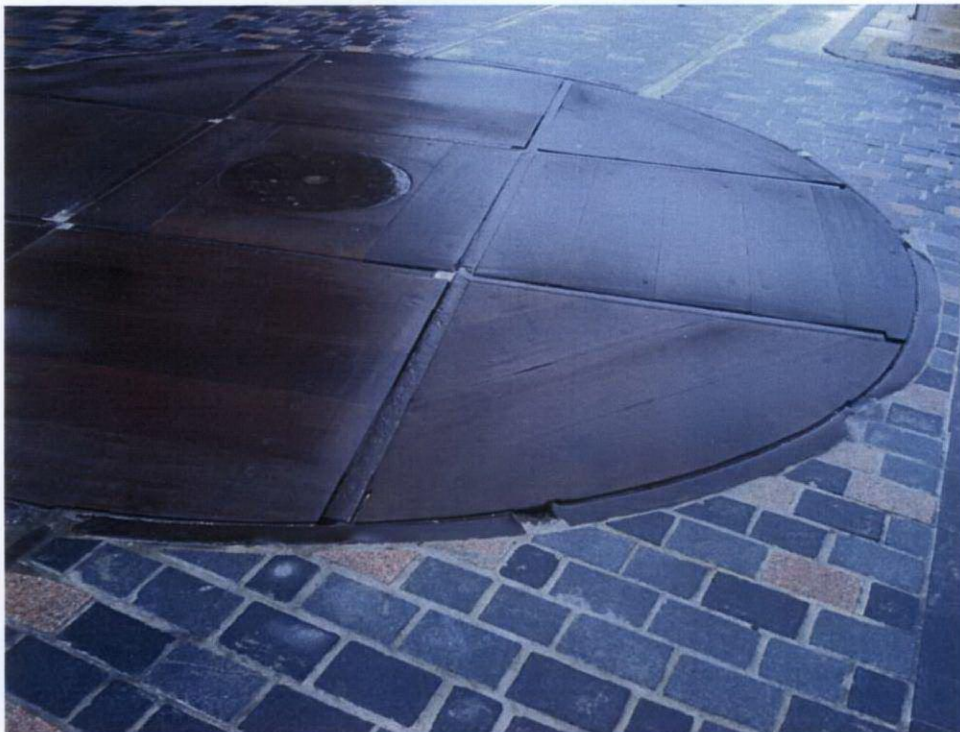
**Image 11:** Reference image. Reuse of a historic turntable within the public realm in Hull.

The design team has looked for comparable uses of the turntables in the public realm. The most relevant example found was in Hull (see Image 11).

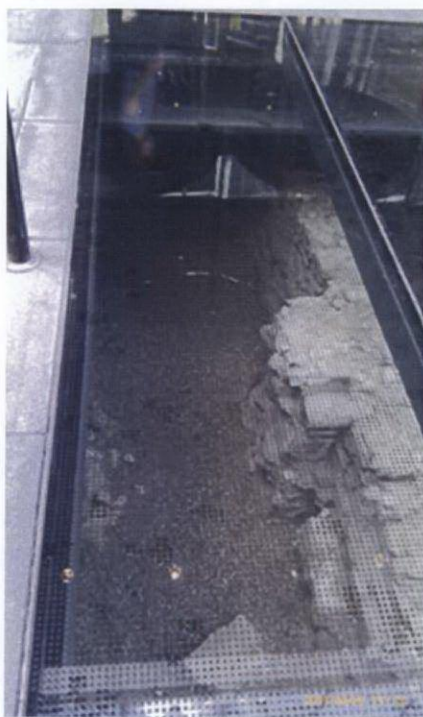
**Image 12:** Spitalfield Market, London

The glass will be capable of taking pedestrian traffic only. It will feature a slip-resistant dot-matrix pattern. The exact regime of the dots is yet to be established, however two examples have been reviewed by the design team and are included here for reference (Images 12 and 13).
