Client:
STANTON WILLIAMS LTD

Project:
**51 FITZROY ROAD,
LONDON**

Title:
TREE CONSTRAINTS PLAN

Drawing Number:
6960/01

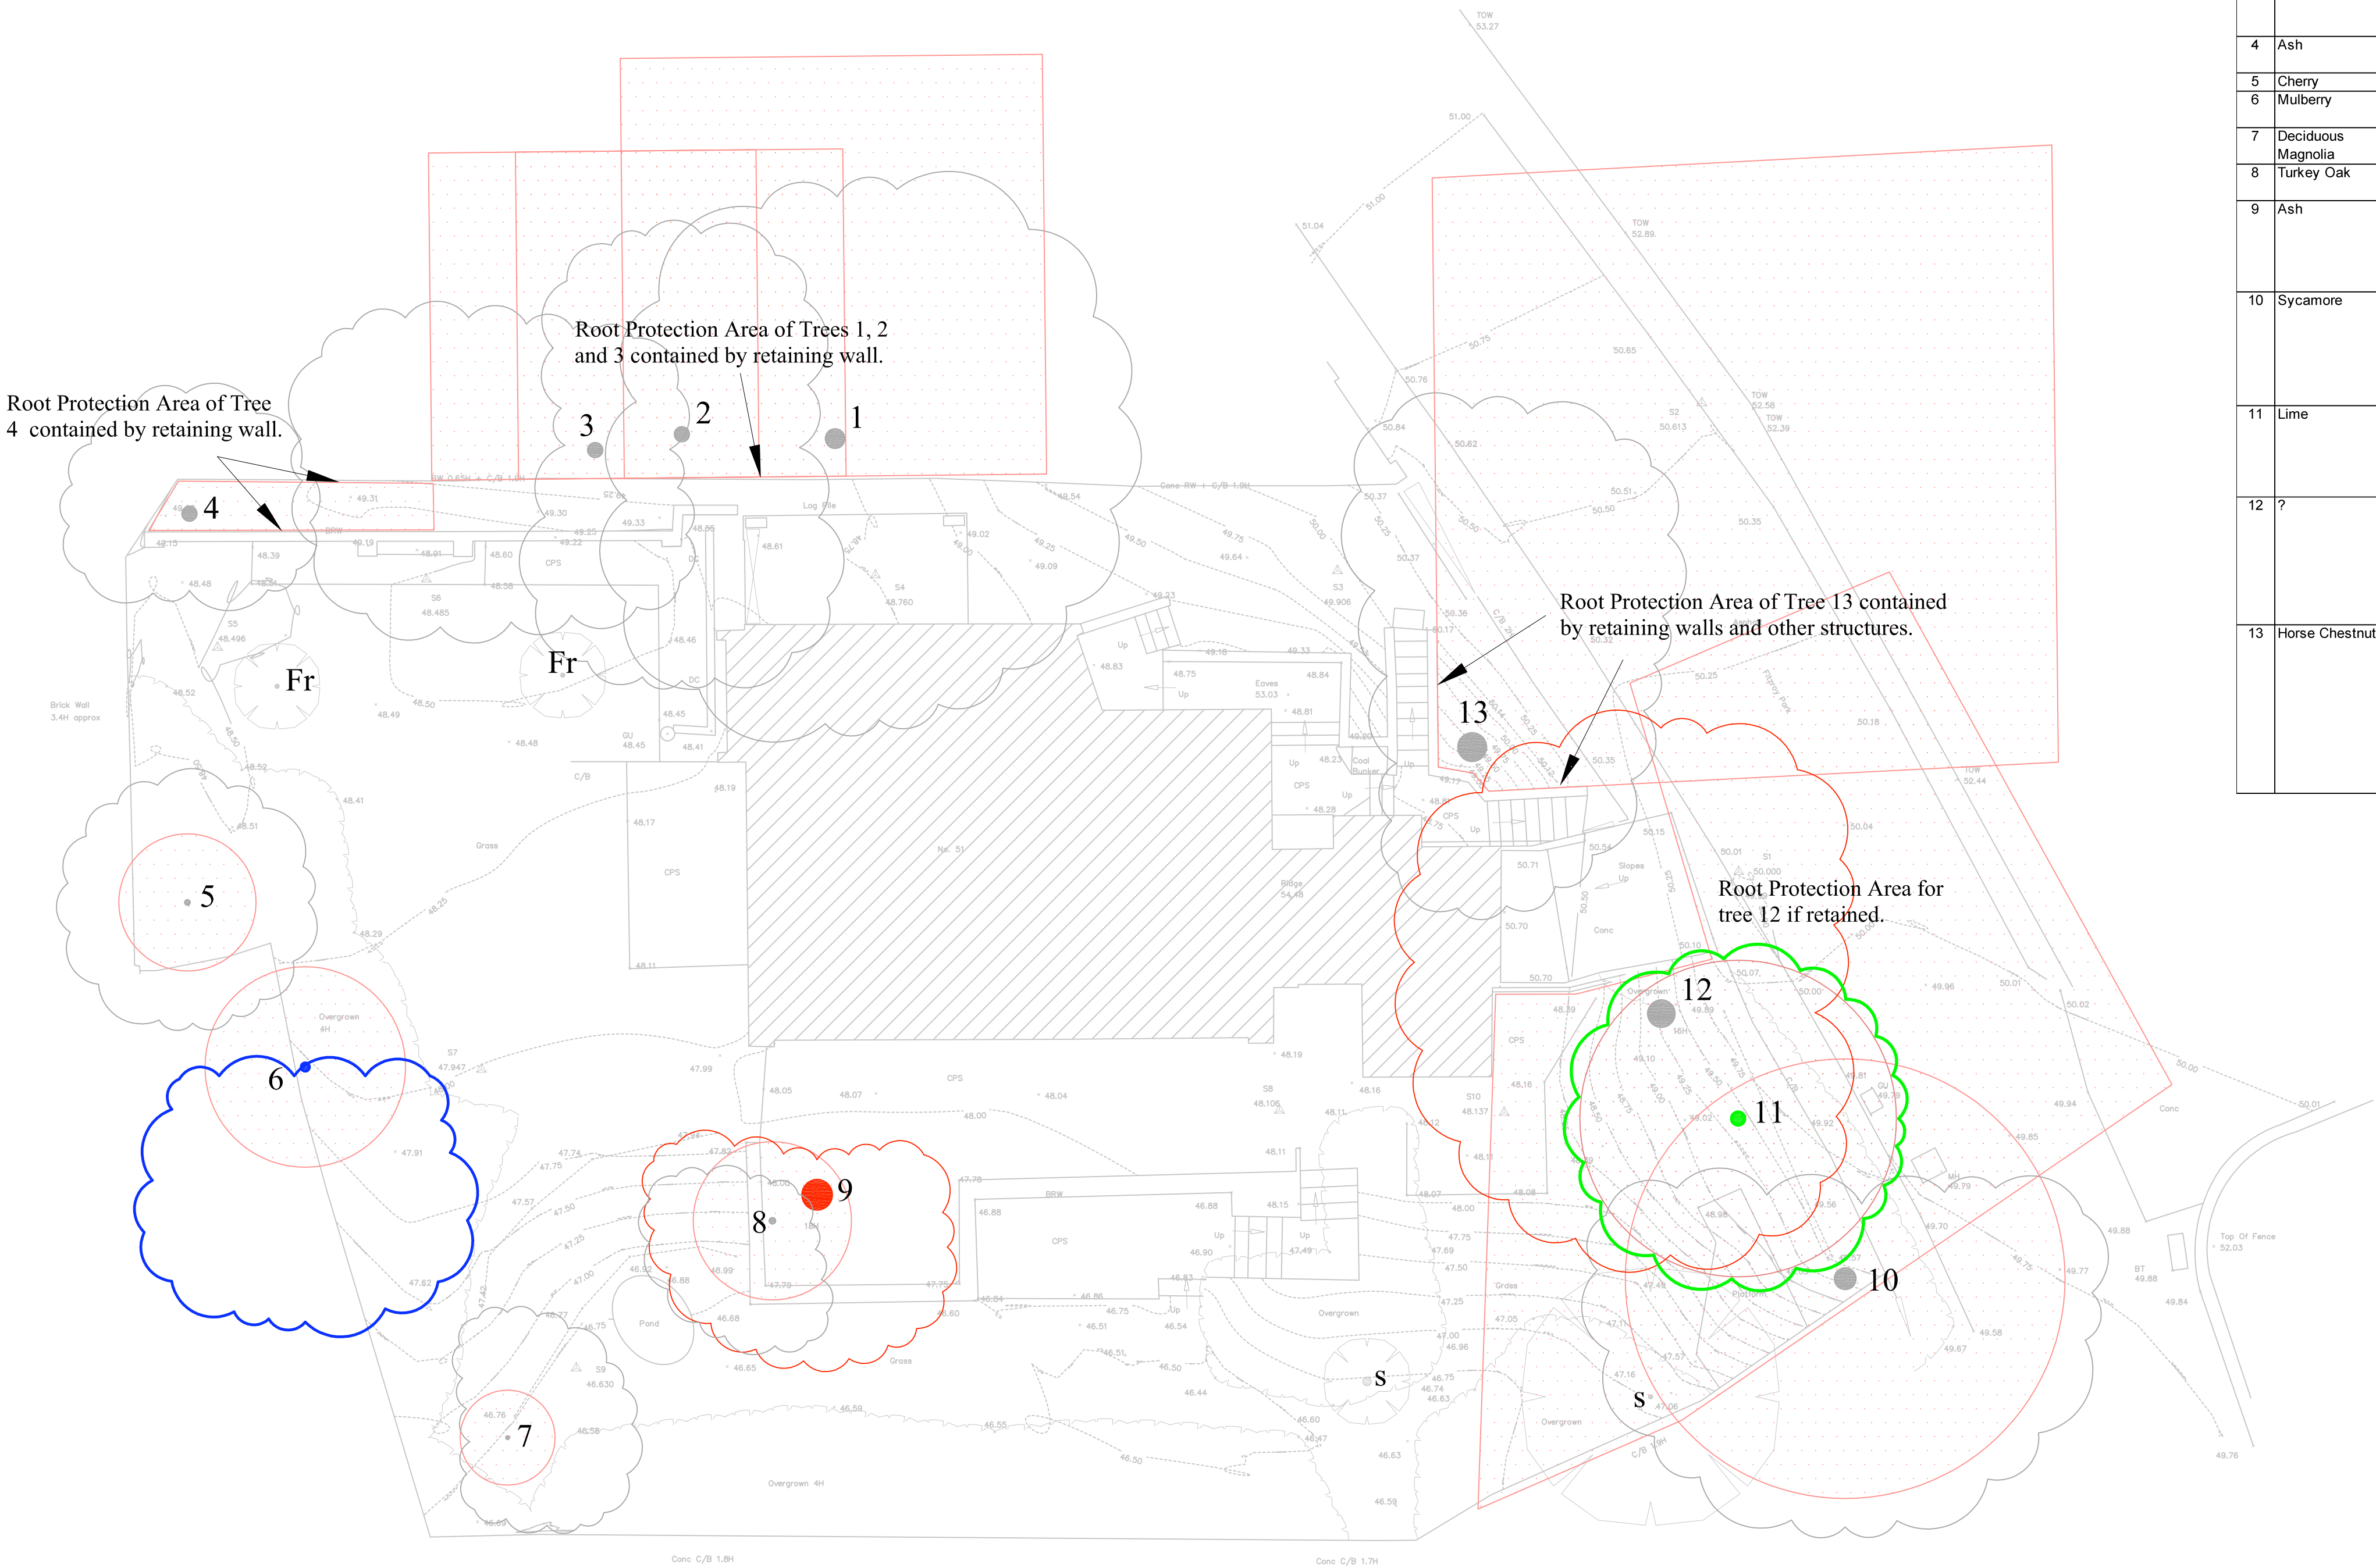
51 FITZROY PARK, LONDON													
Tree No	Species	Ht (m)	Branch Spread (m)				Stem Dia (cm)	Height of crown clearance (m)	Age class	Category grading	Estimated remaining contribution (yrs)	Condition Physiological / Structural	Preliminary management recommendations
			N	E	S	W							
1	Ash	16	6	7	7	6	45e	7	M	C1	>10	Off-site tree that appears to have been pollarded in the distant past at approximately 7 metres above ground level and subsequently regrown. Some decay is evident at the pollard points and the tree may require repollarding at some point in the near future.	
2	Ash	15	5	3	6	3	35e	6	MI	C1	>10	Off-site tree the crown of which consists of three main stems all of which are densely smothered in ivy preventing thorough inspection.	
3	Ash	13	3	2	4	7	35e	6	MI	C1	>10	Asymmetric due to competition with adjoining tree and some decay evident at old pruning points.	
4	Ash	7	3	3	2	3	35m & e	4	Y	C1	>10	Growing in raised bed.

5	Cherry	7	3	3	3	3	13	3	Y	C1	>10	Possibly of self-set origin.	
6	Mulberry	7	0	3	6	3	19	2	Y	B1	>20	Useful tree although, typical of species, leans acutely.	
7	Deciduous Magnolia	7	3	3	2	1	9	1	Y	C1	>10	Of poor shape and form.	
8	Turkey Oak	6	1	1	3	3	15	2	Y	C1	>10	Of poor shape and form suppressed by adjoining Ash.	
9	Ash	15	1	3	4	4	70	3	M	R	<10	Heavily pruned on northern elevation and extensive decay within main stem between 5 and 8 metres above ground level. Numerous woodpecker holes indicate decay is extensive. Small pocket of decay noted at ground level.	Unsuitable for long-term retention.
10	Sycamore	17	2	6	6	6	50m & e	2	MI	C1	>10	Large visually significant tree however it consists of two main stems with fespiparous union at just above ground level. Such unions are prone to failure and therefore the tree's long-term retention is unviable. Both stems are smothered in ivy preventing thorough inspection.

11	Lime	15	4	4	4	4	30e	5	MI	A1	>40	Good quality tree with potential. Main stem smothered in ivy preventing thorough inspection but appears to have been pollarded at approximately 4 metres above ground level and subsequently regrown.	
12	?	?	?	?	?	?	63	5	M	?	?	Ivy has recently been severed and allowed to die and fall from the main stem revealing poor union at approximately 5 metres above ground level with prominent branch bark ribs on each side indicating weakness within the fork and is compounded by extensive decay at same level as a result of limb loss.	
13	Horse Chestnut	13	8	4	4	2	66	3	M	C1	>10	Height clearance given is to lowest limb extending in a northwesterly direction. Height clearance to the west is unrestricted due to pruning that has occurred in the past that has included an overall crown reduction. The tree is visually significant, however, as with most Chestnuts, it is suffering with two folia disorders Leaf Minor and Guignardia, as well as showing signs of infection with phudamonous canker.

Note to design team
Turn off layers IKLAYERR, IKLAYERC and IKTREEPROTC. Prepare design layout without invading remaining root protection areas or consult us before proceeding if invasion is unavoidable. Turn IKLAYERC and KROOTPROTC back on and retain any trees on that layer where their root protection area is located outside your proposals. Return final layout design to us for completion of tree protection drawing to meet your desired scheme.
