FLAT 4  
42 Belsize Sq.  
London  
NW3 4HN  
3rd Oct. 2011

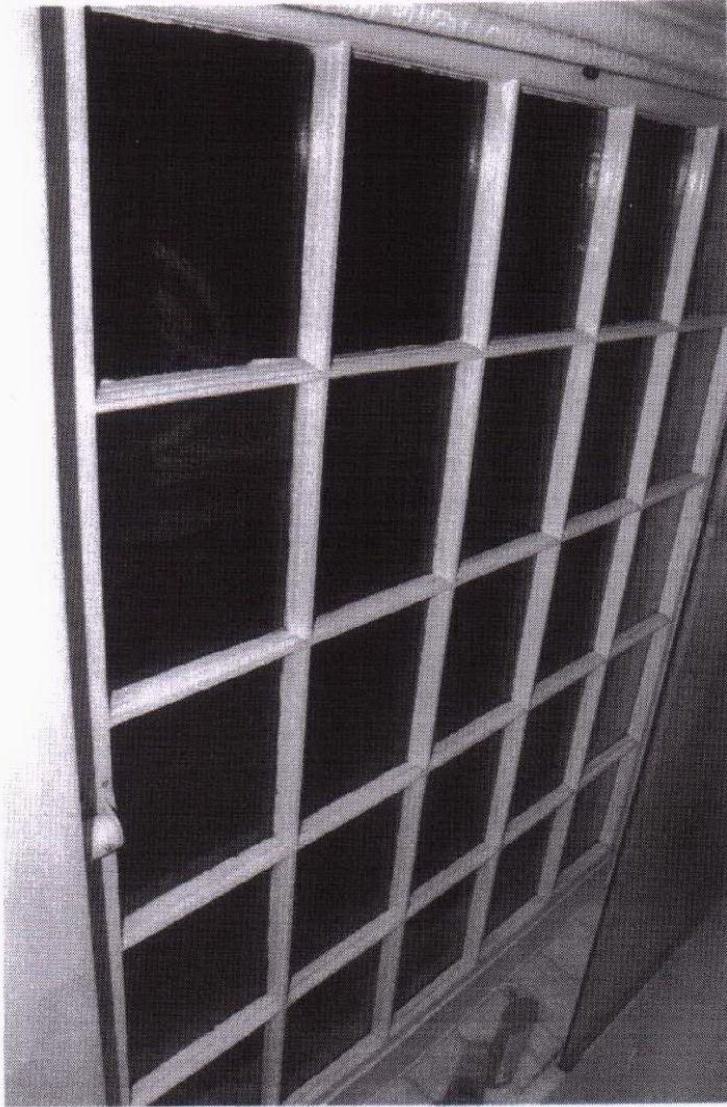
Photo 1E

PHOTO 1E - VIEW OF EXISTING WINDOW

NOT TO SAFETY STANDARDS

AND DANGEROUS FOR

BATHROOM SETTING

Existing Window:

Pivot style opening on a horizontal axis.

No ventilation.

Not to regulation standards.
