Contents

1 THE SITE

CAMDEN LOCK VILLAGE: BUILDINGS DESCRIPTION SEPTEMBER 2011

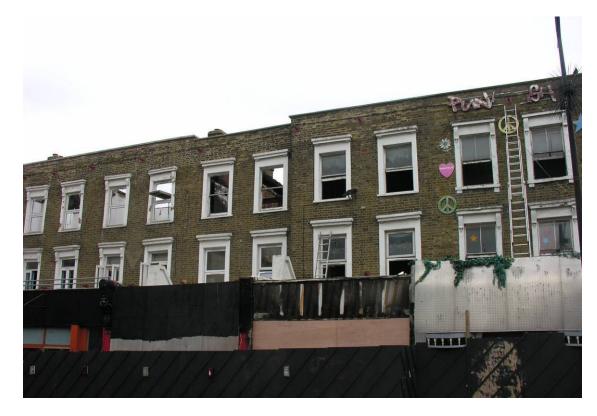
Nos. 1-6 Chalk Farm Road.

Six terrace brick buildings. Three storeys high. Later additions project forward to the front of numbers 1-5 and all had later rear extensions now lost because of the fire.

Only the structure and external walls remain. The basements have been in-filled as part of the stabilisation of the structures. Roofs and floors are currently being replaced.

The fenestration suffered extensive damage and will need replacement.

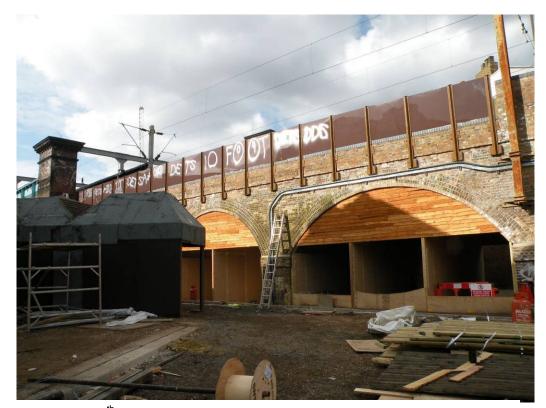
The public house and shops at Nos 7-8 (the former Carnarvon Castle) and No 9 Chalk Farm Road were demolished on 12th February 2008 after the buildings were ravaged by the Camden fire.

The former Nos 7 to 9 Chalk Farm Road photographed on the 6th March 2009.

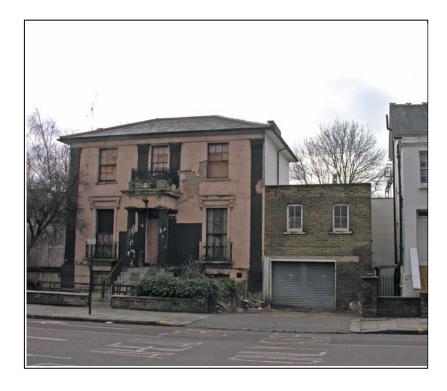
Fig. 23 No. 1 Hawley Road March 2009.

The listed building is in extremely poor condition. Apart from the alterations suffered by the 1C annex, the villa itself keeps its main features but for some losses in the lower floors. The columns holding the portico are made of painted concrete, as are the entrance steps.

The general condition is extremely poor. Large areas of stucco are cracking and detaching from the fabric exposing the brickwork in the background. Many of the sash windows are missing in both front and rear, and the entrance door (described in the listing) and backdoor are not original and thus assumed as the result of unauthorised removal. All the chimney pots are lost and no original pipes can be seen on any of the elevations.

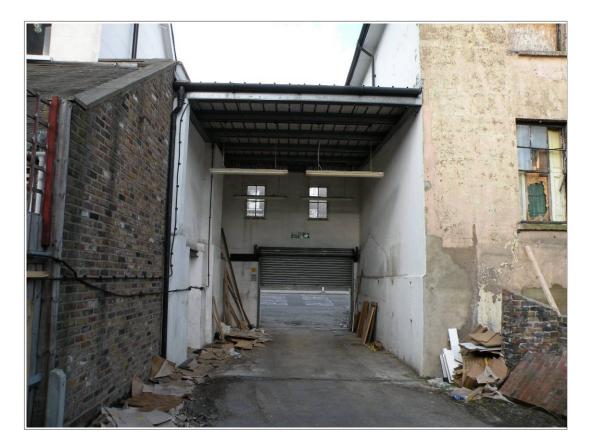
Fig. 30 The back of No 1 C.

The annex No 1C is now an empty space open to the rear, with a light industrial roof added probably in the last decade. The West wall of the villa appears to have been reinforced to receive such roofing, and the front elevation of No 1 C suffered the addition of 6 brick courses at the top provably to increase the height of the new roof.

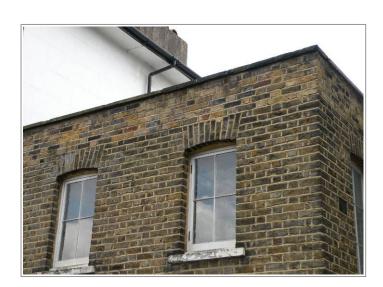
Fig. 32 Six courses brick addition at the top of No 1 C.

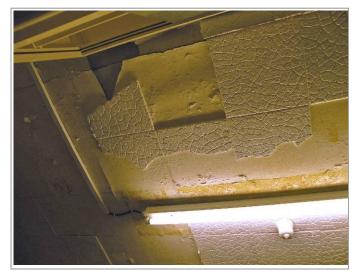
The majority of the rooms have extensive superposition of low quality ceilings and wall papers, every layer is damaged and the original substrate not recognisable. Original floors were not visible and thus identification was not possible.

Fig. 36 Superposition of ceilings.

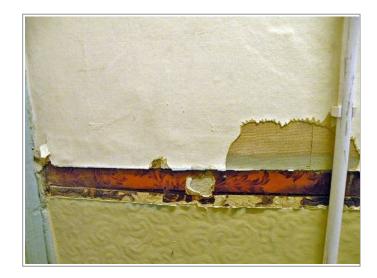
Fig. 40 Superposition of wall paper on the second floor.

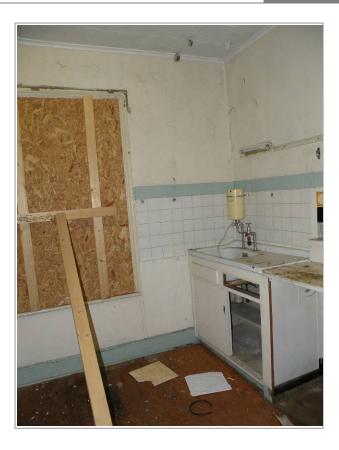
The house has suffered later and very poor kitchen and toilette additions, and has been vandalised throughout. It is presently used for storage but the designated use class is unknown.

Fig. 45 Kitchen addition at the lower ground floor.

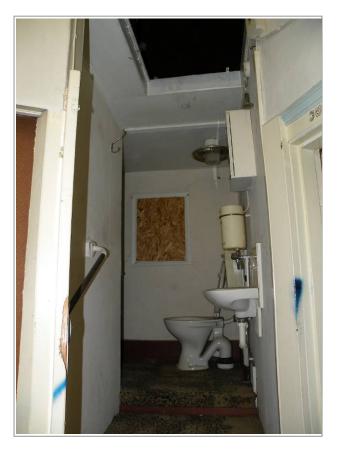
Fig. 46 Toilet addition in the first floor.
