**6 ERSKINE ROAD
LONDON NW3 3AJ**

**Phase 1
Environmental Assessment**

Report No. 3617

30 June 2011

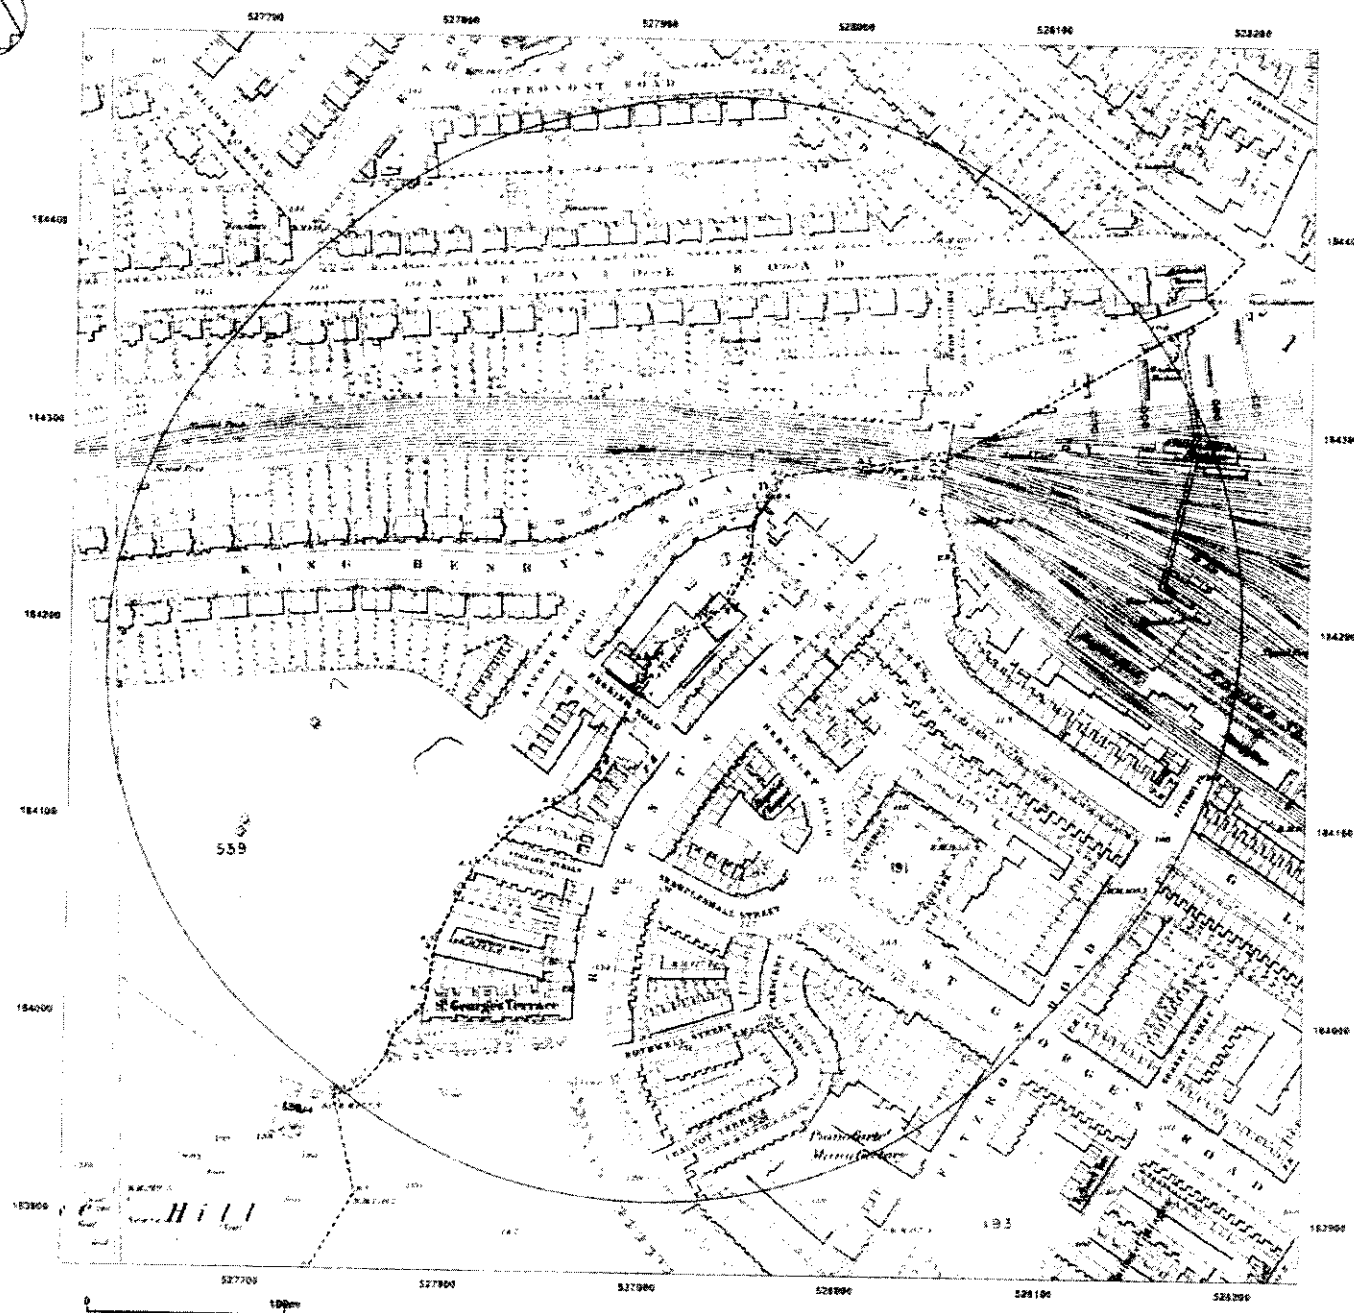
Figure B1

The site was a Timber Yard at that time and contained four buildings. The footprint of two of these suggest that Leeder House and Block 2 had been on site from the earliest map. The third

building lies towards the rear of the site and the fourth, a long thin structure, against the south west boundary of the site.

Extract from Ordnance Survey
County Series: 1871 - 1875

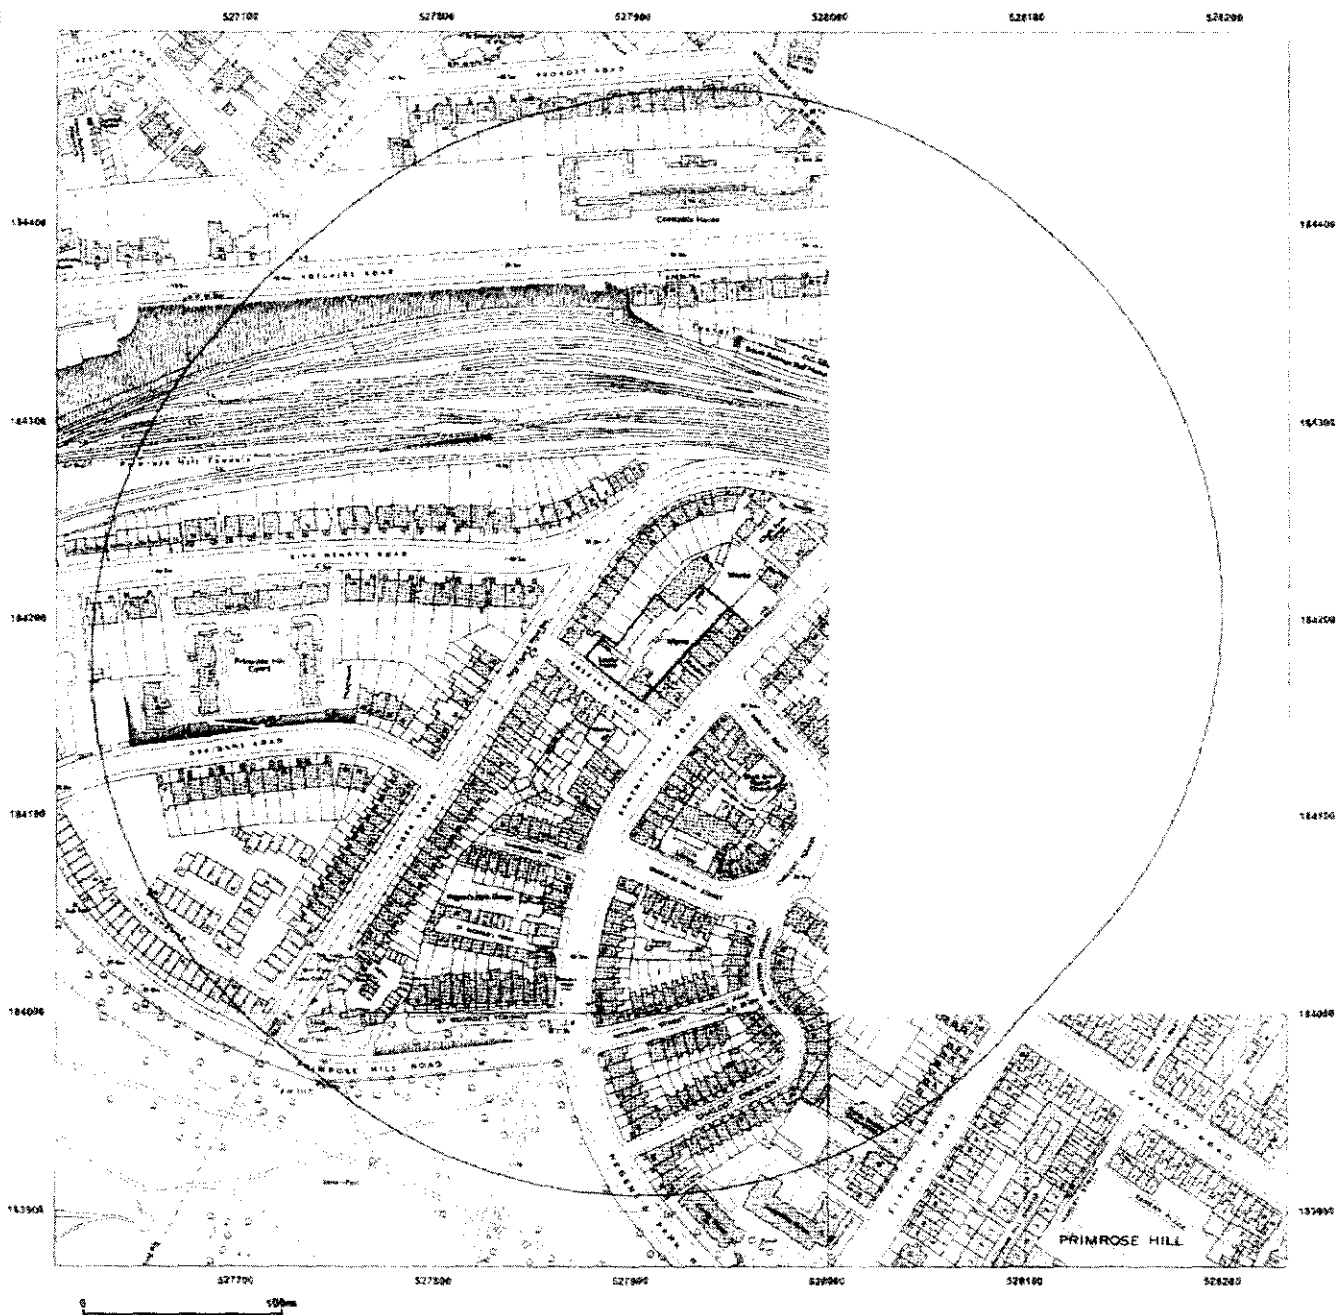
Figure B8

Although the full area of interest was not revised at this time, no significant changes are evident save for the Electrical Fittings Factory at 220 m south east now being the Public Health Department.

Extract from Ordnance Survey
National Grid: 1969 - 1972

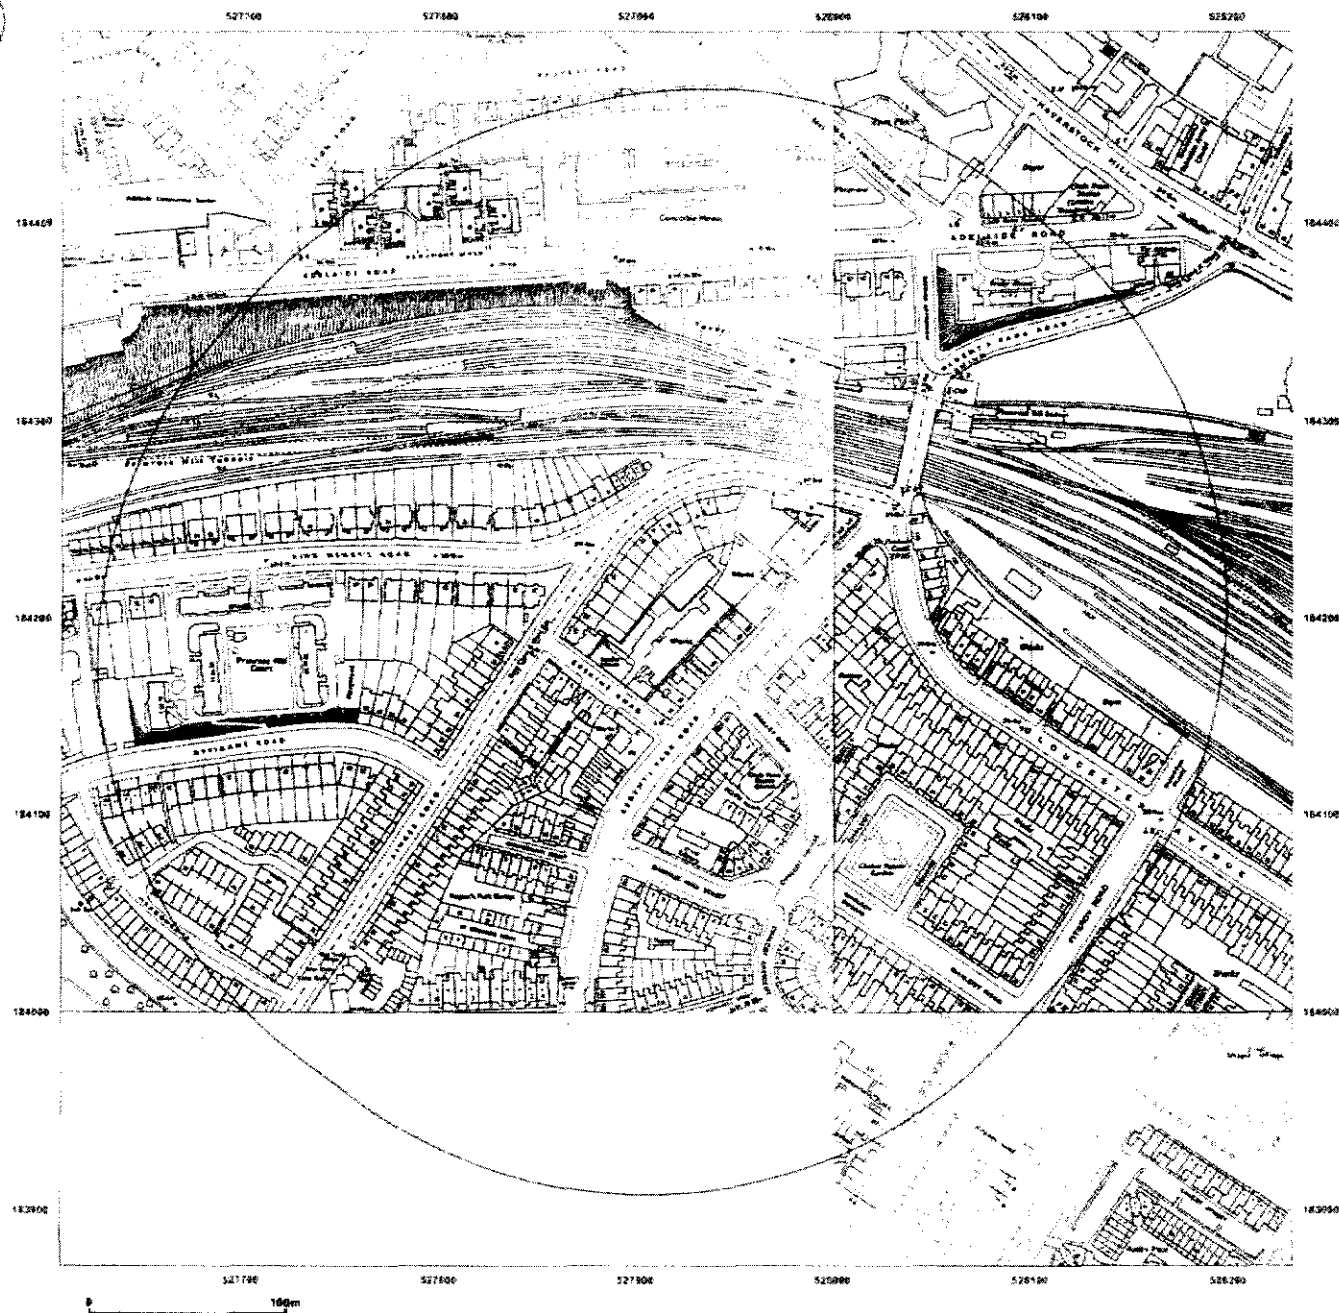
Figure B9

No changes are evident on Figures B9 & B10.

Extract from Ordnance Survey
National Grid: 1982 - 1987

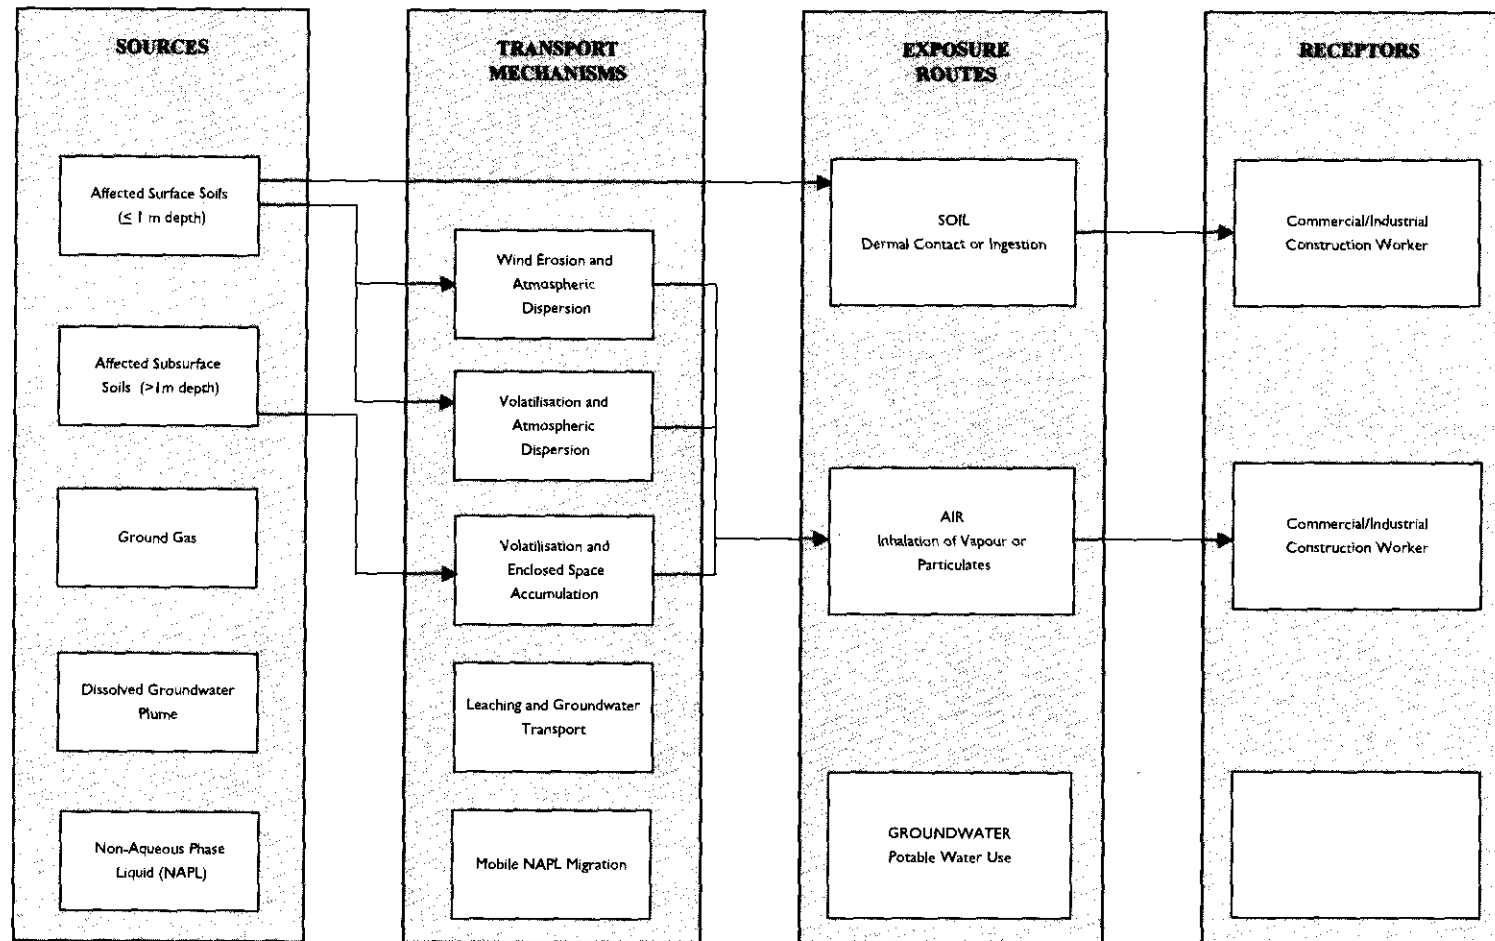
Part IIA of the Environmental Protection Act: 1990 stipulates that a source, pathway and receptor must all be present to form a potential pollution linkage. Based upon the findings of this Assessment, a preliminary conceptual model has been formulated for the source - pathway - receptor interaction and is presented at Appendix D.

PRELIMINARY CONCEPTUAL MODEL
6 Erskine Road, London NW3 3AJ
