**Phase II Geo-Environmental Assessment**  
11-13 St Pancras Way, London, NW1 0PT

**The Unite Group Plc & Travis Perkins (Properties) Ltd**

July 2010

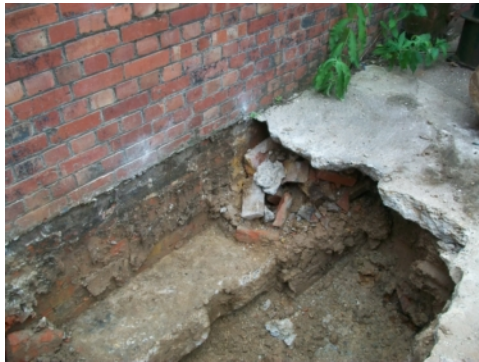
# TRIAL PIT LOG

Depth	Type	PID (ppmV)	HSV (kN/m <sup>2</sup> )	P Pen (kN/m <sup>2</sup> )	Water	Elev. (mAOD)	Depth (Thickness)	STRATA			
								Description	Legend	Geology	Install / Backfill
0.00 - 0.20	CORE						0.20	CONCRETE.		MG	
0.20 - 0.70	CORE						0.70	MADE GROUND: Soft, brown mottled grey, locally slightly silty clay with frequent cobbles of whole brick.		MG	
0.70 - 0.90	CORE						0.90	MADE GROUND: Very compacted, grey brown, clayey sandy gravel. Gravel is fine to coarse, sub-angular to sub-rounded flint.		MG	
0.90 - 0.95	CORE						0.95	Hole terminated at 0.95m bgl.

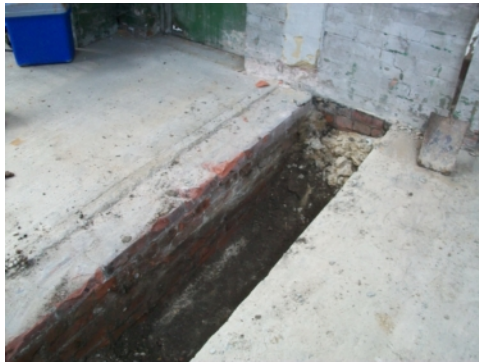
Depth	Type	PID (ppmV)	HSV (kN/m <sup>2</sup> )	P Pen (kN/m <sup>2</sup> )	Water	Elev. (mAOD)	Depth (Thickness)	STRATA			
								Description	Legend	Geology	Install / Backfill
0.25-0.35	ES						0.25	CONCRETE.		MG	
							0.25 - (0.10)	MADE GROUND: Brown, clayey gravelly sand. Gravel is fine to medium, sub-angular to sub-rounded, brick, concrete and flint. Sand is fine to medium. 0.25 - 0.35 m bgl slight non-discernible odour.		MG	
							0.35 - (0.17)	MADE GROUND: Brown to grey brown, slightly gravelly clay. Gravel is fine to coarse, sub-angular brick and occasional concrete.		MG	
							0.52	Refused at 0.52m bgl.

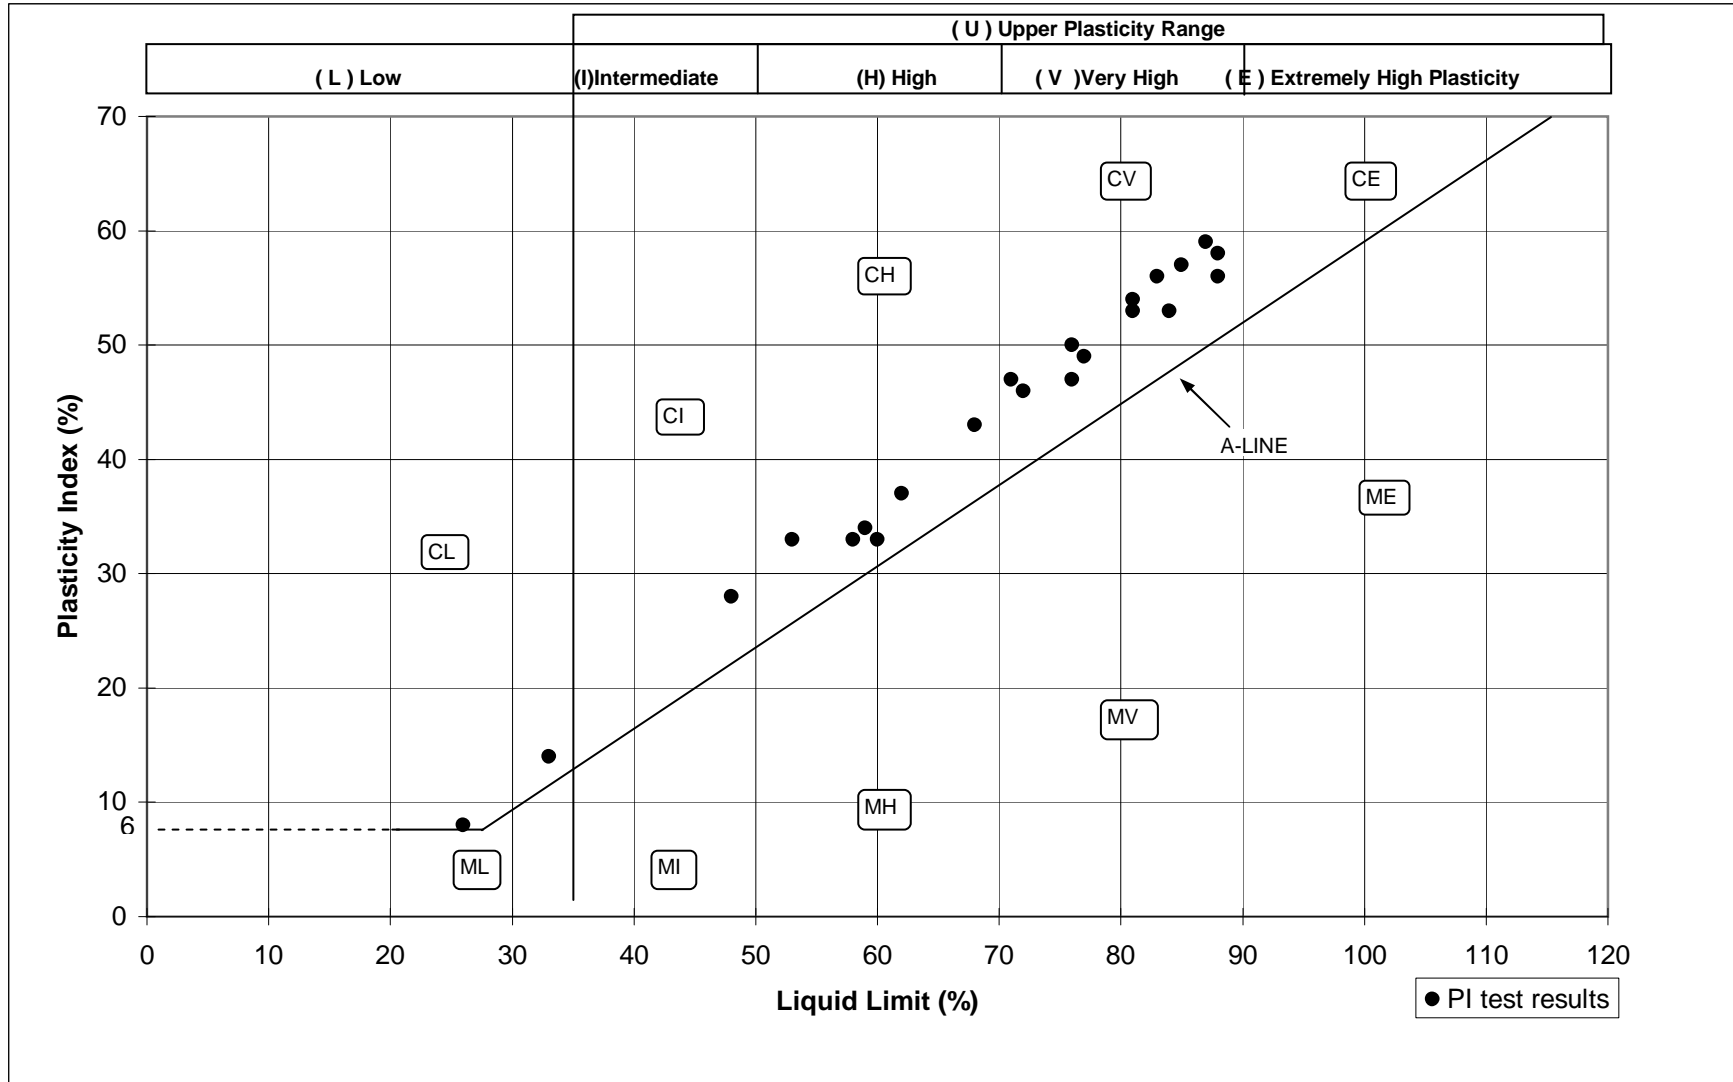
**PLASTICITY CHART from BS5930 : 2000**

Classification testing on the deposit indicated moisture contents to be between 19% and 31%. For the five samples of Lambeth Group, the liquid limit was recorded between 48% to 106%, the plastic limit varied from 20% and 35%. The plasticity index ranged between 28% and 71%. Rating the clay representing the Lambeth Group as intermediate to extremely plastic.

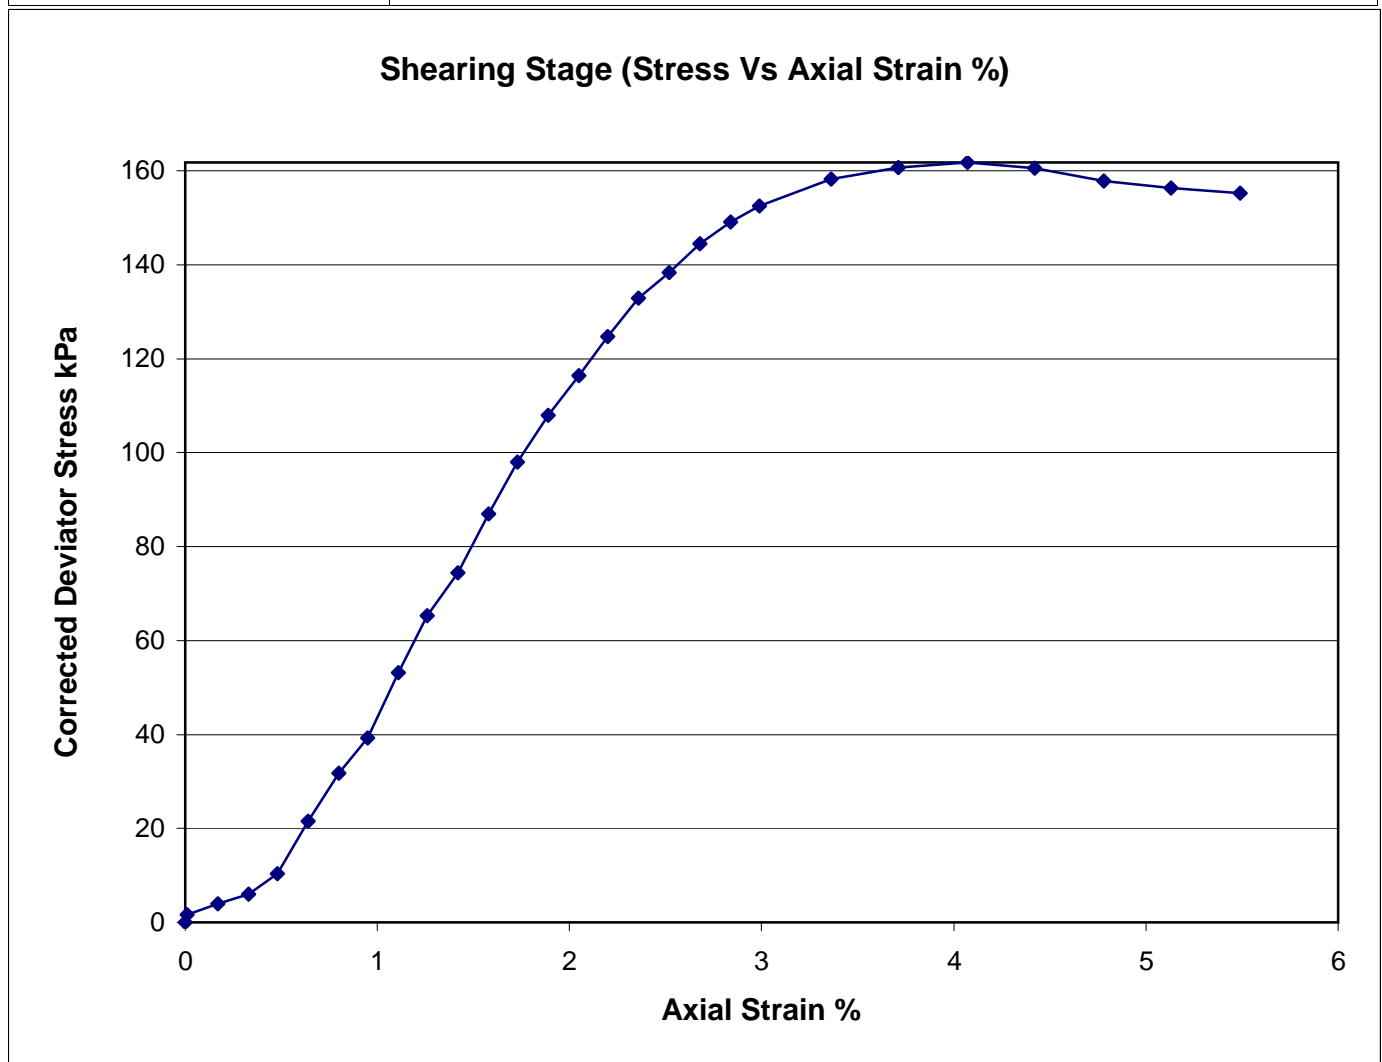
**Undrained Shear Strength in Triaxial Compression without measurement of Pore Pressure (Quick Undrained)**

Test & Sample Details			
<b>Standard</b>	BS 1377 Part 7 Clause 8	<b>Sample Depth (m)</b>	5.00
<b>Sample type</b>	Undisturbed sample - open drive	<b>Particle Density (mg/m<sup>3</sup>)</b>	2.65
<b>Variations from procedure</b>	None	<b>Lab temperature (°C)</b>	21
<b>Sample description</b>	Firm brown / light brown fissured CLAY with pockets of gypsum

Conditions at Failure			
Failure criterion	Maximum Deviator Stress		
Maximum corrected deviator stress (kPa)	162		
Axial strain (%)	4.1		
Corrected deviator stress (kPa)	0.0	Undrained shear strength (kPa)	81
Final Density (mg/m <sup>3</sup> )	1.91	Final Moisture Content (%)	30.3

**Mode of Failure**      **B**

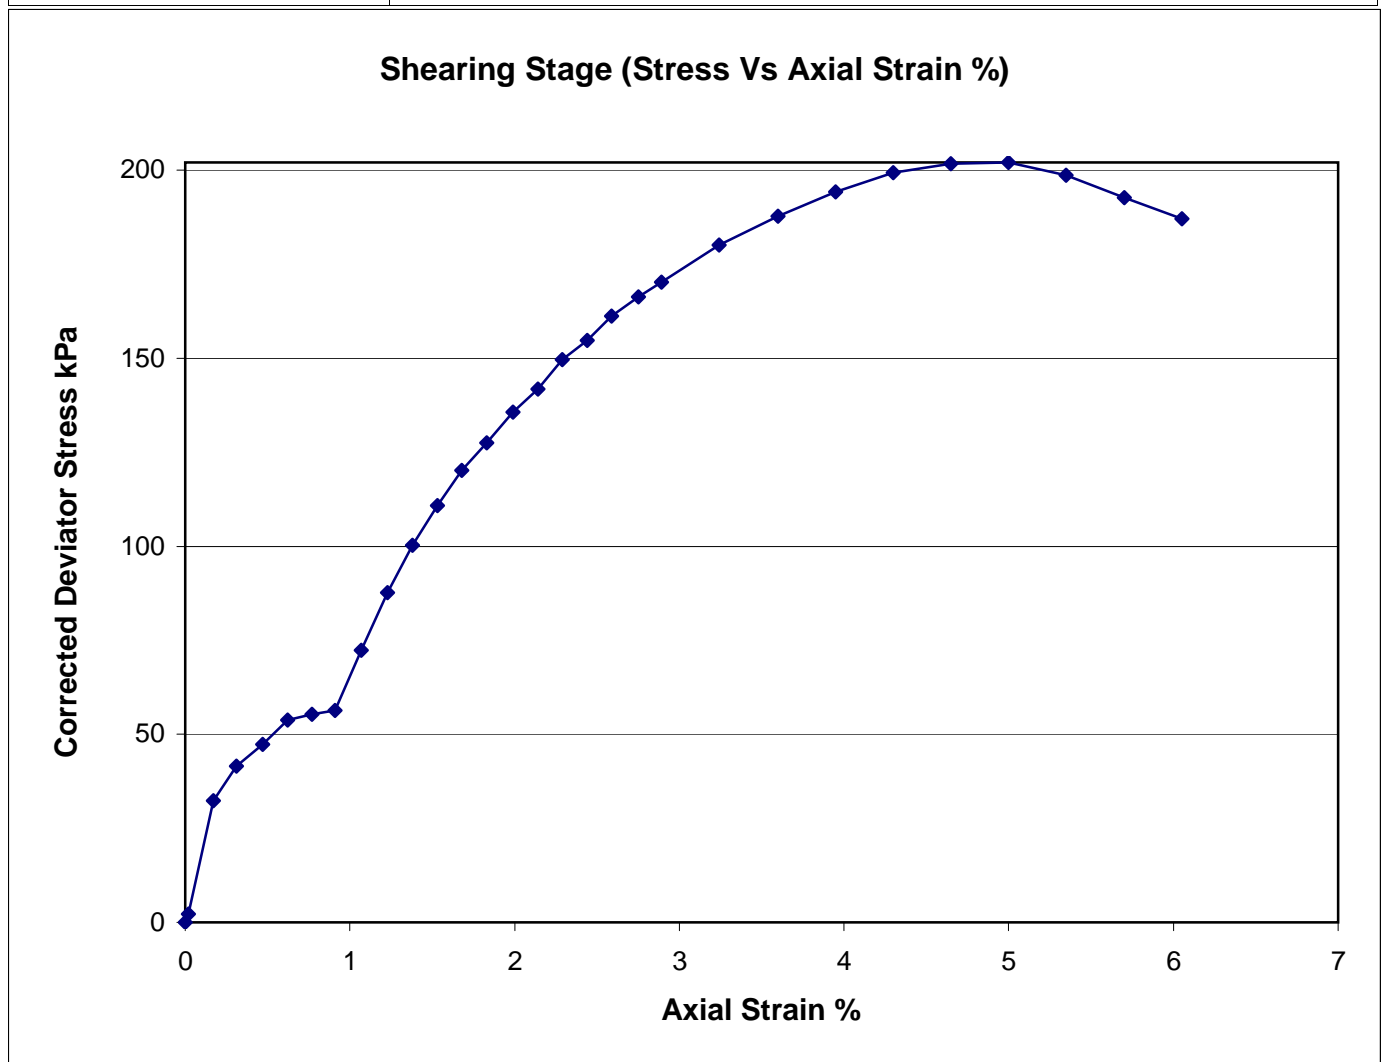
Test & Sample Details			
<b>Standard</b>	BS 1377 Part 7 Clause 8	<b>Sample Depth (m)</b>	8.00
<b>Sample type</b>	Undisturbed sample - open drive	<b>Particle Density (mg/m<sup>3</sup>)</b>	2.65
<b>Variations from procedure</b>	None	<b>Lab temperature (°C)</b>	21
<b>Sample description</b>	Firm brown CLAY

Conditions at Failure			
Failure criterion	Maximum Deviator Stress		
Maximum corrected deviator stress (kPa)	202		
Axial strain (%)	5.0		
Corrected deviator stress (kPa)	0.0	Undrained shear strength (kPa)	101
Final Density (mg/m <sup>3</sup> )	1.98	Final Moisture Content (%)	28.5

**Mode of Failure** **B**
