# Design & Access Statement

The Telephone Exchange,  
5 North Crescent, Chenies Street,  
London, WC1E 7PH

# Telephone Exchange Refurbishment

1030/DAS Rev - August 2010

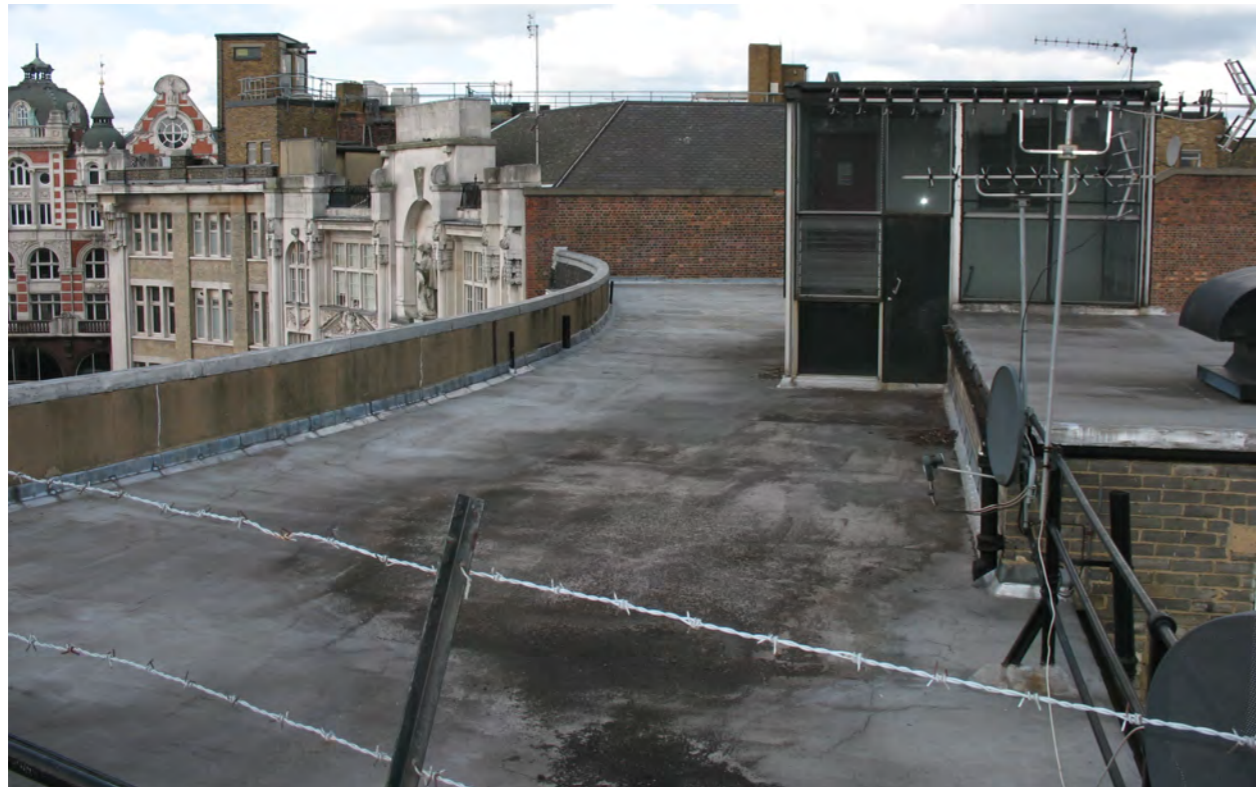
The existing asphalt roofs to both the front and rear buildings have deteriorated over time and have come to the end of their useful lives. We intend to lay new waterproof membranes across all the areas of flat roof. These new membranes will be light grey in colour (i.e. to match the appearance of the existing roof surfaces) and they will come with a minimum 20 year guarantee. In order to minimise disruption to the operation of the building the new roof surfaces will be laid over the top of the existing asphalt layers.

At present the flat roofs to both front and rear areas do not contain any insulation, the mastic asphalt covering is laid directly over the concrete structure. This causes the third floor office area to the front and the large first floor office space to the rear of the building, in particular, to be very cold in the winter and very warm in the summer.

PH09 - The poor condition of the existing asphalt surface to the front flat roof

During the process of laying the new waterproof membranes, we will take the

opportunity to install a 120mm deep layer of rigid foam insulation between the old and new waterproofing membranes in order to bring the thermal performance of the roof in line with current building regulations.

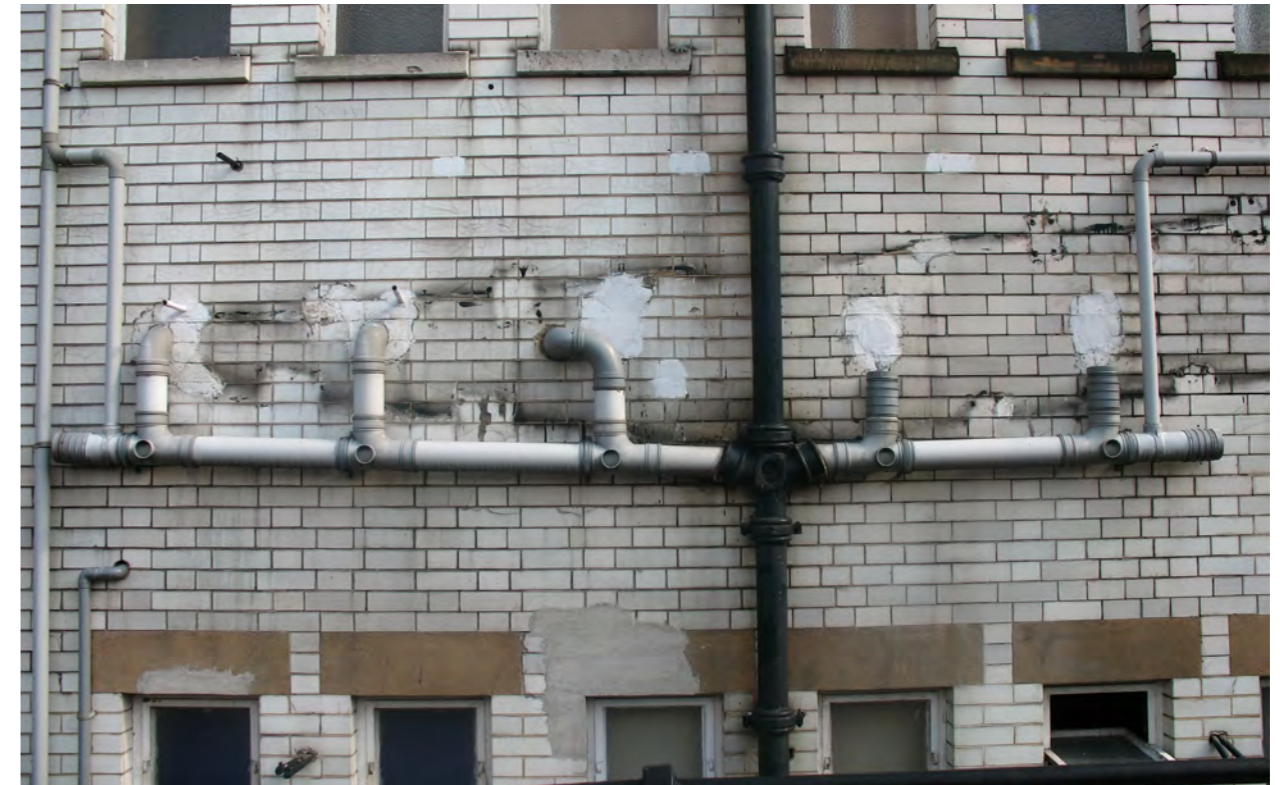
PH11 - The existing glazed faced brickwork to the rear wall of the front building

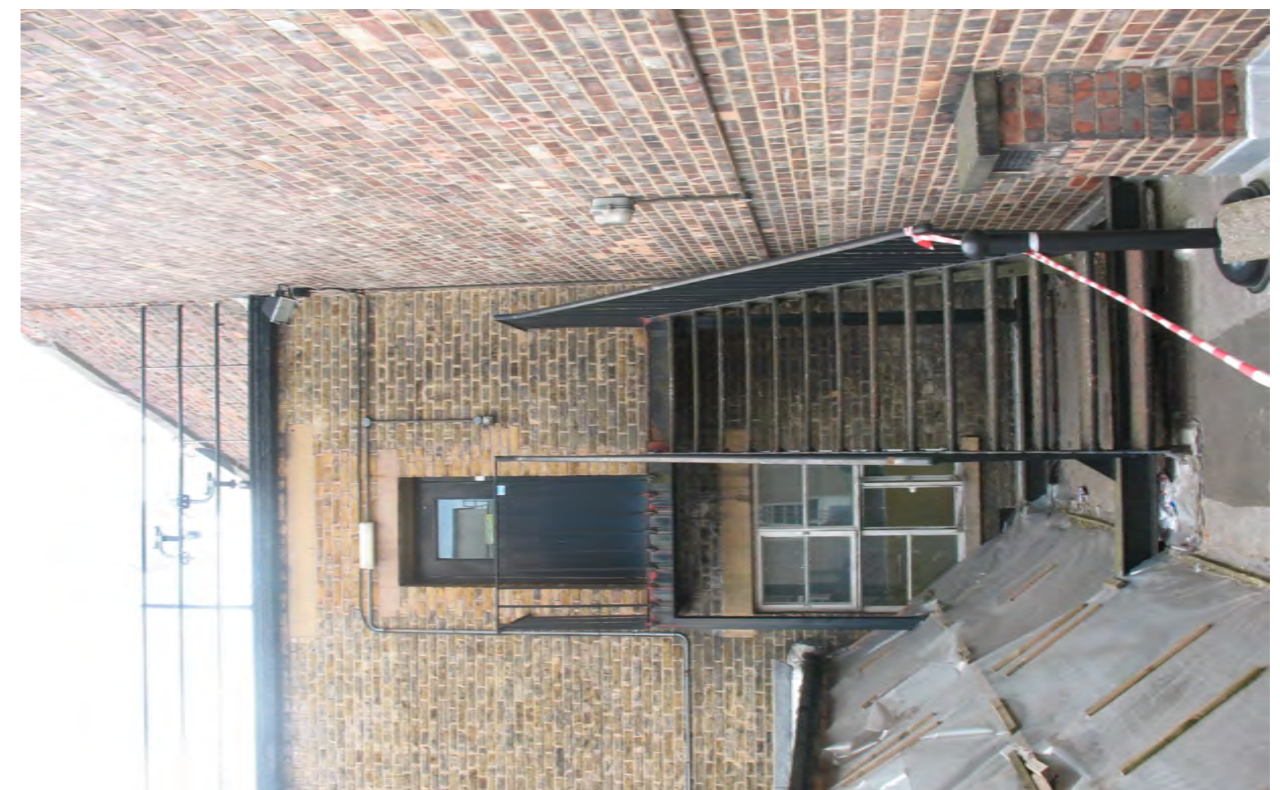
PH12 - The fire escape staircase to the rear of the front building

The two fire escape staircases (the first to the rear of the front building adjacent the party wall with Minerva House and the second to the side elevation of the rear building) will be removed of all rust, the condition of the steelwork will be investigated and they will be repaired and redecorated as necessary.

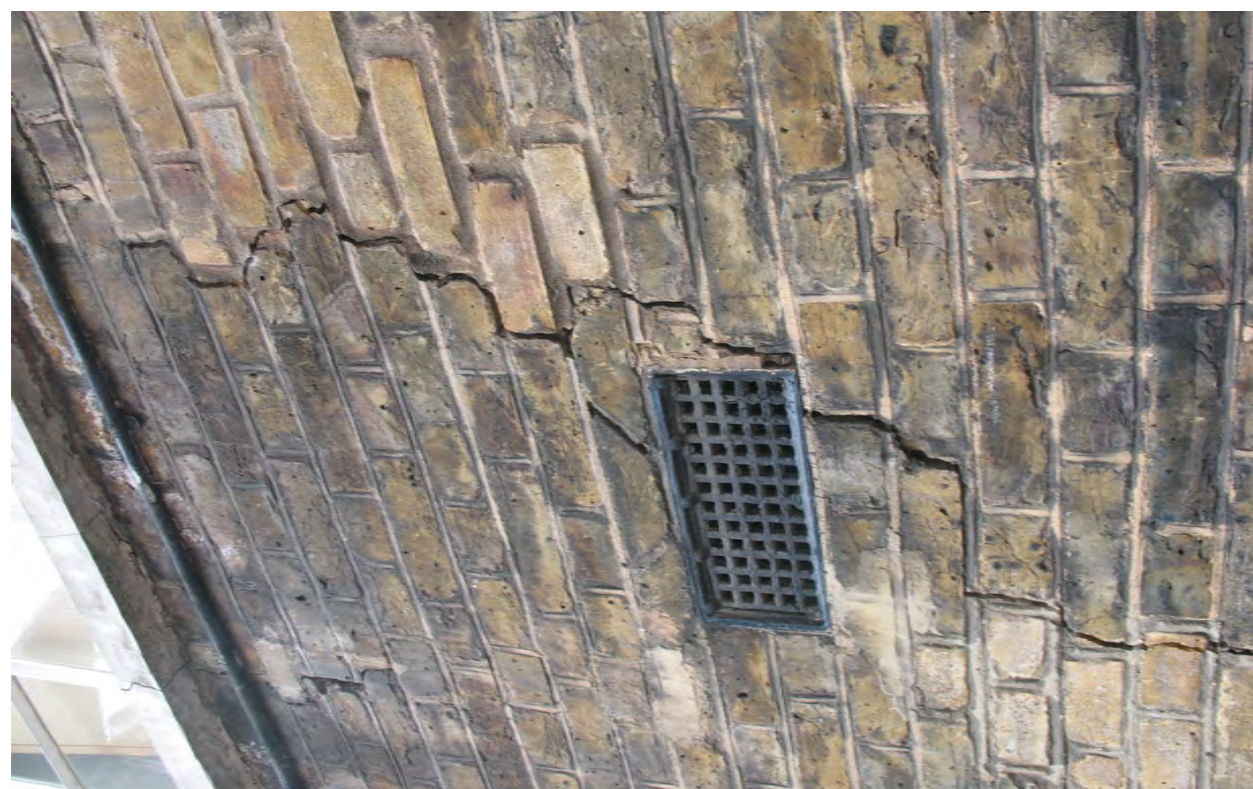
PH13 - The structural fracture to the brickwork to the side elevation

The structural fracture to the brickwork to the side elevation of the rear building will be investigated and repaired. The project team's Structural Engineer will determine the extent and method of the repair.

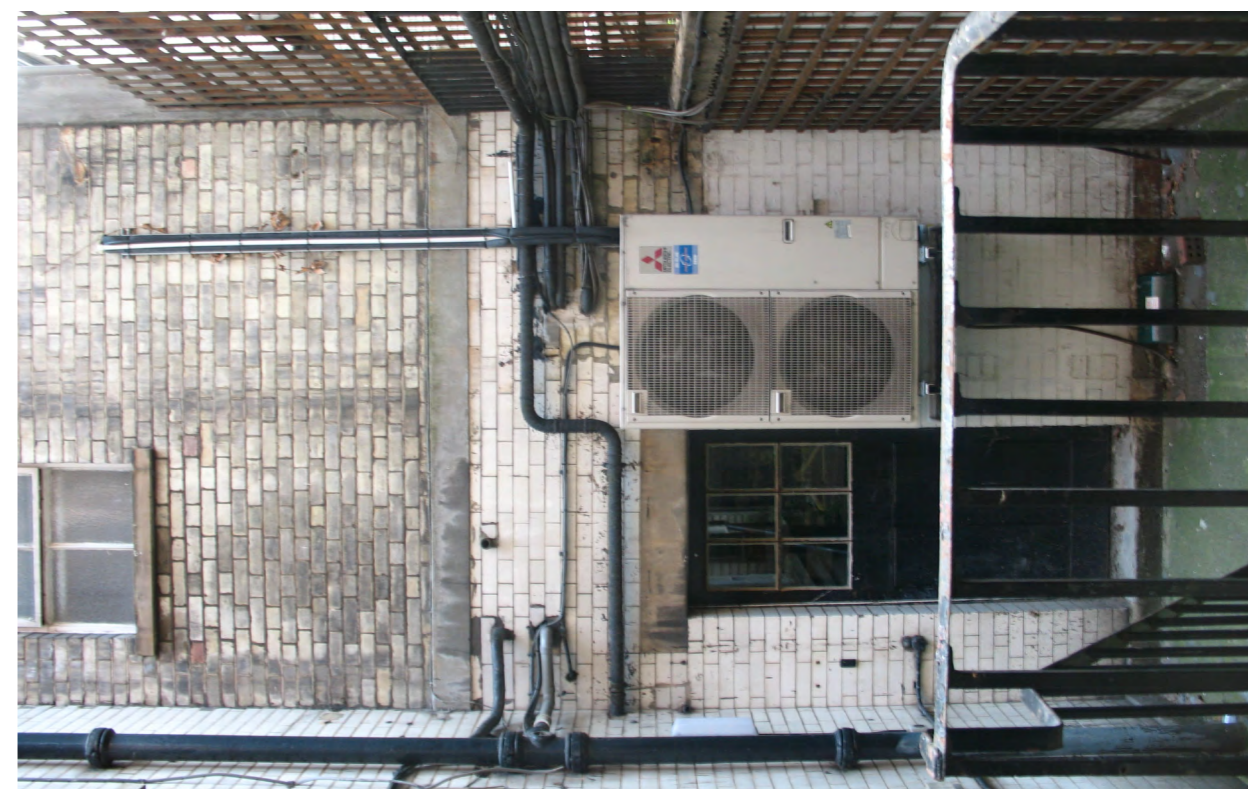
At present a series of external condenser units is located within the service yard area to the rear of the building and on top of the flat roof of the rear part of the building. These units provide comfort cooling to meeting rooms and specific private office areas at various levels.

PH14 - One of the existing condenser units within the service yard area

Firstly, we propose to decommission and remove all the existing condenser units within the service yard area between the front and rear buildings, many of which use outdated toxic and flammable refrigerants and are approaching the end of their useful lives. These will be replaced with new models (that will use environmentally friendly refrigerant R410A as a cooling medium) of similar dimensions that will serve the basement floor of the building.

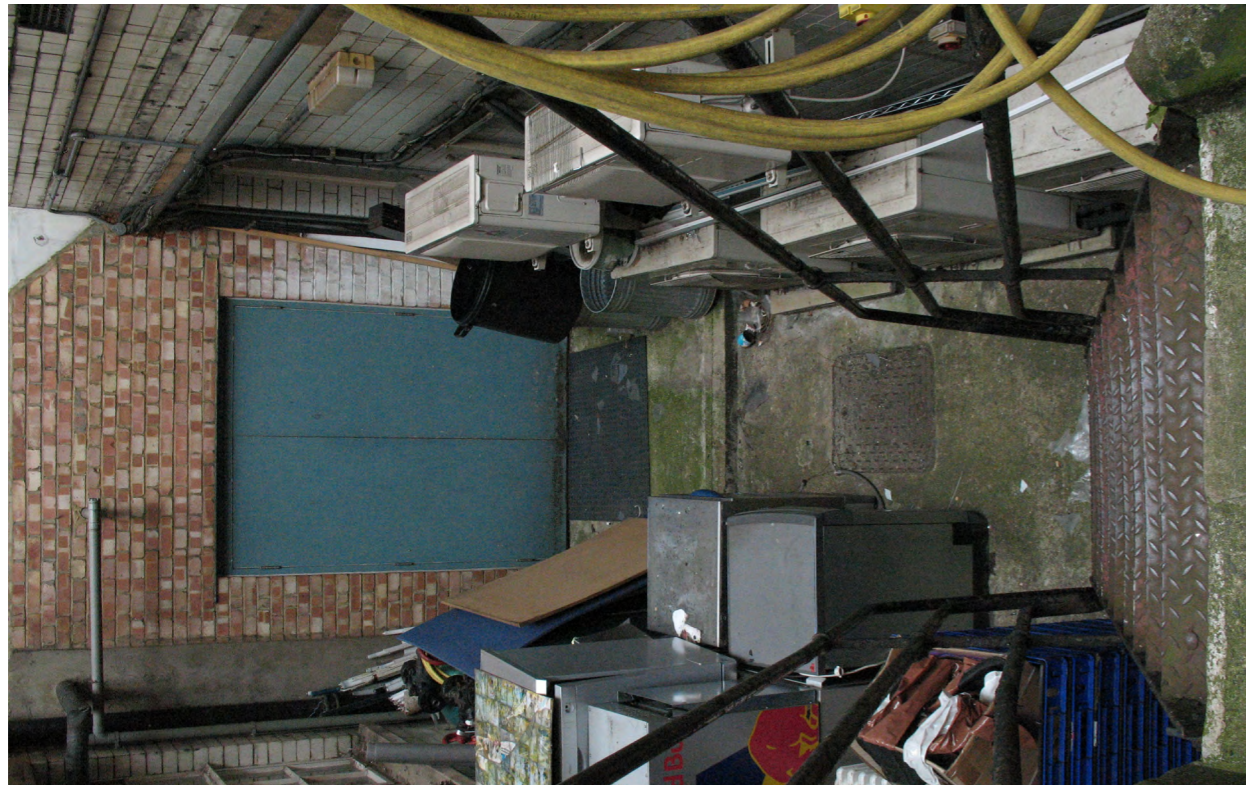
PH15 - Some of the existing condenser units within the service yard area

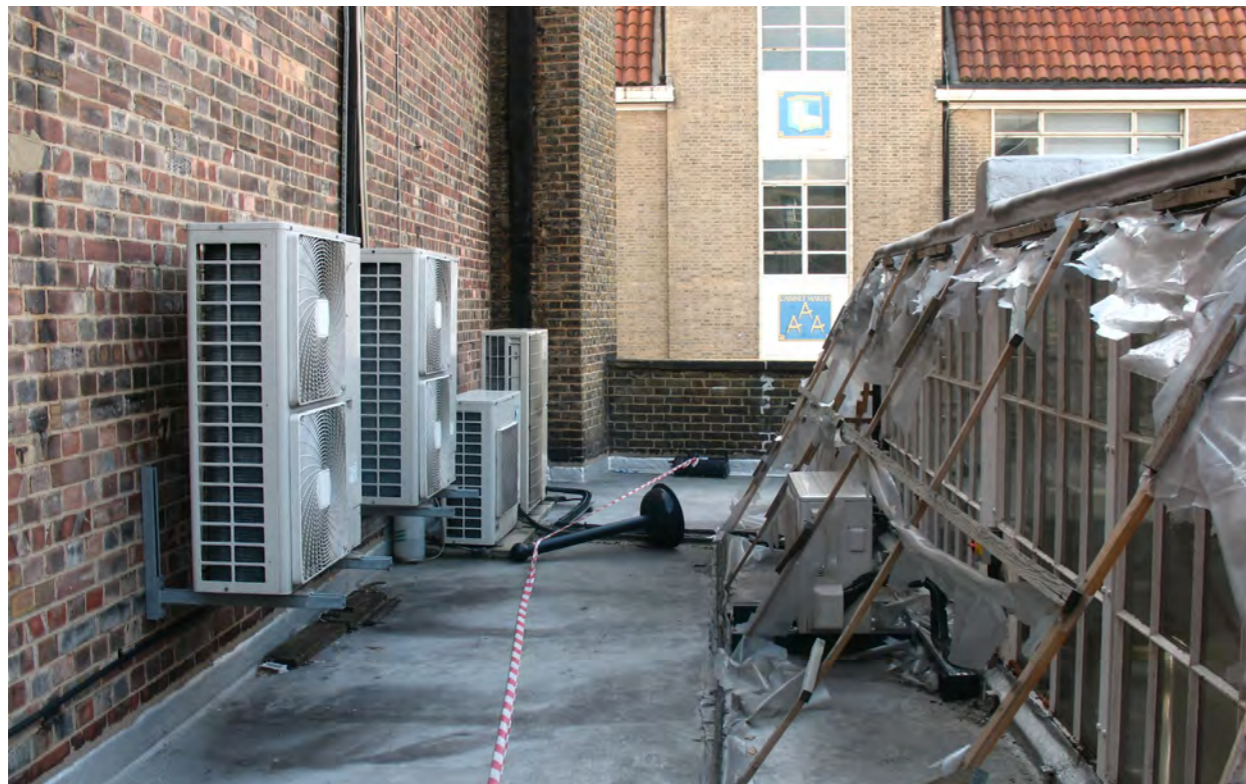
PH16 - Further existing condenser units on the roof & windows to raised roof light

Secondly, we propose to decommission and remove the seven existing con-

denser units at roof level (again, these are old models that use volatile refrigerants).

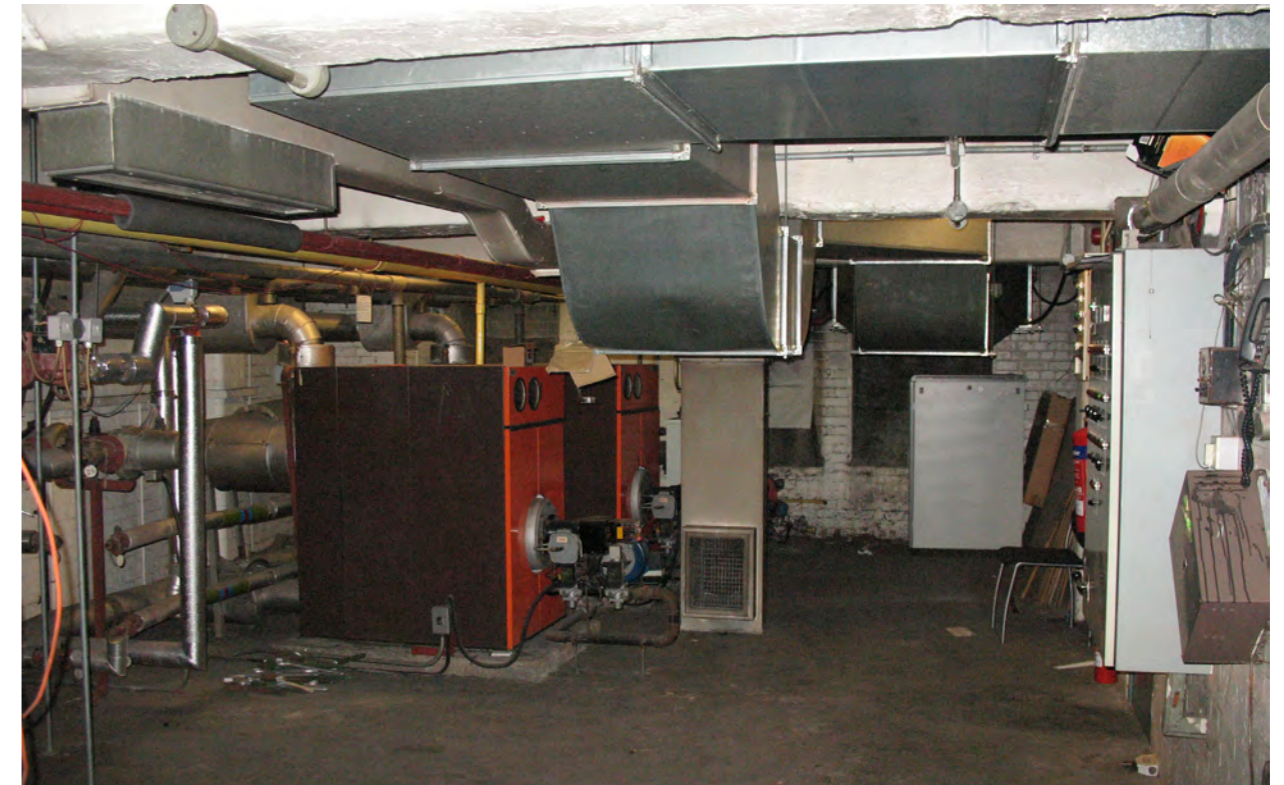
PH17 - The existing boiler room

The existing boiler and control system is to be removed and replaced with a new hot water system with modern more energy efficient boilers. The new contemporary controls and management systems will help minimise energy consumption.

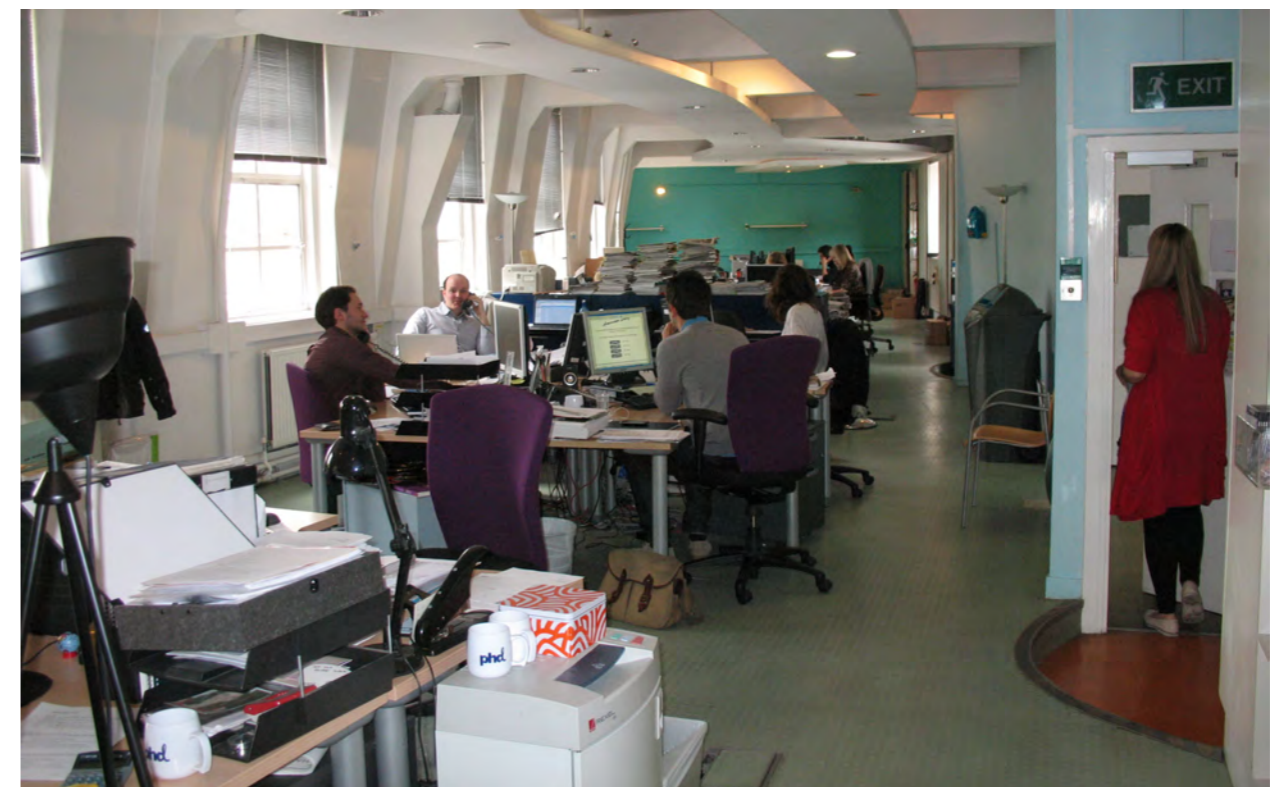
PH18 - The third floor office space where one of the ramps will be located

Small (Part M compliant) ramps will be created at basement, second and third floor in order to provide level access between the lift lobbies and the general office areas.

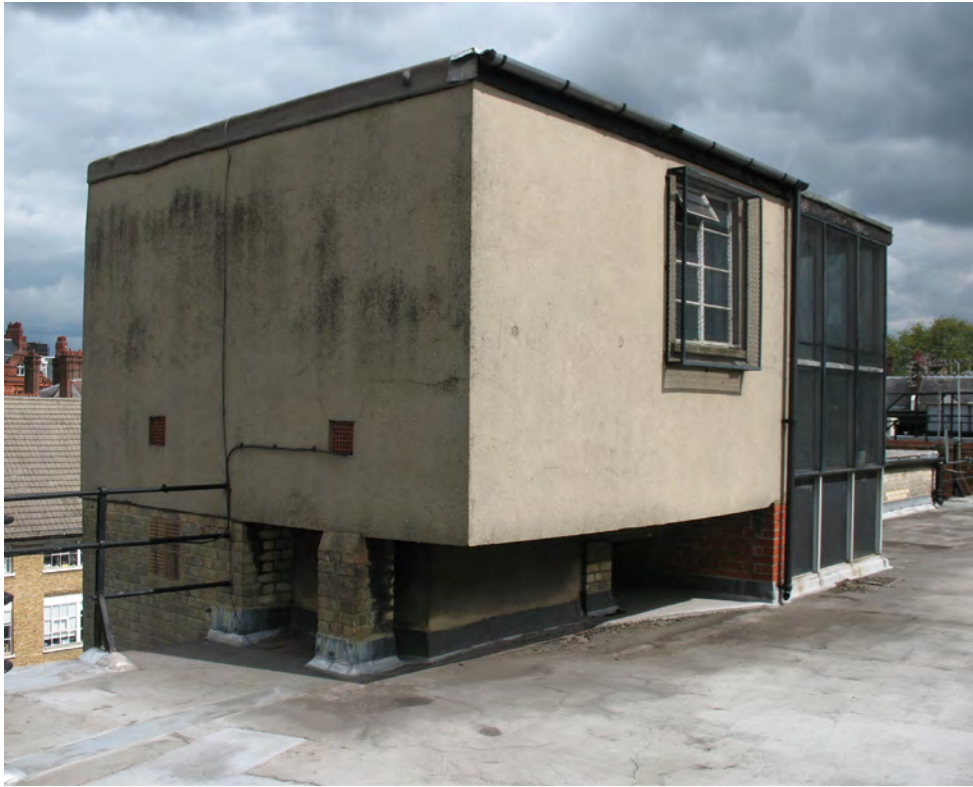
PH24 - Roof-top lift motor room

The lift plant room enclosure to the roof of the front building is also to be repaired.
