**25 Bracknell Gardens
London NW3 7EE**

Structural Engineer's Report For Planning Application

Prepared by: Andy Toohey
 May 2010
 19208

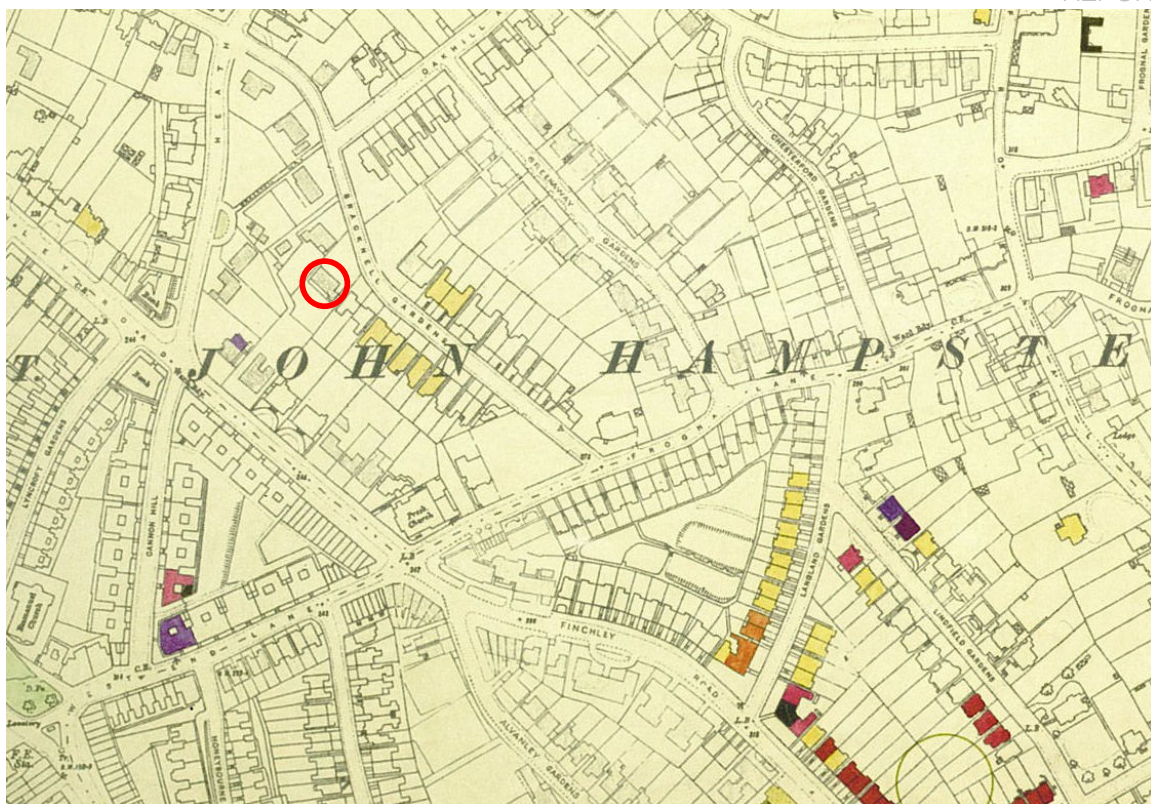
Map 5: Bomb Damage Map

As described in section 2, it appears that the original parts of the existing building will date from the 1920's. Bomb damage maps suggest that there was no damage to the building during WWII. Preliminary research into past Planning Applications suggests that the following alterations have occurred over recent years:
