## 30-32 Great Queen Street, 26 and 28 Parker Street, London WC2

London Borough of Camden Standing Building Report

18 July 2008

This short report describes office fixtures on the first floor of a building at 30–31 Great Queen Street, London WC2, and is written to supplement a longer report containing an assessment of the architectural and historic interest of the building, issued in November 2007 (Dwyer & Westman). This supplementary report was first issued in May 2008; the present document, dated July 2008, contains additional documentary evidence and minor revisions.

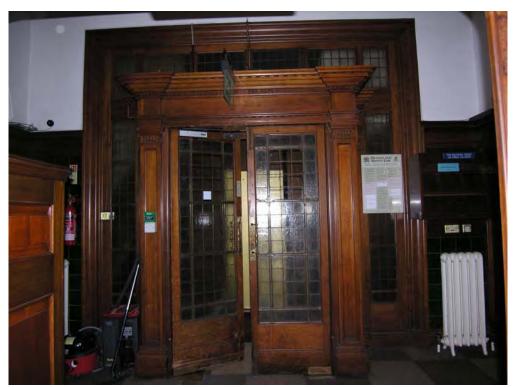
Fig 4 Room 17, main entrance porch, looking west (2787.jpg).

The main entrance to the first floor is from a staircase and a lift in the stairwell, in the south-west part of the building, through an internal porch with a two-leaf door. The doors are partly glazed, with hammered glass in small rectangular panes set in copper cames. The panes at eye height are clear, so one can see more clearly if anyone is on the other side of the door (Fig 4). A secondary entrance exists to the north-east, where there is another staircase beyond the WCs. This also has a 2-leaf door, similarly glazed but otherwise much less ornate.

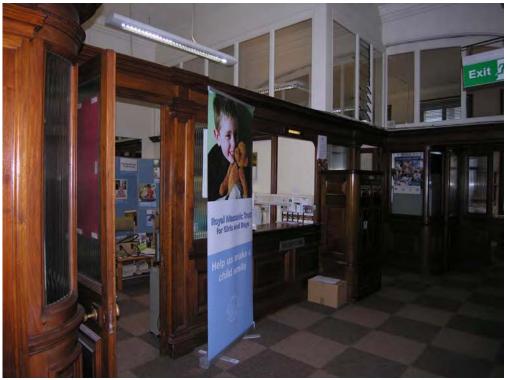
Fig 5 Room 17, reception counter, looking south-east (4888.jpg).

The central passage on the first floor and distinct office spaces to west and east of it are defined by low-level partition walls (Figs 5 and 6). These partition walls can be divided into four categories (Fig 1):

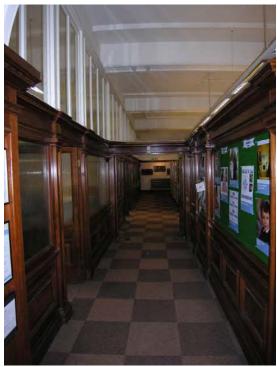
Fig 6 The west side of the central passage, looking north-west to rooms 14 and 15 (001.jpg).

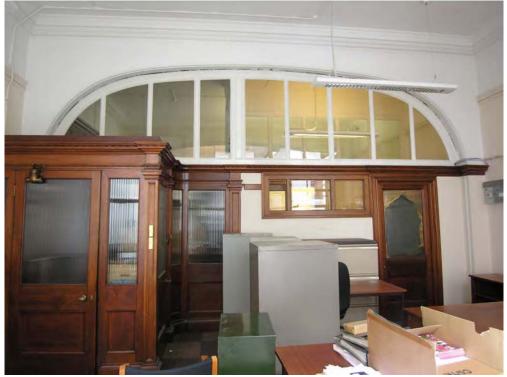
Fig 7 North wall of room 2. To the left, a 2-leaf door to the central passage; to the centre and right, a wall separating room 2 from room 12, with glazing above it. (2777.jpg).

The partition walls are interrupted by doorways, with single-leaf doors generally swinging inwards to the office spaces (Fig 7), and by larger windows than the usual type. The latter form openings, about 1.88m long and 1.05m high, characterised by curved upper corners, and these openings were formerly closed with 3-leaf folding glazed windows. An example survives in the east wall of room 16, intact except for the counter or shelf that formerly extended into the room from the sill of the opening (Fig 9).

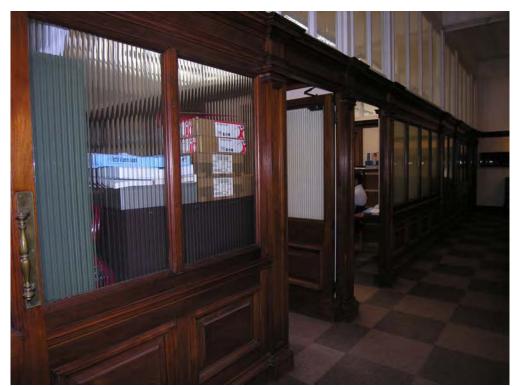
Fig 8 Partition along the central passage (4882.jpg).

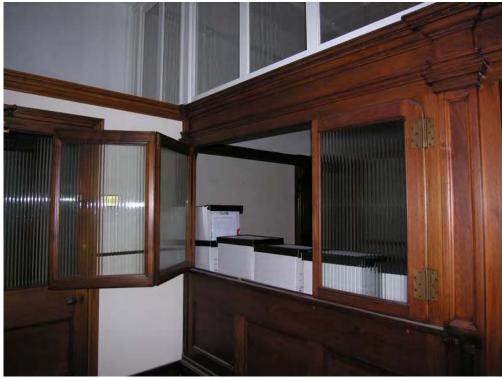
Fig 9 Folding 3-leaf window and counter in the east wall of room 16, internal face, looking north-east. A shelf or counter formerly under the window opening has been removed. (2876.jpg).

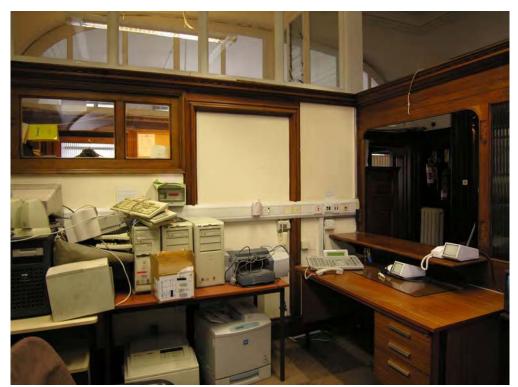
Fig 10 The south-west corner of room 10, showing reception counter, blocked doorway to room 12 and a mixture of fixtures and fittings (2793.jpg).

An example of a sill, with a modified counter, exists in the west wall of room 10 (Fig 10), which now serves as the reception counter for the first floor, and probably did so originally, situated as it is immediately opposite the main entrance.

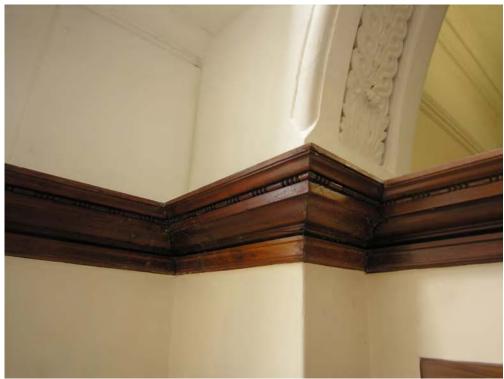
Fig 11 Detail of cornice in the south-east corner of room 11 (2794.jpg).

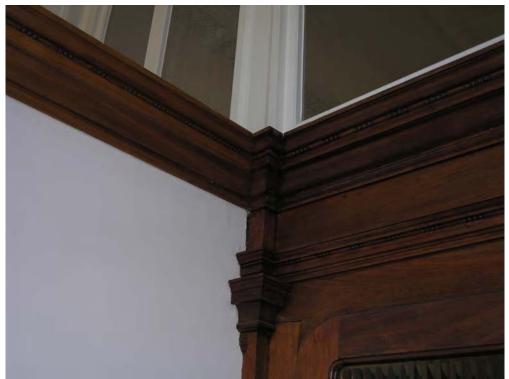
Fig 12 Detail of jointing in the north-east corner of room 13 (4875.jpg).

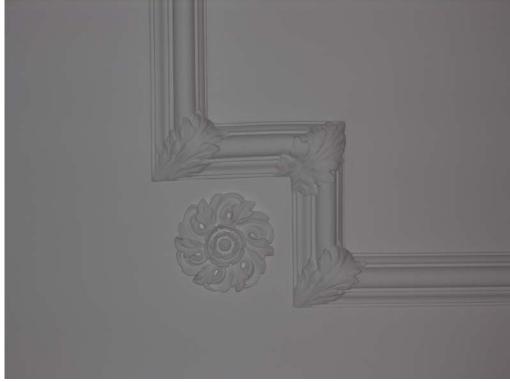
Fig 13 Detail of plaster ceiling decoration in room 28 (2873.jpg)

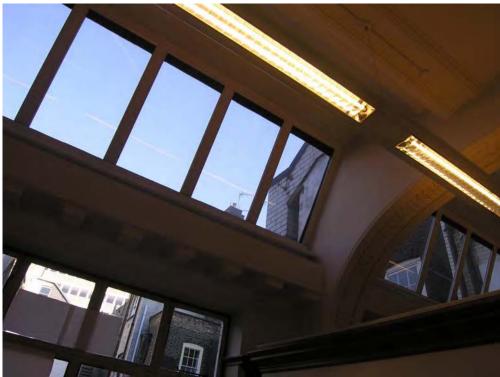
Fig 15 External upper windows along the east wall, looking south-east, showing traces on the outside buttresses of the framing of previous windows (4896.jpg).
