WANDA MARTIN GDN FLAT 34 BELSIZÉ PARK NW3 4DX

# LIME *Tilia species*

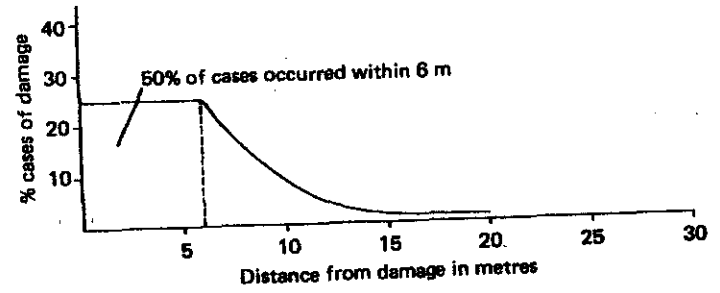
4. Graph showing the reduction in percentage of cases of damage recorded as the distance of trees from buildings increases (for shrinkable clay soils).

1. Maximum tree-to-damage distance recorded: 20 m.  
In 90% of cases the tree was closer than 11 m.
2. Normal maximum height in shrinkable clay urban areas:  
*Tilia x europaea*, common lime: 21 – 24 m,  
*T. cordata*, small-leaved lime: 20 m,  
*T. euchlora*, Caucasian lime: 16 – 18 m.
3. Proportion of cases of damage occurring within certain bands of distance from the tree species on shrinkable clay soils:

% of cases of damage	Distance from damage (m)
0	Over 20
10	11 – 20
15	8 – 11
25	6 – 8
25	4 – 6
25	1 – 4
