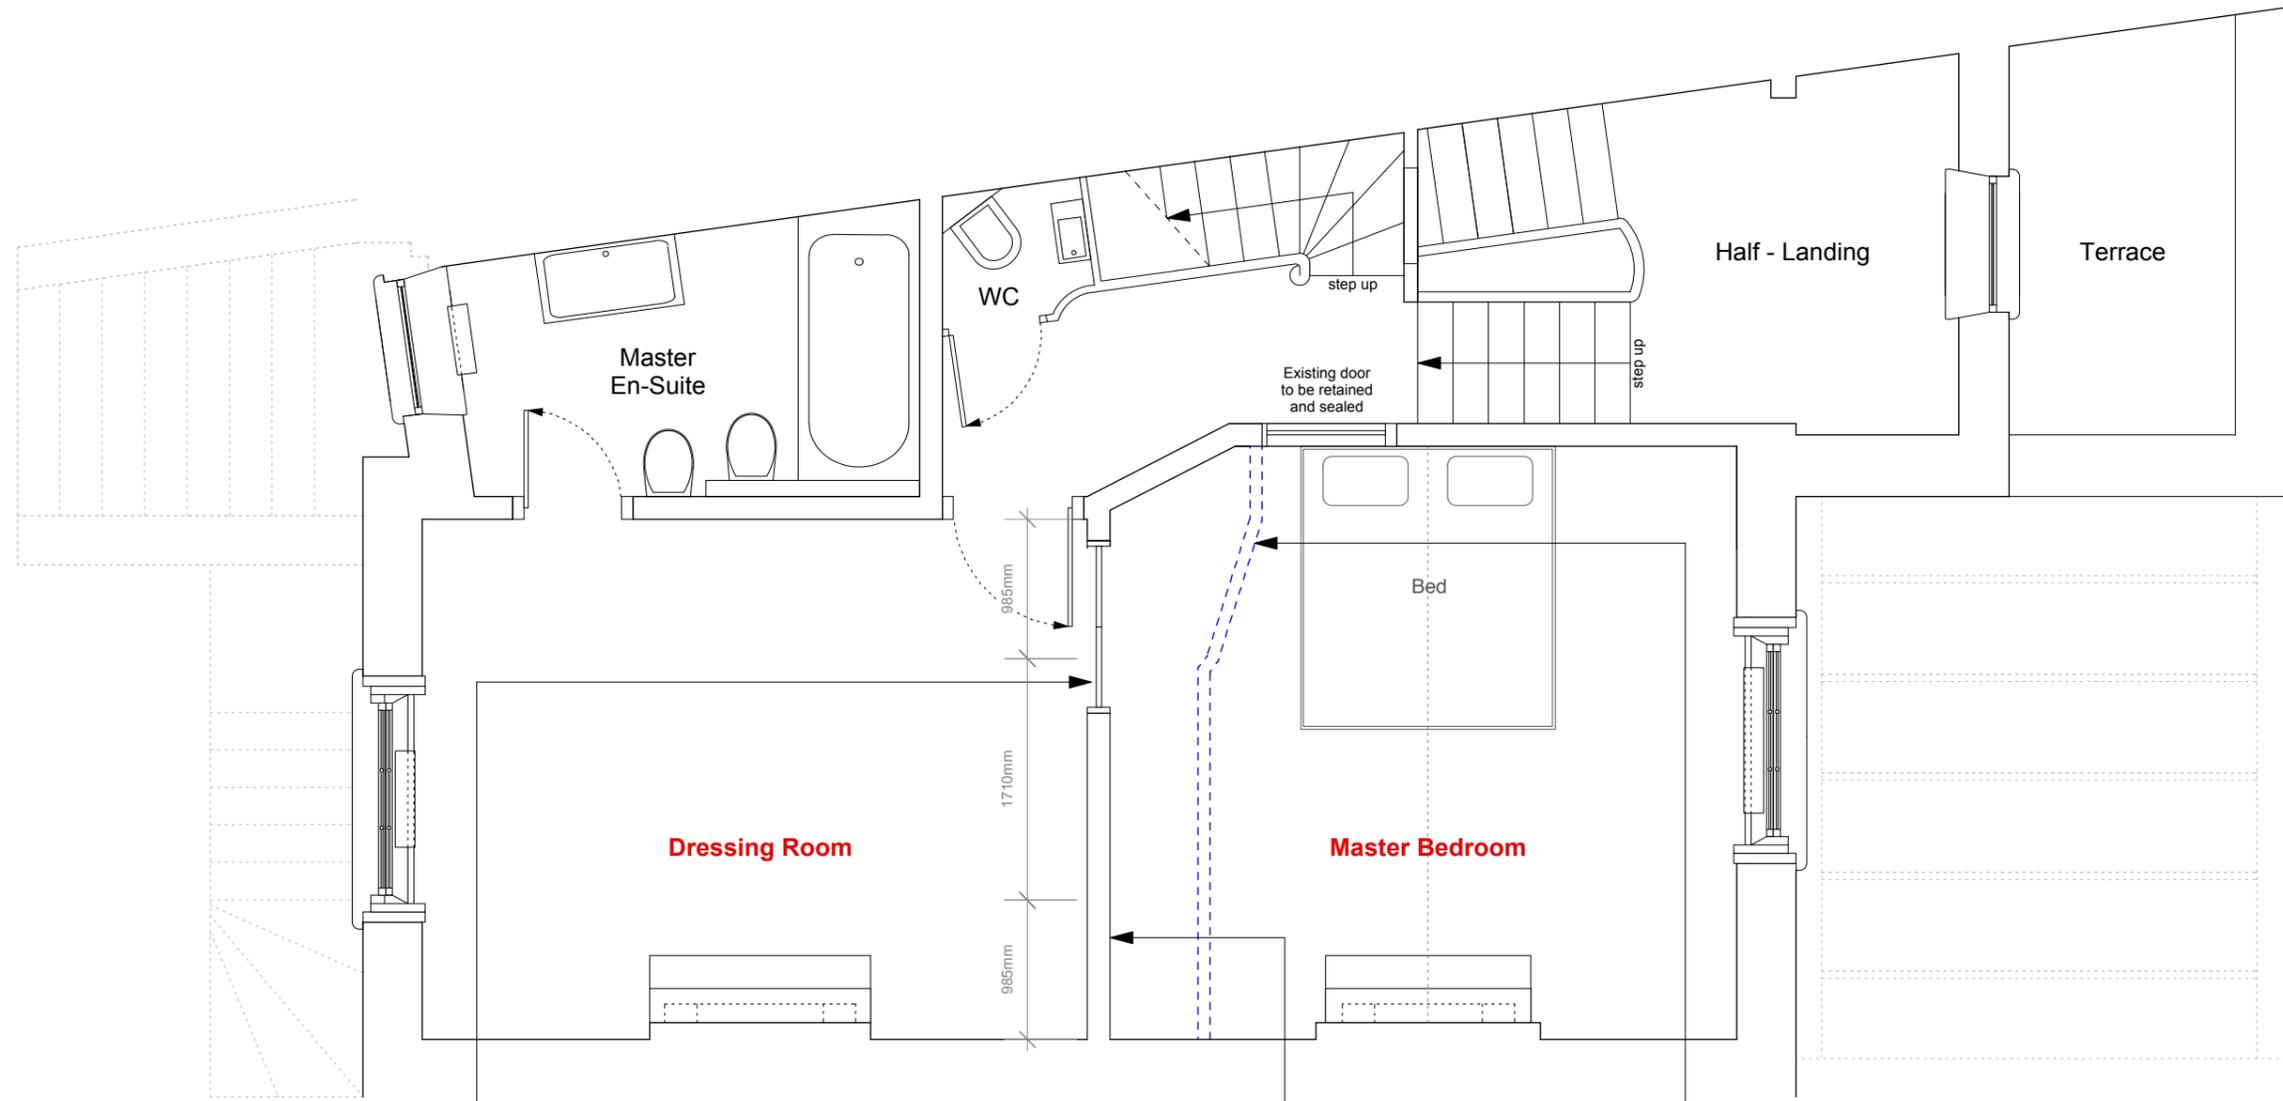
Existing opening between rooms to be retained

Blue dotted line denotes non-original partition as shown in drawing PL 04 to be demolished

Removal of high level steel strap subject to engineers details. Engineers drawings to be approved if repair works alter historic structure
