**Kings Cross Station  
Redevelopment Programme  
Package 2**

**South Facade  
Existing Glazing Bar  
Cross Sections**

**MSR-CSS-1136**

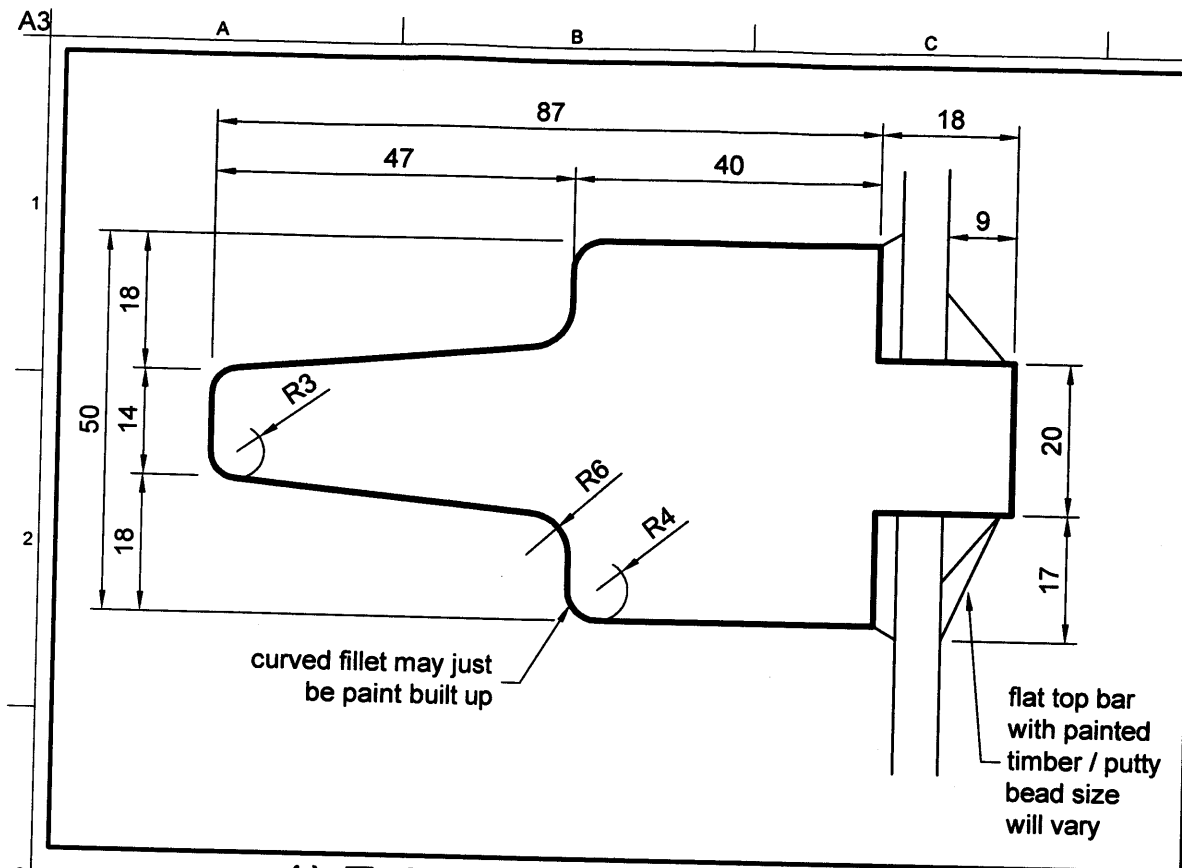
**1) Existing Metal Vertical  
Glazing Bar Detail**

Verified on site.

- Sections 2-4 are taken from record drawings dating from 1977, dimensions were verified by survey in November 2007. Cross section 1 is based on the measured dimensions and a detailed examination of survey photos.
- The existing south facade window framing comprises a variety of section shapes in a variety of materials and dating from the various refurbishments carried out on the station
- See drawing MSR-CSS-1137 for detailed photographs relating to these sections.

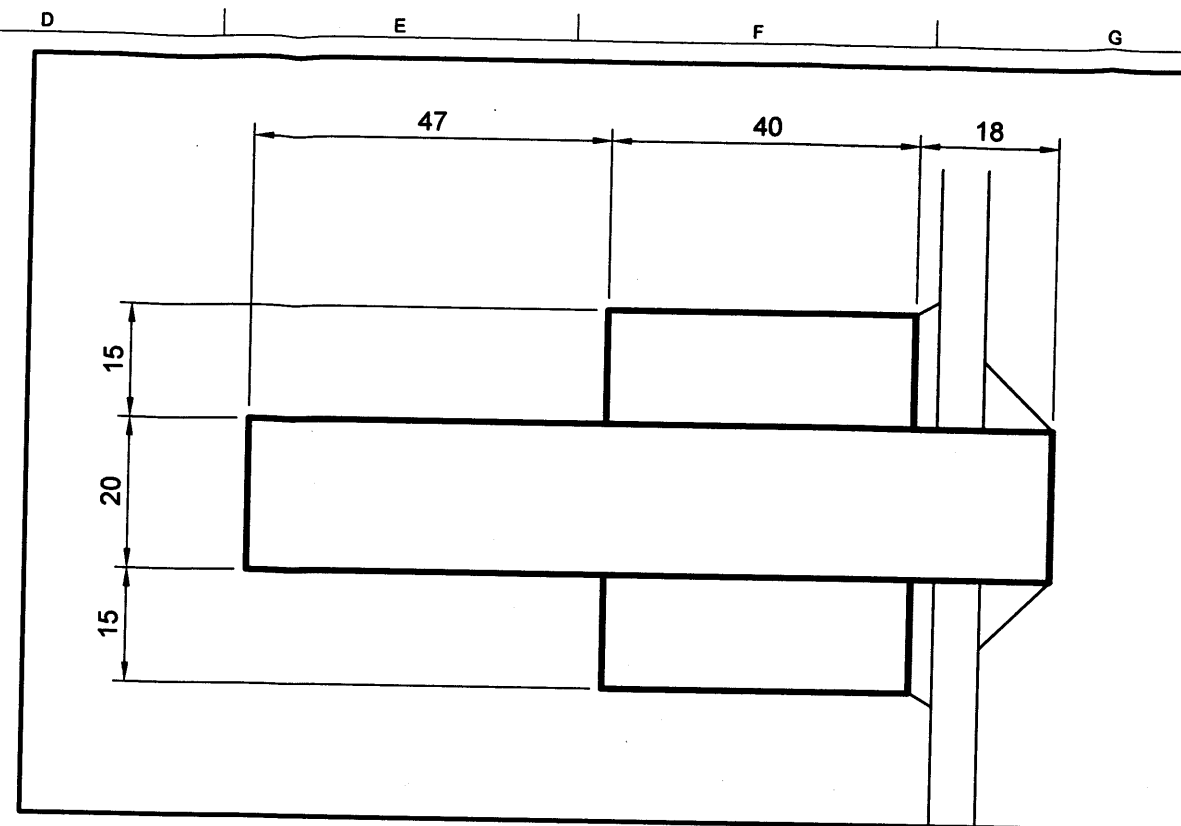
**2) Existing Metal Vertical  
Glazing Bar Detail**

Taken from record drawing

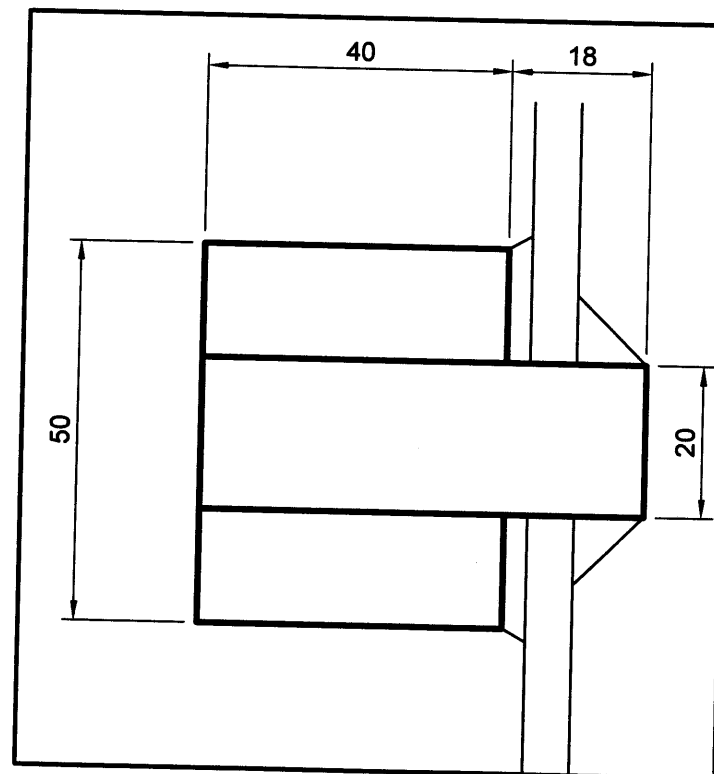
**3) Existing Metal Horizontal  
Glazing Bar Detail**

Taken from record drawing

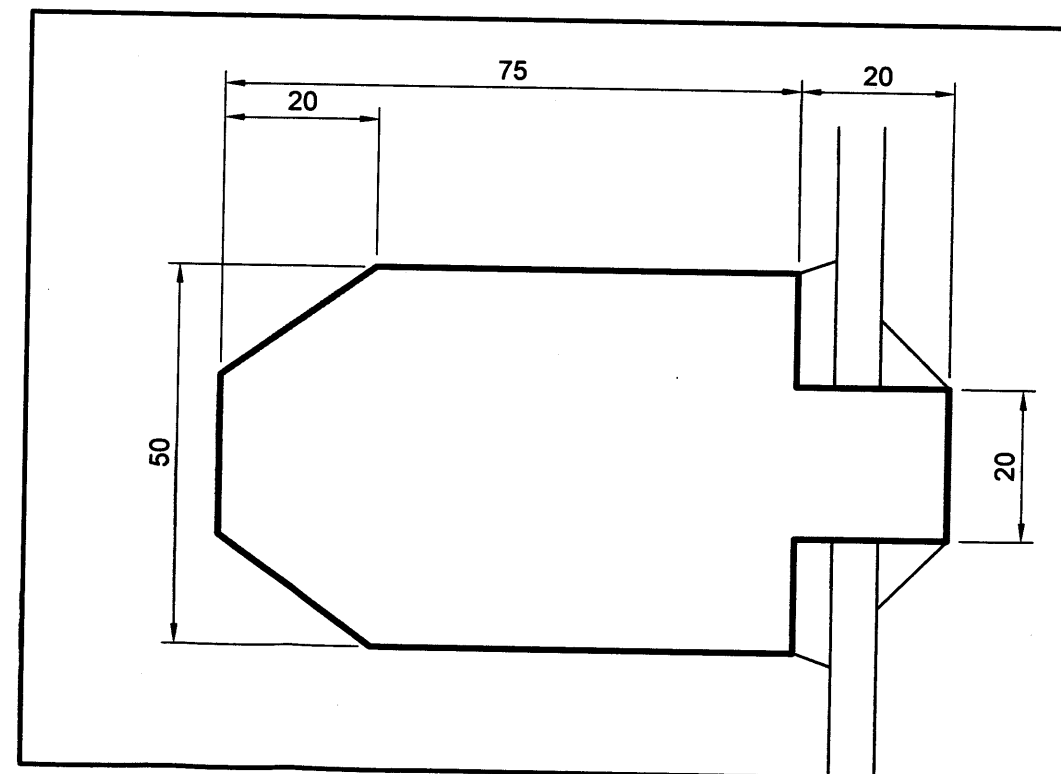
**4) Existing Timber Horizontal & Vertical  
Glazing Bar Detail**

Taken from record drawing
