*Brief History of Witanhurst 1960s to present*

## WITANHURST, HIGHGATE

### LANDSCAPE SURVEY

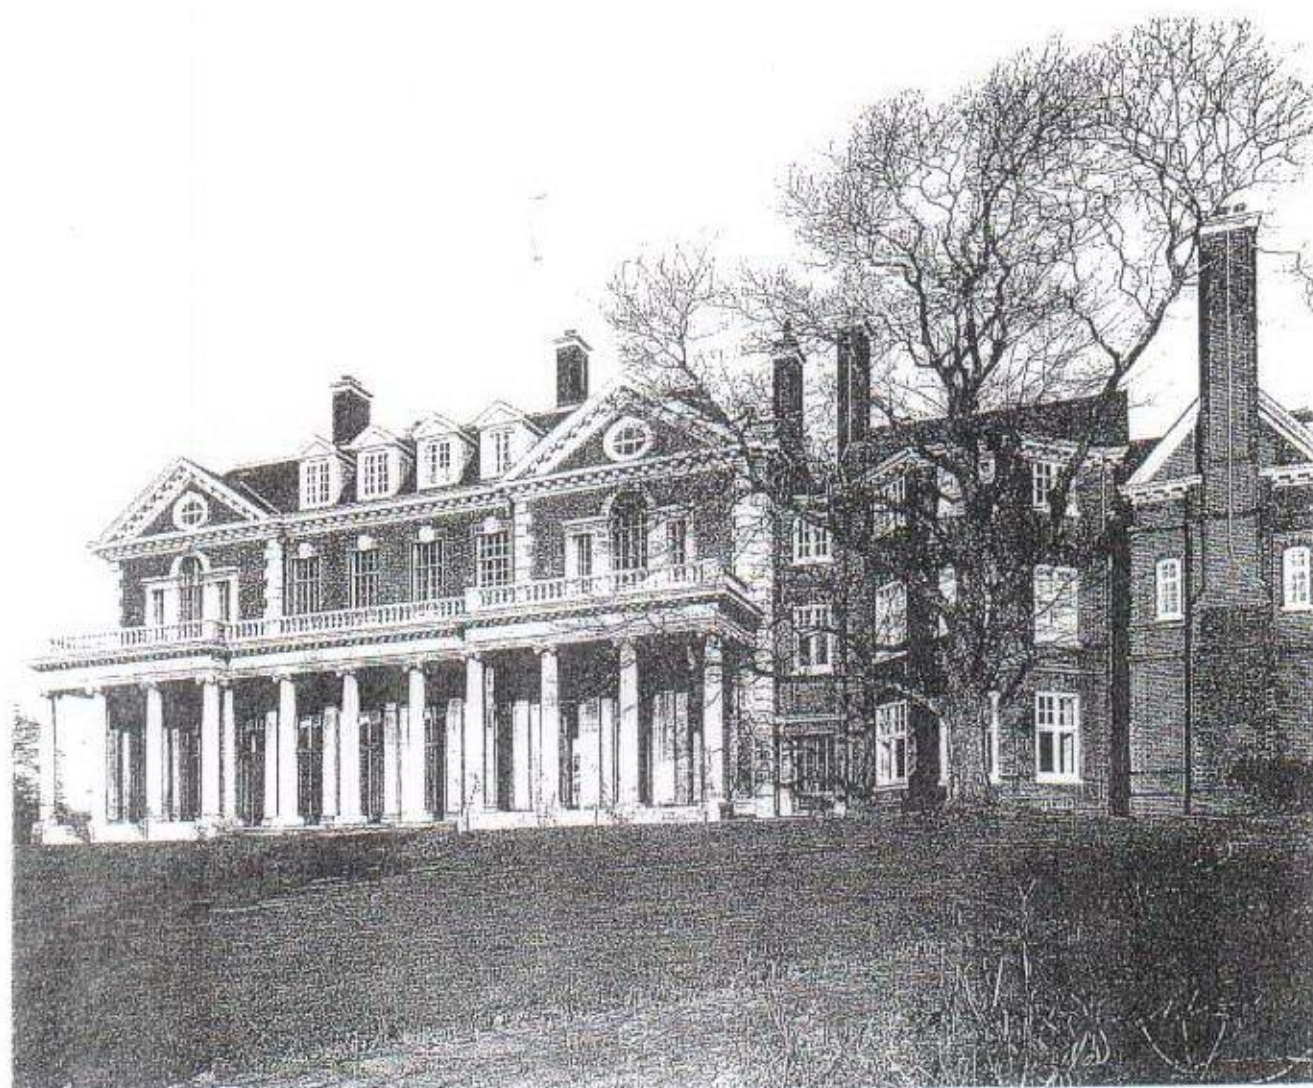
Fig 12 Loggia on the south west front of the Mansion  
with lawns and paths leading to the garden below  
GLC Photo. Library  
Metropolitan Archives 90.0.HIG 71/1504
