THE BRITISH MUSEUM  
The South Stair, Central Saloon  
and Galleries 37 to 40

PLASTERWORK  
GALLERIES 37, 38, 39  
SECTION THROUGH CEILING

| THE BRITISH MUSEUM | |
| SMOKE PIPES THROUGH<br>CEILING | T.07/JK |

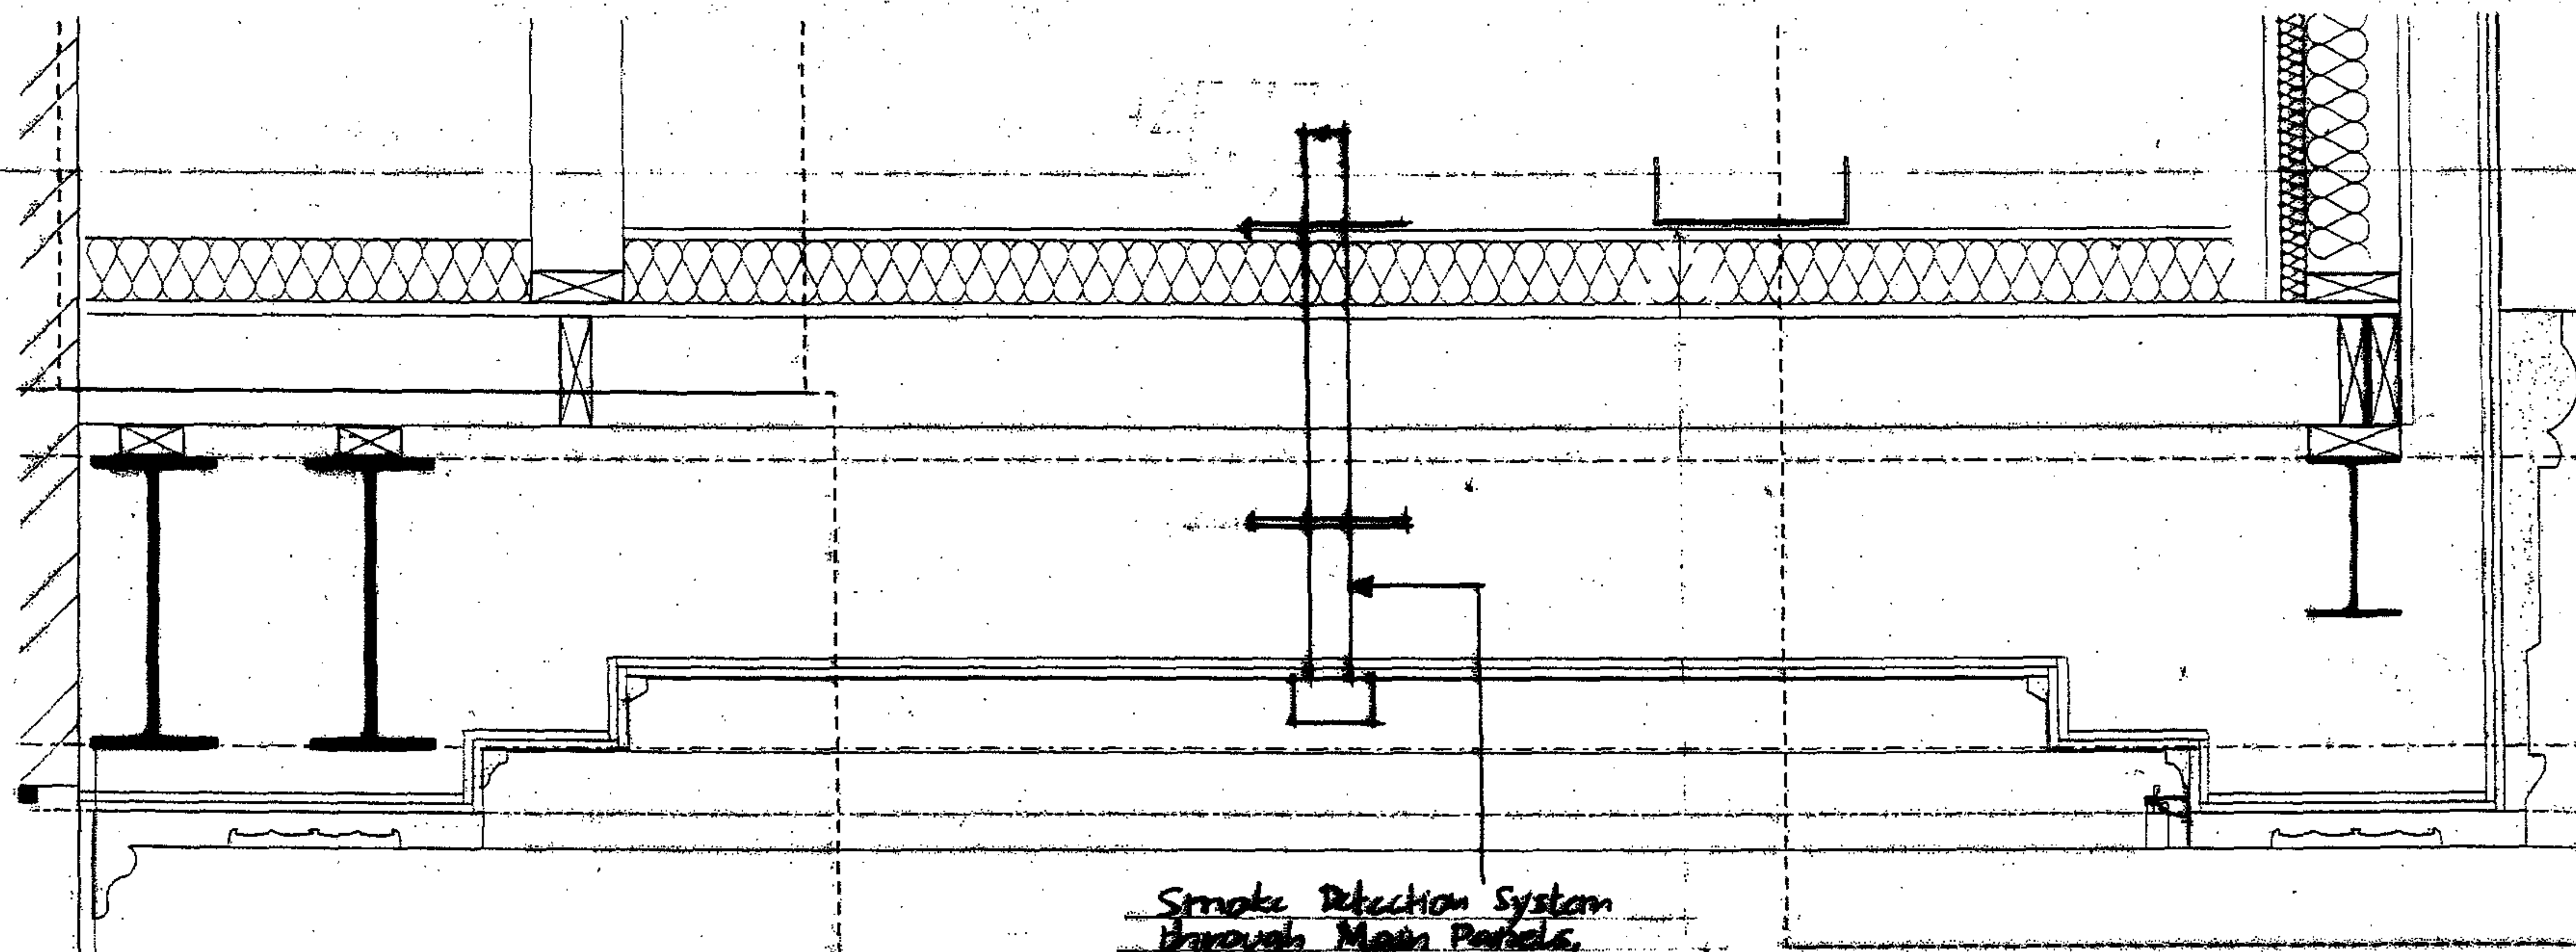
New copper roof  
(pitched)

New Aspirating Type  
Smoke Detector. Hole drilled  
through ceiling to take  
pipe. Allow 12 No. Holes.  
Sealed with  
Int. Mastic.

New copper  
lined gutter

Detail Based on Central Saloon

Smoke Detection System  
through Main Panels,  
with Pipe Connection to Void.  
By Asparting Pipe Supplier Ltd.

Ceiling Contractor to Allow for  
Making Good 12 No. Holes.  
Use Sealing with Mastic.
