9 WOBURN WALK - GROUND FLOOR ROOM G1

9 WOBURN WALK - FIRST FLOOR ROOM F1

9 WOBURN WALK – FIRST FLOOR ROOMS F2, F3 & F4

9 WOBURN WALK – SECOND FLOOR ROOM S1

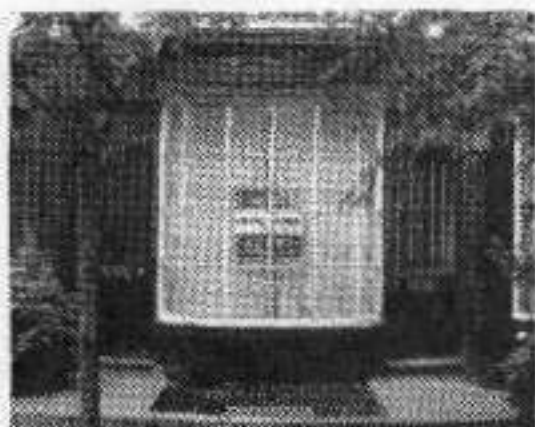
Ground Floor – Photograph G1

- Main entrance door to be retained and redecorated. Lower panels have been covered and boarded up externally these panels will be removed to expose the original door behind. (Photographs G 1 and G 2)
- Hallway to retain the existing skirting, dado rail and cornice.
- Original staircase to first floor to have dado rail and skirting reinstated, along with new windows at half landing. (Photograph G 3)

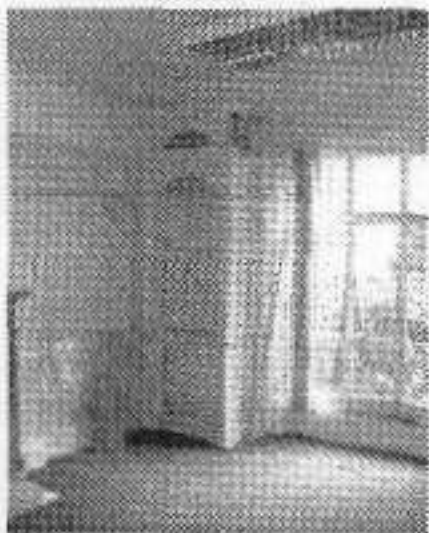
First Floor Room 1 – Photograph F1- 1

- Existing bookcases above radiators to either side of window to be removed (photographs F1-1 and F1- 4) - later addition.
- Reinstall skirtings, dado, picture rail where bookcases removed to match existing.
- Existing casement window to balcony and shutters to be retained and overhauled (photographs F1- 7 and F1- 6).
- Existing fireplace (photograph F1- 3).
- Ceilings and walls to be redecorated.
- Door DF/01 to be retained and redecorated.
- Stud walls to store area (photograph F1- 2) to be removed. This has been added at a later date as there is evidence of the original skirting within the cupboard. (photograph F-8)

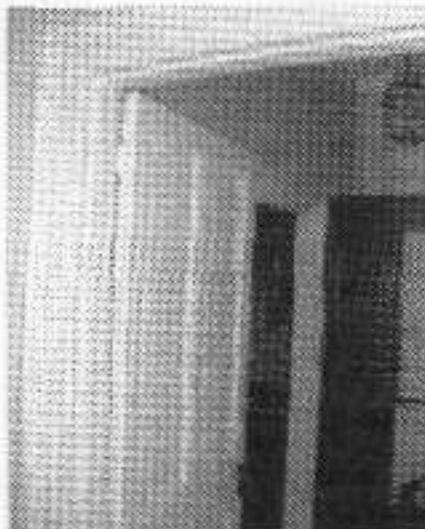
First Floor Room 1 – Photograph F2-2

- Existing alcove unit (photograph F2-3) to be removed (later addition).
- DF/02 (photograph F2-2) to be retained and refurbished.
- DF/04 into conservatory (F6) is not original (photograph F2-4) and is to be replaced with sash windows similar to WS/03 (see example photograph).
- Original staircase, handrail and square balustrade (photograph F2-4) to be retained and redecorated.
- Stair handrail and balustrade to second floor to be retained and made good.

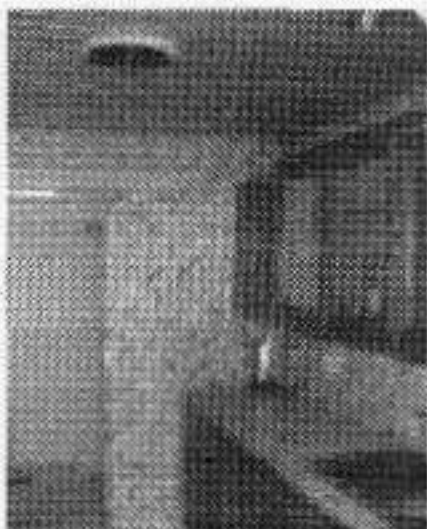
First Floor Room 4 – Photograph F2-1

- All kitchen units to be removed (photographs F4-1 and F4-2), together with false ceilings. Original ceiling to be investigated as to its condition and any features which may be missing are to be reinstated.

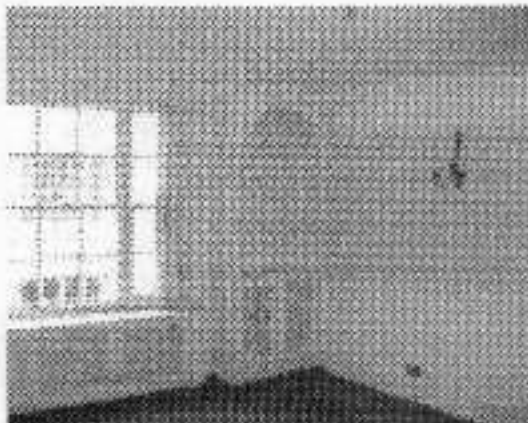
Second Floor Room 1
Photograph S1-1

- Existing bookcases to either side of window (photographs S1-1 and S1-5) to be removed.
- Where bookcases are removed skirting, dado, picture rail and cornice to be reinstated to match existing. Walls to be made good.
- Existing window to be retained and overhauled. Radiator casing under to be removed and skirting to be added if non-existent.
- Existing fireplace (photograph S1-4)
- Door DS/01 (photograph S1-2) to be retained and redecorated.
- Existing mirror-faced wardrobes (photographs S1-2 and S1-3) to be removed. Existing skirting continues through to wall.

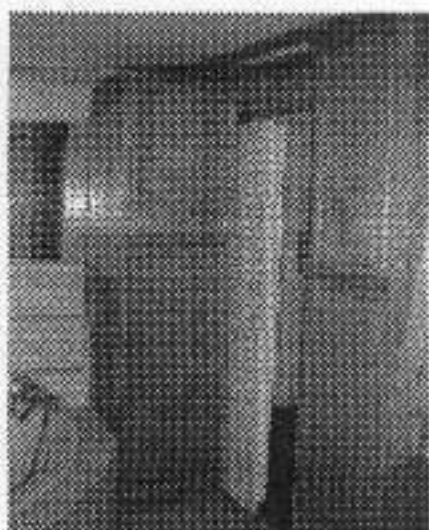
Second Floor Room 3
Photograph S3-1

- All bathroom fittings and boxing to be removed (photograph S3-1 and S3-2).
- Windows to be retained and made good. Casing under windows to be removed.
