SOUTH STAIR, CENTRAL SALOON AND GALLERY 37

Historical Development and Record Information

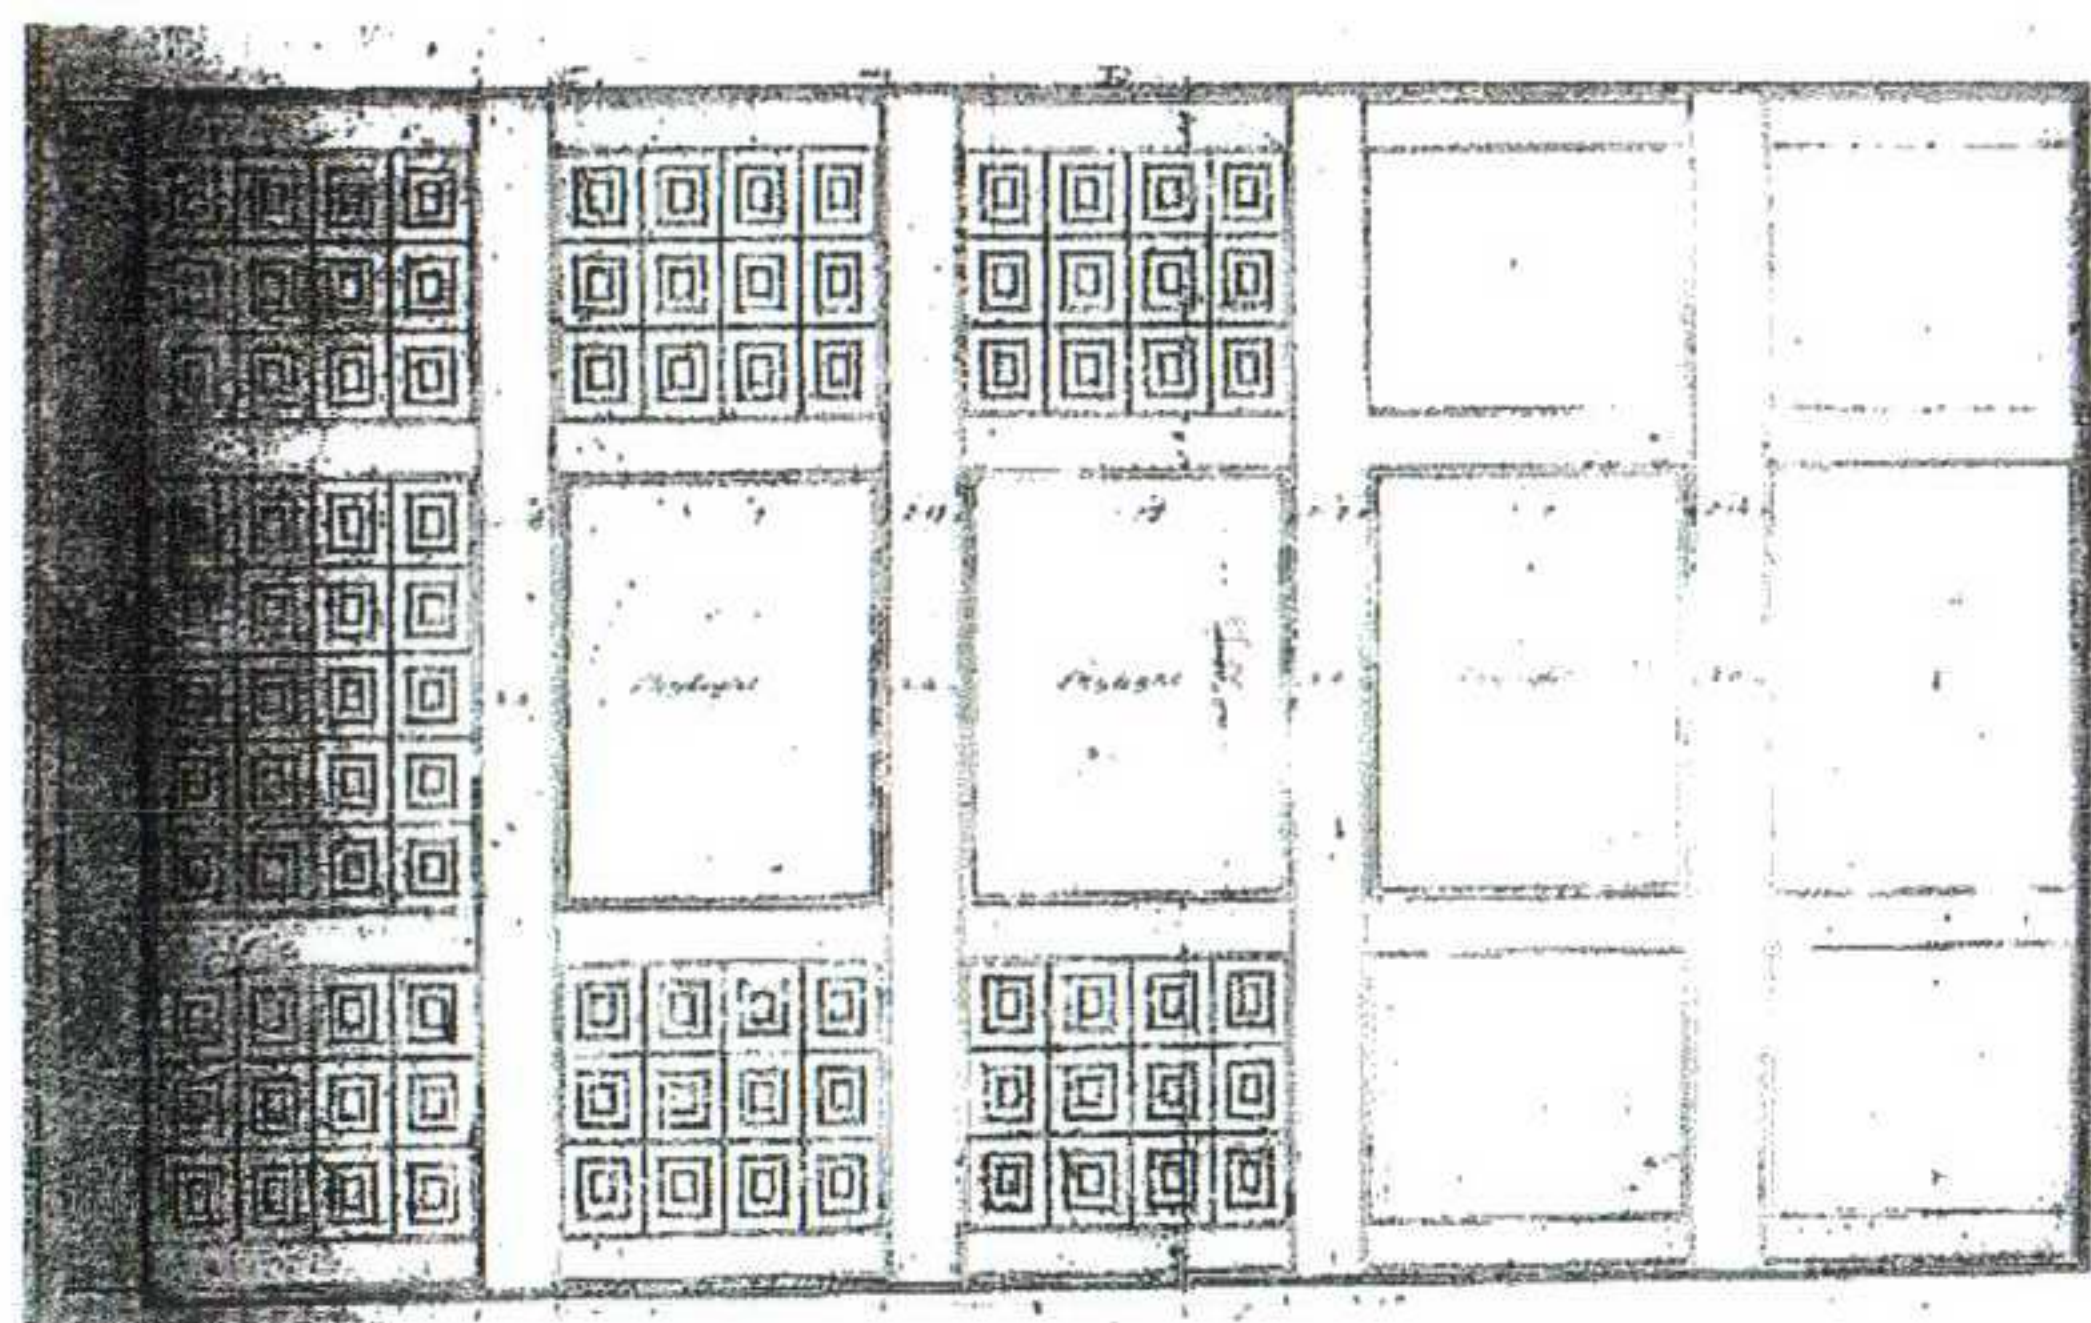
Design drawings for the proposed ceiling to the South Stair dated 1843 illustrating the downstand beams bisecting the roof light

- The ceiling to the South Stair was originally designed with five equal bays, divided by down stand beams running across a central glazed roof lantern (pg.18). Whilst it is likely (from post bomb damage photographs) that this design was originally implemented, the reconstructed ceiling incorporating a single lay light omitted the dividing down stand beams. This has recently been decorated in an interpretation of the original 1847 Collman and Davis polychrome colour scheme as part of the Great Court Project.

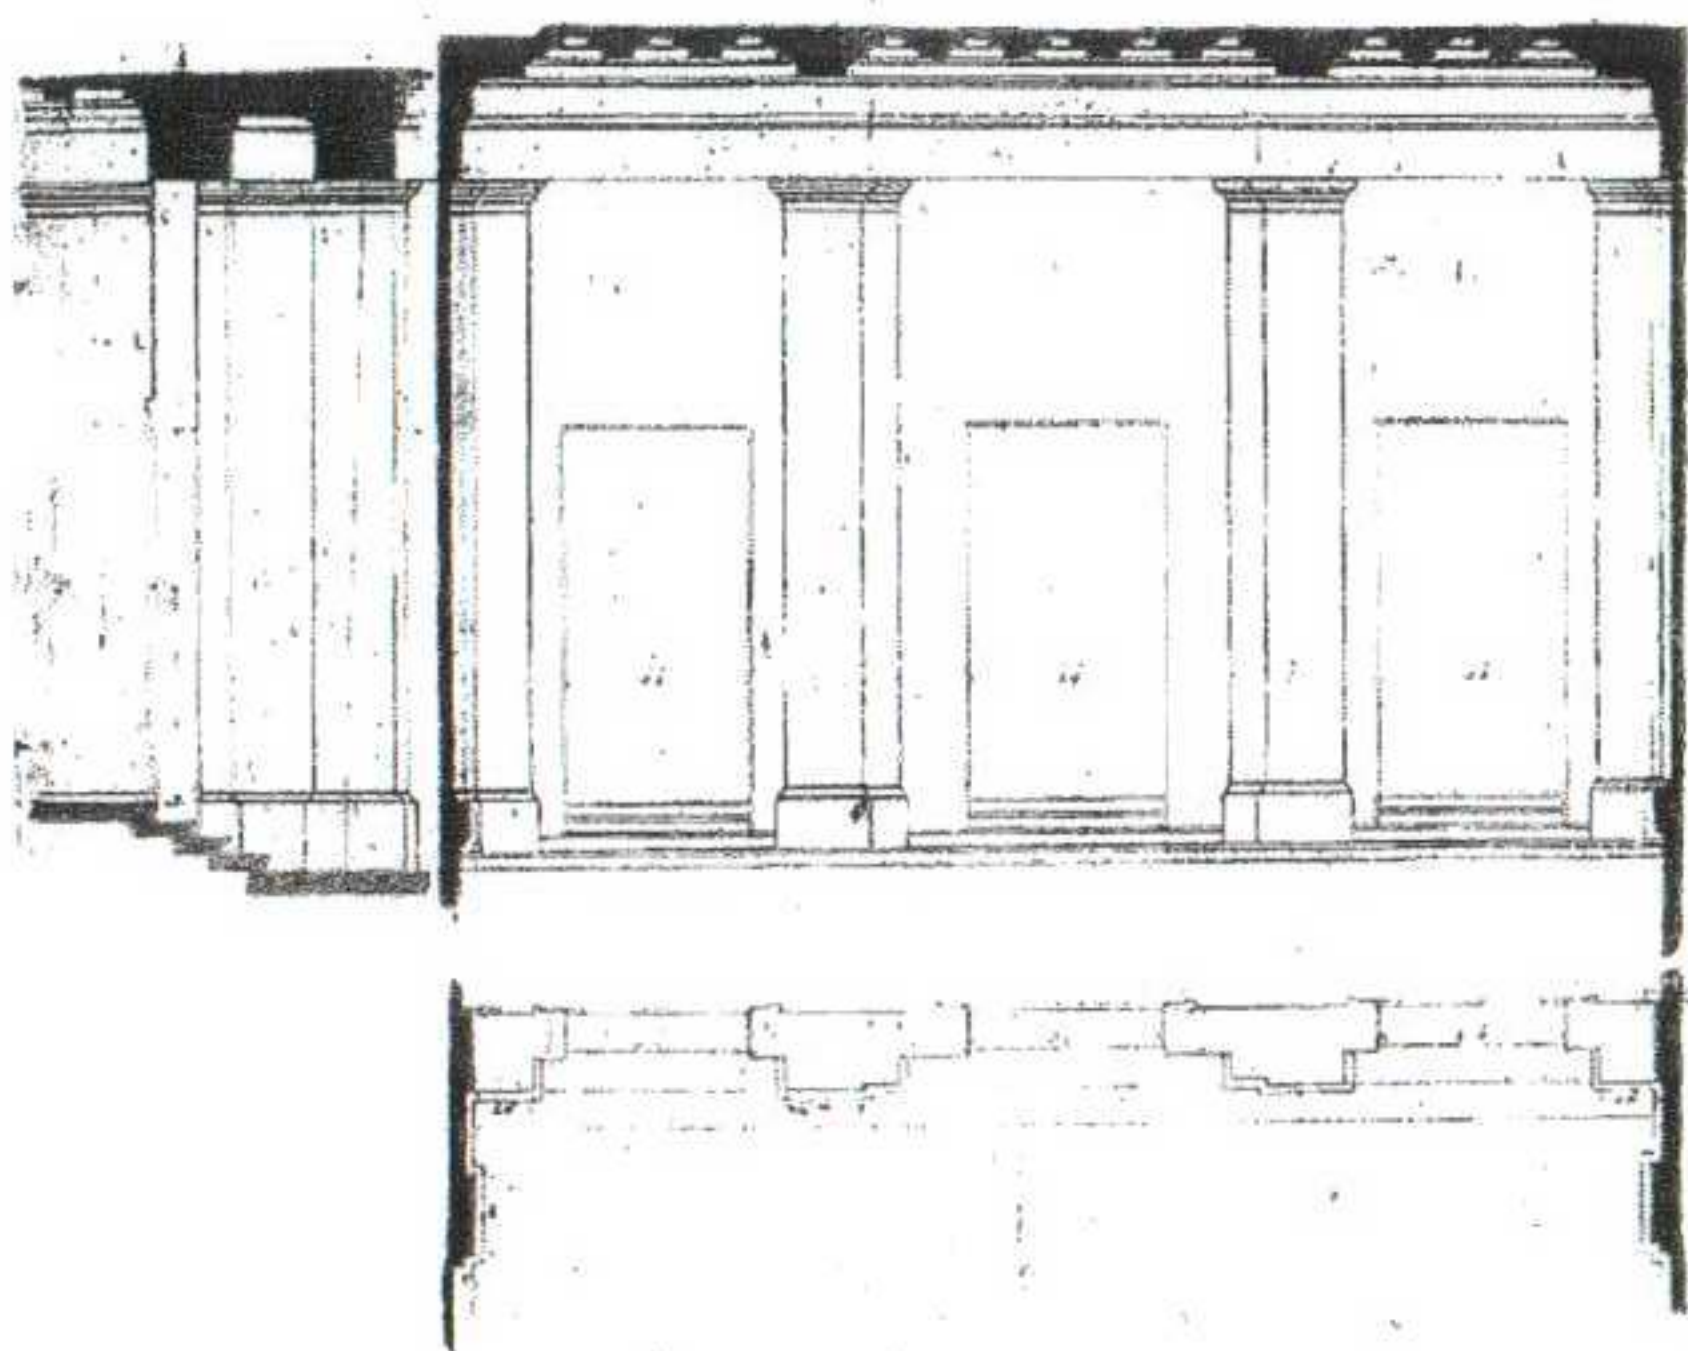
Design drawings for the proposed screen between the South Stair and the Grand Saloon dated 1847. This scheme was implemented and is evident in archive photographs illustrating the bomb damage of 1941.

- 'Consideration should be given to reinstating the pre-second world war skylight and ceiling configuration as the present design clashes with the remaining neo-classical detail.'
- It would appear that the South Stair and Central Saloon were originally designed to be separated by a screen of double circular columns (subsequently modified to two square columns), framing three stepped openings (pg.5).

However, a screen wall with framed openings was actually constructed between the South Stair and Central Saloon as is evident in photographs recording post bomb damage (pg.19). This screen was demolished with the reordering of the spaces following extensive bomb damage in 1941.

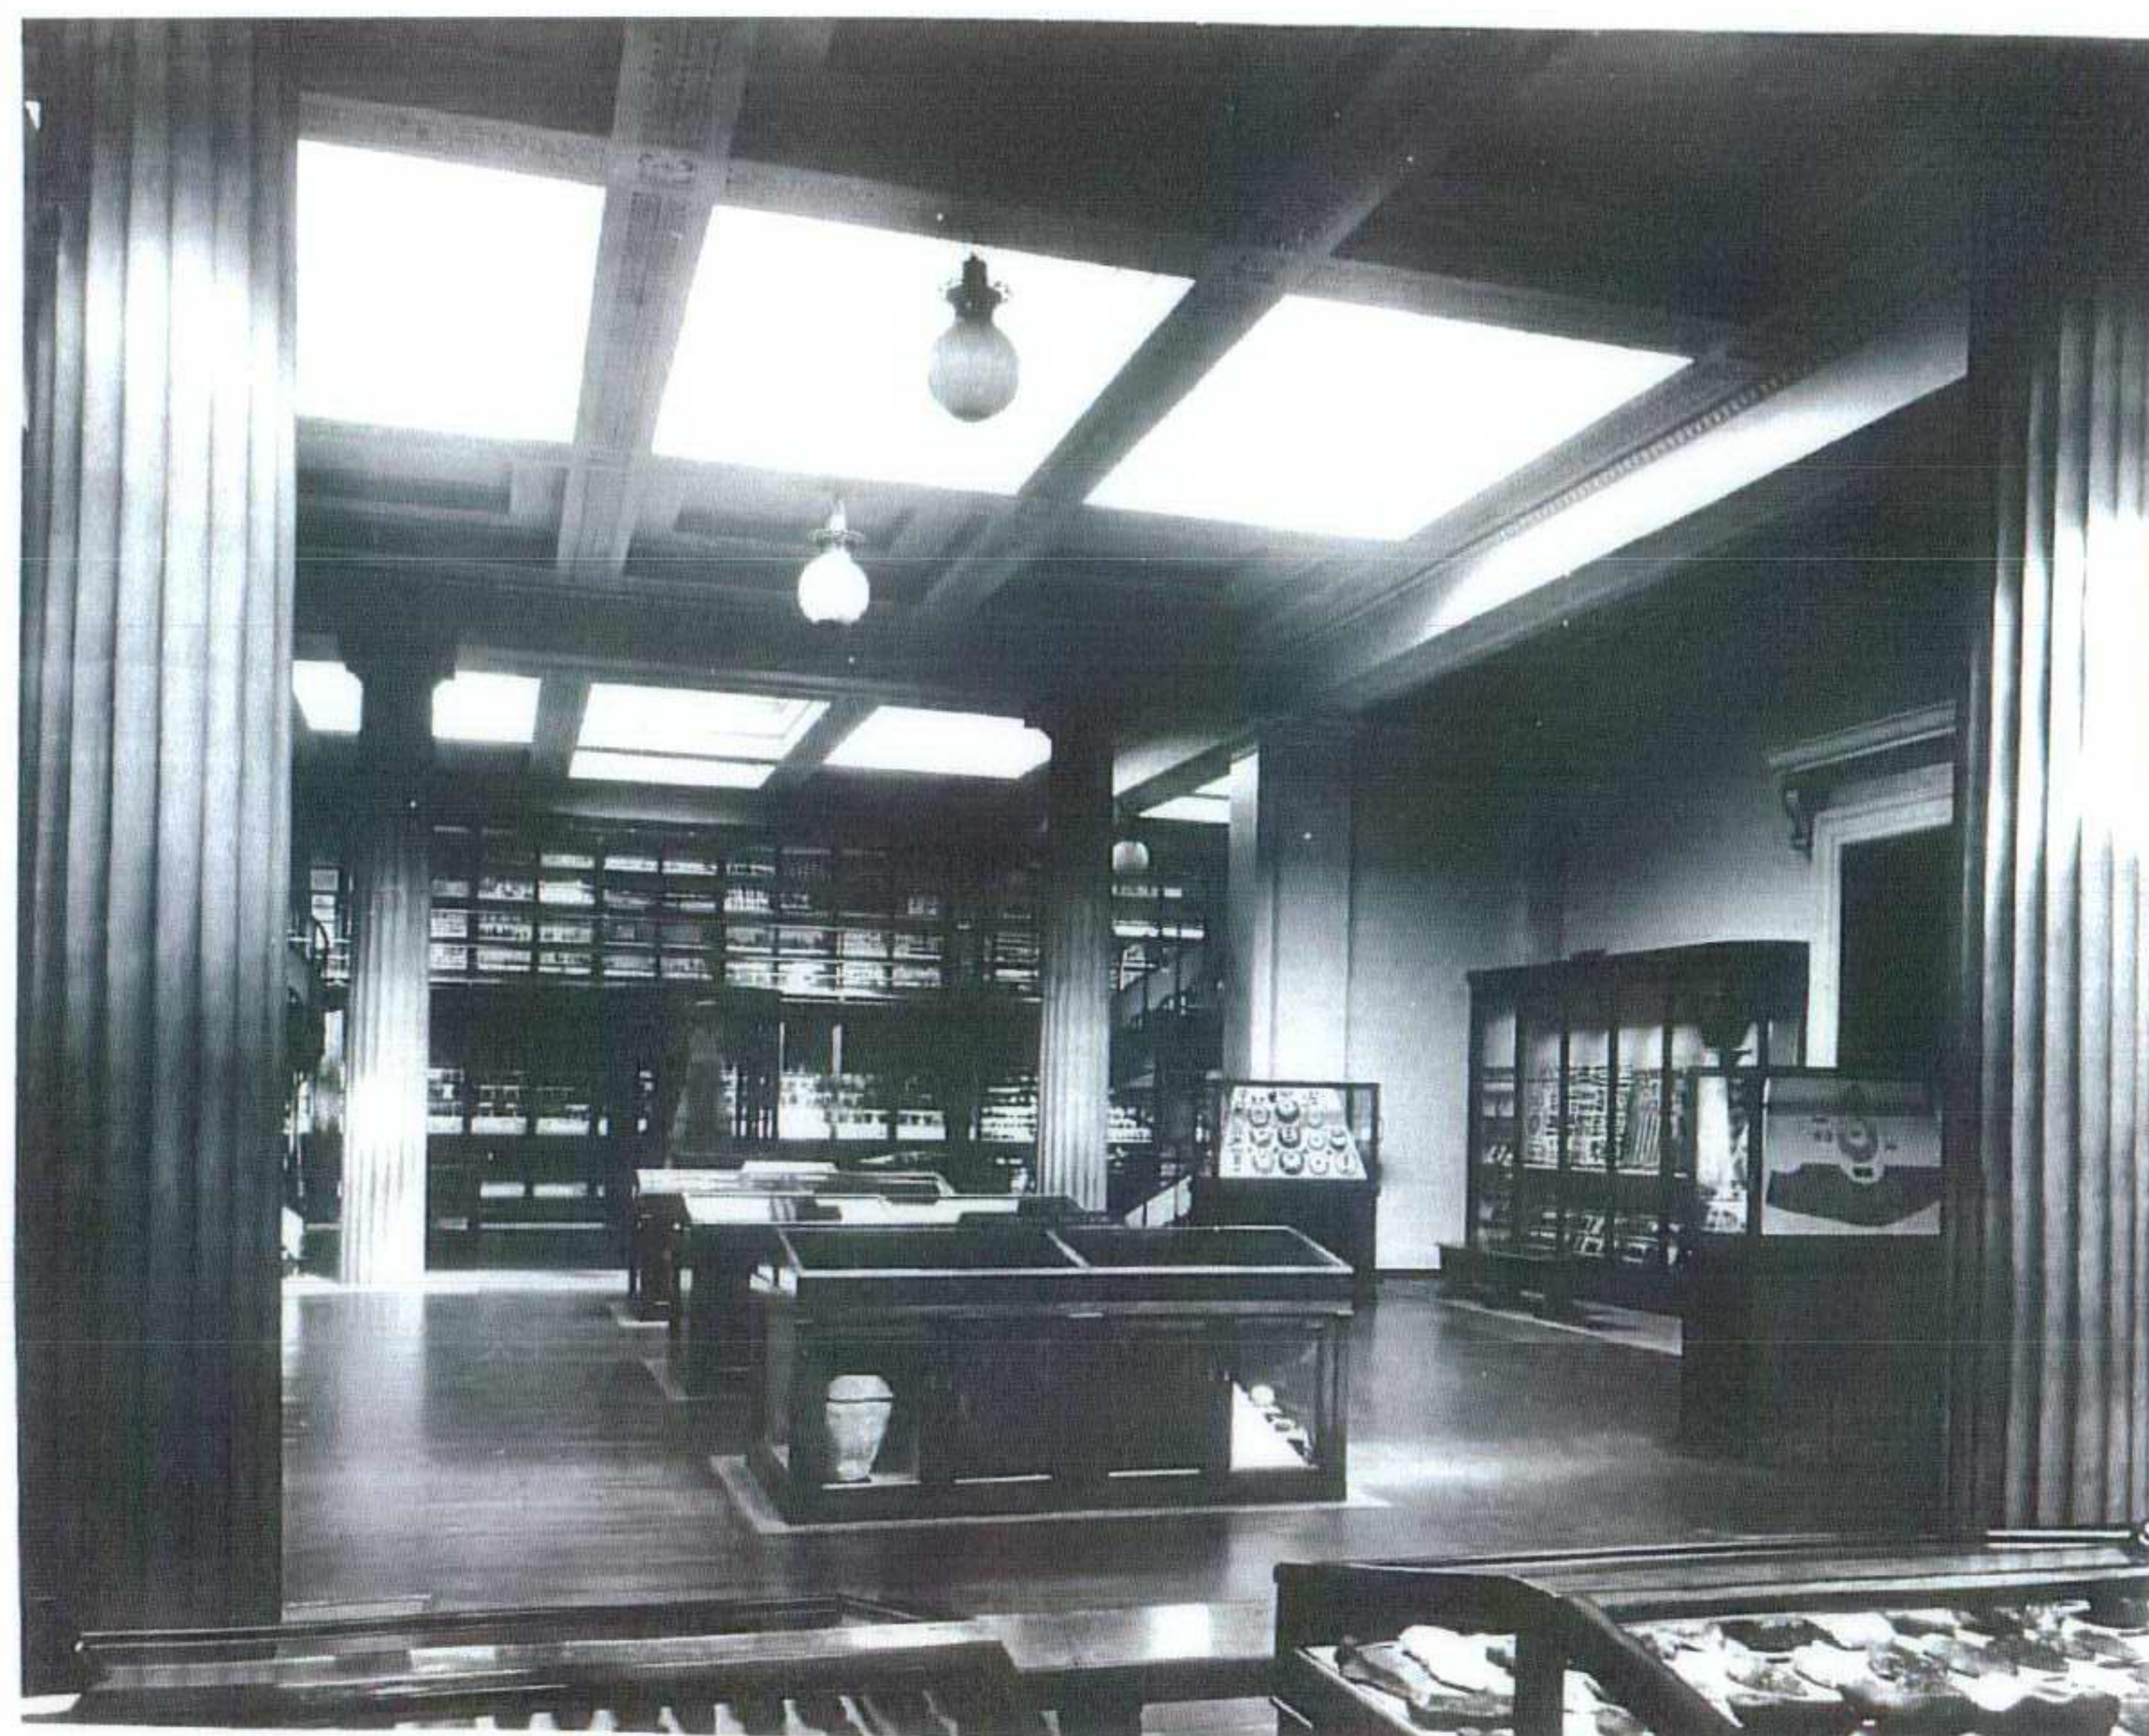
Grand Saloon looking North and illustrating the ceiling configuration and rooflight prior to bomb damage in 1941. The photograph also illustrates the embellishments to the door opening into Gallery 40

- Similarly, a large single lay light was introduced in the Central Saloon although this has now been replaced with a grid of modern ceiling tiles (pg.21), cutting out all natural daylight where there was once a roof lantern. The original pre-war configuration of this ceiling is recorded on a survey of this area carried out in 1931 (pg.20) and a pre-war photograph on page 5.

However, it would appear from pre-war photographs (pg.4) that the original cornice above the door into Gallery 40 has been removed. The original door canopies above the doors into Galleries 38 and 69 do, however, appear to be original. It is also worth noting that there was originally a cornice of the same design above the central opening in the screen wall between the South Stair and Central Saloon.

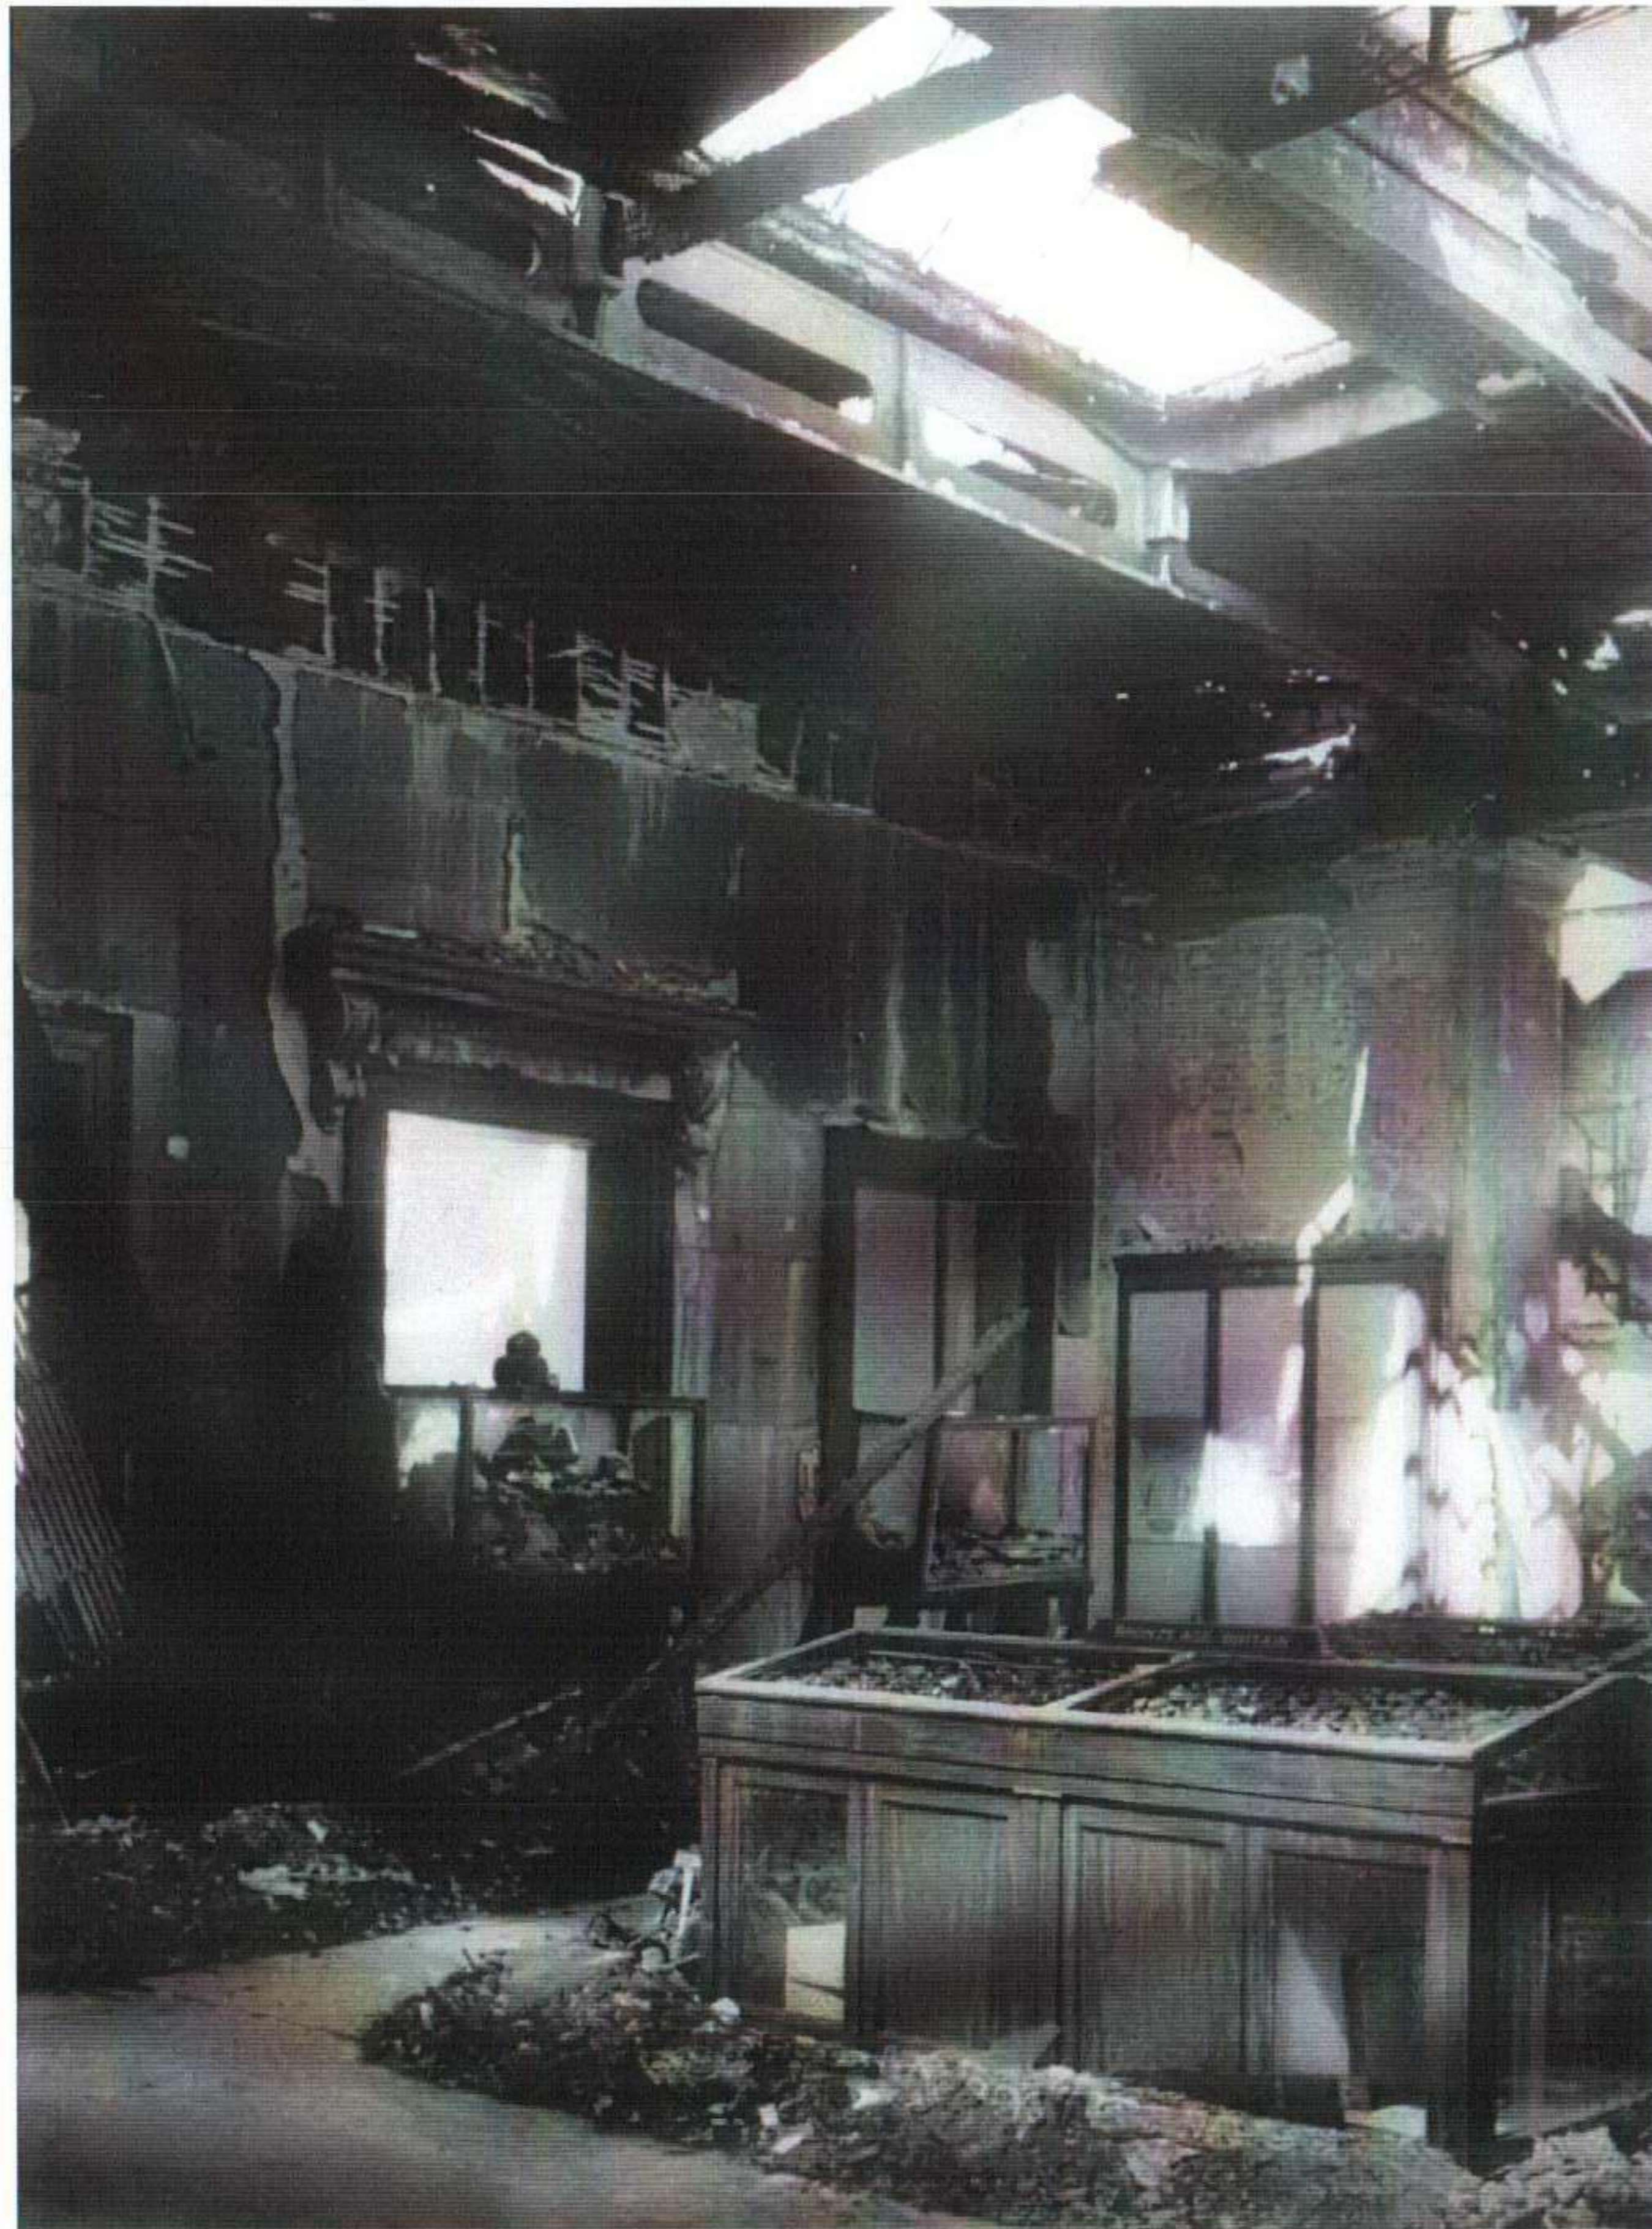
view towards original screen wall from Central Saloon following 1941 bomb damage

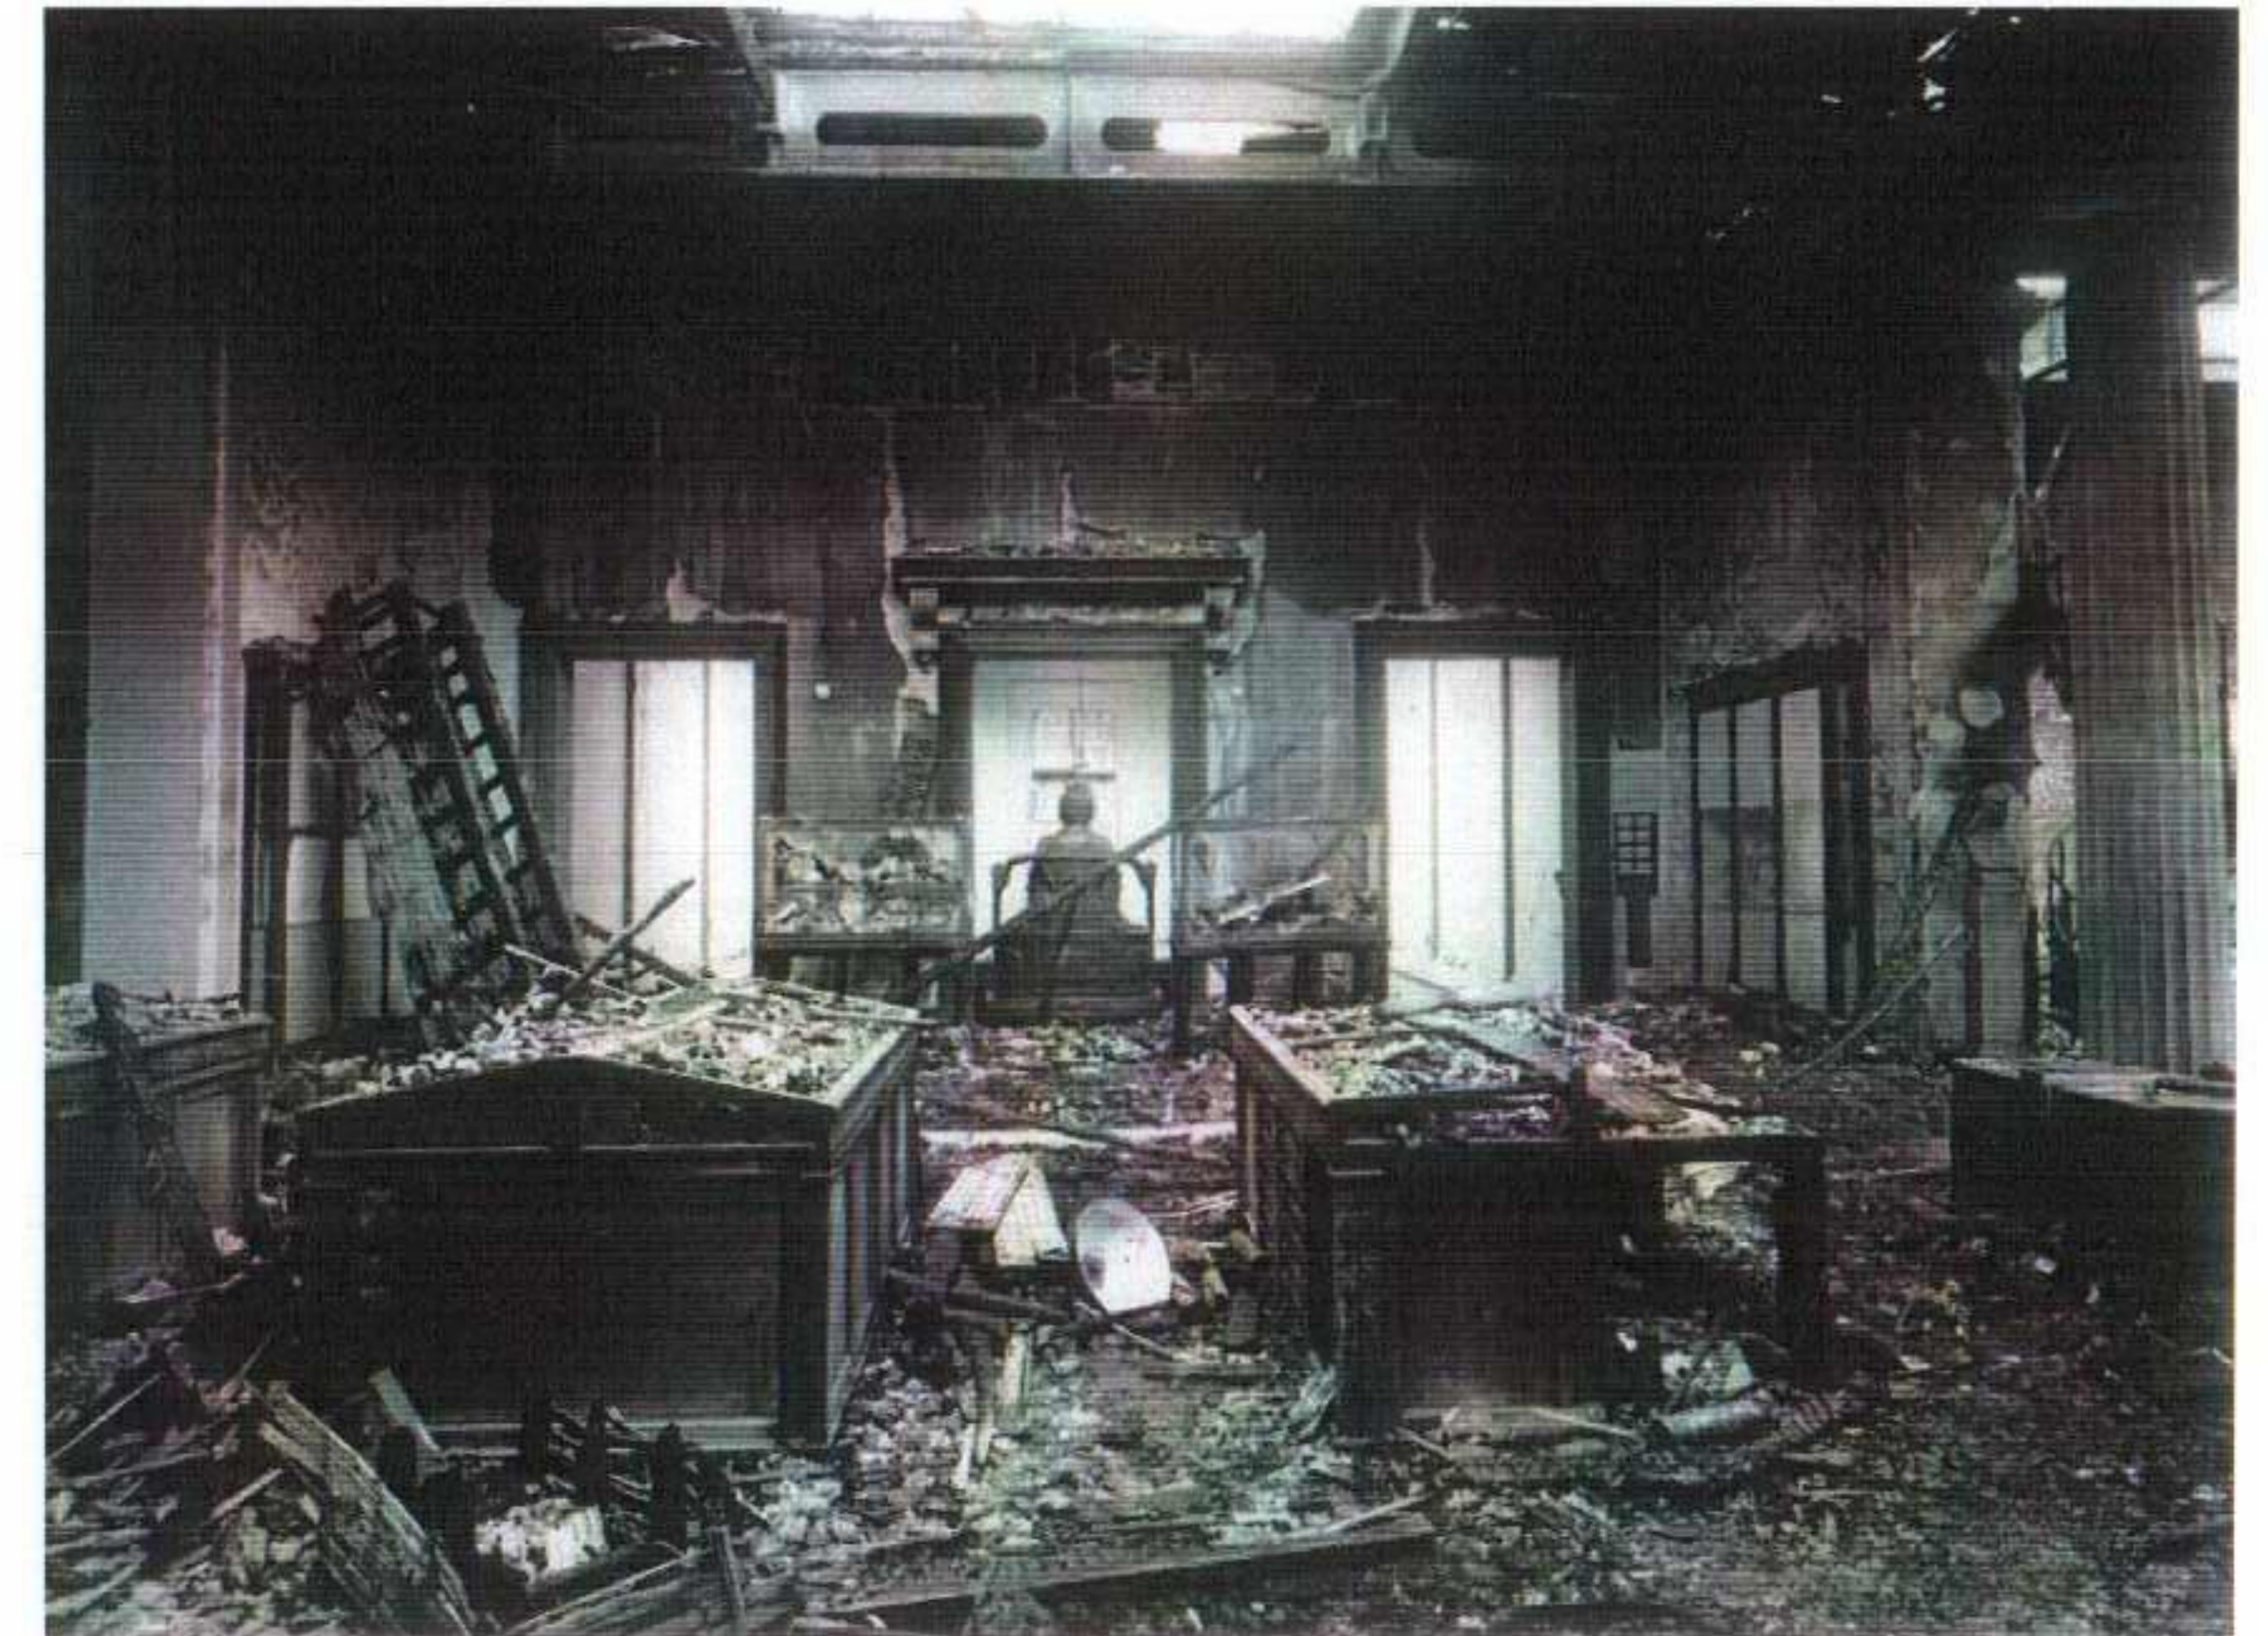
view towards original screen wall from Central Saloon following 1941 bomb damage

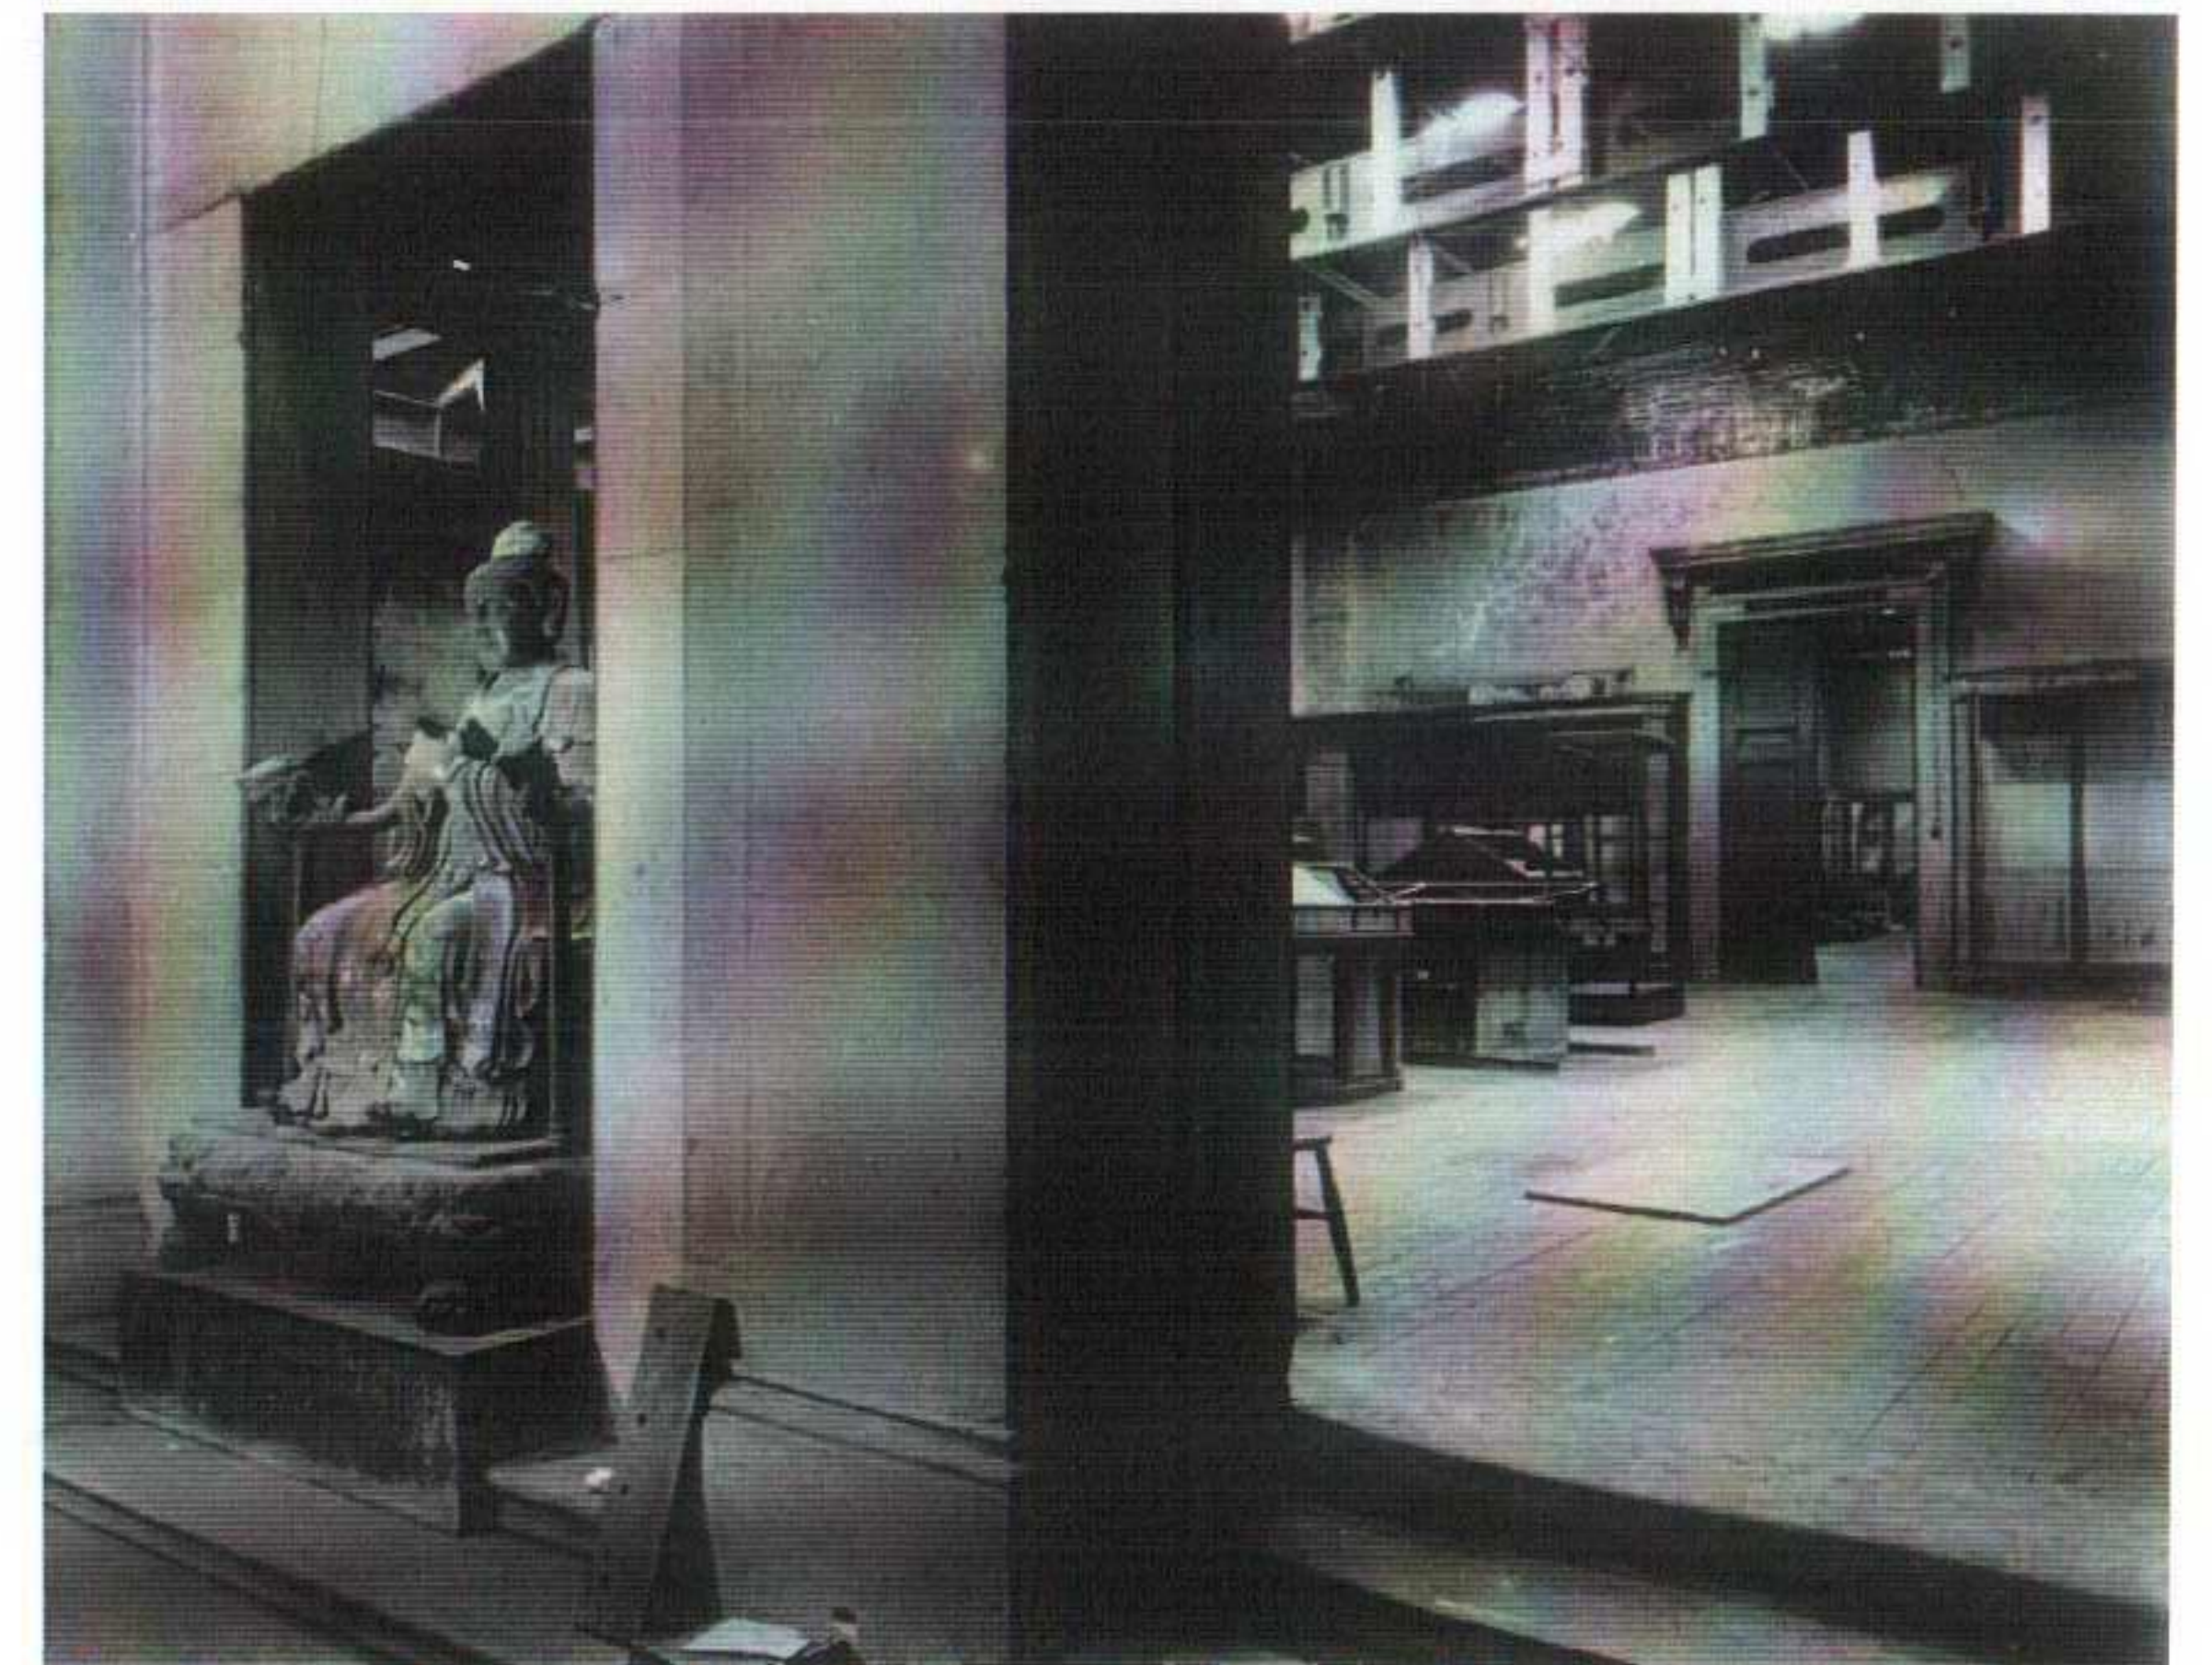
view from top of South Stair landing through openings in original screen wall towards Central Saloon
