SOUTH STAIR, CENTRAL SALOON AND GALLERY 37

Historical Development and Record Information

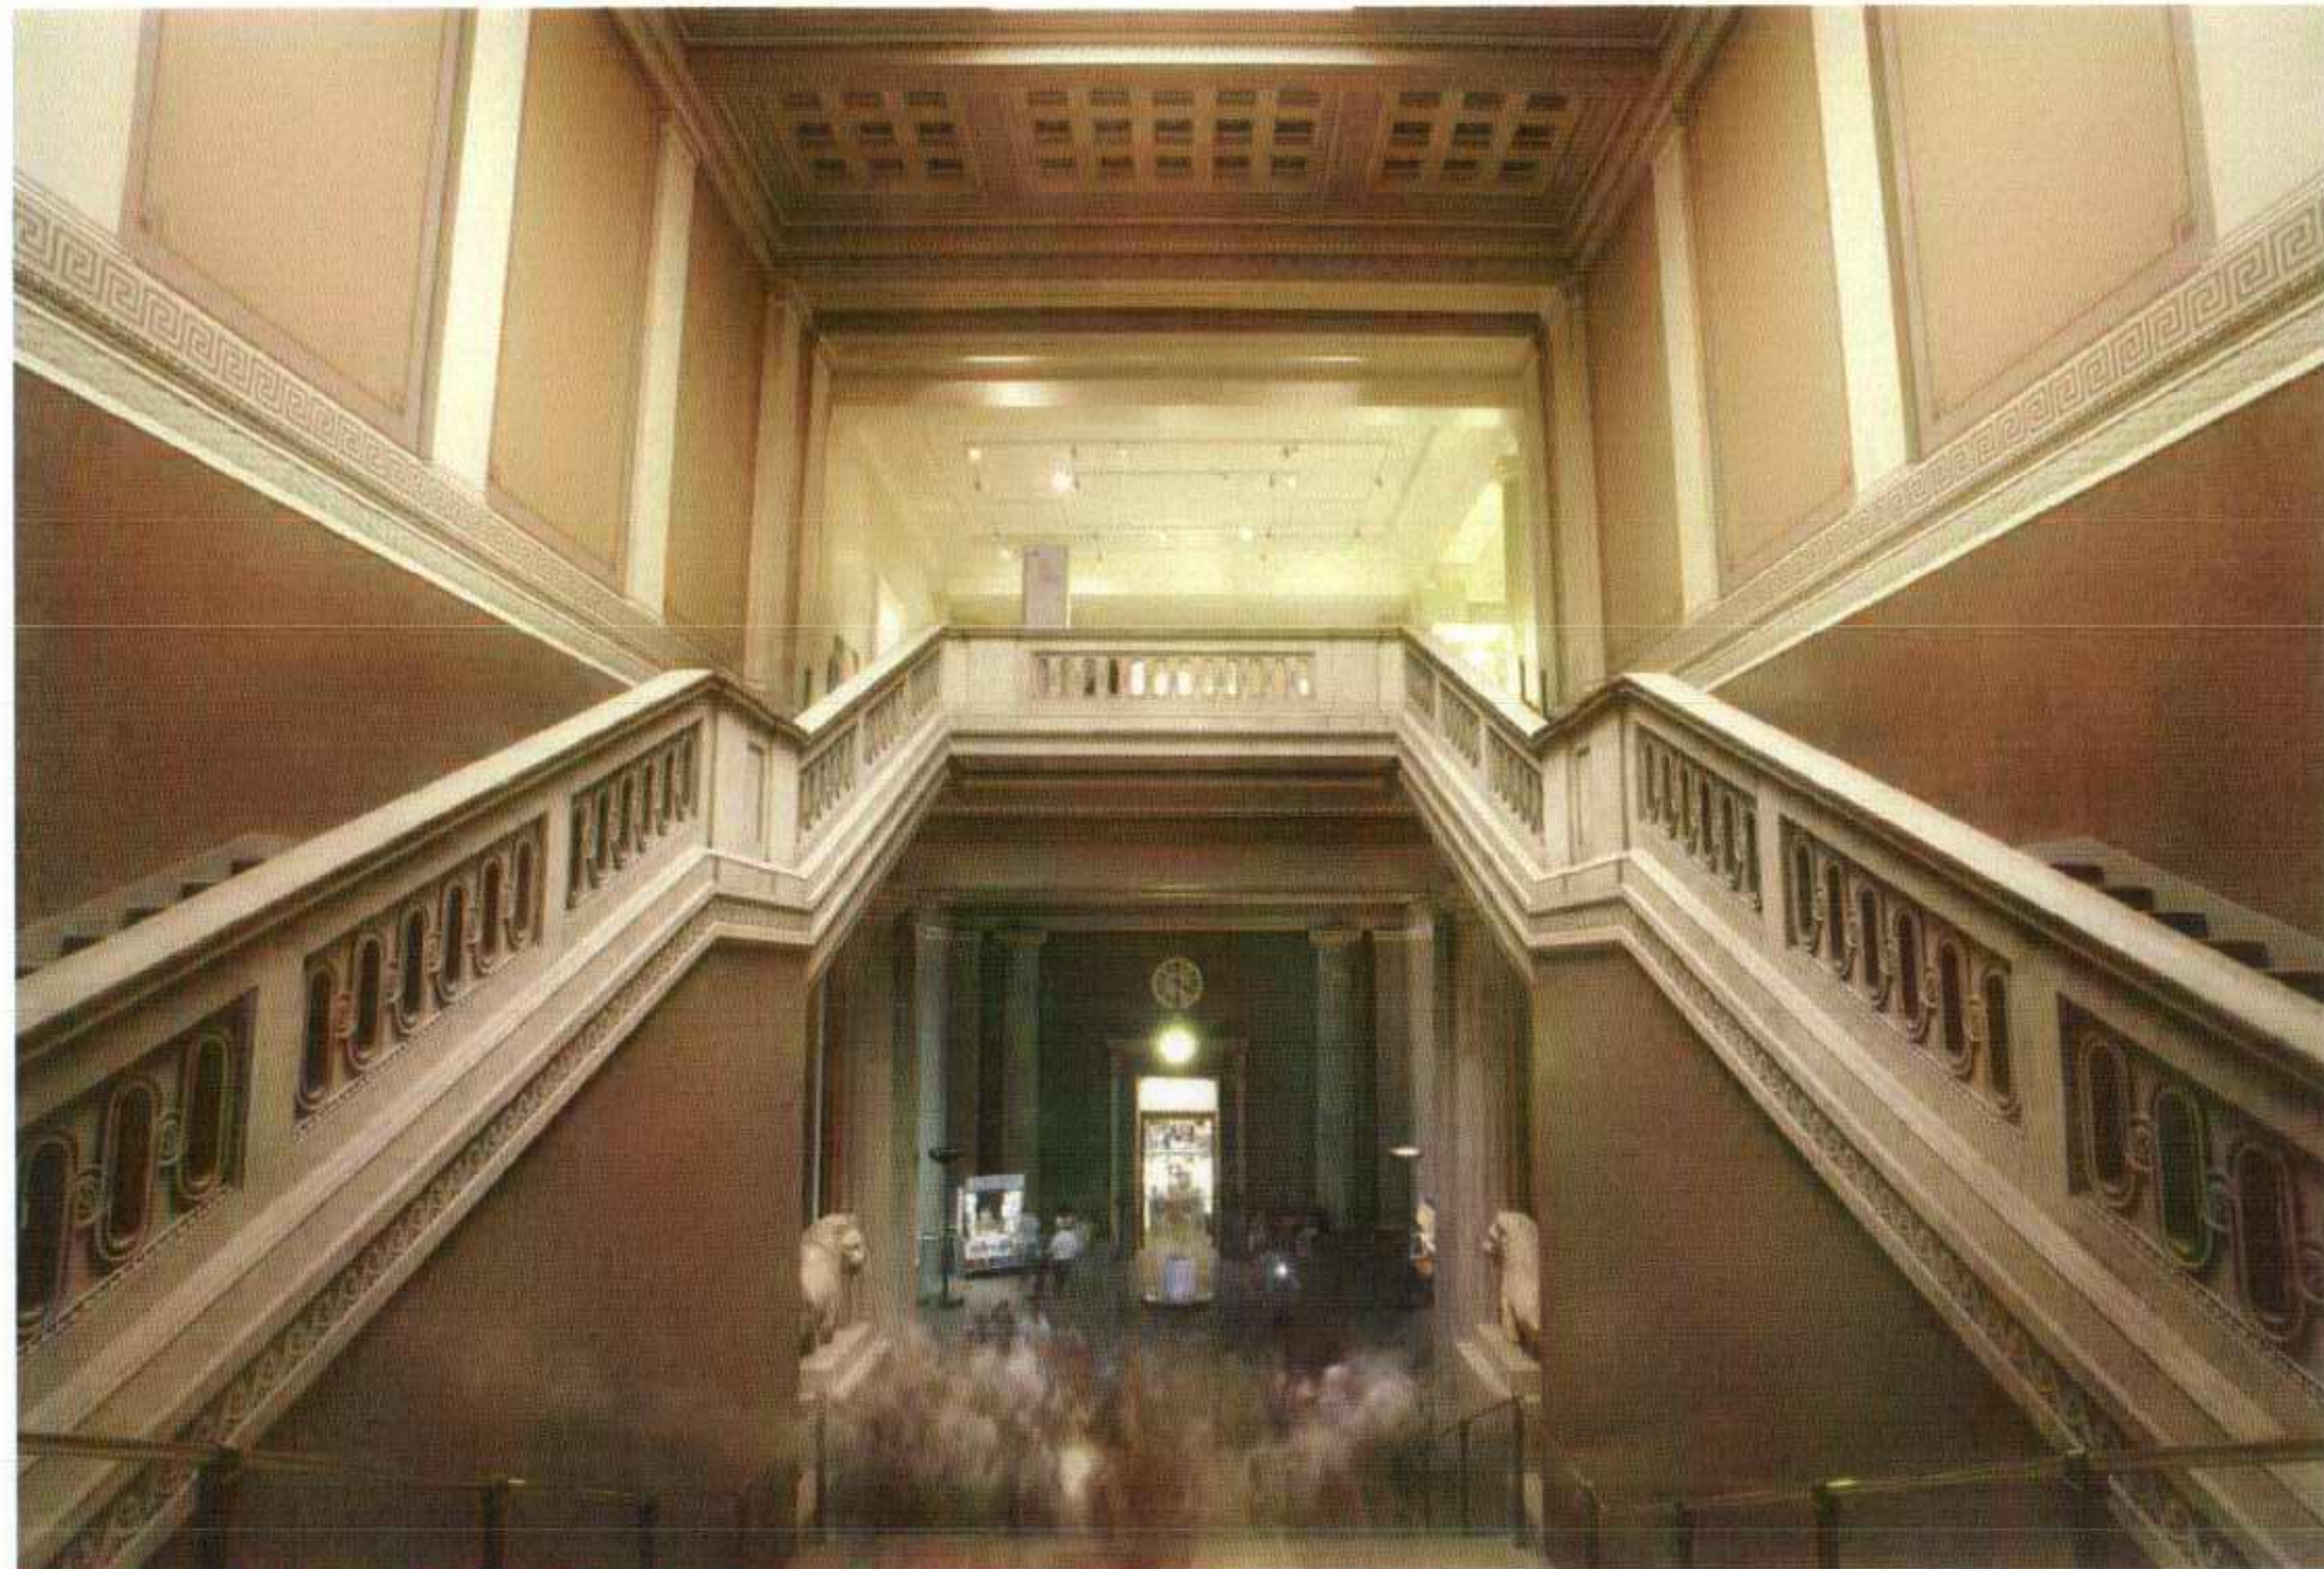
Existing view from South Stair landing up to Central Saloon

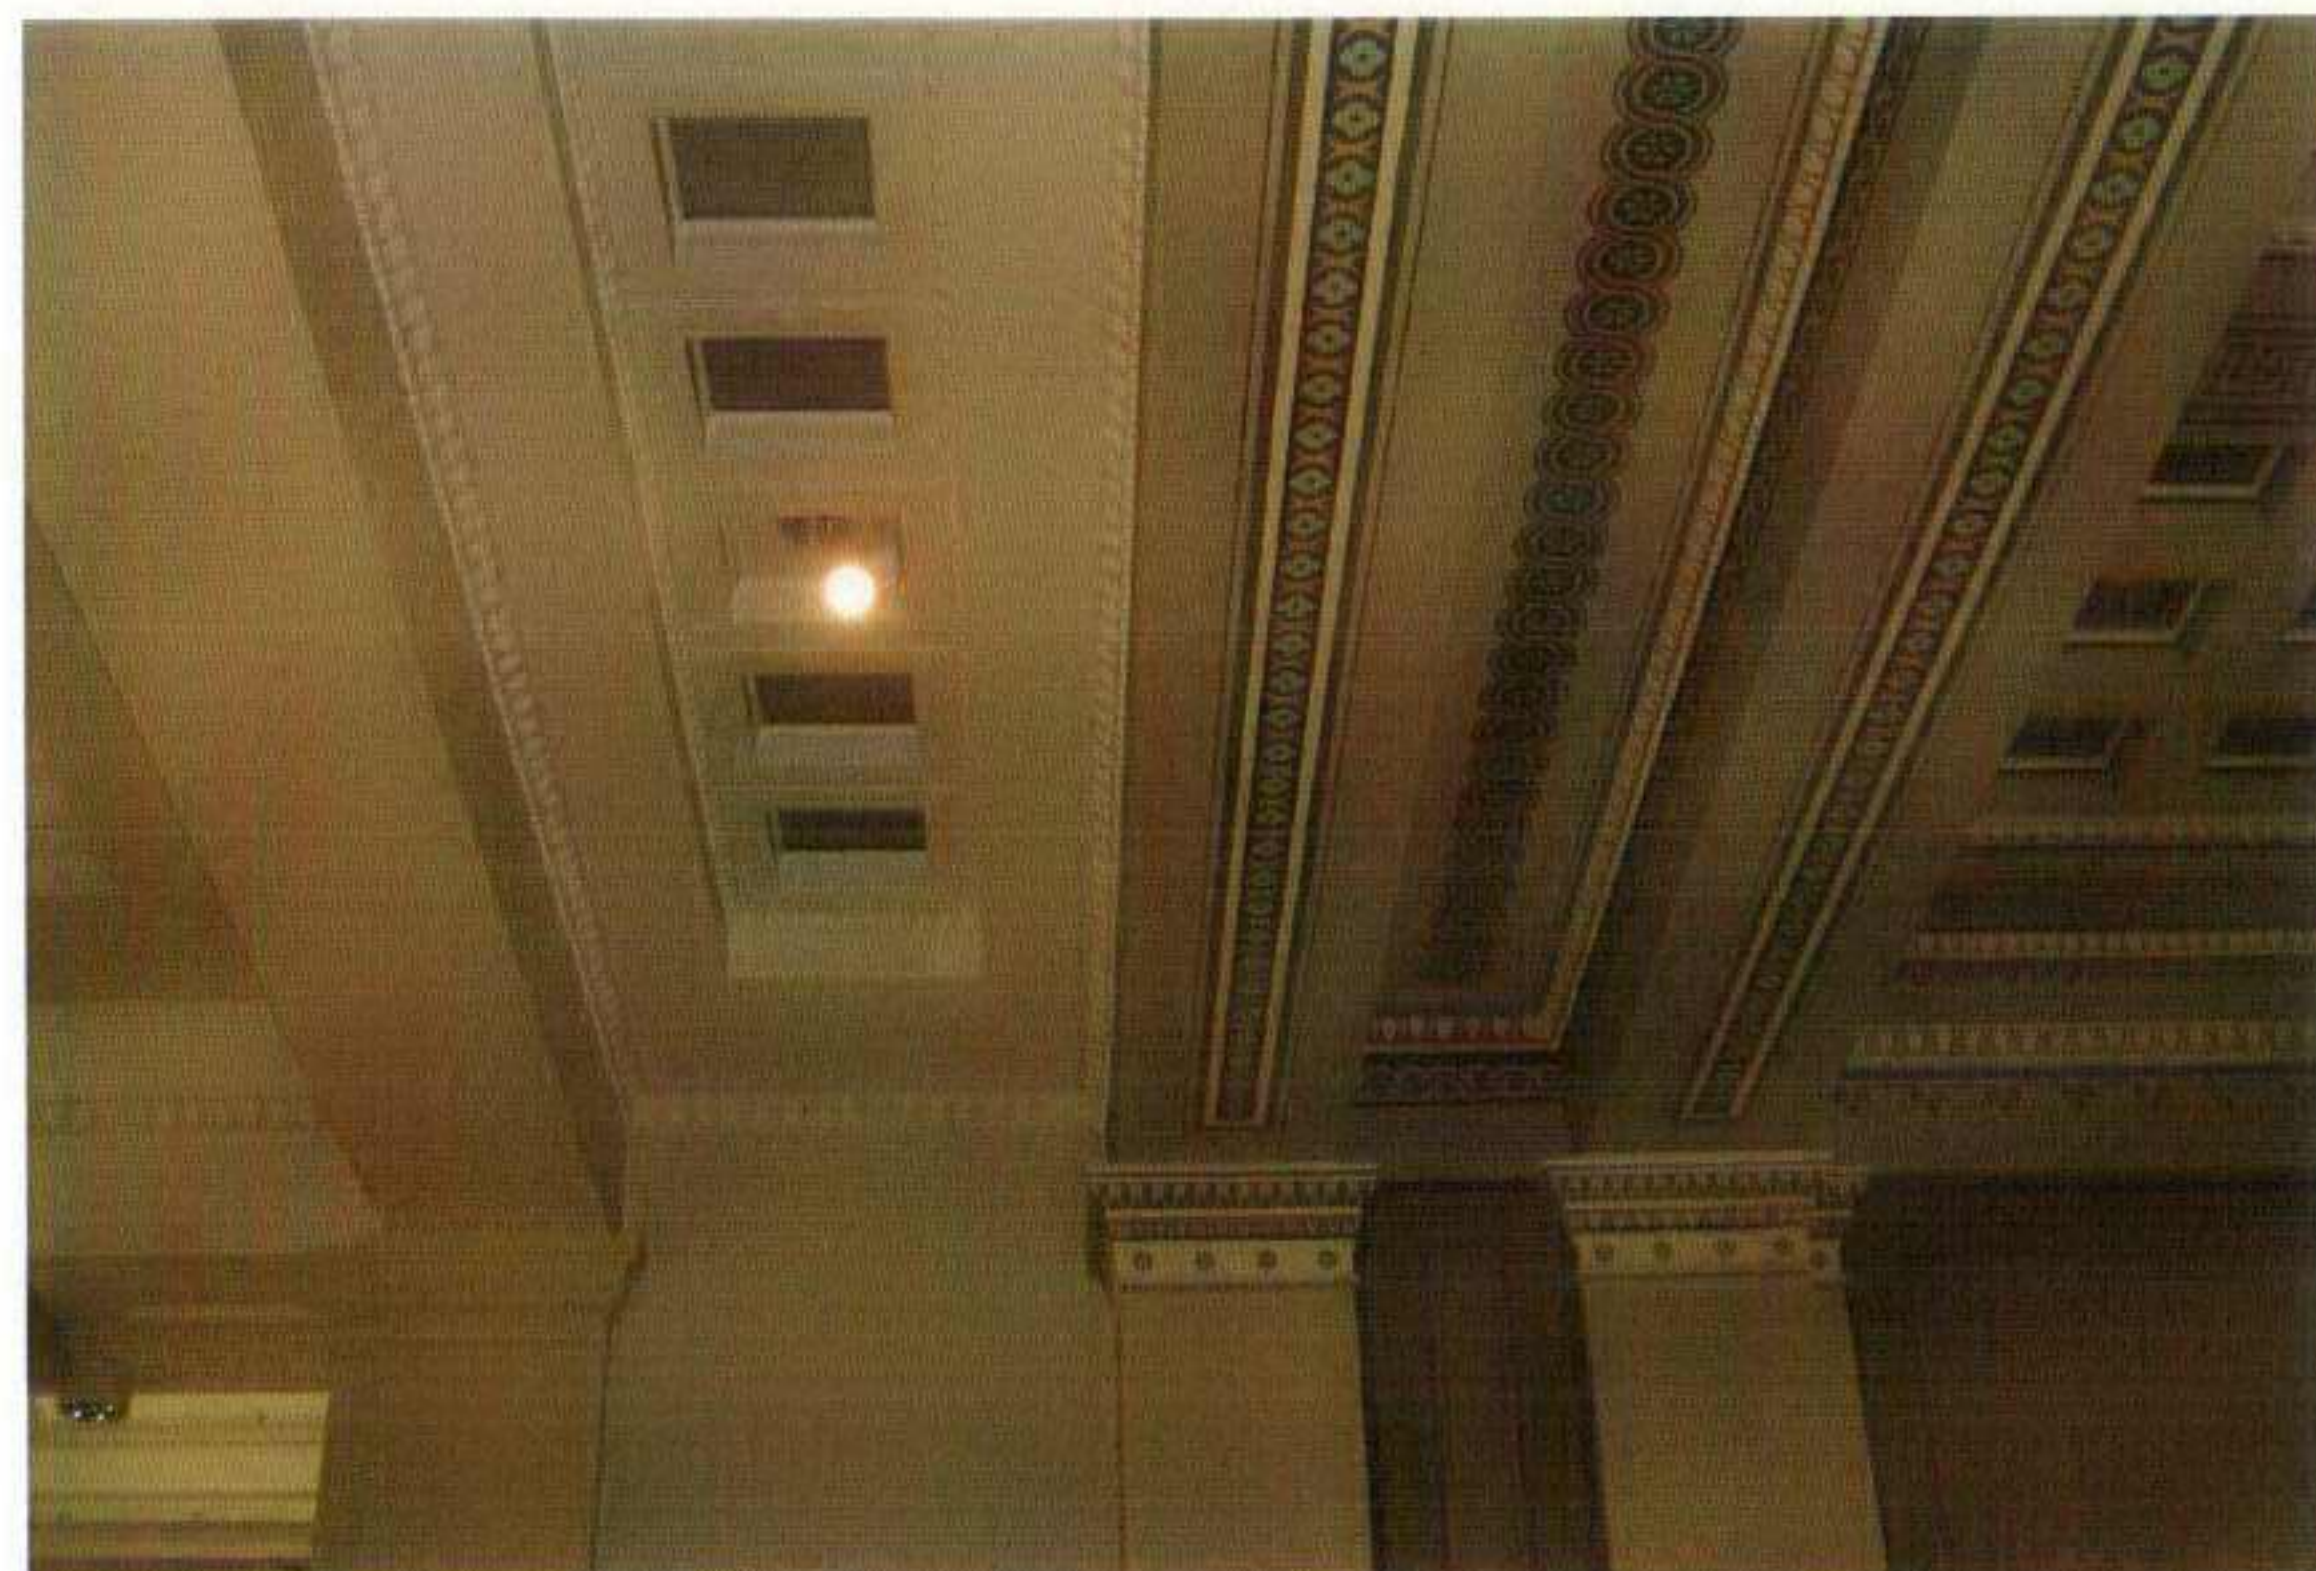
Existing ceiling line between Central Saloon and recently reinstated polychrome ceiling to South Stair

- The ceiling to the South Stair was originally designed with five equal bays, divided by down stand beams running across a central glazed roof lantern (pg.18). Whilst it is likely (from post bomb damage photographs) that this design was originally implemented, the reconstructed ceiling incorporating a single lay light omitted the dividing down stand beams. This has recently been decorated in an interpretation of the original 1847 Collman and Davis polychrome colour scheme as part of the Great Court Project.

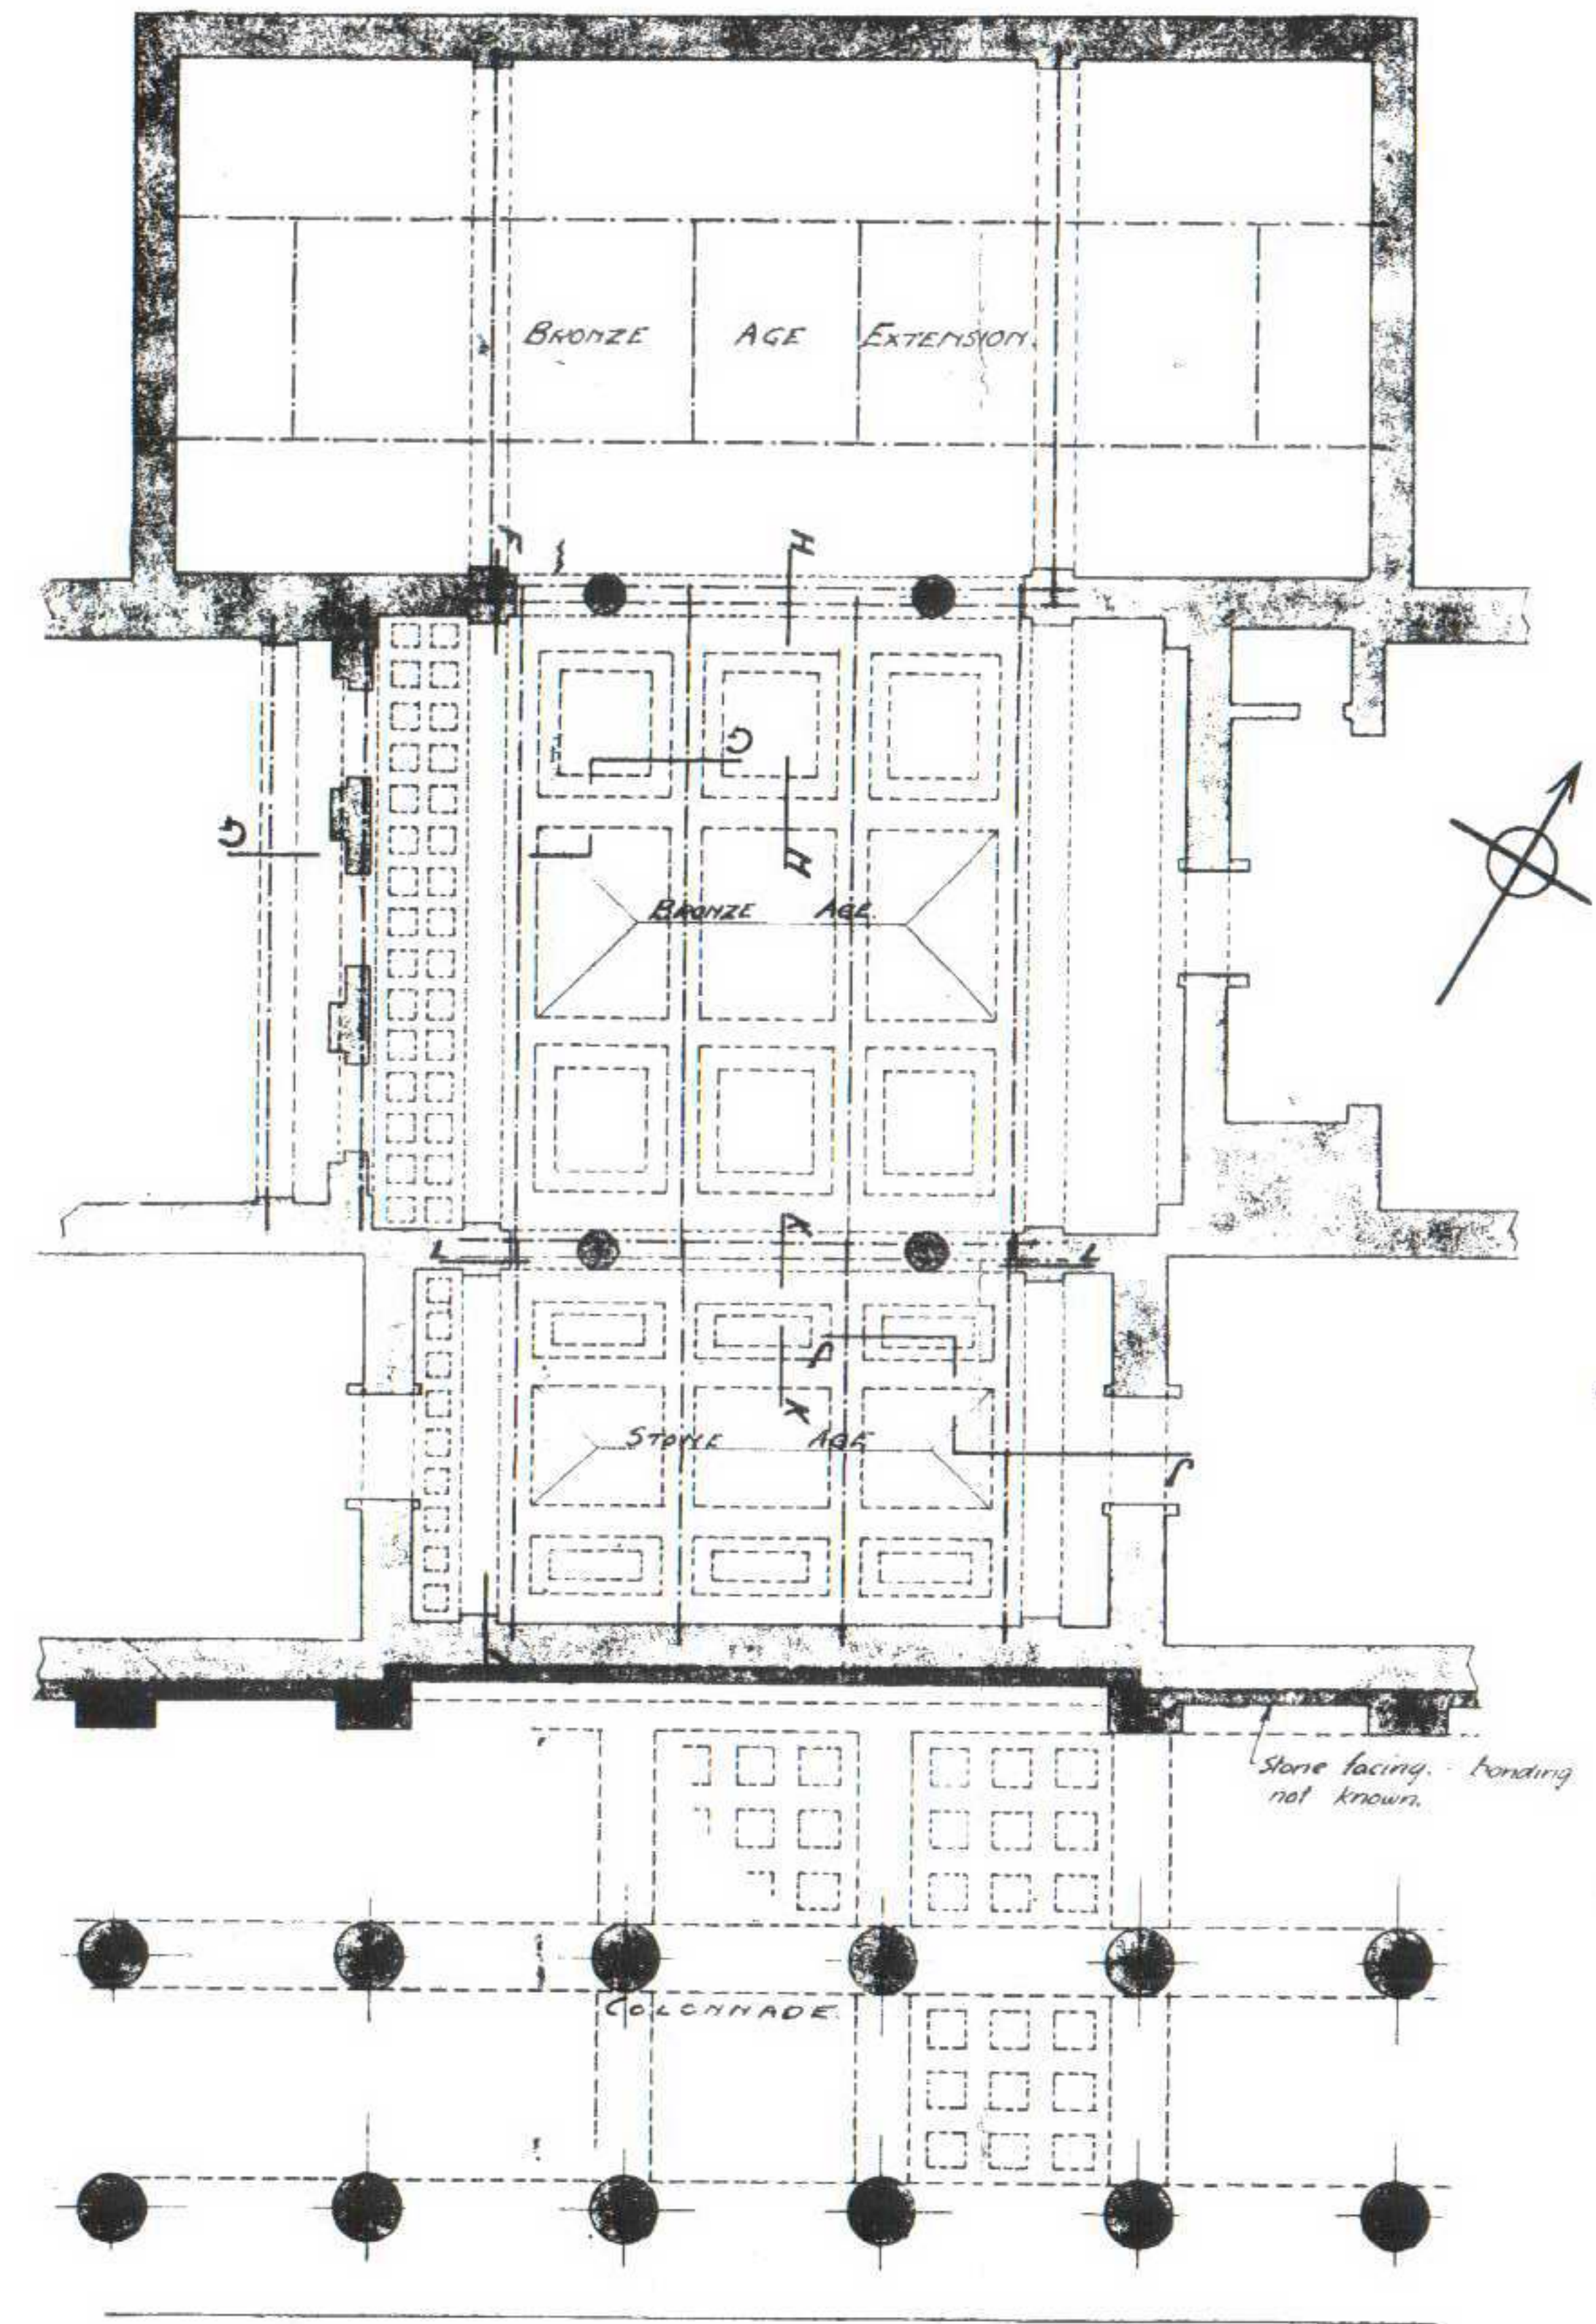
PLAN SHOWING CEILING AND SKYLIGHTS.

1931 survey drawing of Central Saloon showing original screen wall to South Stair and coffered ceiling

- Similarly, a large single lay light was introduced in the Central Saloon although this has now been replaced with a grid of modern ceiling tiles (pg.21), cutting out all natural daylight where there was once a roof lantern. The original pre-war configuration of this ceiling is recorded on a survey of this area carried out in 1931 (pg.20) and a pre-war photograph on page 5.

- The roof lantern and ceiling to Gallery 37, however, would appear to have not been materially effected by bomb damage. Minor alterations to this ceiling appear to have been the local infilling of some edge coffer alongside the doorways into adjacent Galleries 38 and 68. The original coffers are illustrated on the 1931 survey drawing mentioned above.

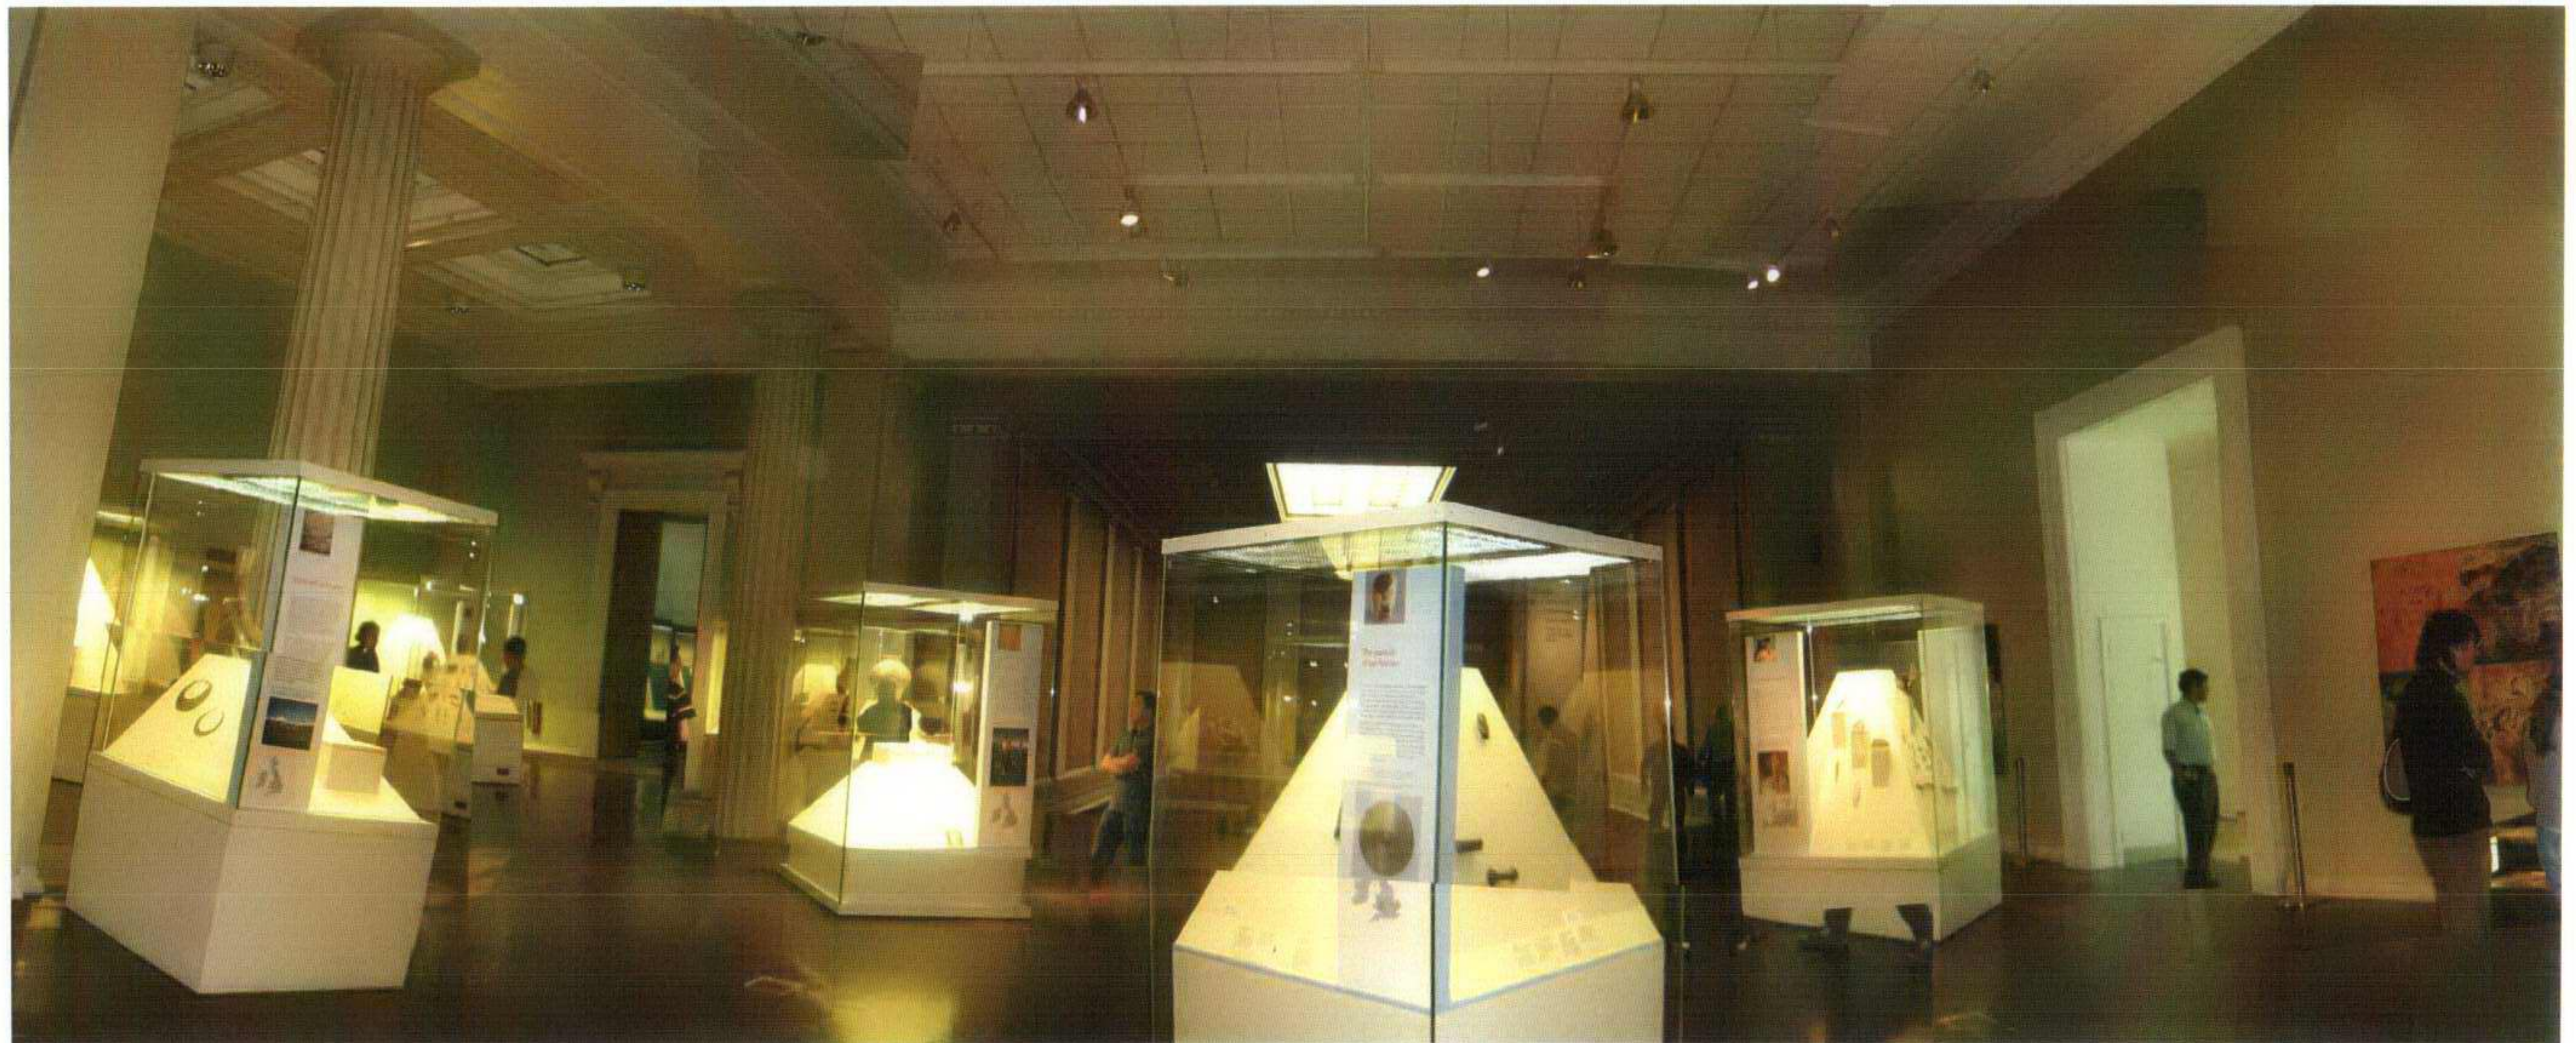
The Central Saloon from Gallery 40 with Gallery 37 to the left, the South Stair in the background and the opening to the South Portico and Great Court to the right

The new single opening from the Central Saloon into this lobby reflects the scale and remaining detail of the existing doorway into the adjacent Gallery 40 corridor. However, the spatial connection to the lobby and Great Court beyond appears relatively discrete and the light limestone floor (matching the Great Court) further detaches this space from the Central Saloon and South Stair.

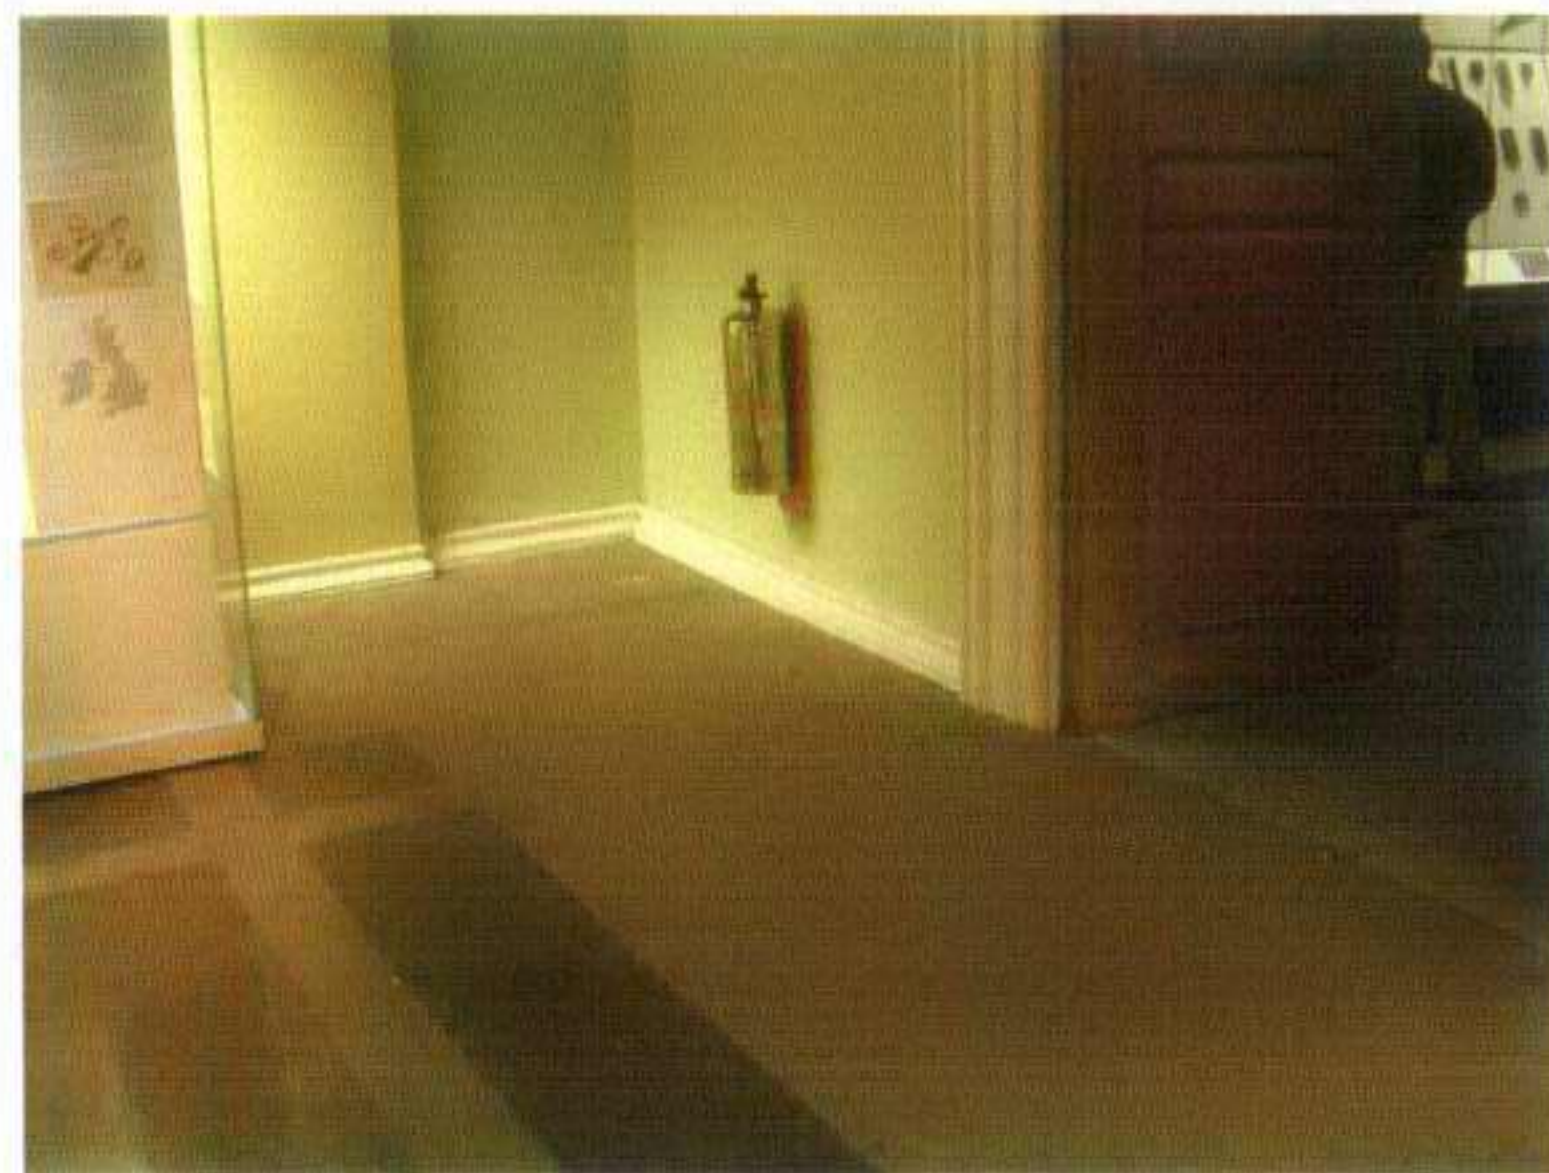
Existing stone /slate floor detail in Gallery 37 looking towards doorway into Gallery 68

- Following bomb damage and post-war strengthening of the floor structure, it appears from recent site investigations that the original timber floor finishes to the Central Saloon and Gallery 37 have been replaced. These now incorporate a mixture of modern tongue and groove timber or plywood boarding with a linoleum finish.
- Although the original stone borders with integral slate duct covers still remain within Gallery 37, localised areas around the two stone columns appear to have been reinstated in modern concrete screed.
- Although altered in some places, it would appear that most of the original features and joinery to the doorways leading off from the Central Saloon and Gallery 37 are original and remain intact. These include full height timber doors which fold back flush into the adjacent door reveal linings and architraves.

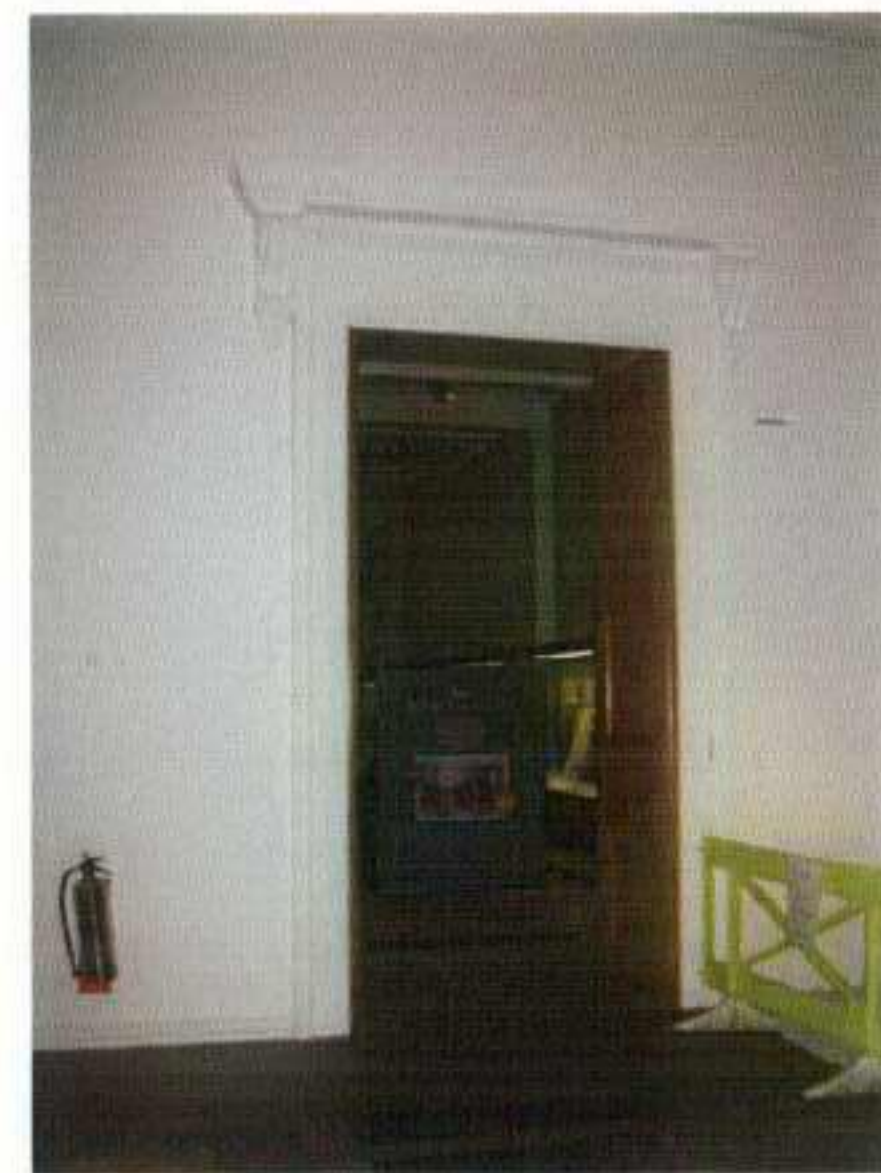
Existing doorway and cornice into Gallery 68 from Gallery 37

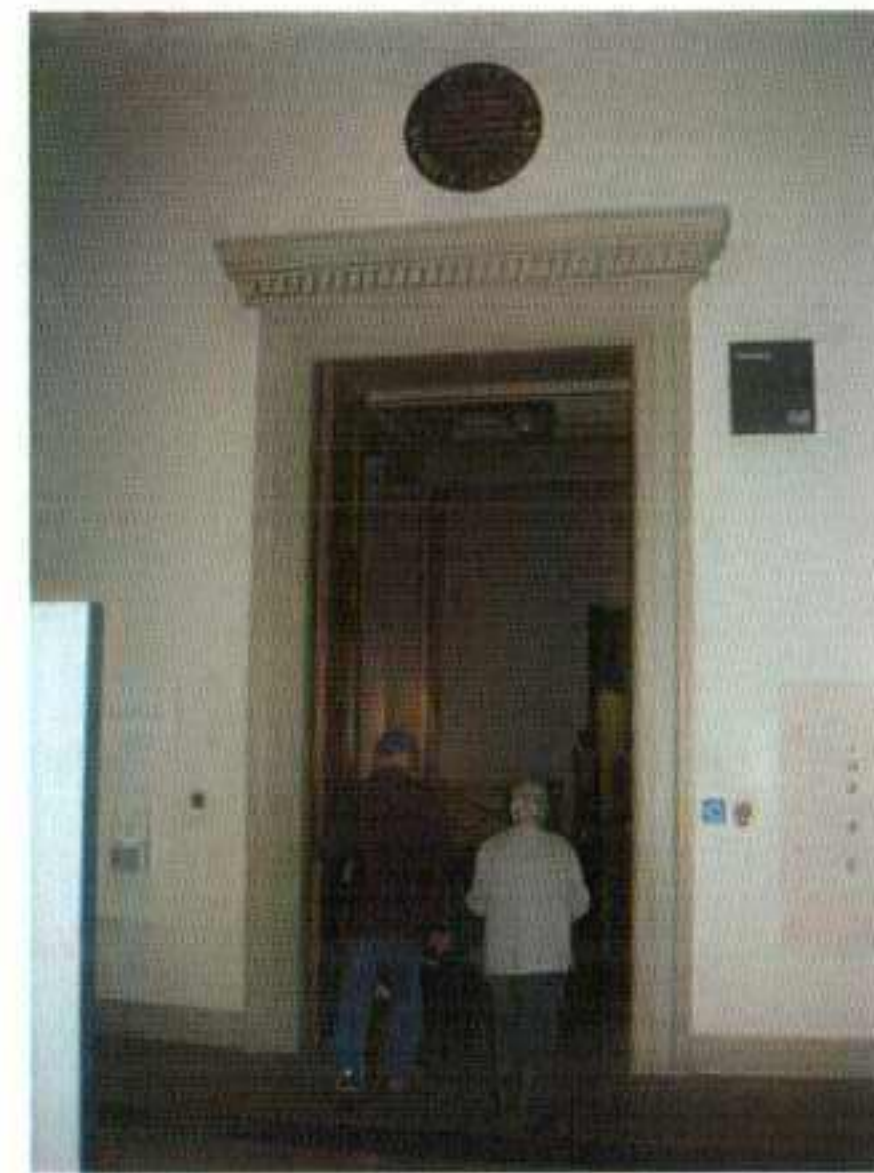
Existing doorway and cornice into Gallery 37 from Gallery 68

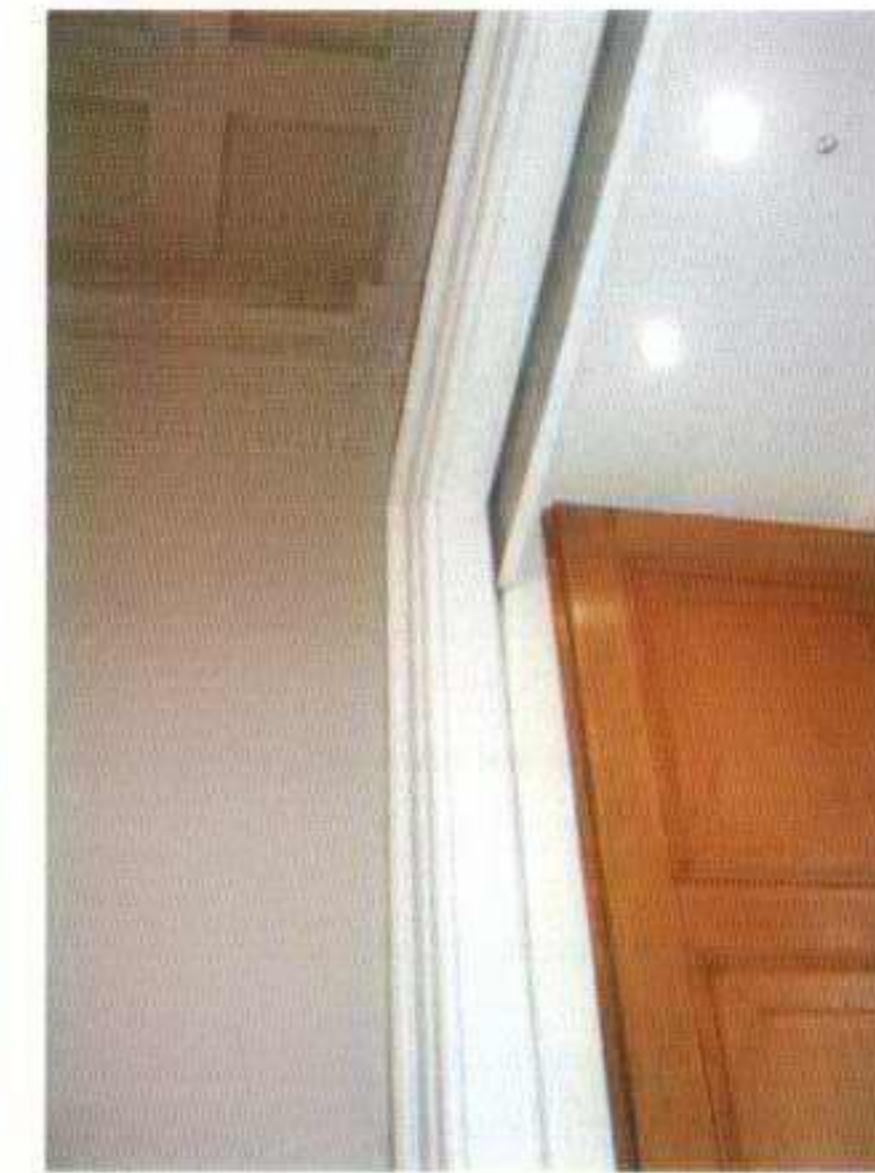
Typical fire shutter detail used elsewhere in the Museum

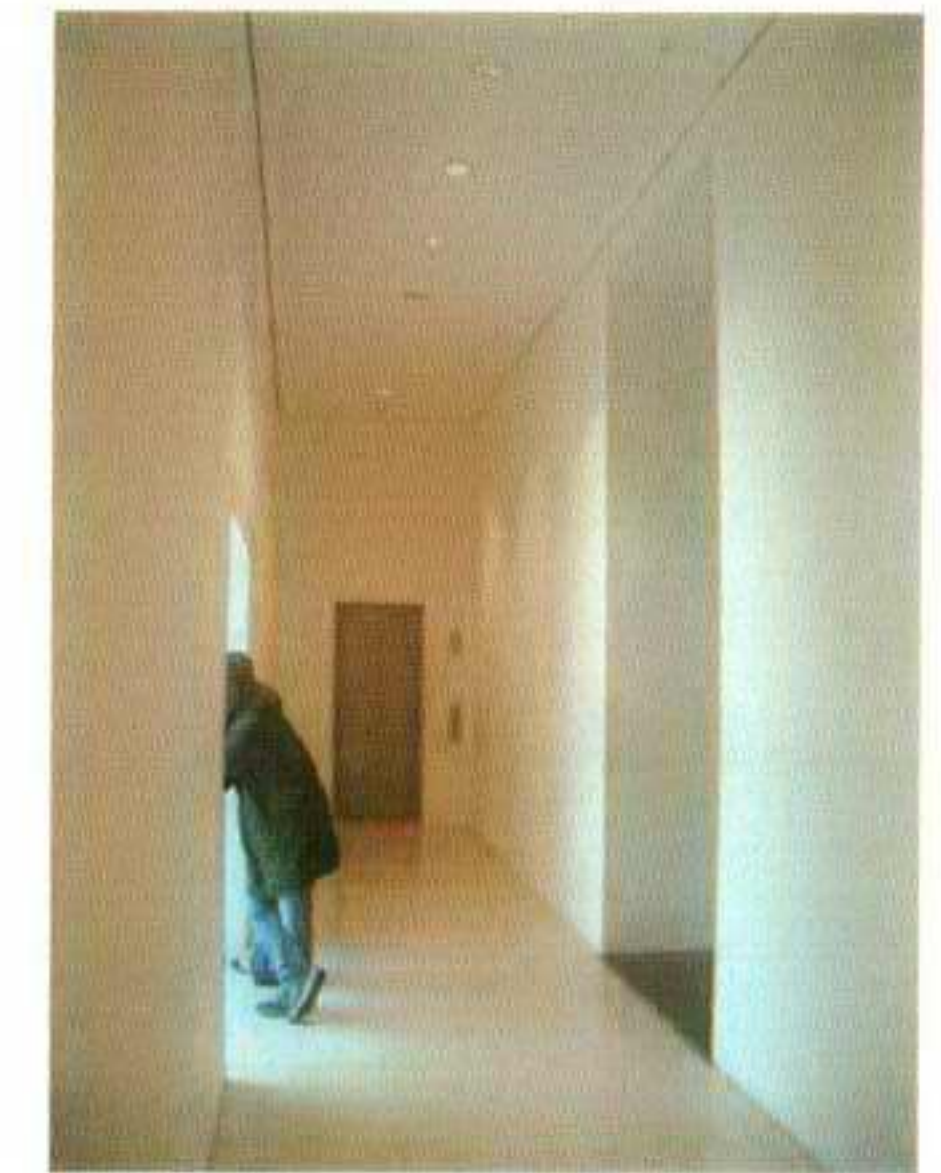
The lift lobby to the South Portico looking into the Great Court (left)

- 'Consideration should be given to reinstating the original screen wall at the top of the principle (South) staircase to reform a subdivided spatial hierarchy and reinforce the surprise of the view into the Great Court from the Central Saloon.'
- A north extension to the Central Saloon was added in 1877, involving the removal of the north wall and replaced with two columns (pg.18). This extension was subsequently modified, a lift lobby added within a reconstructed South Portico and the north wall reconfigured with a single opening as part of the Great Court project (pg.30).
