## GALLERIES 38, 39 AND 40

### Historical Development and Record Information

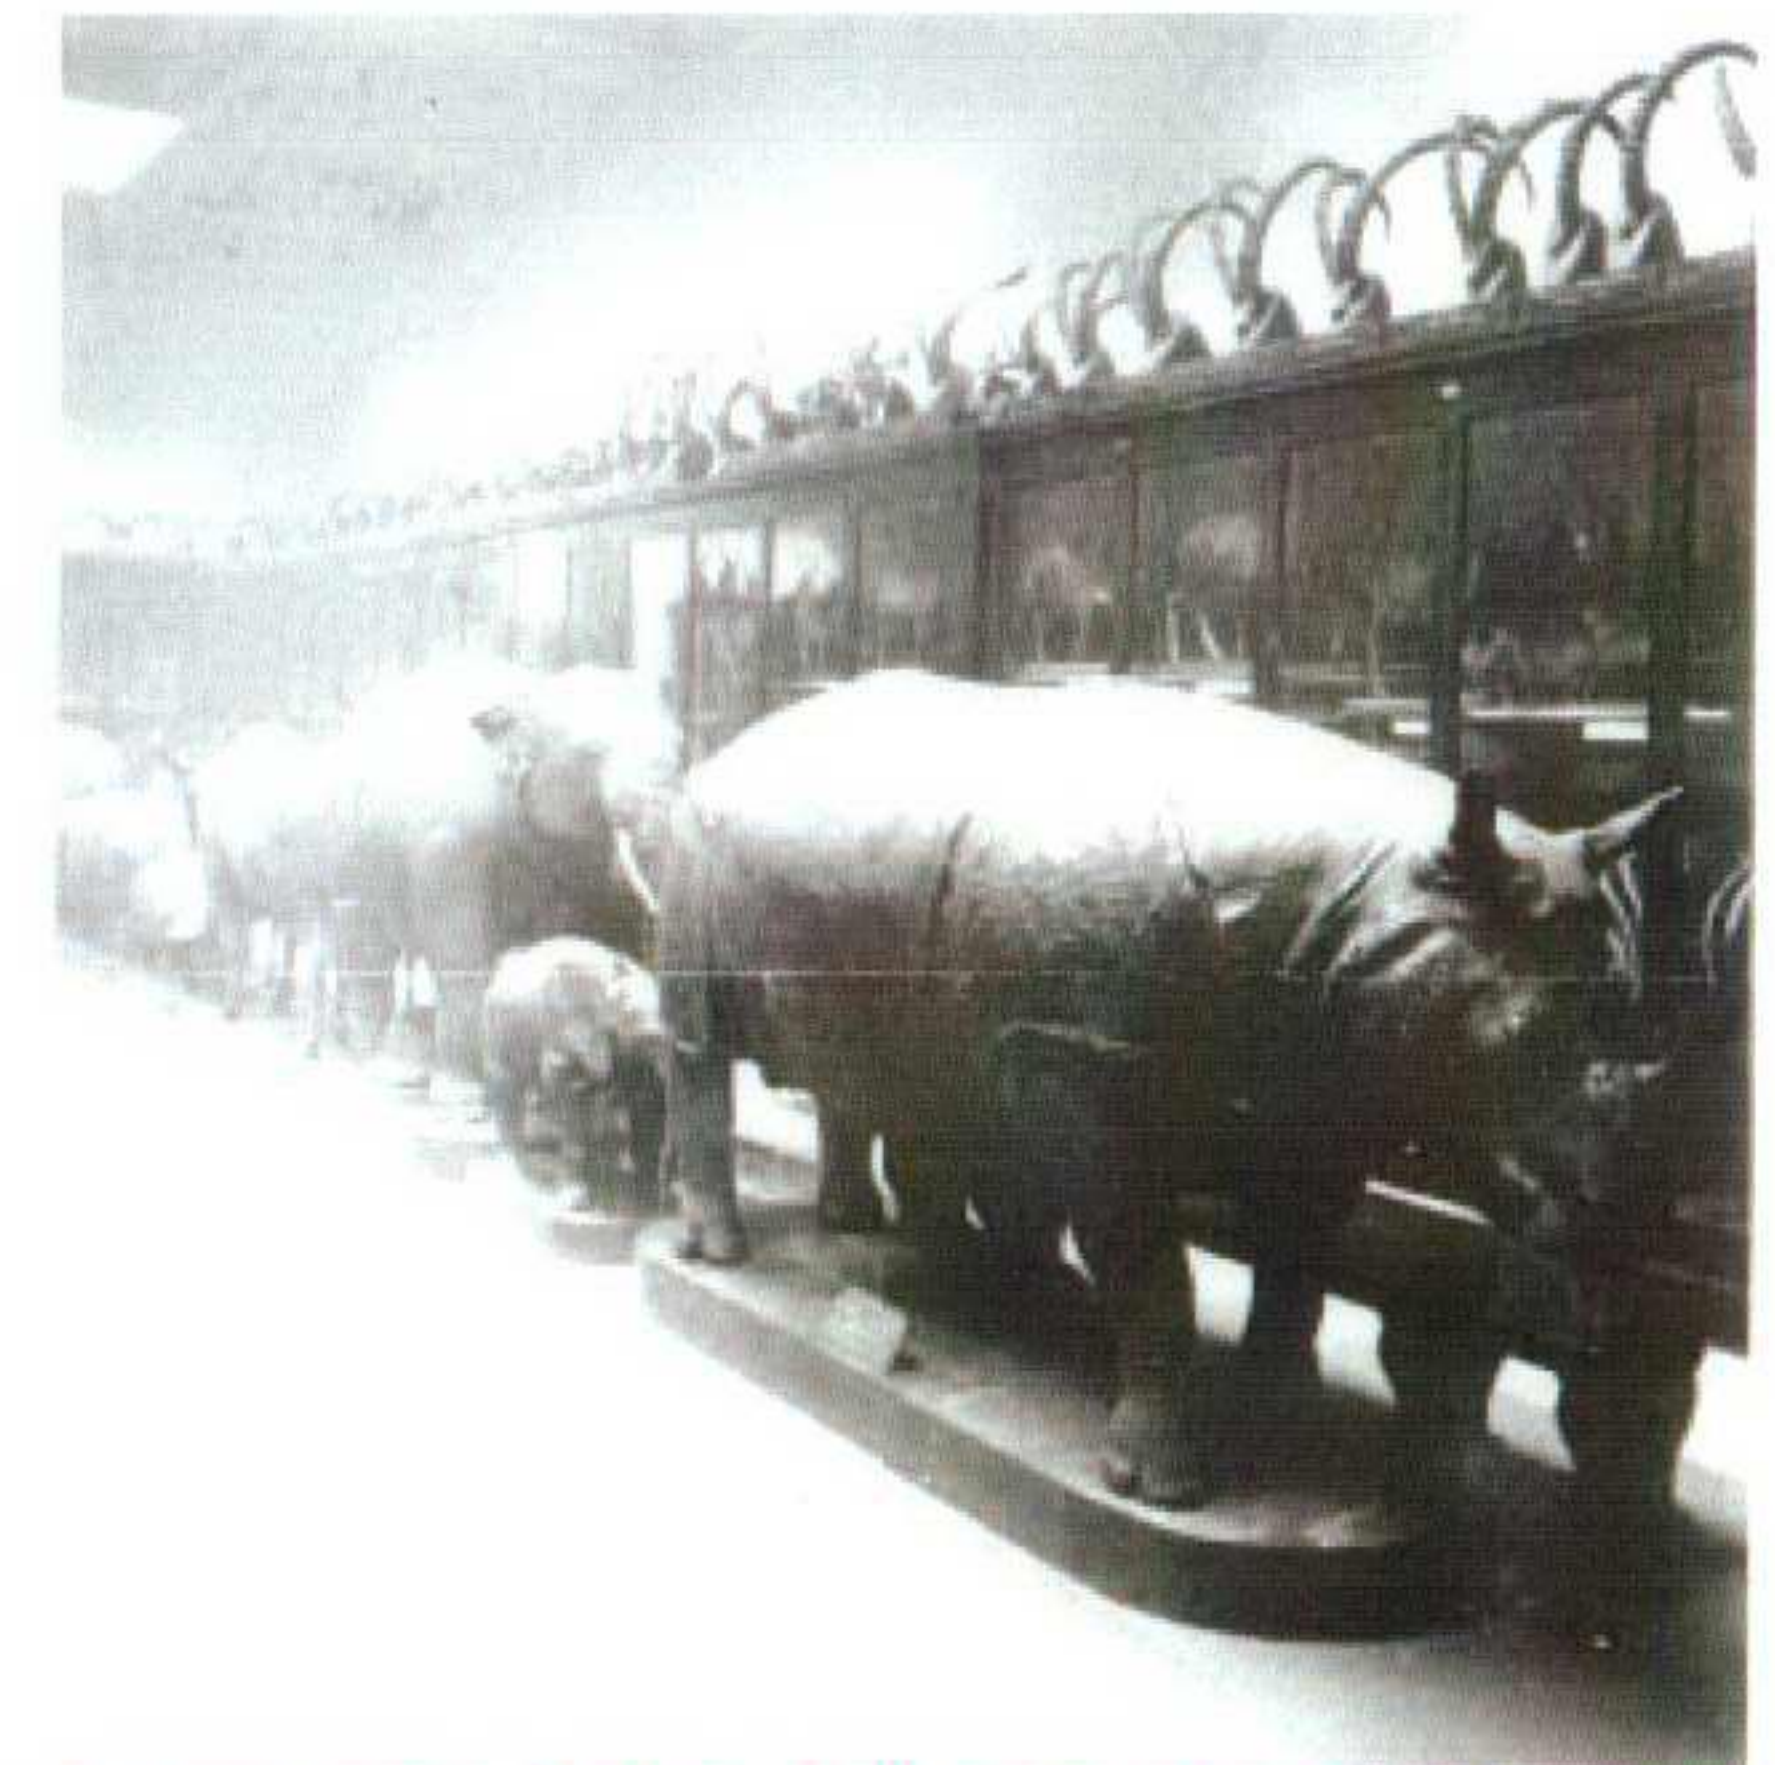
Archive photograph of Gallery 40 illustrating the ceiling layout and wall cabinets

- The original ceiling configuration and detailing can be seen in a number of archive photographs included within this report. This appears to have been a coffer and beam arrangement with three separate central roof lanterns, similar in configuration and detail to the existing ceilings in Galleries 37, 38 and 39 and original ceiling in the Central Saloon.

- Archive photographs indicate the original arrangement of the Gallery with continuous display cabinets located on both the north and side walls.
- The new steel roof structure incorporated a full length suspended mezzanine floor and access staircase along the north side of the gallery.
- From current information and site investigations it appears that majority of original finishes within this gallery have been replaced including ceilings, walls and floor finishes. In addition a number of fixed items of furniture and wall mounted steel work/brackets have been integrated in the space.

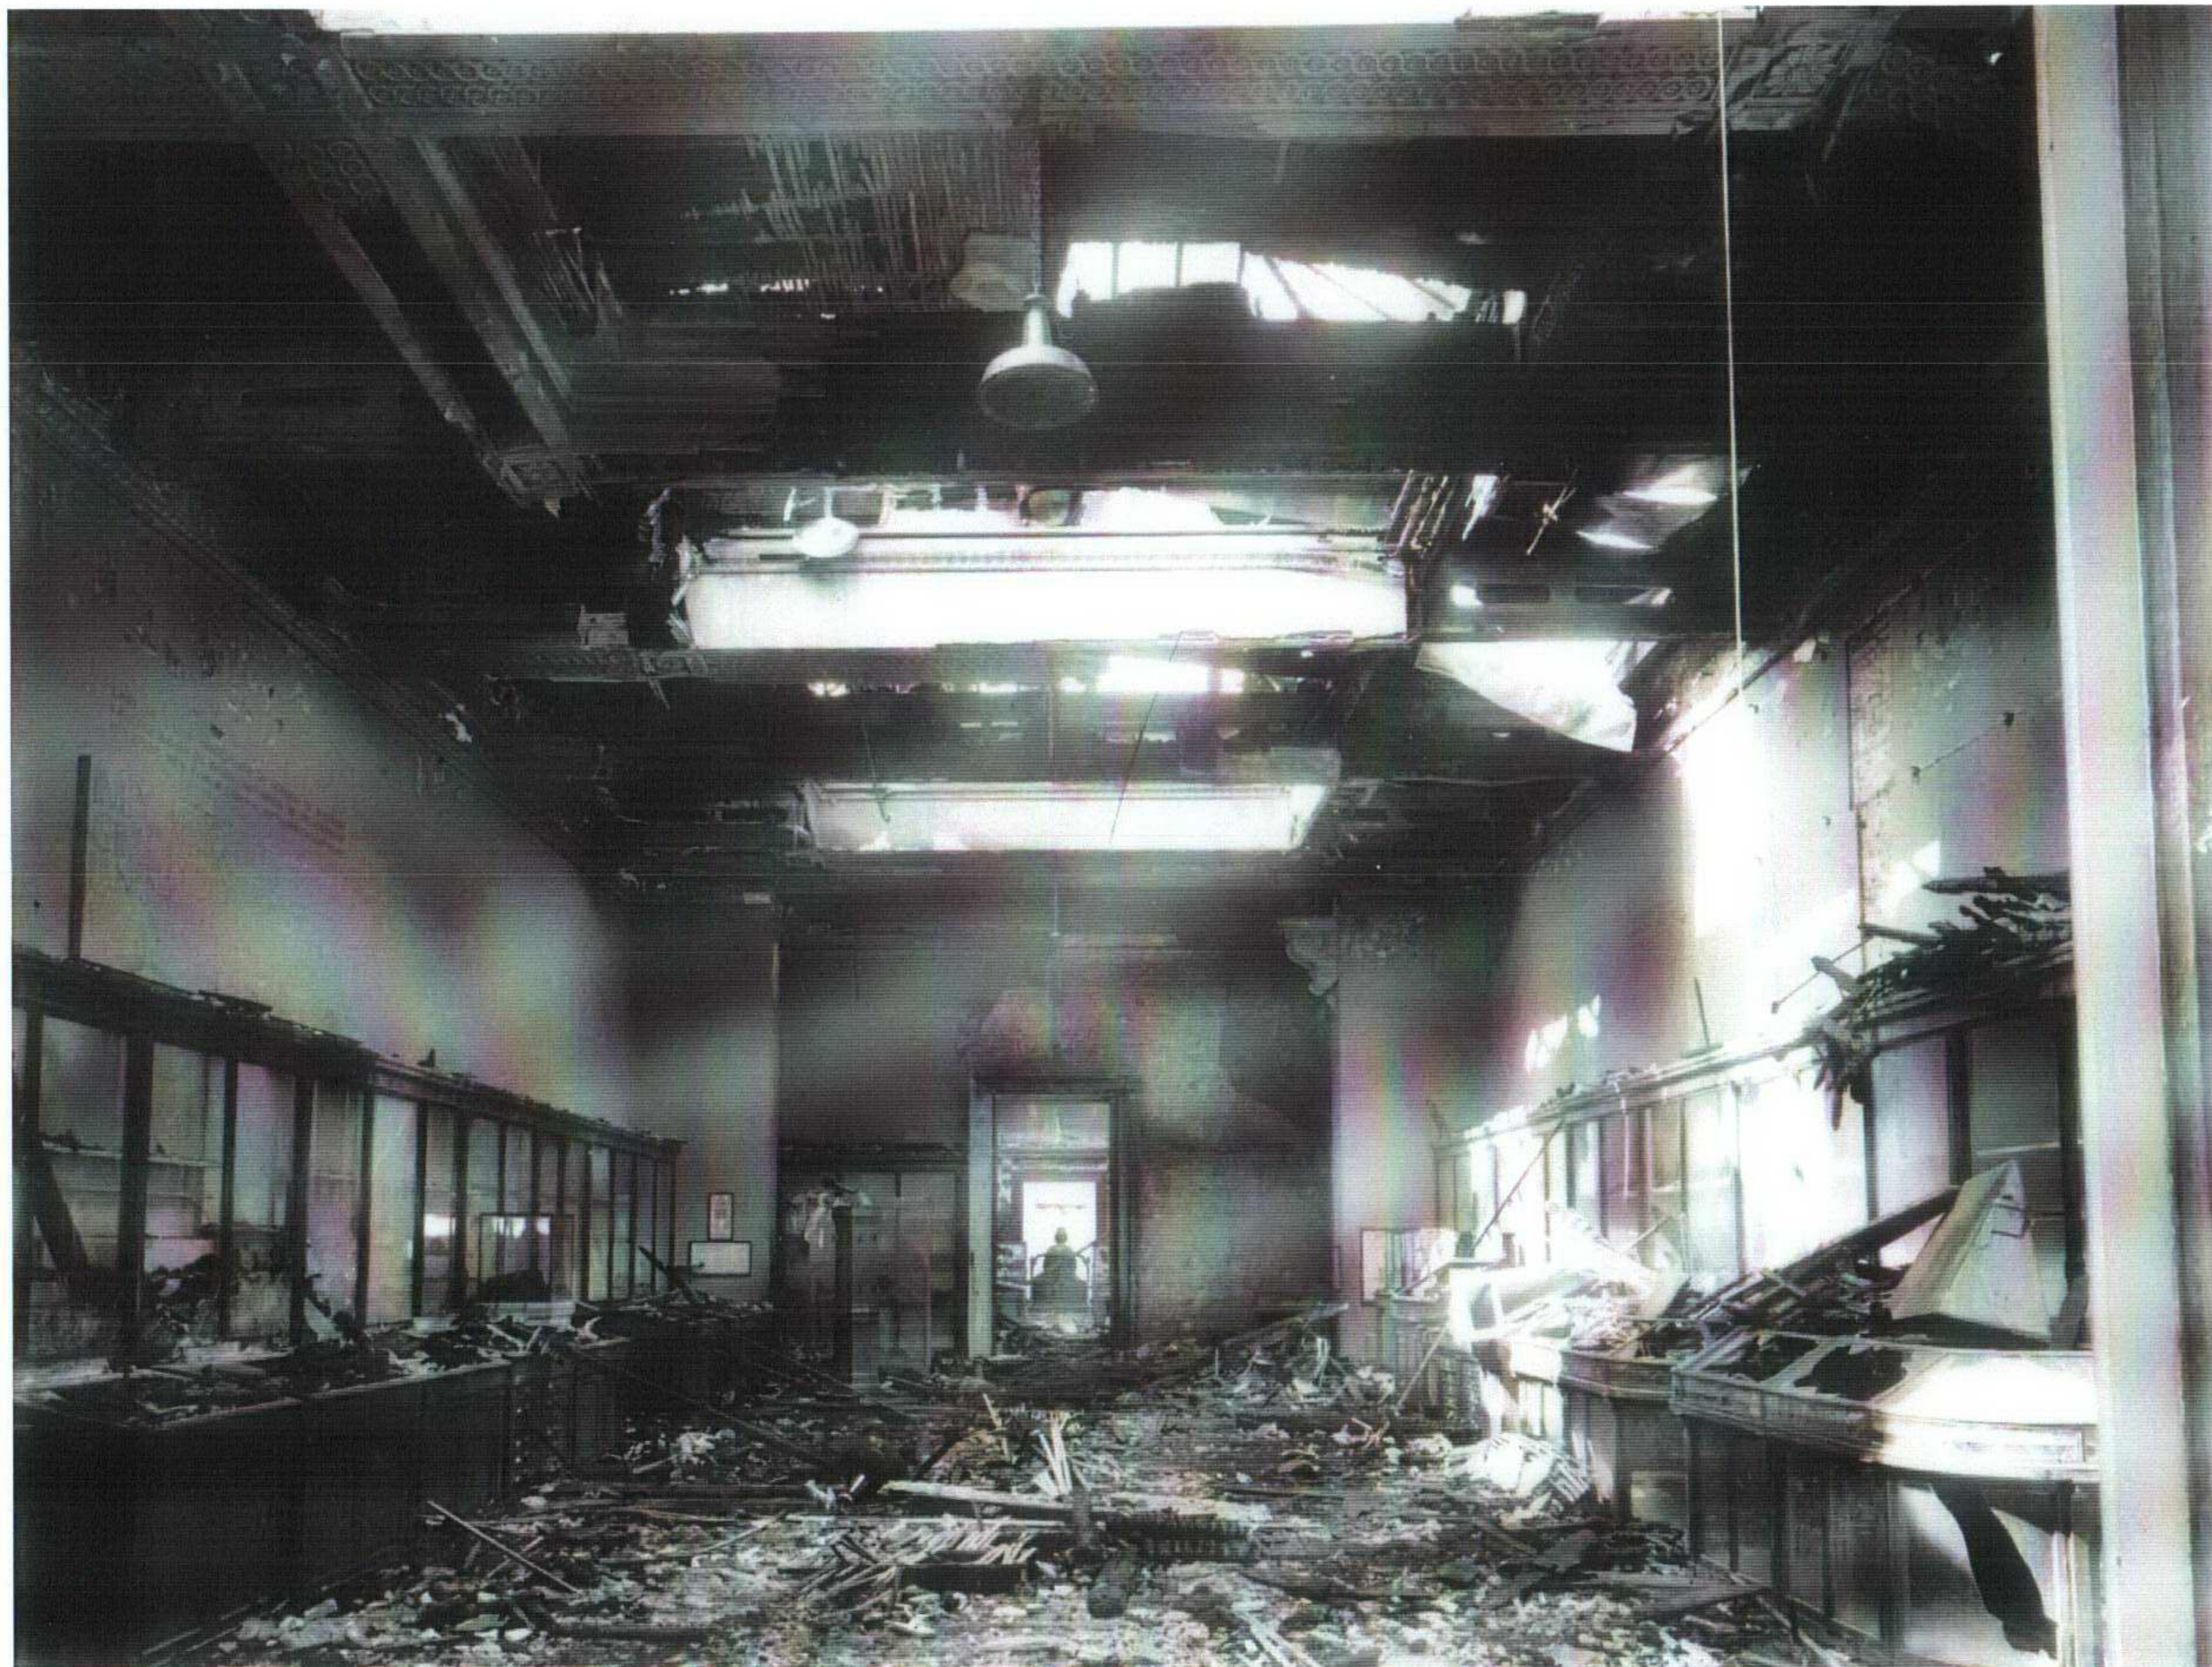
Archive photograph showing bomb damage in Gallery 40 looking towards vestibule and doorway into Central Saloon

- Archive drawings and post-bomb damage photographs indicate a full height vestibule and embellished cross beam arrangement at the west end of Gallery 40. Although this vestibule and crossbeam were removed after the war, it is possible to see a similar arrangement within the Grenville library on the floor below.

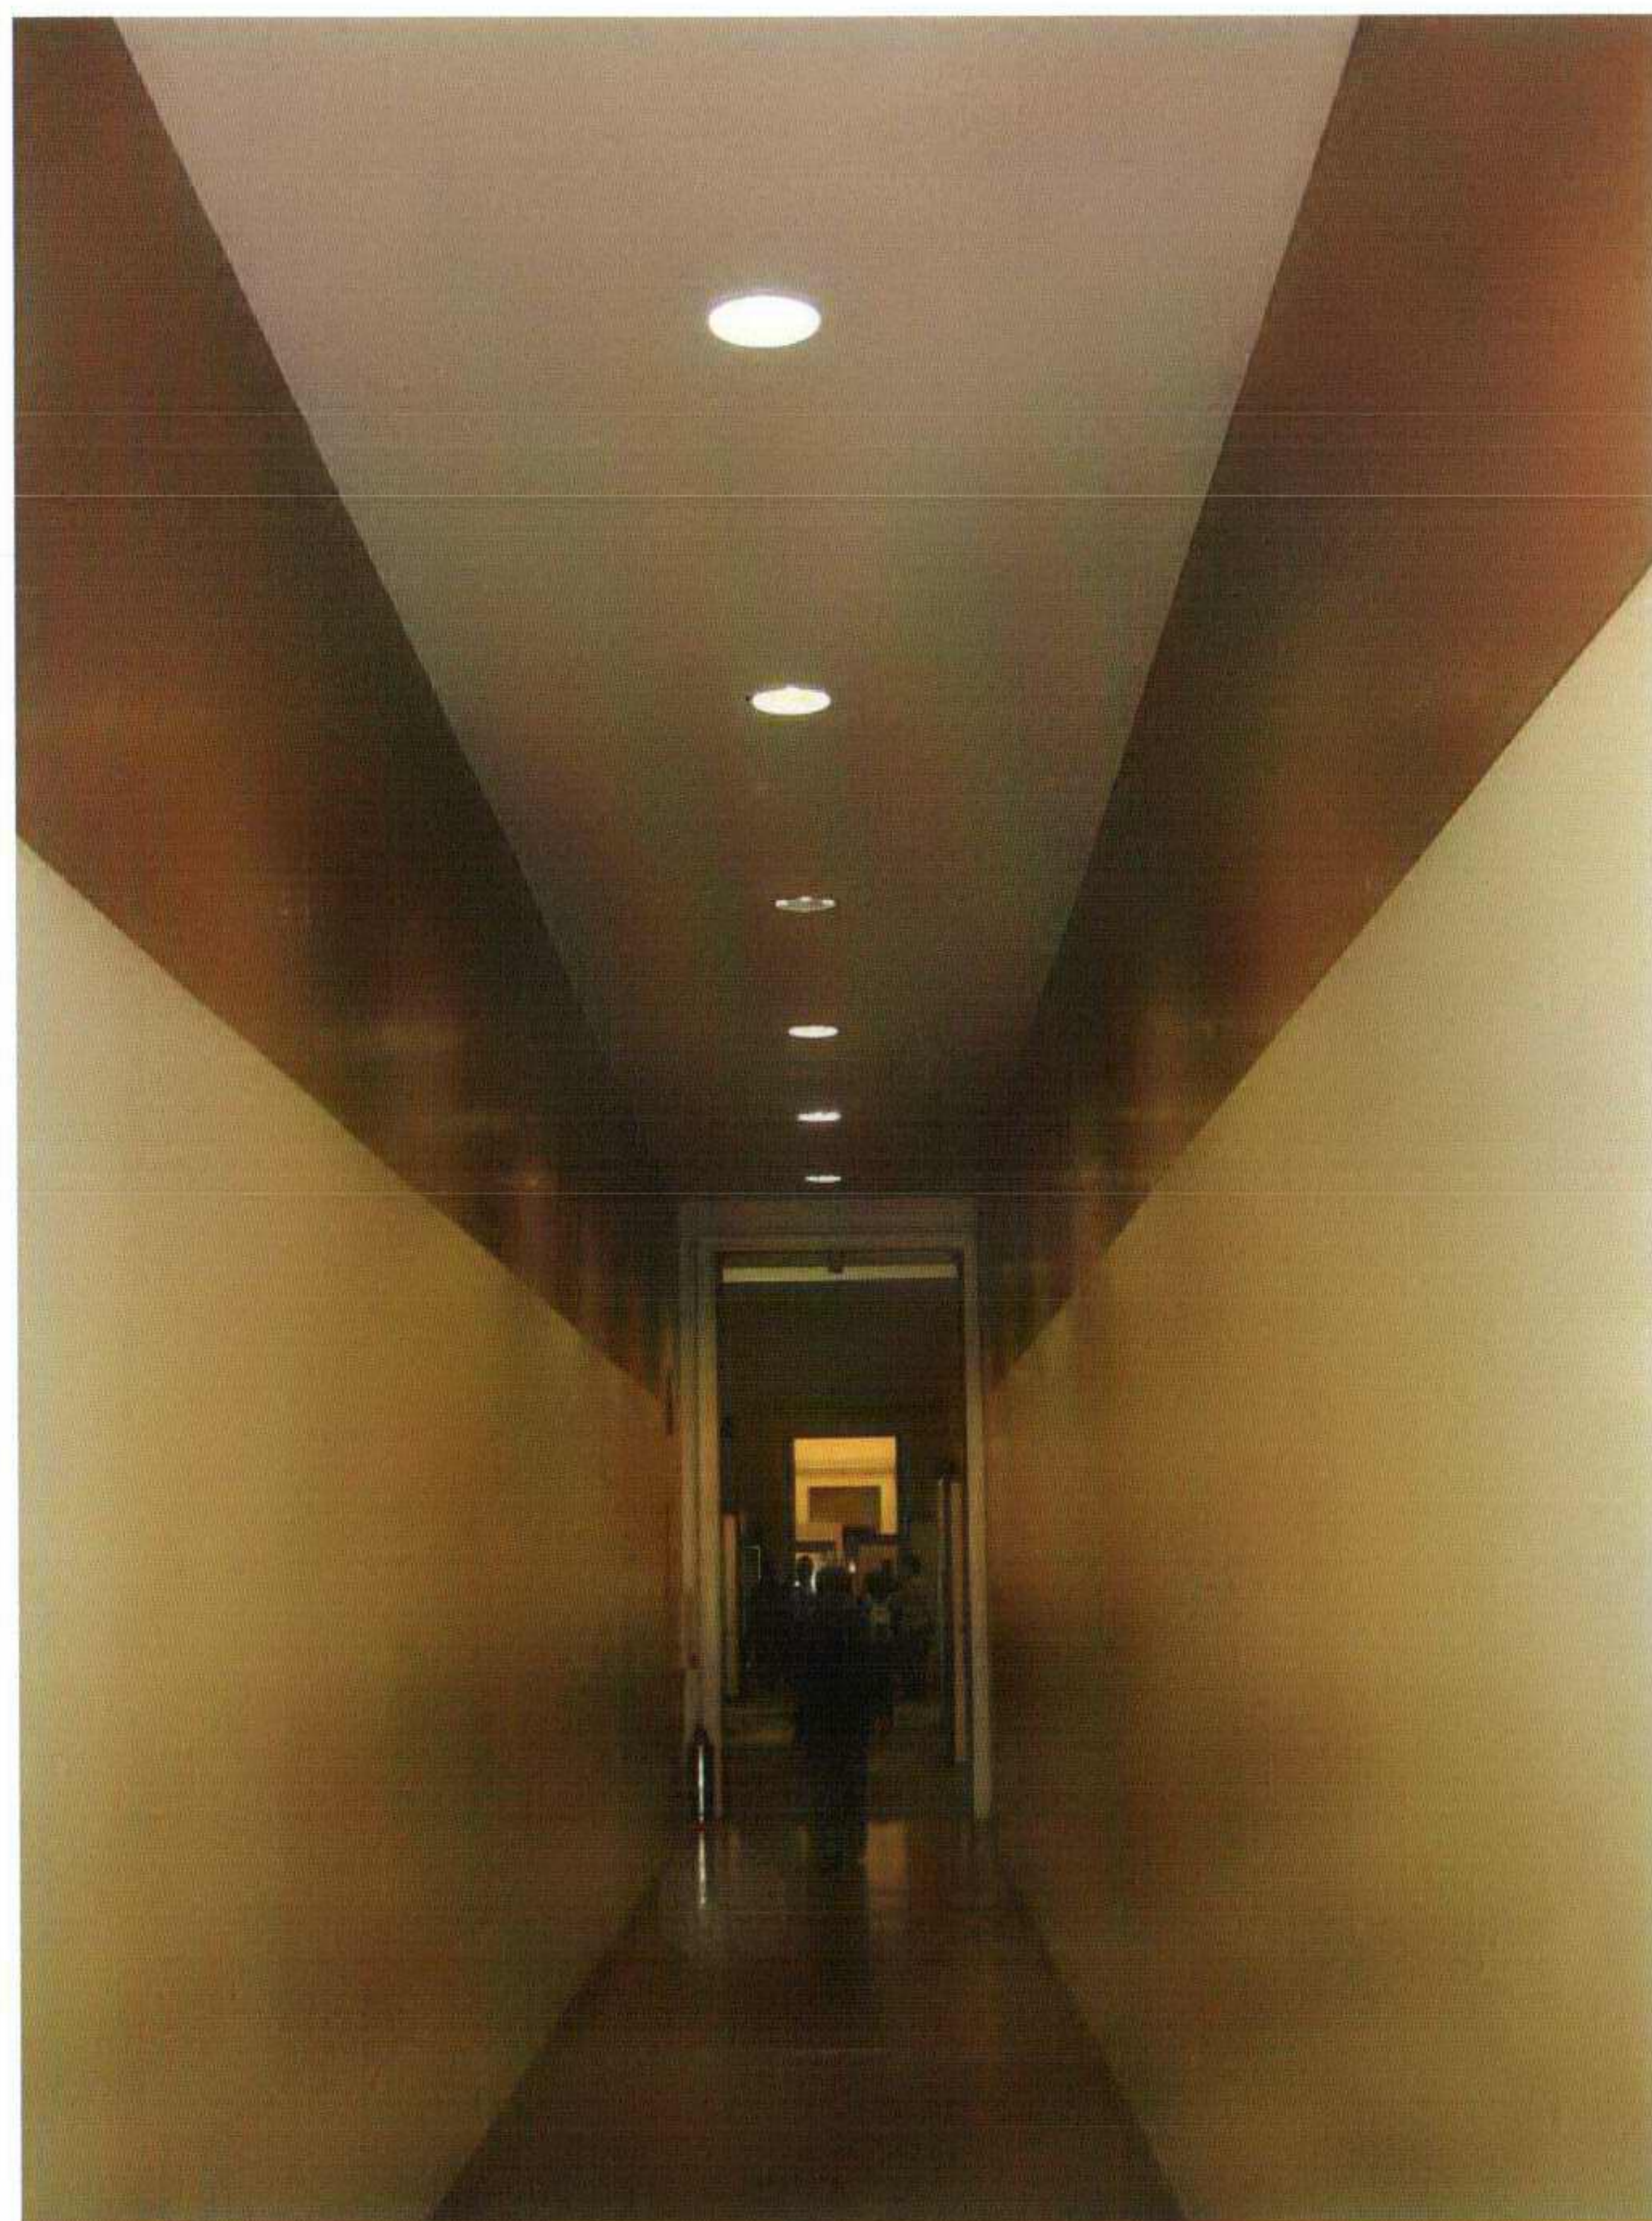
The partitioned access route through Gallery 40

- Horizontal security grills and metal solar control louvres at high level within the roof lanterns.
- Sub-division of both spaces with modern dry lining to create temporary storage and maintain public access through to Botanical stair and Gallery 47 during the Great Court Project.
- Linoleum floor finish and plywood substrata across all original stone and timber flooring.
- Modern opening into Gallery 40 from Gallery 39 appears inconsistent with historical records.
- Modern door and architrave from Gallery 39 into Botanical stair corridor.

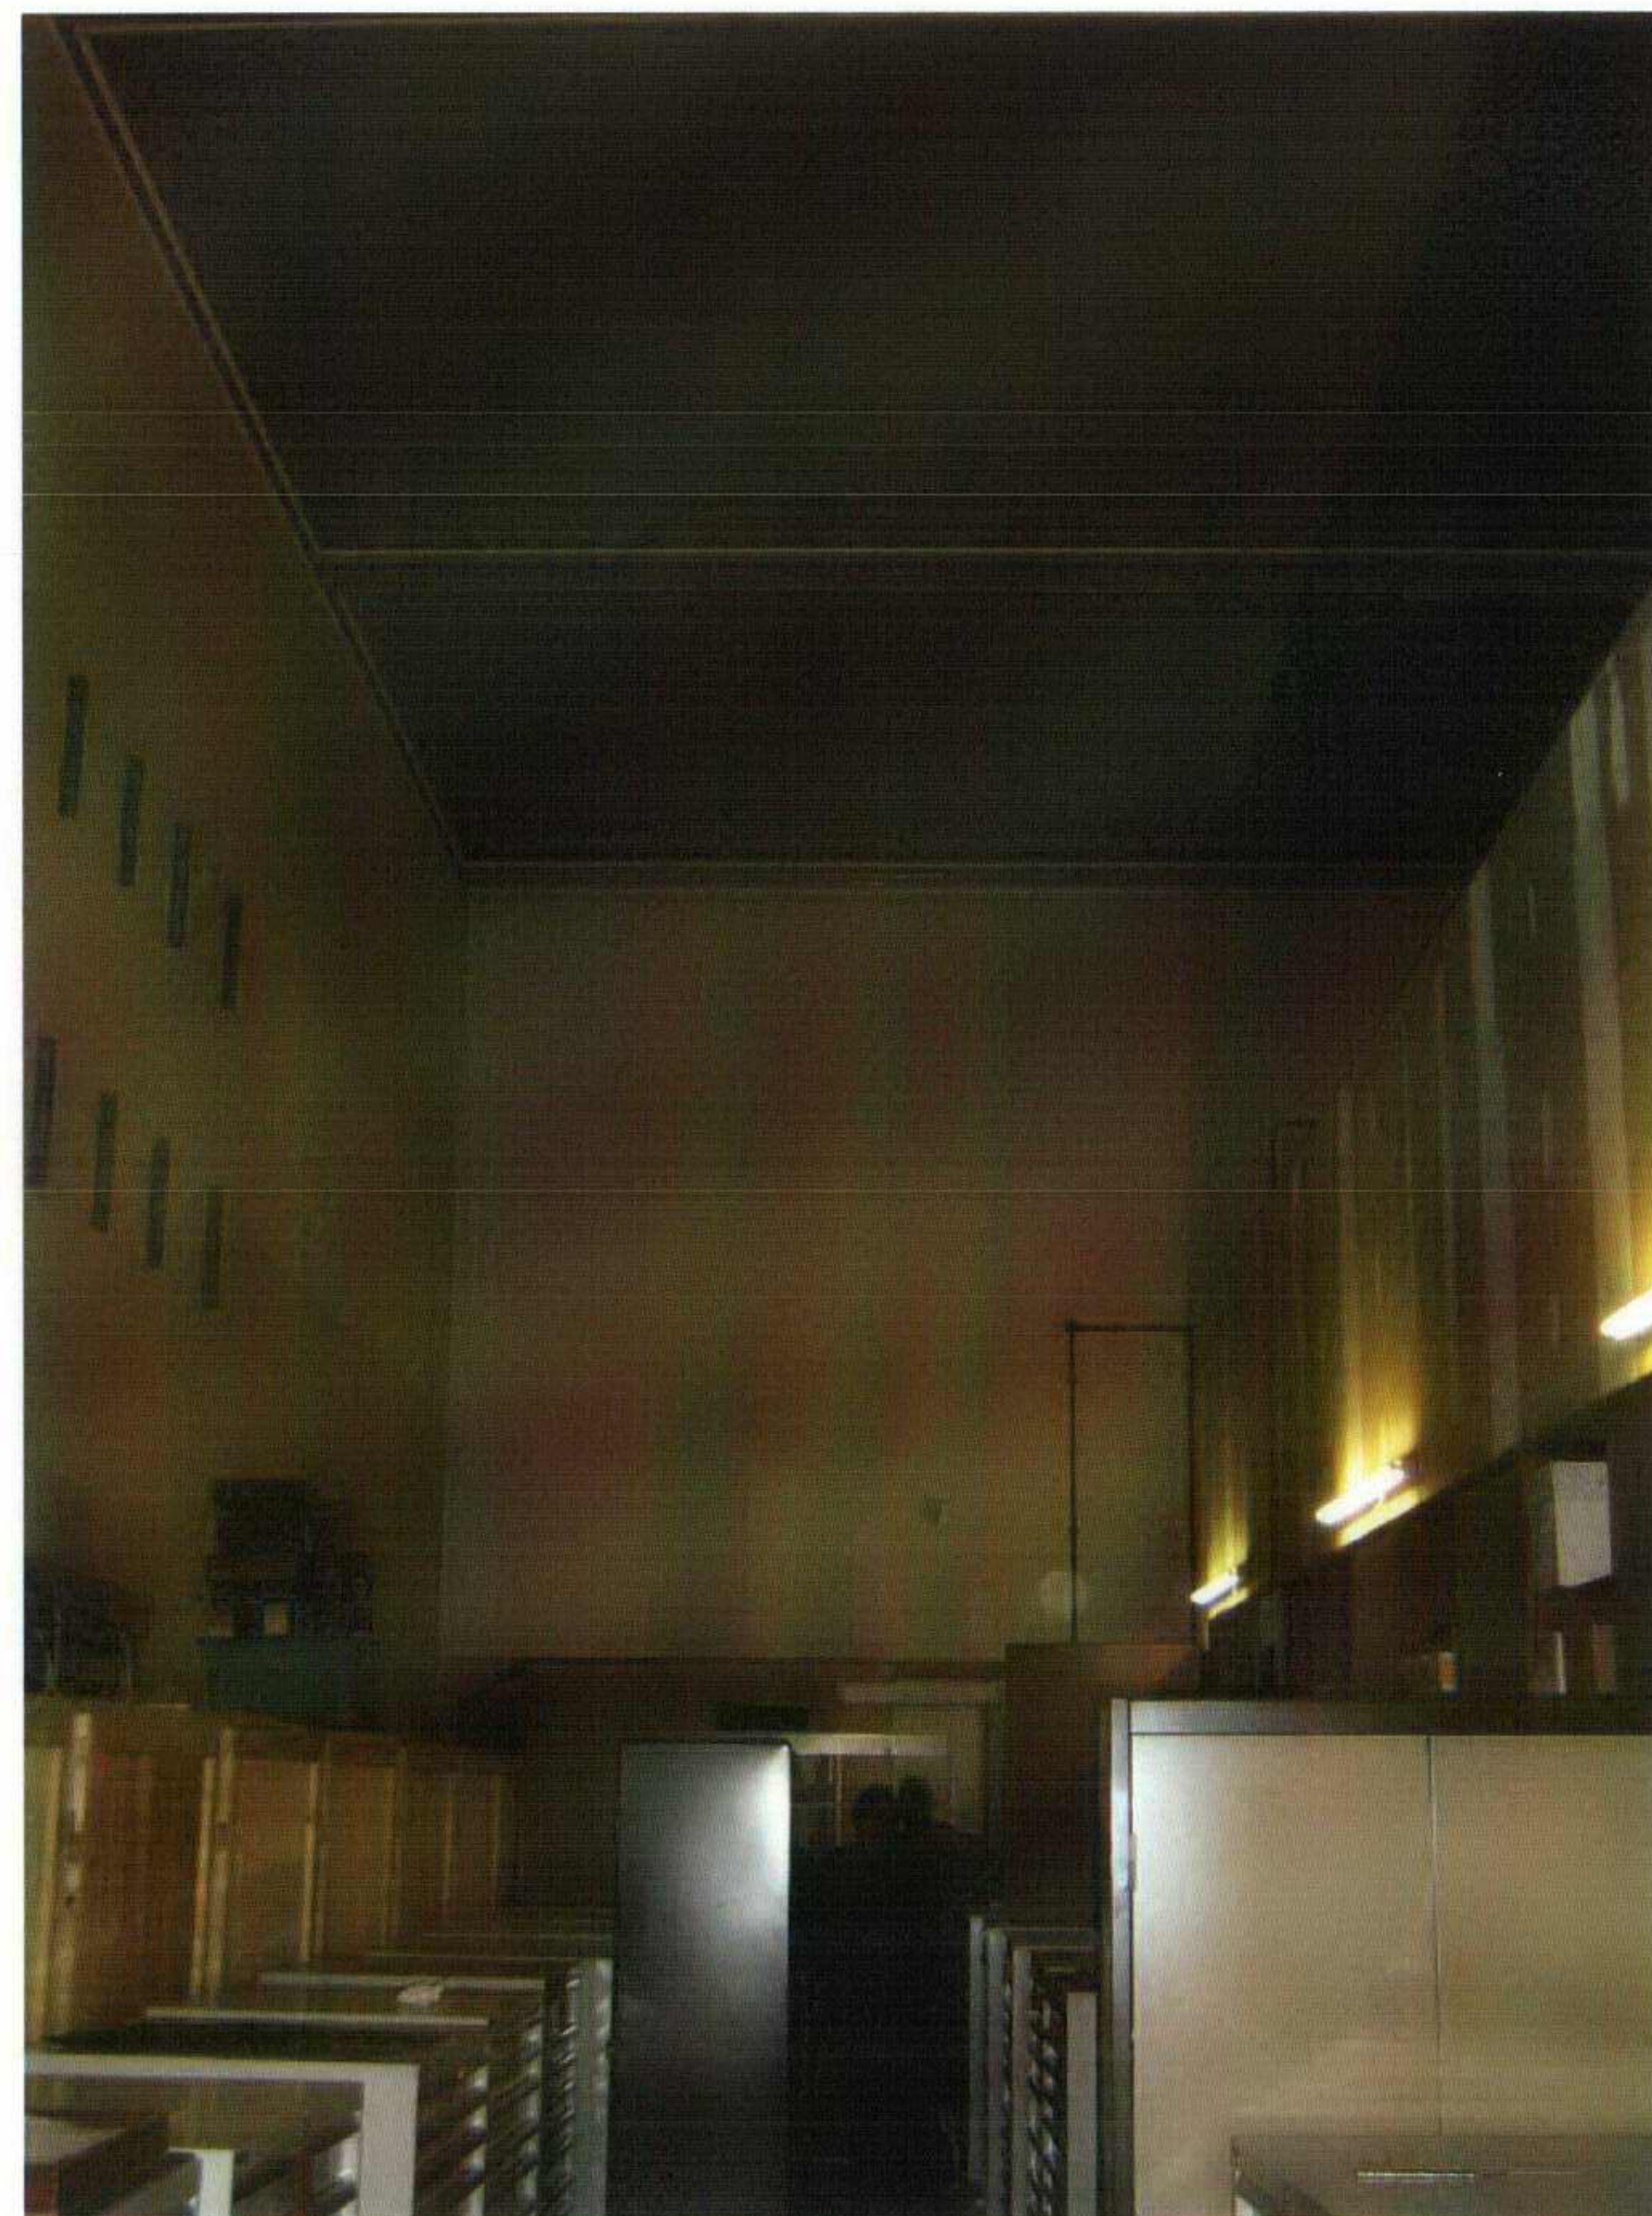
Gallery 40 with the partitioned access route to the right

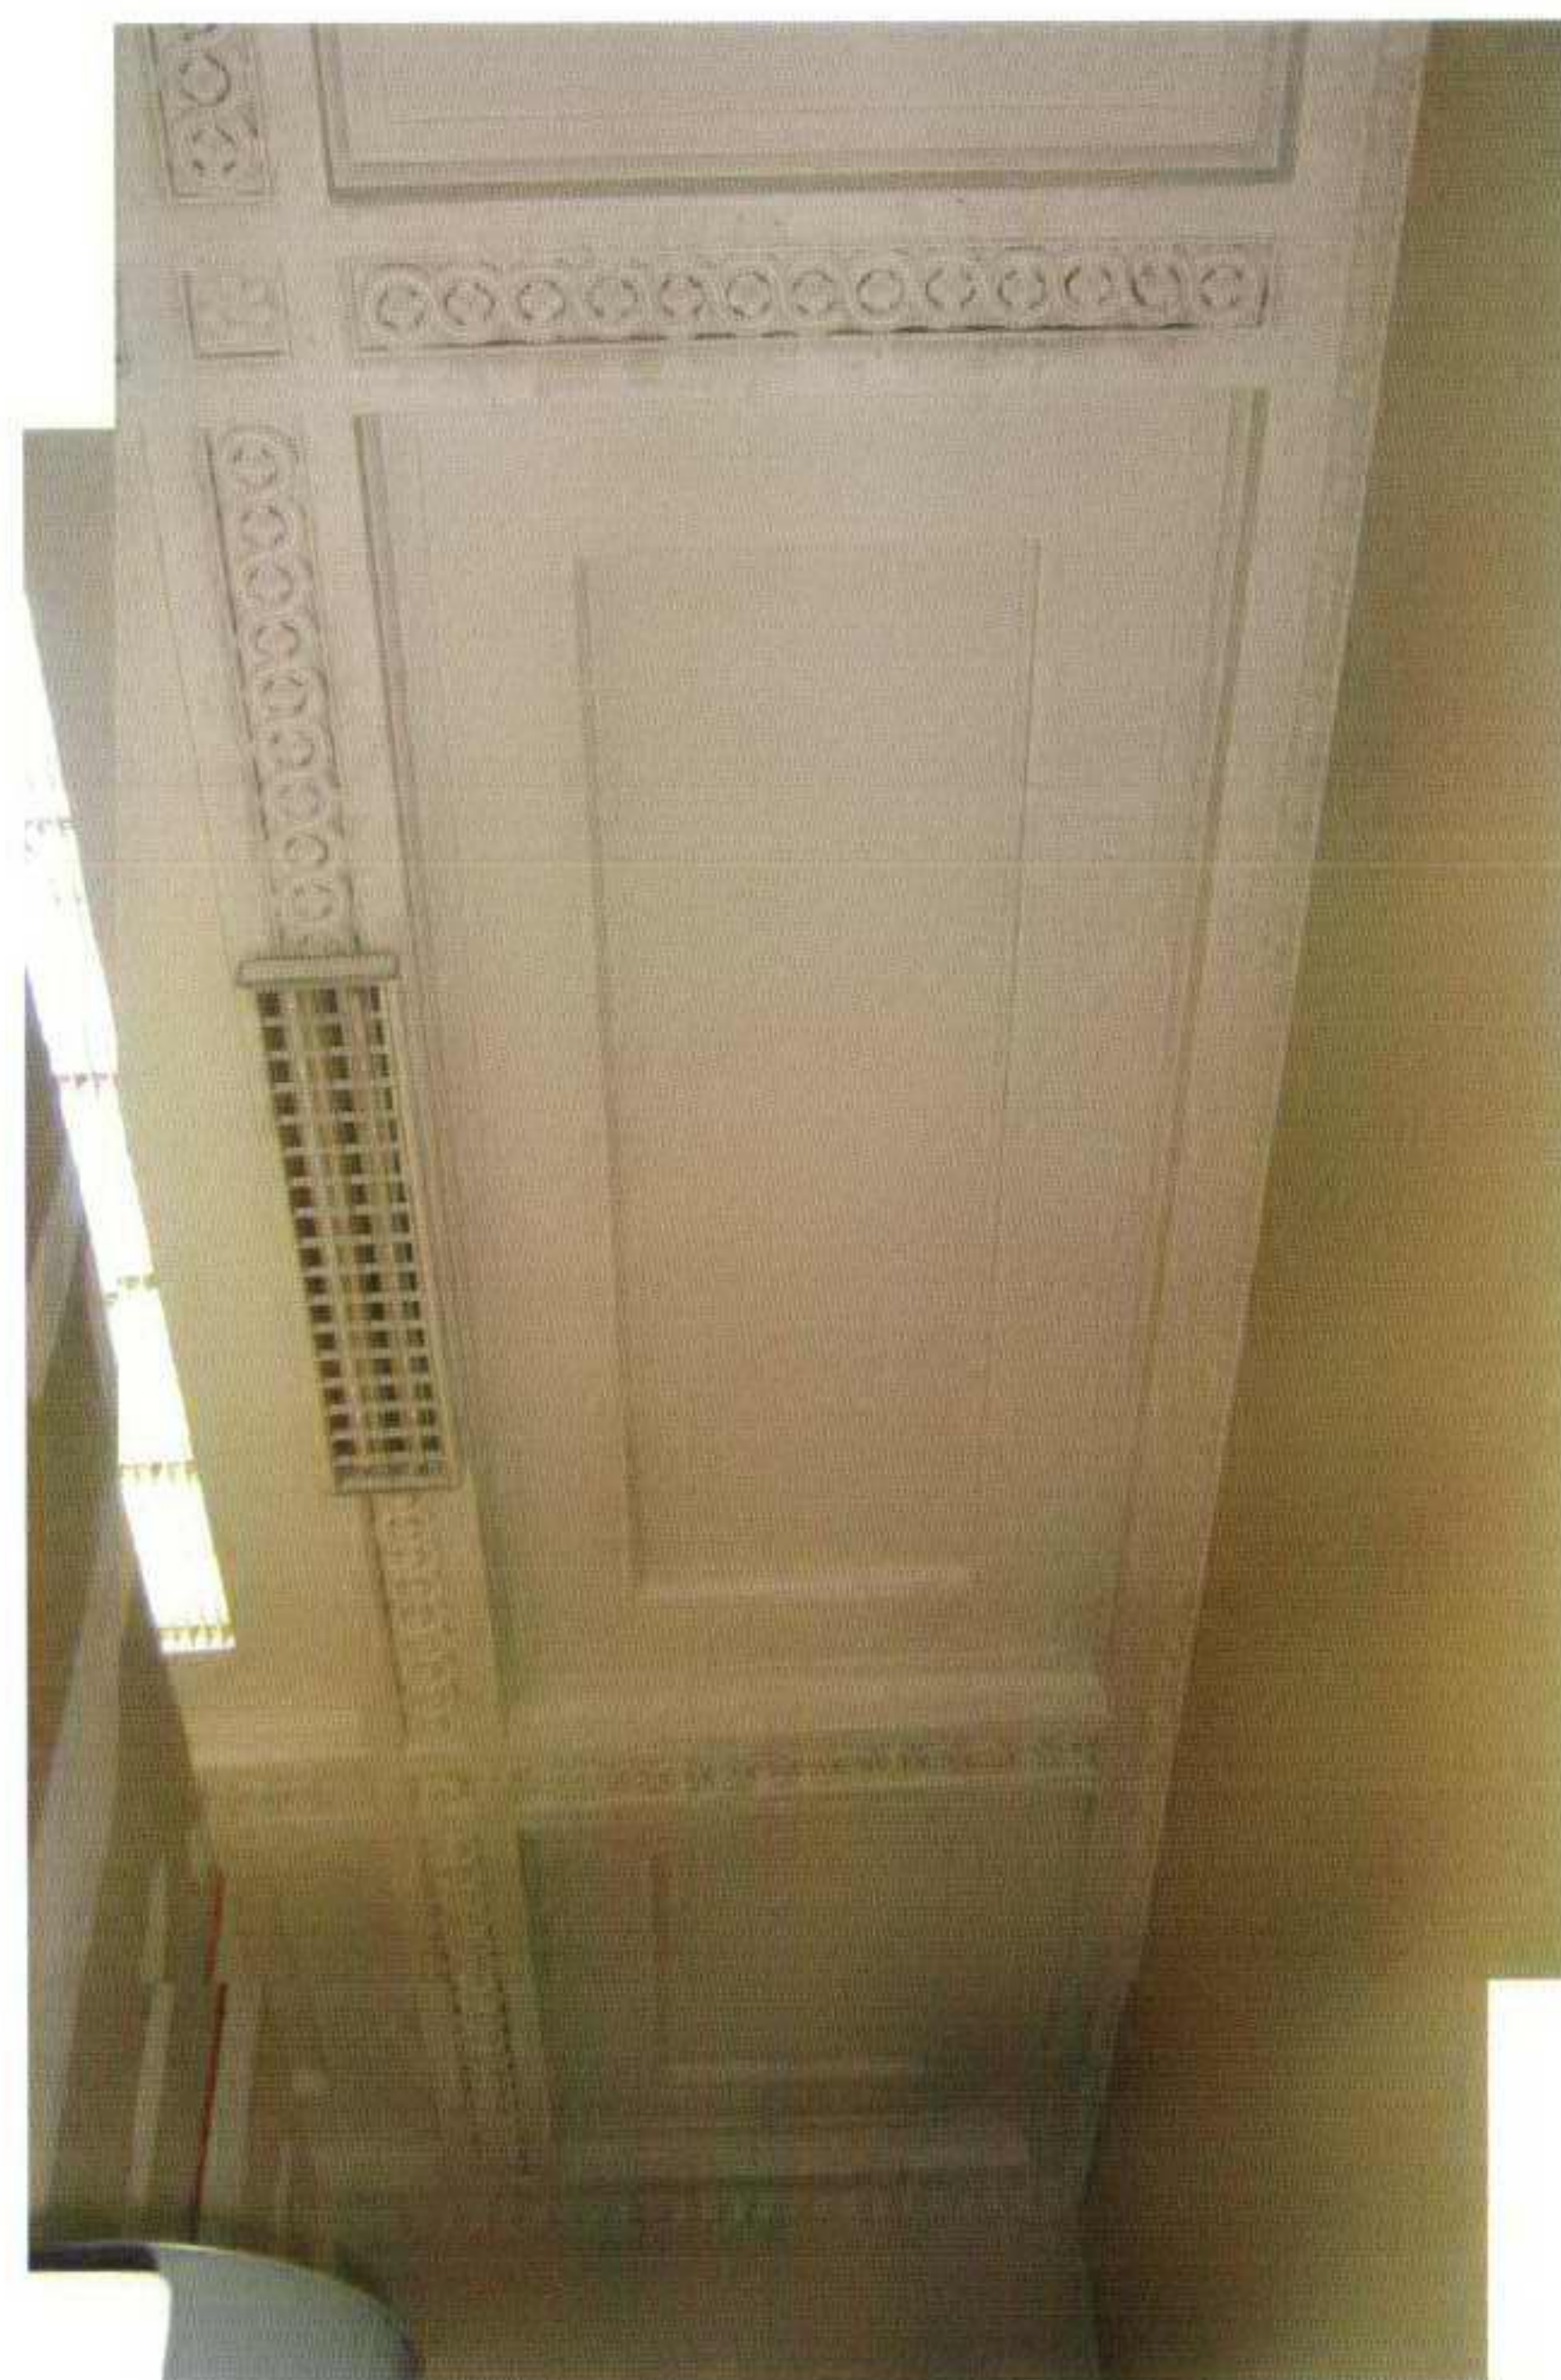
Existing ceiling within Gallery 38

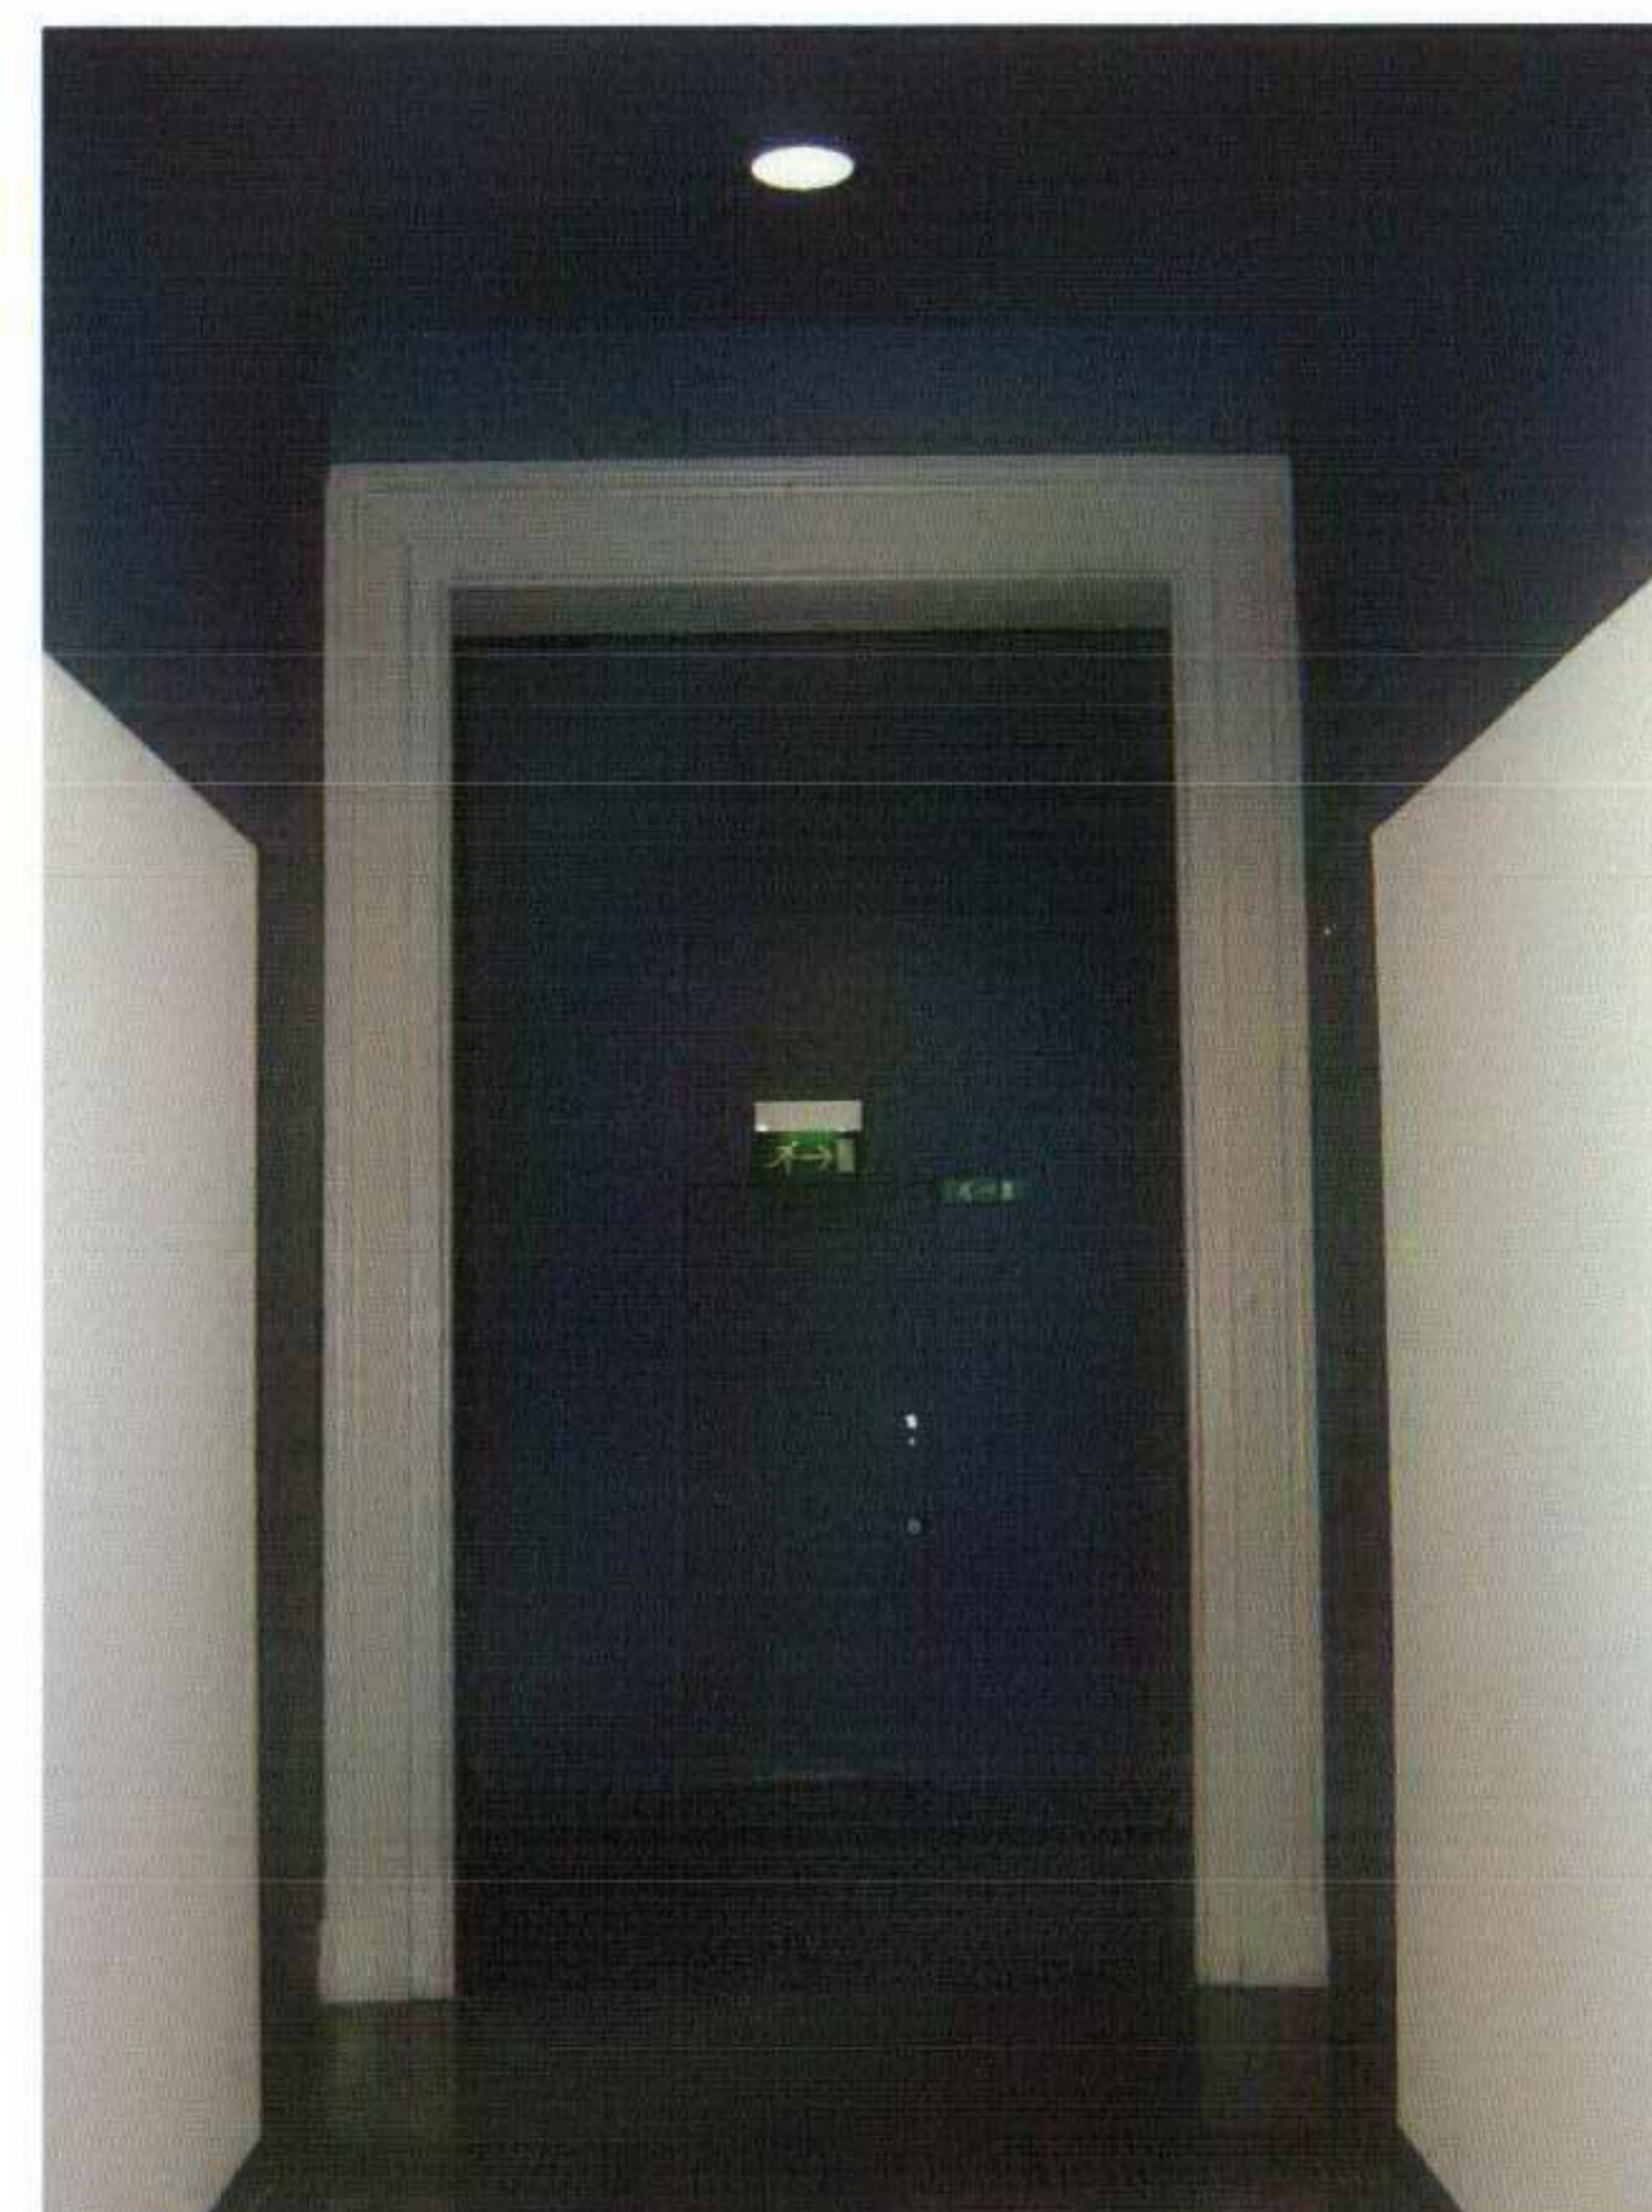
Existing door casing, architrave and skirting within Gallery 38
