**19 FORTESS ROAD,
CAMDEN,
LONDON, NW5**

Contaminated Land Assessment

Client: Empyrean Developments Ltd

Reference: JM/HB/P14-708/03 Rev A

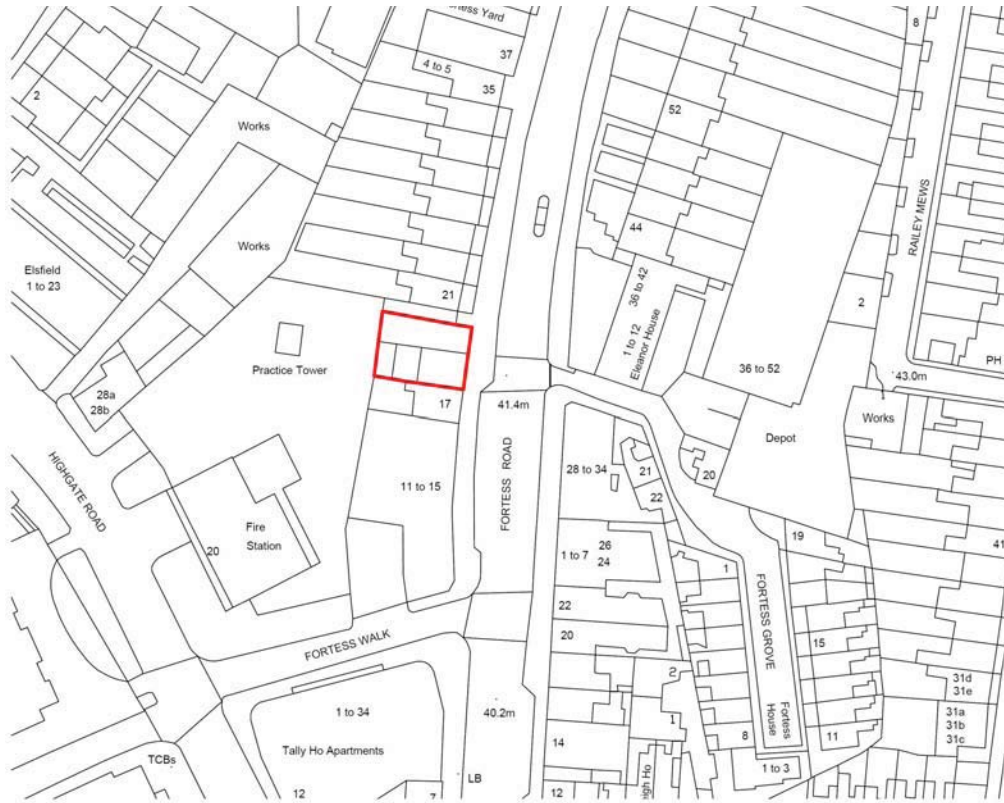
Figure 3.1: Site Location Plan

- 3.1 The site is located at 19 Fortess Road, Camden, London and centred at OS grid reference 528970, 185430. Site Layout is shown on Drawing GA 200.10 which is included at the rear of the report. The site covers an area of approximately 0.02ha, as shown by the red line boundary in Figure 3.1. The site is set within a mixed commercial and residential area.

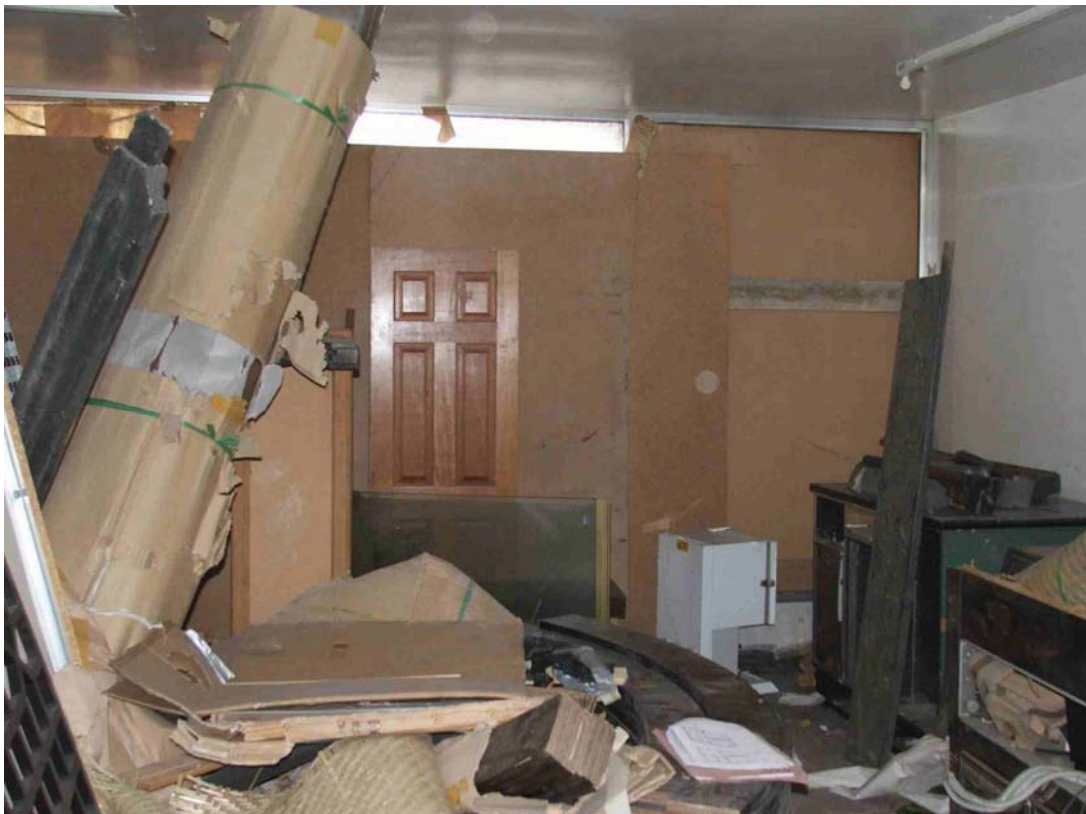
Figure 3.2: View of former shop (boarded shop-front windows)

- 3.3 The building was most recently in use as a retail unit, with a small yard and external lean-to/outbuilding to the rear. Domestic waste, furniture and scrap wood was present in the retail shop area (see Figure 3.2). An internal stairwell led down to the basement floor (not considered as part of this application). Within the small yard area, a rectangular open lightwell was present, revealing an access door and window for the basement (at a lower elevation). Ground cover in the yard was noted to be concrete (see Figures 3.3 and 3.4).

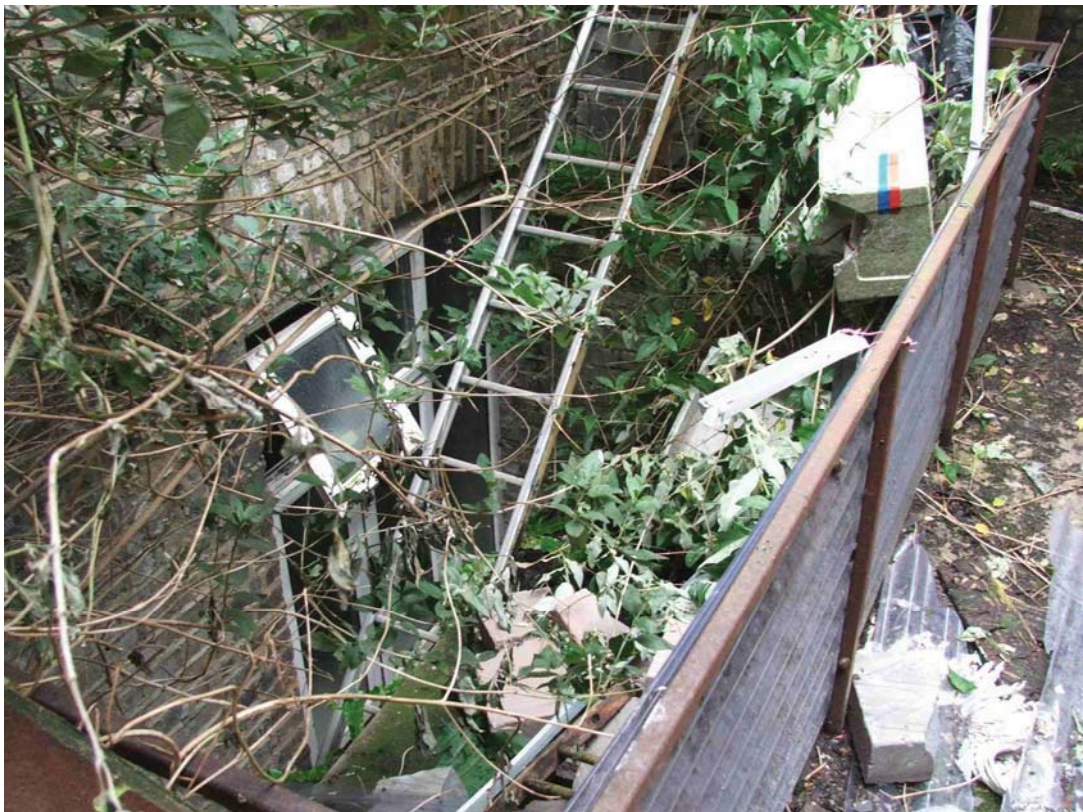
Figure 3.4: Lightwell to basement area (in yard)

- 3.8 A surface water drain was noted within the floor of the storage/workshop area to rear of the site, along with a foul and surface water drain at the bottom of the lightwell. In addition, a damaged and corroded manhole cover was observed in the workshop area.

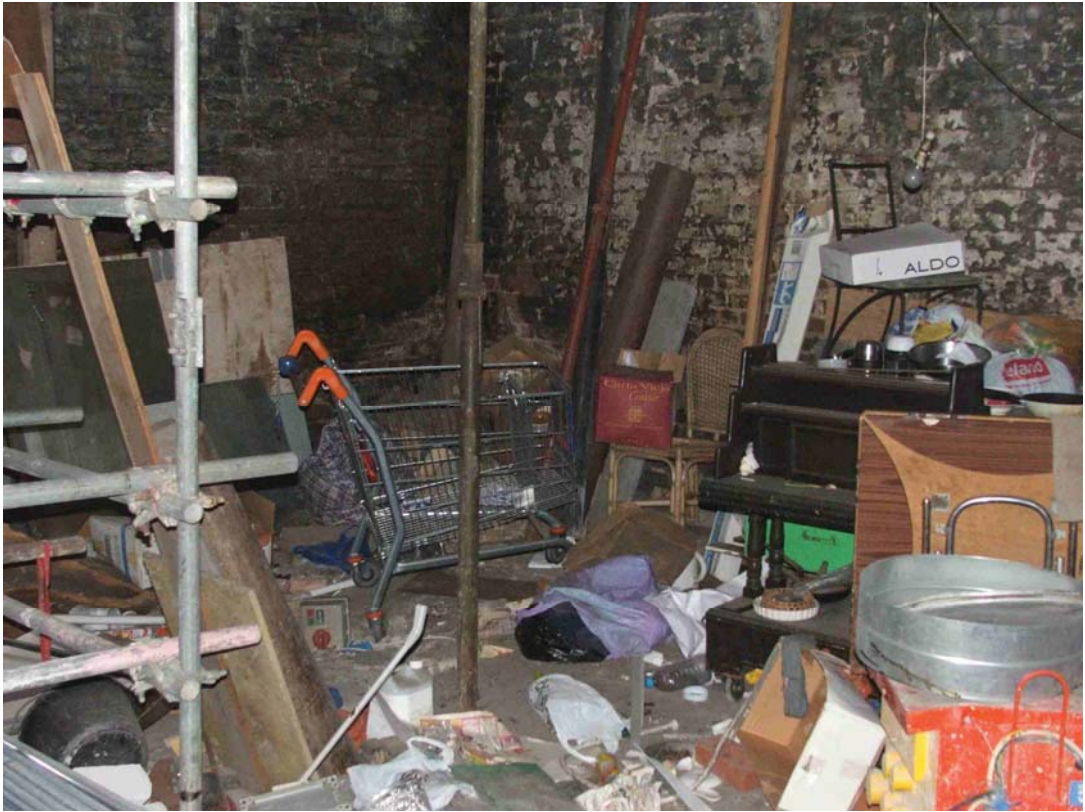
Figure 3.5: Internal view of outbuilding

- 3.5 The outbuilding at the rear of the property is a single storey lean-to type structure, was noted to be in a poor state of repair. Domestic waste, general rubbish, dilapidated furniture and scaffold poles were present in the outbuilding (see Figure 3.5).

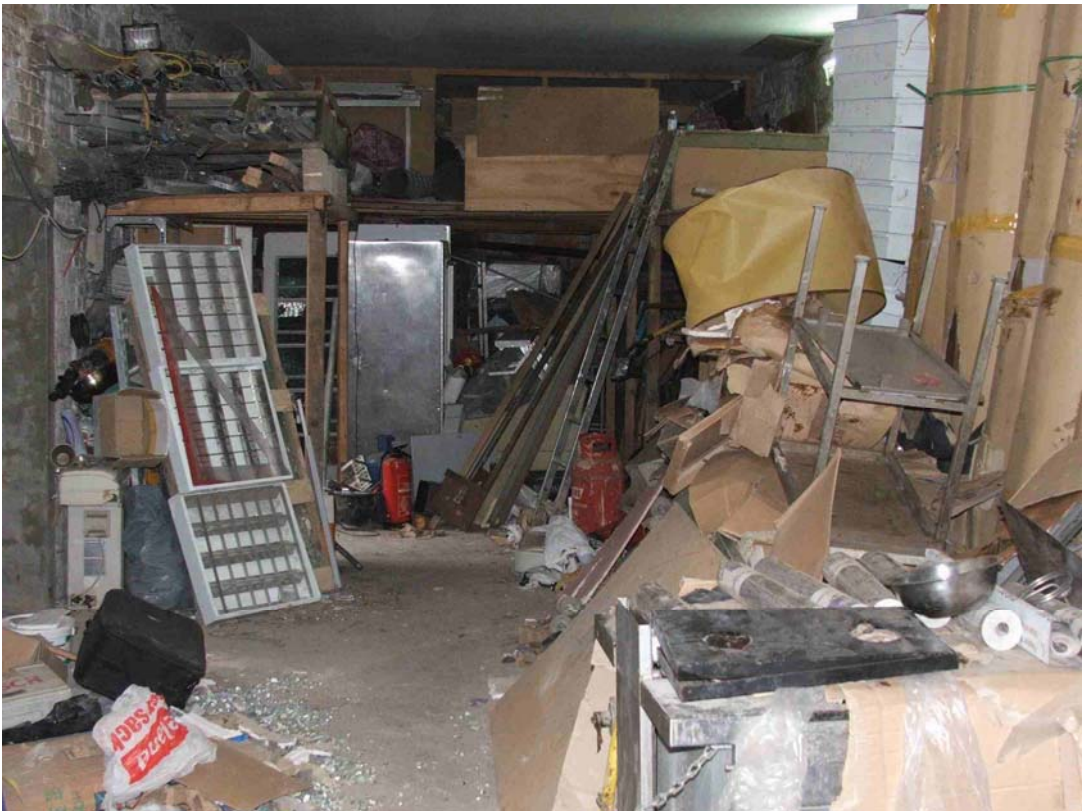
Figure 3.6: Internal view of store

- 3.6 The northern part of the building, appears to have been constructed at a later date, and is of similar construction type but with a flat roof. The eastern elevation of the property has a roller shutter/garage door, to a storeroom at the rear. Both the garage and the store contained general waste (including paint), commercial cooling equipment, gas canisters and building materials etc (see Figure 3.6). Ground cover in the garage was noted to be of concrete in poor to fair condition.

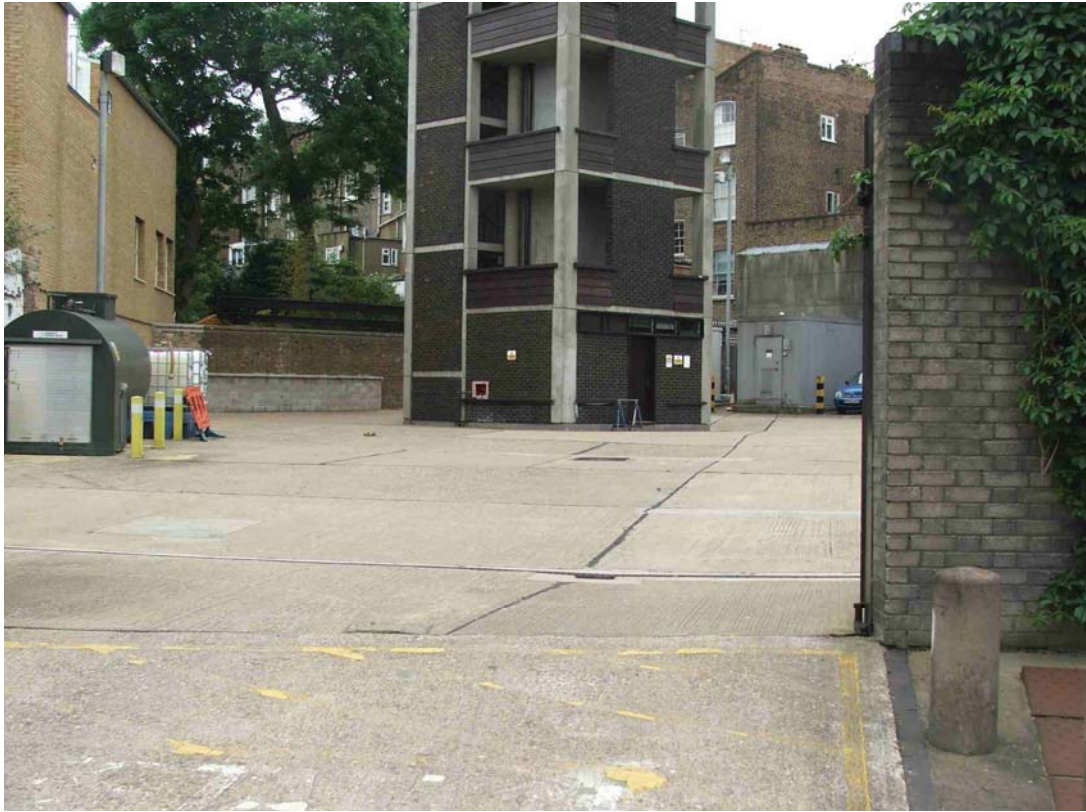
Figure 3.7: Off-site Fire Station, with fuel tank (LHS), practice tower (C) and generator (RHS)

- 3.13 The fire station is present immediately west situated between the western site boundary and Highgate Road further west. From a roadside inspection of the fire station site, an above ground fuel tank was visible along the north-western wall of the fire station, approximately 35m west of the site (see Figure 3.7). In addition, an industrial generator housing or similar was observed adjacent to the eastern site boundary of the fire station (i.e. located immediately adjacent to the retaining wall which forms the western boundary of the subject site). Hardstanding across the fire station was noted to be formed of jointed concrete slabs.

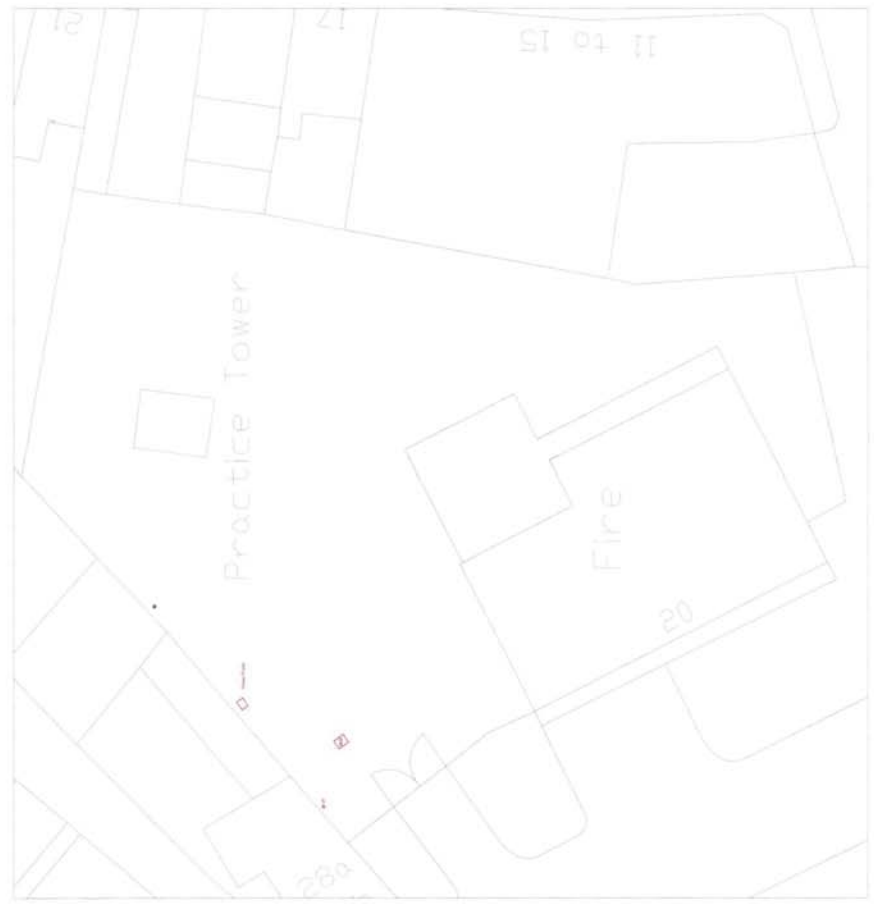
EXISTING: DERV FUEL INSTALLATION (TO BE DISCOMMISSIONED) SCALE 1:200

1. The current below ground fuel tanks generally [including this particular site] are being decommissioned due to their age and condition with the result that

- The Fire Brigade vehicle fleet will predominantly utilise Public Petrol Stations.
 - Most importantly any potential risk to the environment caused by accidental leakage of the existing tank facility will be negated.
