Listed building consent

The purpose of this application is to obtain permission to

Flat 15 B is located on the south side of Rowley Way close to the junction with Abbey Road

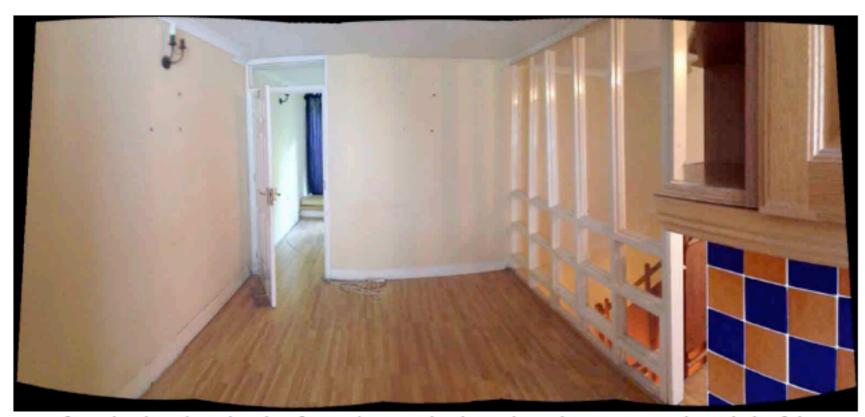
A solid partition – with single leaf door - has been inserted across the living/dining room to separate the dining area from the living area. We propose to remove this partition and door to restore the room to its original state.

view from kitchen (north side of room) towards plasterboard partition and single leaf door

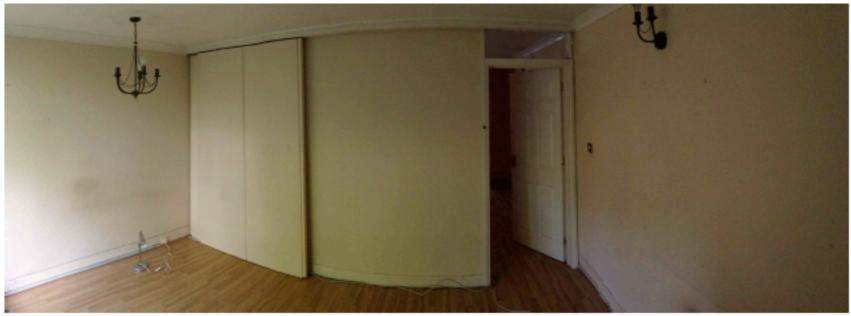
View from the south side of the partition, showing the original sliding doors parked on the left hand side

Fortunately the existing sliding doors are still in position, on the south side of the inserted partition. The ceiling track and part of the floor track remain intact. The doors and track will be re-furbished.

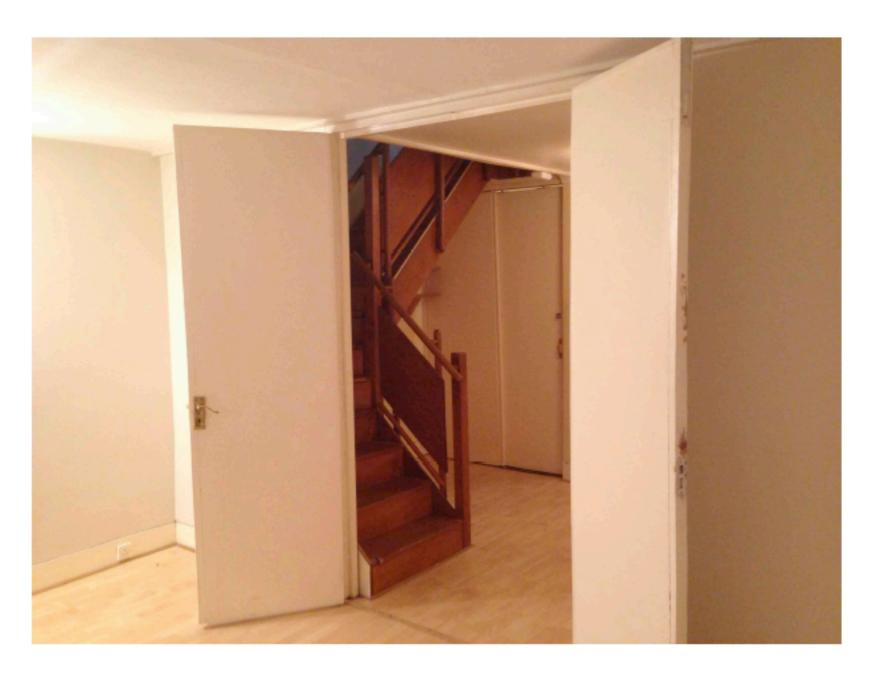
The original sliding doors have been removed and replaced with two conventional door

The sliding doors were replaced with these inward opening hinged doors into what is now a single room. We believe that the sliding doors were relocated to the other side or the hall to form the storeroom shown in document 2C (the doors can be seen here in the distance, under the stairs). We intend to remove the hinged doors and return the sliding doors to their correct location.

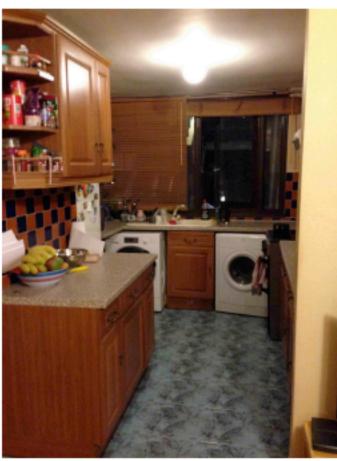
The original kitchen worktop, sink, shelving and cupboards have all been removed and replaced with a design unsympathetic to the original.

Previous leaseholders have removed the original concrete tiled work surface and have installed a new worktop to accommodate electrical appliances underneath. (The photograph above was taken in January 2014 while the flat was still occupied)

We will replace the worktop and cupboards with simpler, more appropriate fittings. (See Document 4 "Heritage statement...." extracts from the Maintenance Handbook)

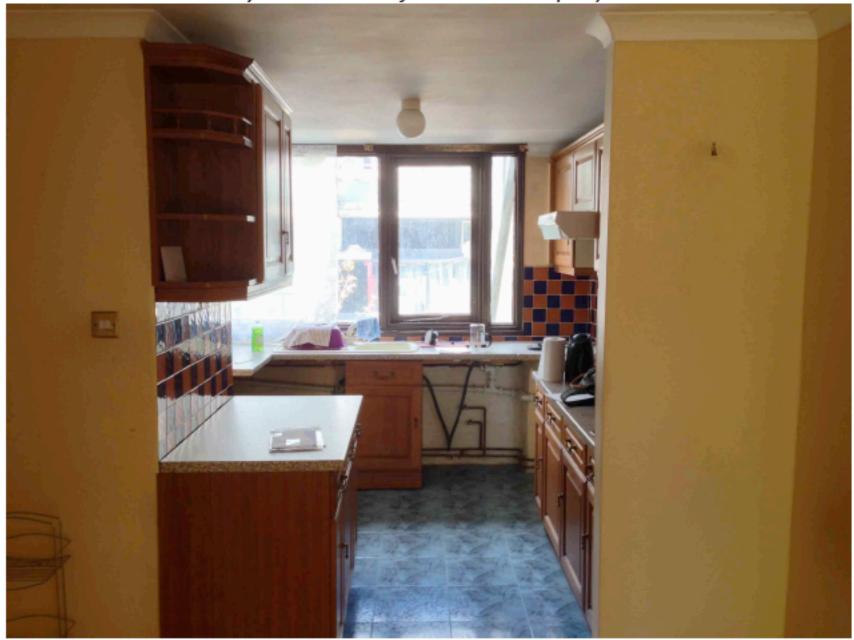
View of kitchen with appliances removed May 2014

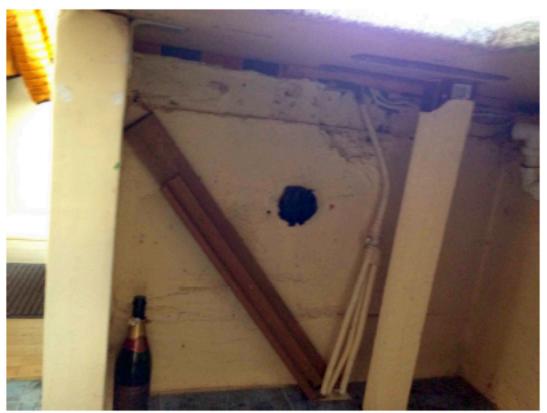
View under corner counter by small kitchen entrance door,

This shows wall tiles (not original) coming down to the level of where the top of the concrete counter would have finished.

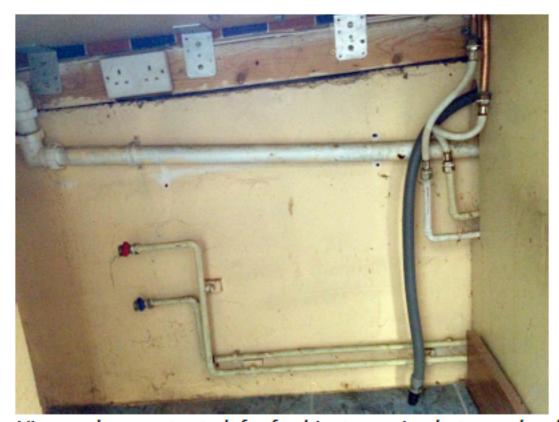
View under counter to left of cabinet seen in photographs above.

A timber pattress has been inserted into the groove left by the removal of the original concrete counter along the line of original worktop recess

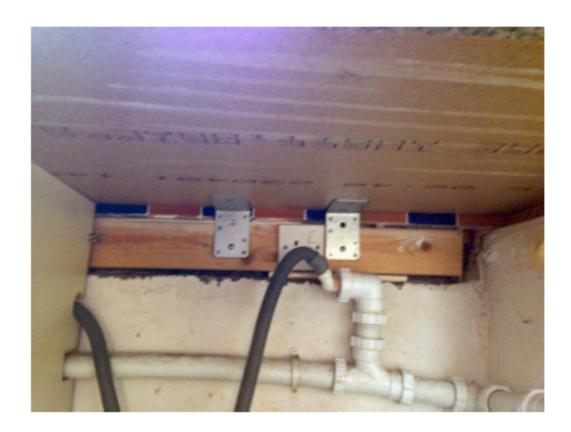
View underneath counter to right of cabinet

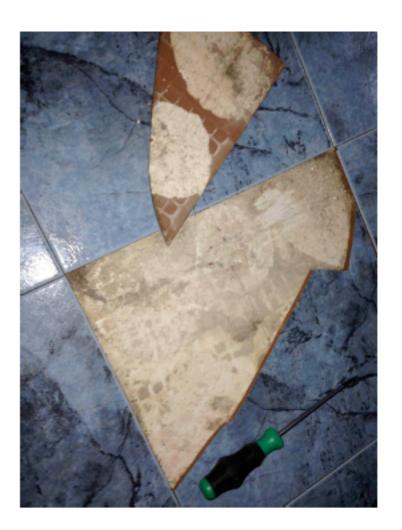
C.03 Kitchen Flooring

A ceramic tiled floor has been laid onto the concrete floor. No evidence of original vinyl tiles. The ceramic tiles will be removed.

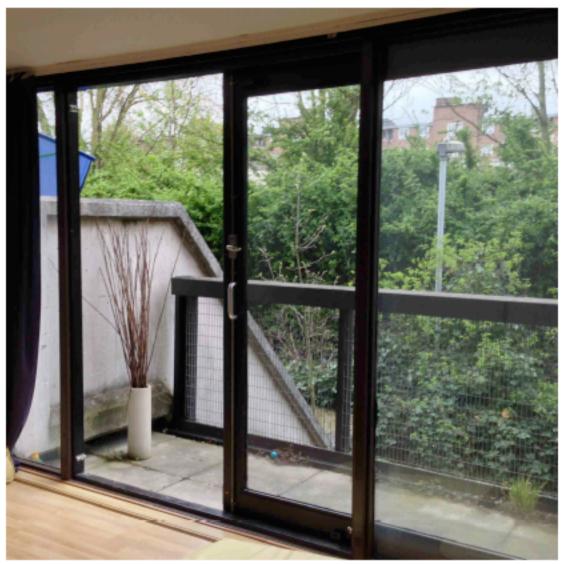
The raised floor adjacent to the window is currently encased in a timber effect plastic floor. This will be removed and if we find the original timber boarded surface intact underneath, we will restore it.

Raised service area in front of balcony sliding door.

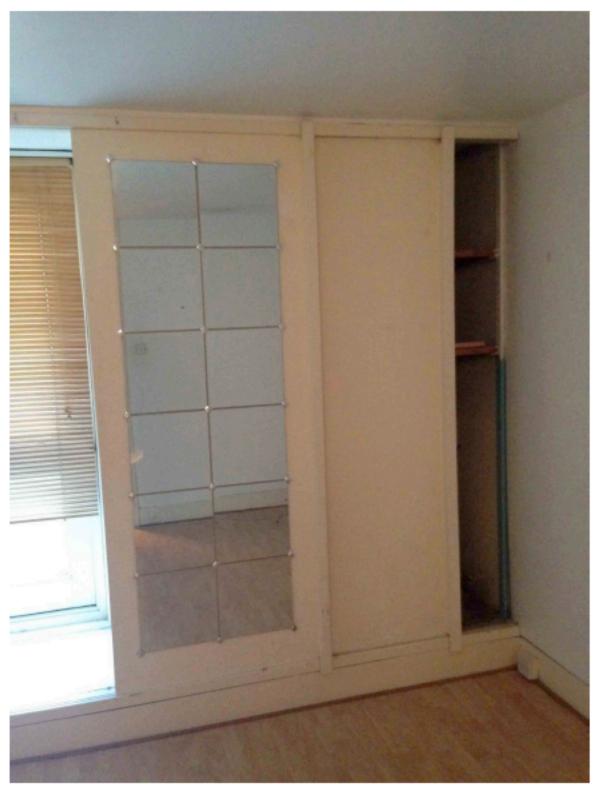
The double bedroom has remained pretty much intact, except that one of the sliding doors to the cupboard is warped and twisted. The cupboard contains a hot water tank. We will refurbish the doors, replacing the twisted door with a replica. Internal shelving survives and will be refurbished.

Twisted sliding door is binding and will be repaired or replaced to match. Mirrors to be removed.
