## Stage 2: Site Investigation

**53 Agar Grove,  
London Borough of Camden,  
London  
NW1 9UE**

**3PM**

Job No. 13.7883  
February 2014 Rev 1

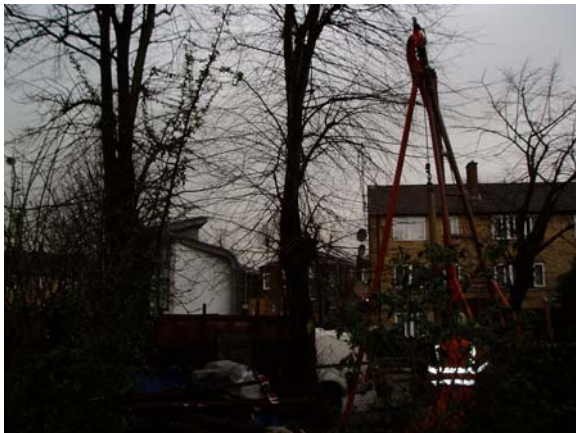
- A. View of existing property from rear
- B. View of existing rear garden area
- C. Existing trees on site 10-12m high.
- D. Existing trees on site

WS2, located near to the north west corner of the site was completed close to an existing tree on site. Whereas WS1 was positioned within the garden at a suitable distance away from existing trees. For such high volume change potential soils a reduction in soil moisture content would be expected nearer the tree in the upper soils than away from them. However no discrepancy was noted since the soils were considered heavily saturated.

However the potential to lose its moisture (shrink) just as quickly as it has gained (swelled) is considered high and the effect of the trees should be considered.

Although no soil desiccation characteristics have been noted on site, deepening of any shallow foundation design is likely to be required as a result of the high volume change clay soils and existing trees on site. Subsequently foundation designs should be checked against the current NHBC Guidance when building near trees for final foundations depths.

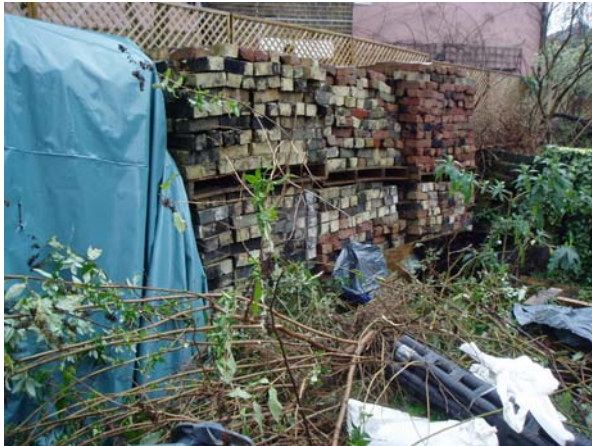
- E. Bricks located at rear of property
- F. BH1 drilling set up
- G. TP1 – plan view
- H. TP1 plan view showing limited foundation

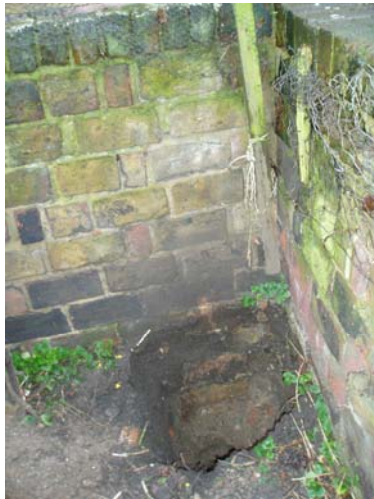
- I. TP1
- J. WS1 GL – 1.0mbgl
- K. WS1 spoil material GL – 1.00mbgl
- L. WS1 1.00m – 2.00mbgl

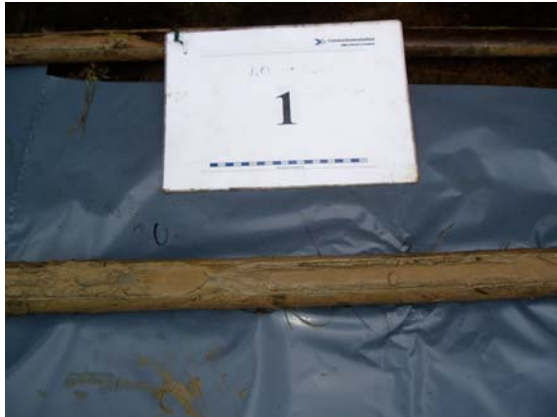
- M. WS1 2.00-3.00mbgl
- N. WS1 3.00-4.00mbgl
- O. TP2 plan view
- P. TP2 showing limited foundation

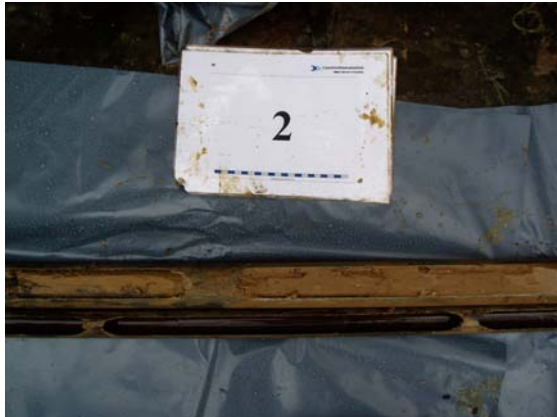
Q. WS2 1.0-2.0mbgl

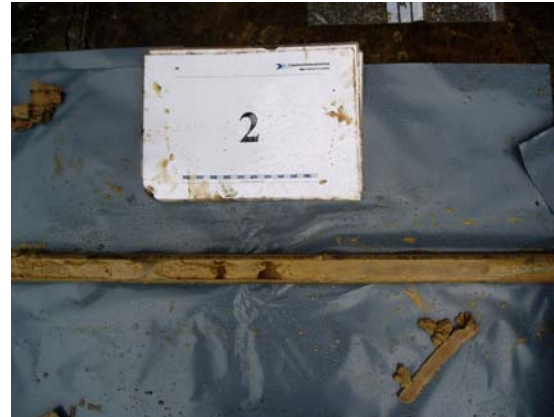
R. WS2 2.0-2.80mbgl

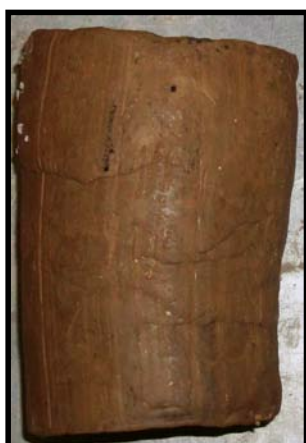
**Post Test Specimen**

**Client ref:** 13-7883  
**Location:** 53 Agar Grove, Camden  
**Contract Number:** 22207-050214  
**Hole Number** BH1  
**Sample Number:** N/A  
**Depth (m) :** 1.20-1.65  
**Sample Type :** U

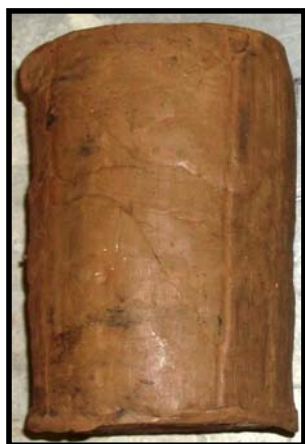
**Post Test Specimen**

**Test Report:****Undrained Shear Strength in Triaxial Compression  
BS 1377 : Part7 : Clause 8 : 1990 Single Stage Test  
without measurement of Pore Pressure****Client ref:****13-7883****Location:****53 Agar Grove, Camden****Contract Number:****22207-050214****Hole Number****BH1****Sample Number:****N/A****Depth (m) :****3.00-3.40****Sample Type :****U**

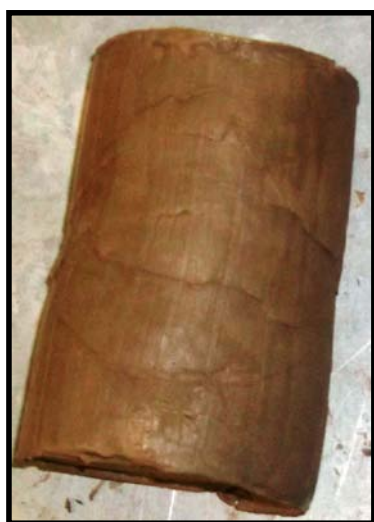
**Post Test Specimen**

**Test Report:****Undrained Shear Strength in Triaxial Compression  
BS 1377 : Part 7 : Clause 8 : 1990 Single Stage Test  
without measurement of Pore Pressure****Client ref:****13-7883****Location:****53 Agar Grove, Camden****Contract Number:****22207-050214****Hole Number****BH1****Sample Number:****N/A****Depth (m) :****5.00-5.45****Sample Type :****U**

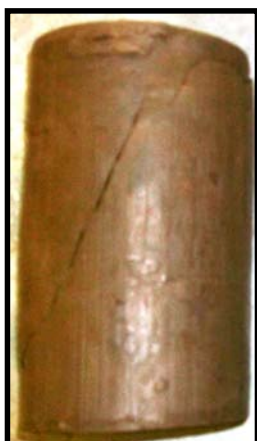
**Post Test Specimen**

**Test Report:****Undrained Shear Strength in Triaxial Compression  
BS 1377 : Part7 : Clause 8 : 1990 Single Stage Test  
without measurement of Pore Pressure****Client ref:****13-7883****Location:****53 Agar Grove, Camden****Contract Number:****22207-050214****Hole Number****BH1****Sample Number:****N/A****Depth (m) :****8.00-8.45****Sample Type :****U**

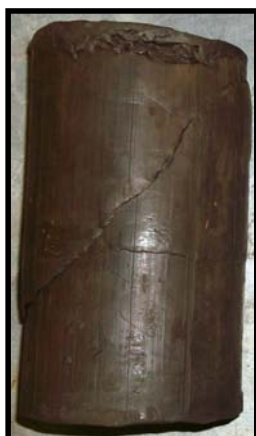
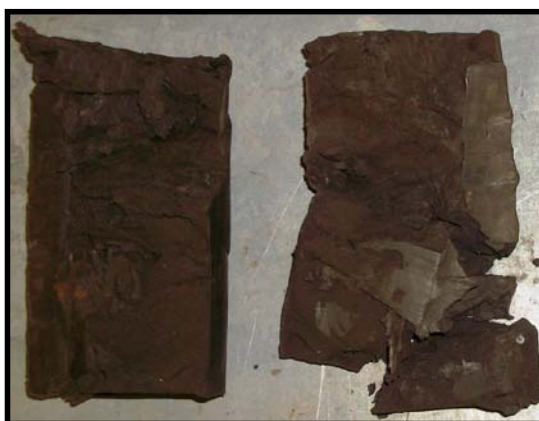
| Diameter (mm): | | 100 | Height (mm): | | 200 | Test: | U 100 mm Single Stage. | | |
|---|---|---|---|---|---|---|---|---|---|
| A | 26.5 | 2.08 | 1.64 | 280 | 284 | 142 | 6.0 | Compound | Sample taken from Top of tube<br>Rate of strain = 2 %/min<br>Latex Membrane used 0.2 mm thickness |

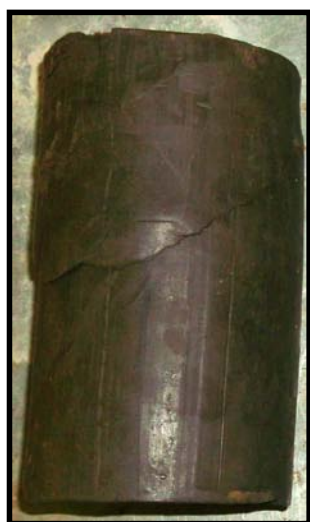
**Post Test Specimen**

**Client ref:** 13-7883  
**Location:** 53 Agar Grove, Camden  
**Contract Number:** 22207-050214  
**Hole Number** BH1  
**Sample Number:** N/A  
**Depth (m) :** 20.00-20.45  
**Sample Type :** U
