REPORT ON MORTAR ANALYSIS BY BS 4551: 2005 + A1: 2010 + A2: 2003

AP 2420
The Elms,
Fitzroy Park, Highgate, London

Samples S1 and S2
External Render

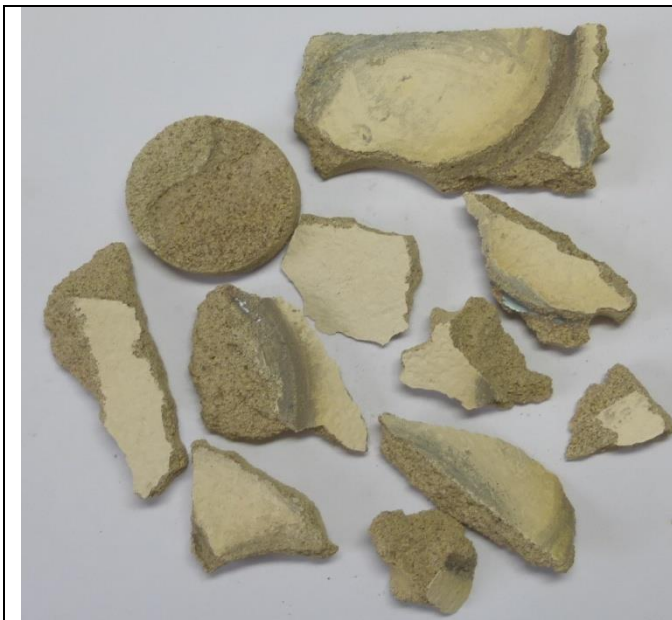
Plate 1. Sample S1 as received, with the sample consisting of several pieces of the finishing coat, with adhering paint finish on the outer surface and traces of the underlying intermediate coat adhering to its underside.

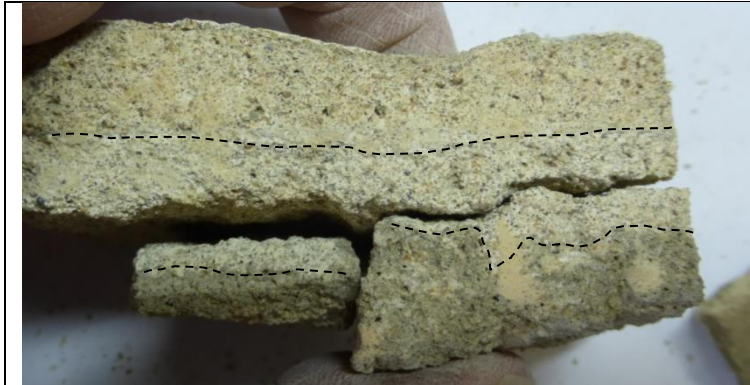
Plate 3. Sample S2 as received, with the sample reconstructed to show the top coat, intermediate coat and base coat. The coat interfaces are highlighted by broken lines superimposed onto the image.

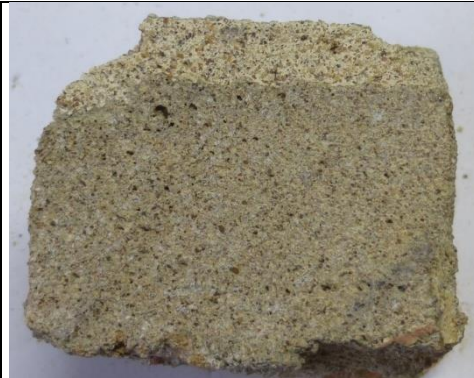
Plate 4. Separate sub-sample of the base coat with adhering intermediate coat on top. Again the intermediate coat appears to be a white cement mix, whereas the base coat is a grey OPC mix.

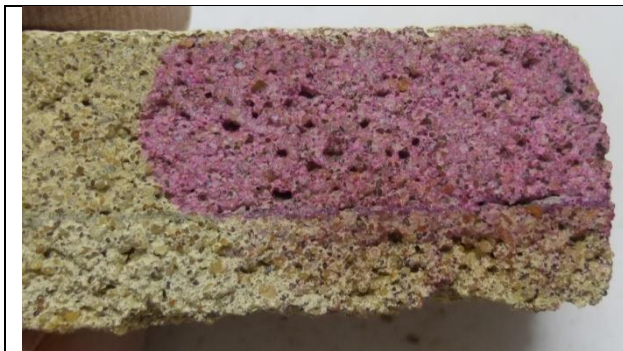
On testing a freshly fractured surface with a phenolphthalein indicator solution, the mortar was found to be only carbonated to a depth of 0.8mm from the outer surface in the finishing coat, with the intermediate coat only carbonated at the outer contact surface, whereas the base coat showed no indication of carbonation.

Plate 5. Finish coat tested with a droplet of phenolphthalein indicator solution, the fuchsia colour indicating that the mortar had not carbonated, except close to the outer surface.

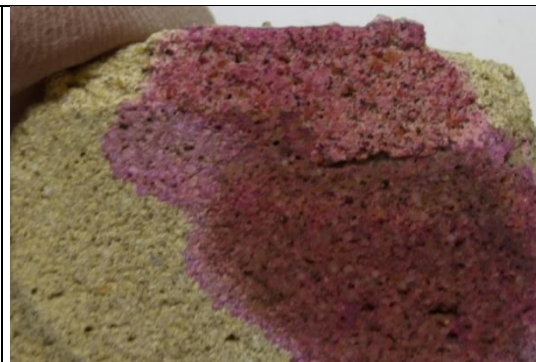
Plate 6. Phenolphthalein indicator test on intermediate coat and base coat again indicating no carbonation.
