REPORT ON TREE ROOT INVESTIGATION at 18 Redington Road, London, NW3 7RG

Report by Dr Martin Dobson
BSc DPhil FArborA MEWI
Registered Consultant of the Arboricultural Association

26 September 2014

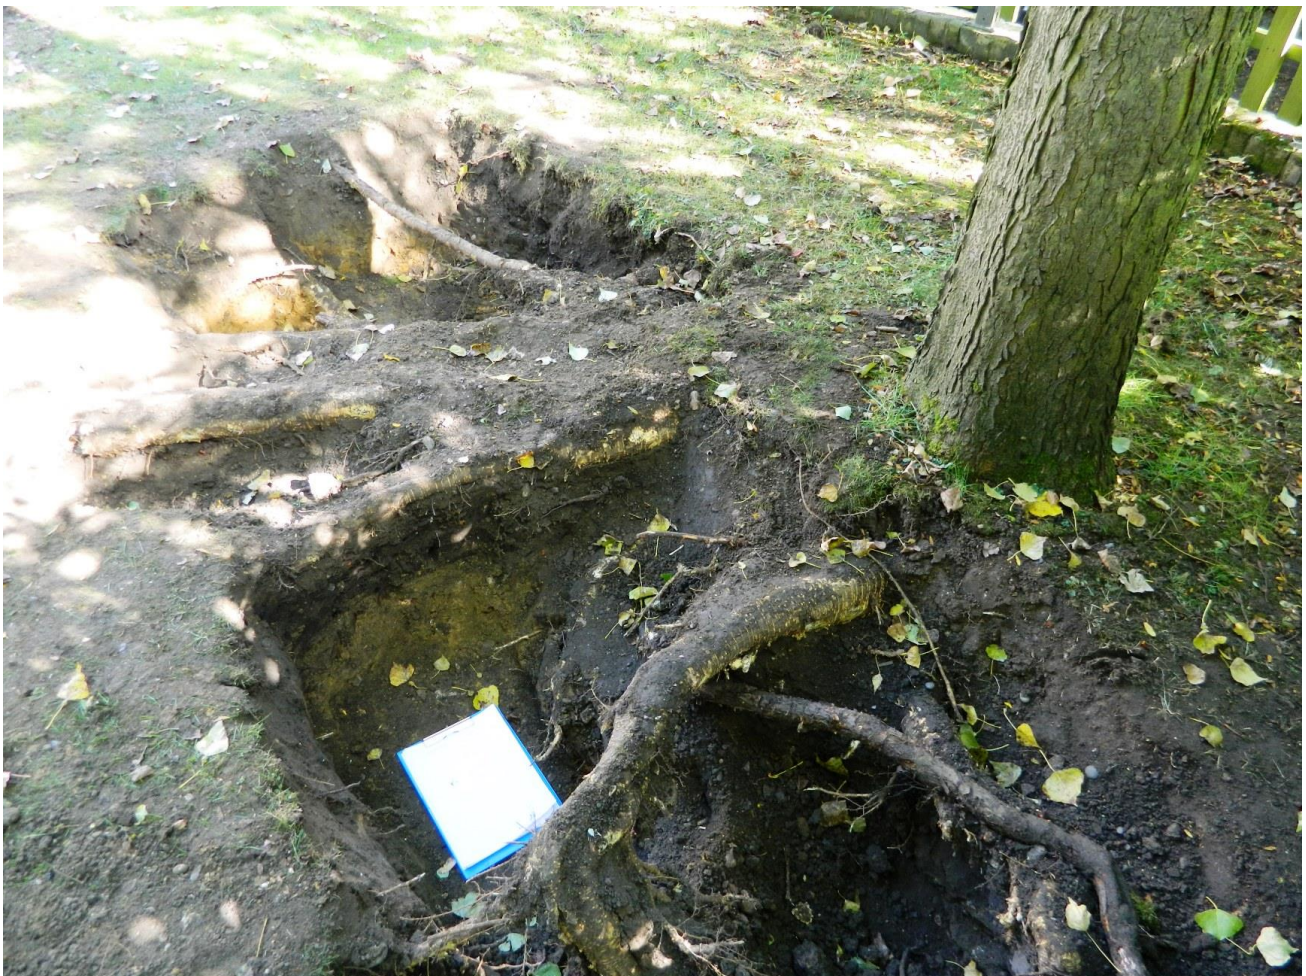
Figure 1. Exposed structural roots of T5. The edge of the roof slab of the existing underground garage is level with the right hand edge of the clipboard, i.e. 600 mm away from the trunk.

- 2.3 The investigation was carried out by hand digging so that the main structural roots were retained undamaged.
- 2.4 It was discovered that the edge of the roof slab of the garage was 600 mm away from the trunk of the tree (Figures 1 and 2). There was a depth of 500 mm of soil above the garage roof. Within this soil depth, and typically less than 10 mm below ground level, there were five woody roots radiating out from the trunk with diameters ranging from 40 – 120 mm diameter. A further two roots (70 – 90 mm diameter) grew parallel with the roof slab for some distance before growing over it, one of which was at a depth of 400 mm. Thus, piling adjacent to the tree would necessitate cutting seven main anchoring structural roots within about 600 mm of the trunk. In my opinion this would result in T5 becoming hazardous, especially as anchorage on the other side of the tree is restricted since there is a 1.3 m high retaining wall 1.7 m away from the trunk (Figure 3). The tree cannot therefore safely be retained as in all probability it would fall over – especially as the main weight of the tree is on the side away from the roots to be cut.

- 3.1 An investigation of the rooting of Pagoda tree T5 has been carried out by hand digging soil from around the roots.
- 3.2 It has been established that the roof slab of the existing basement garage is 600 mm away from the trunk of the tree and that there is 500 mm of soil above the garage roof.
- 3.3 Seven main structural roots grow over the roof slab (40 – 120 mm diameter) and would need to be cut in order to implement the planning consent. Cutting these roots would render the tree hazardous and liable to collapse.
- 3.4 The tree cannot therefore safely be retained and should be felled as shown in the approved drawing.

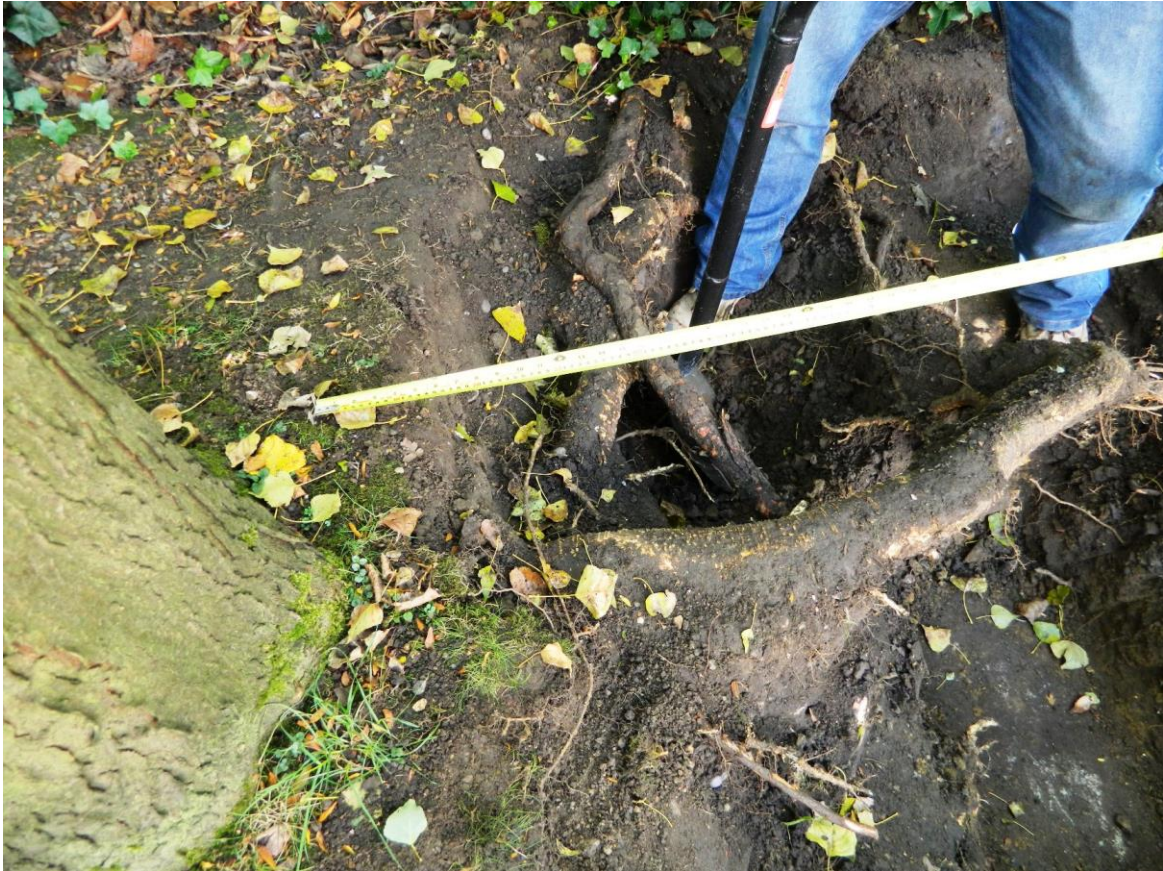
Figure 2. The edge of the garage roof slab is marked by the position of the spade and is 600 mm away from the trunk

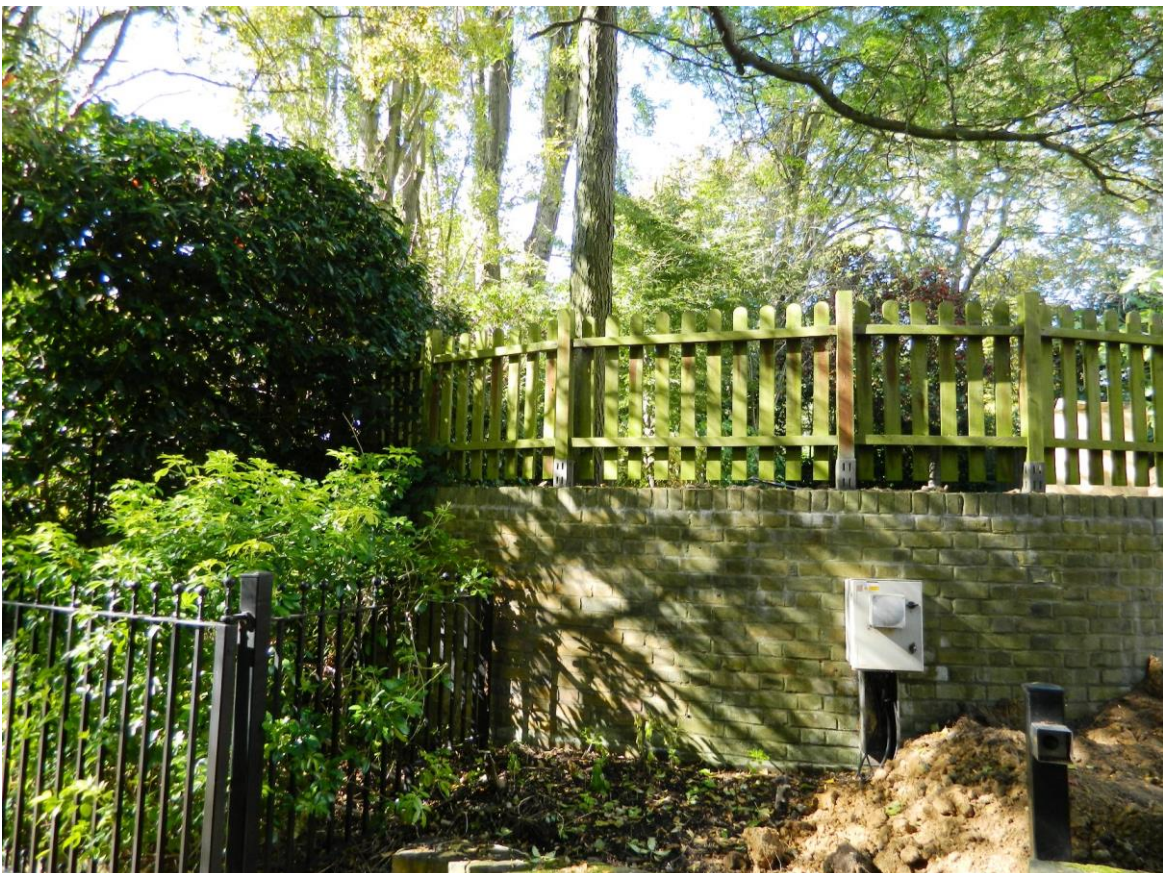
Figure 3. Retaining wall 1.3 m high and 1.7 m away from the trunk of T5 restricting root growth

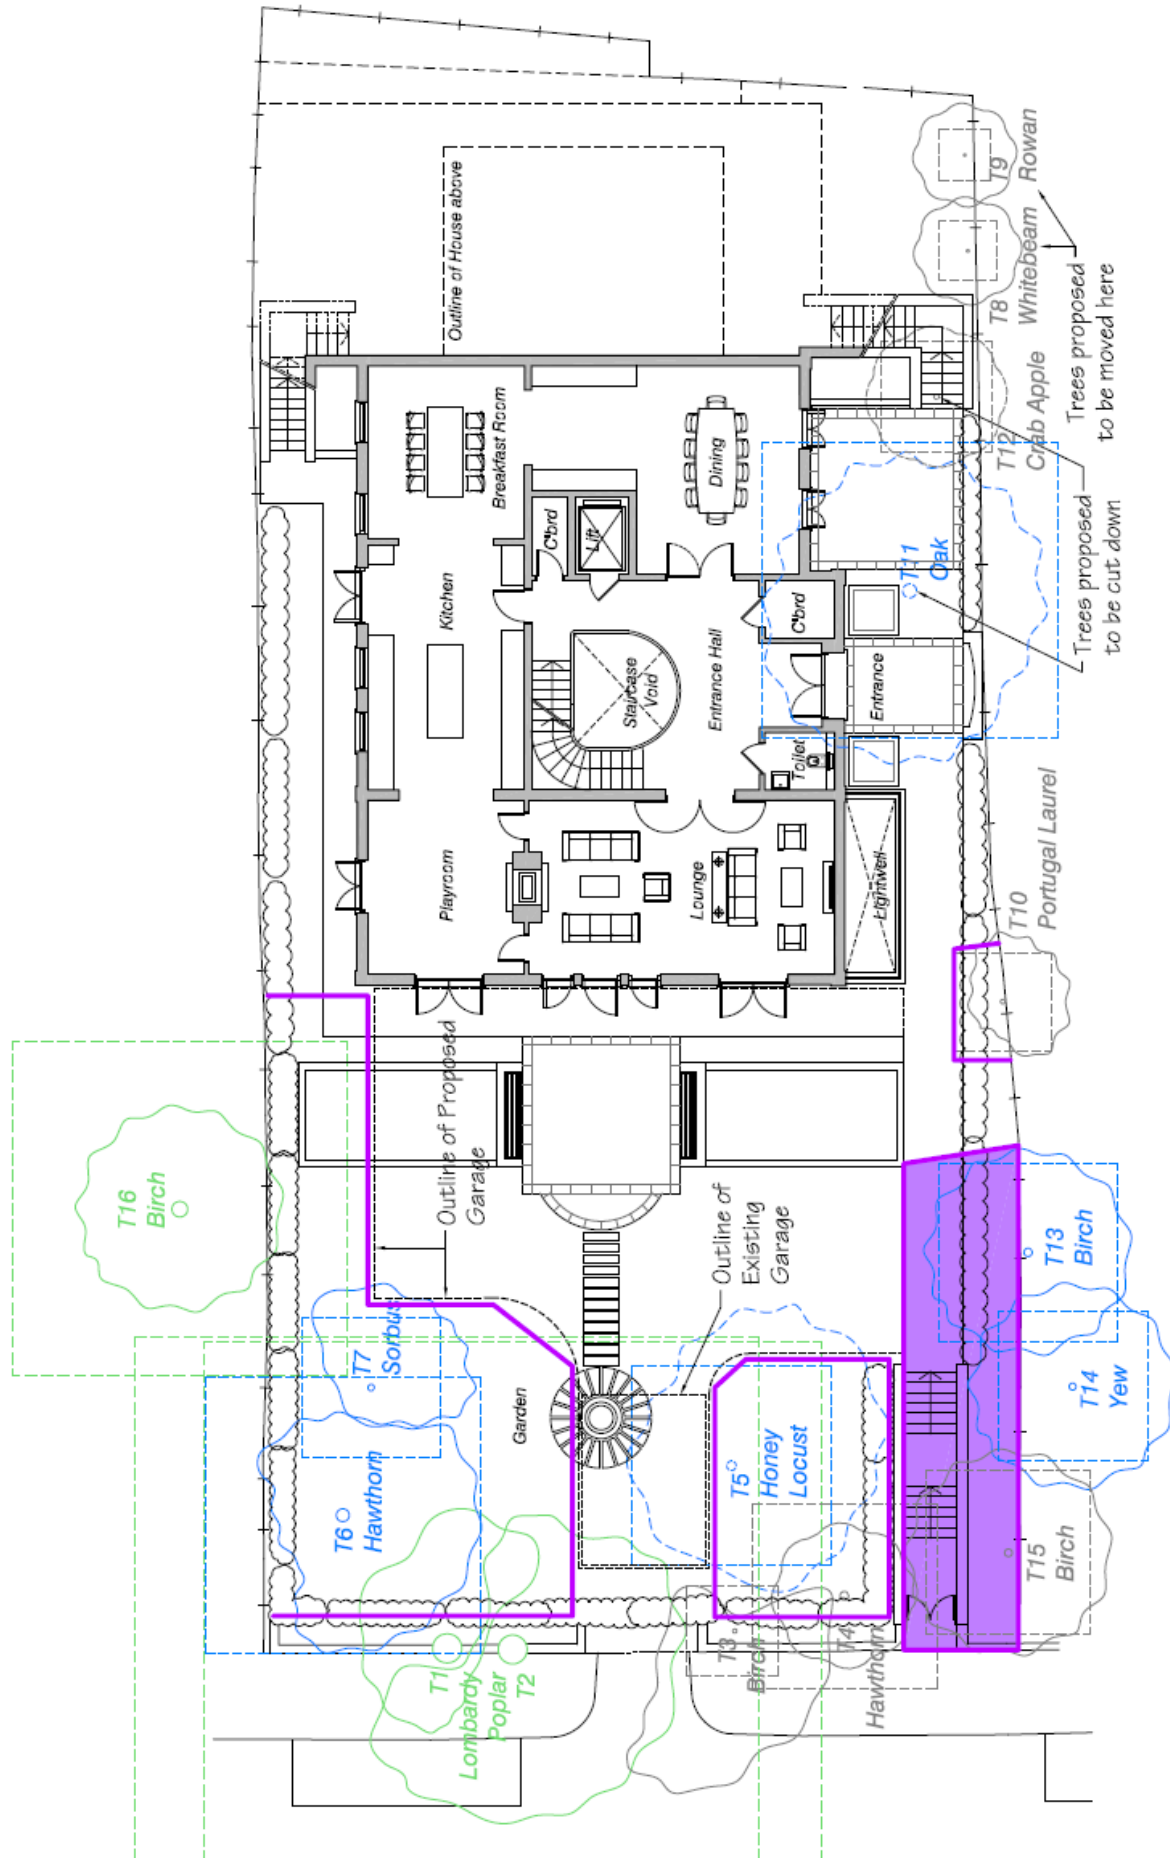
APPENDIX MD1

Approved ground floor plan. The trees scheduled for removal (T5, T11 and T12) are marked with a dashed canopy outline

- 1.4 The approved drawing is reproduced here at Appendix **MD1** and shows that three trees were scheduled for removal, namely, T5 Pagoda tree (*Sophora japonica*), T11 Oak and T12 Crab apple. Trees to be removed are indicated by a dashed canopy outline. However, only two of the trees (T11 and T12) are marked by annotation as being removed. There is therefore a degree of ambiguity as to whether T5 is approved for removal or not.
