# ***HERTS & ESSEX SITE INVESTIGATIONS***

## ***Phase I DESK TOP STUDY REPORT***

**277a Grays Inn Road,  
London  
WC1X 8QF**

**Sept 2014  
Report No. 12138**

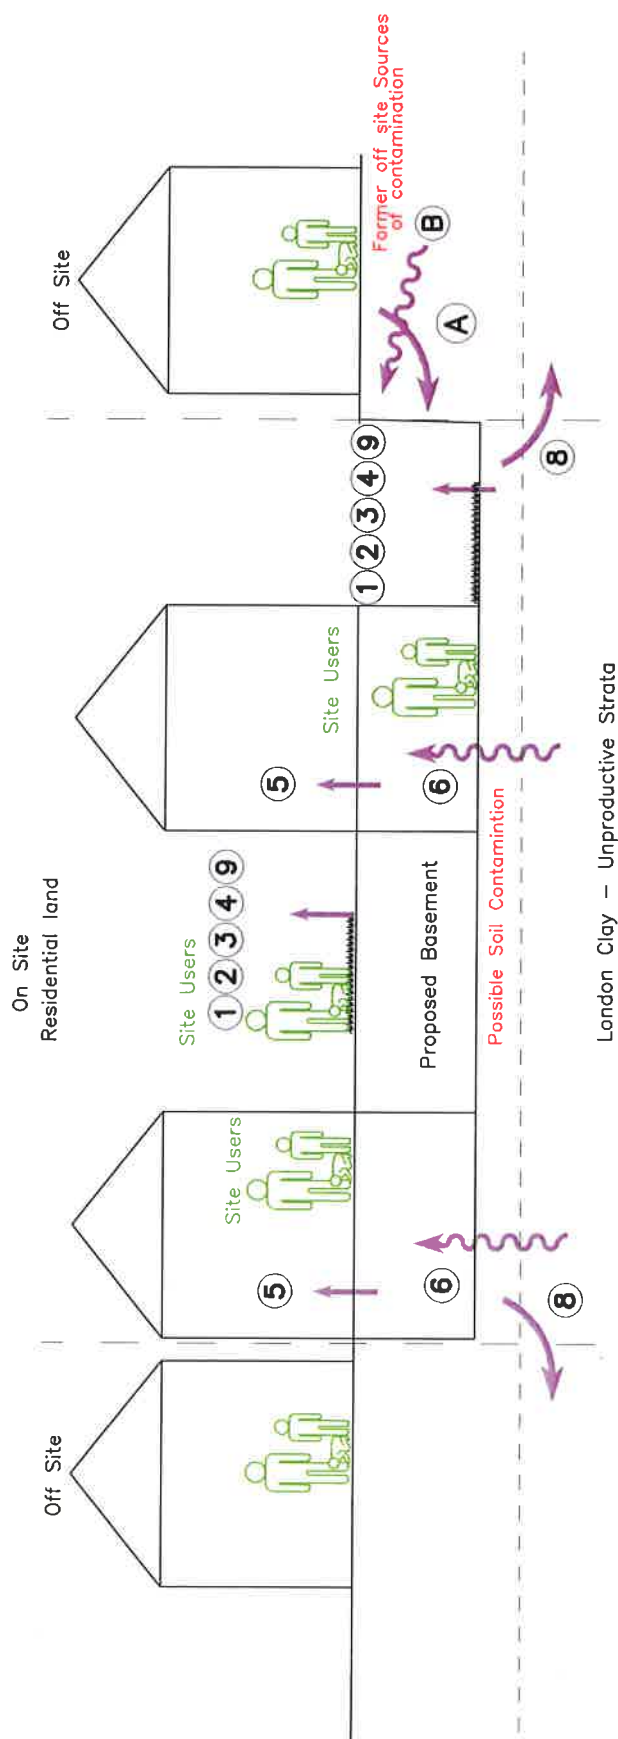
Sketch No: DTS/12138/01/01

### Off Site Sources

- A Migration of contamination to the site area
- B Migration of land gases/ Vapours to the site area
- C Migration of contaminated groundwater to the site area

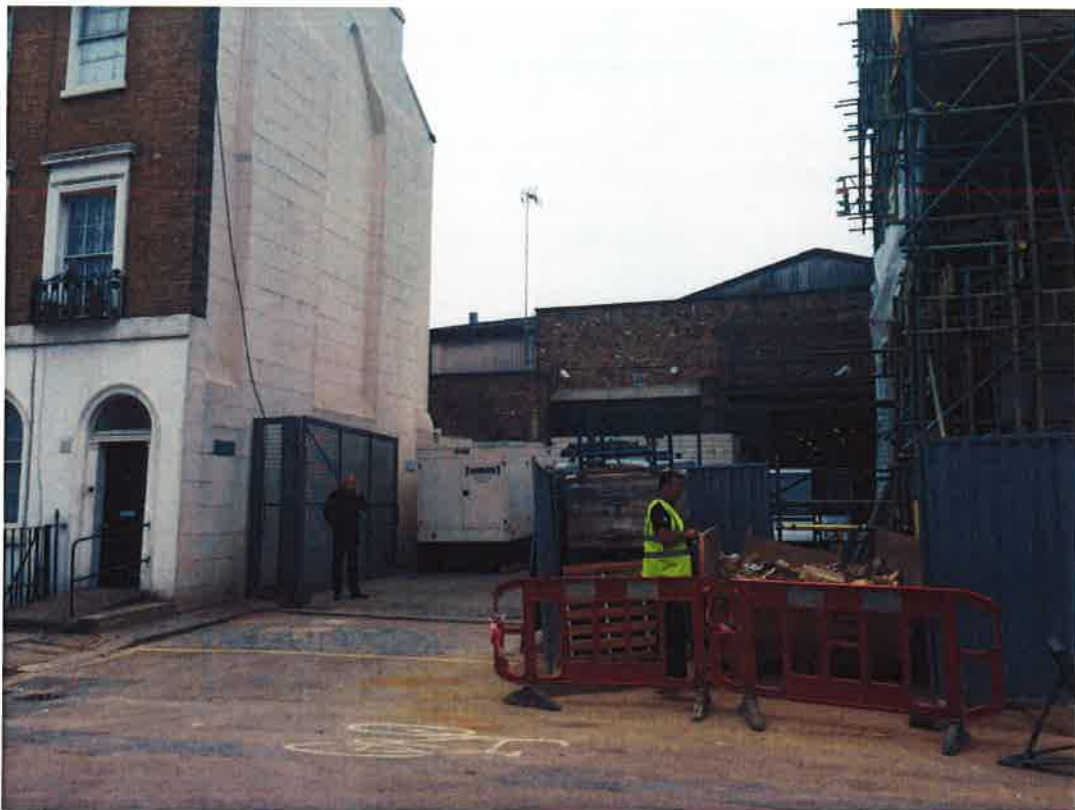
Access to the site area is gained from St Chad's Street, which is in place to the north of the site area. Where metal gates open out onto a small cobble yard area.

*Print 2 – View of the access to the site area looking from St Chads Street*

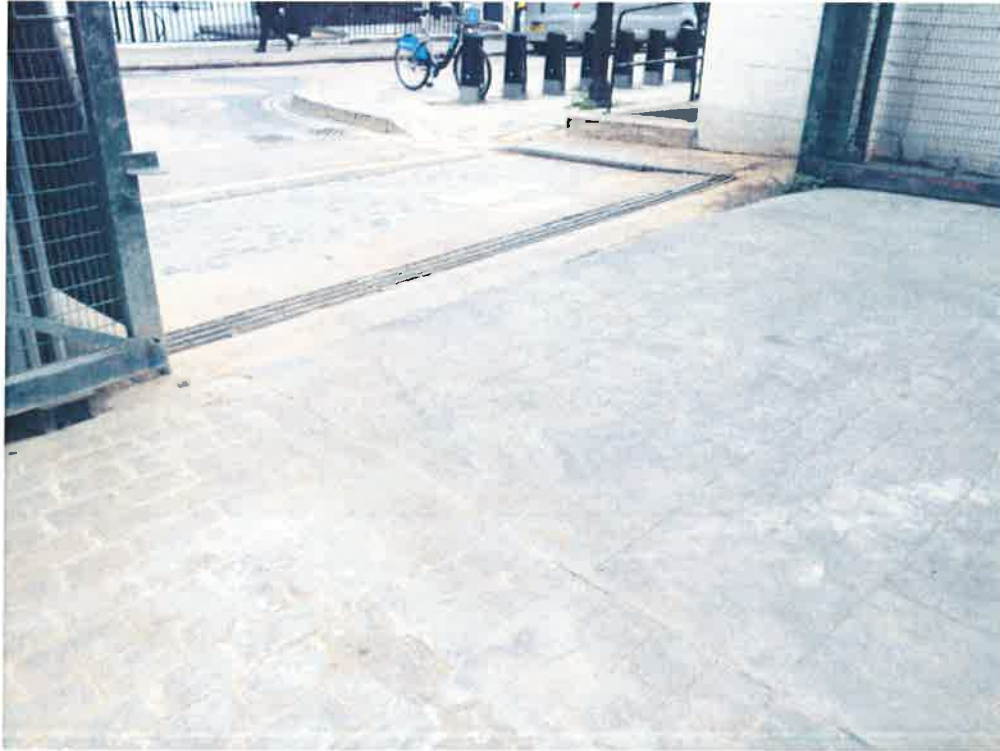
The yard area is laid to cobble stones, and slopes up slightly to the ground level within the building. Along the entrance to the yard area there is a gully in place, which looked to be in a good condition.

*Print 5 – View of the yard area within the north of the site area - gully along the entrance to the site area.*

Within the north of the site area, there is a gully in place collecting surface water run off from the yard area of the site area this looked to be in a good condition and will therefore reduce the potential for surface water run off impacting on the site area.
