Maitland Park Estate

GEOTECHNICAL AND ENVIRONMENTAL DESK STUDY

MAITLAND PARK GEOTECHNICAL AND ENVIRONMENTAL DESK STUDY

Ref 61031879-MP-GE/EV-RPT-001

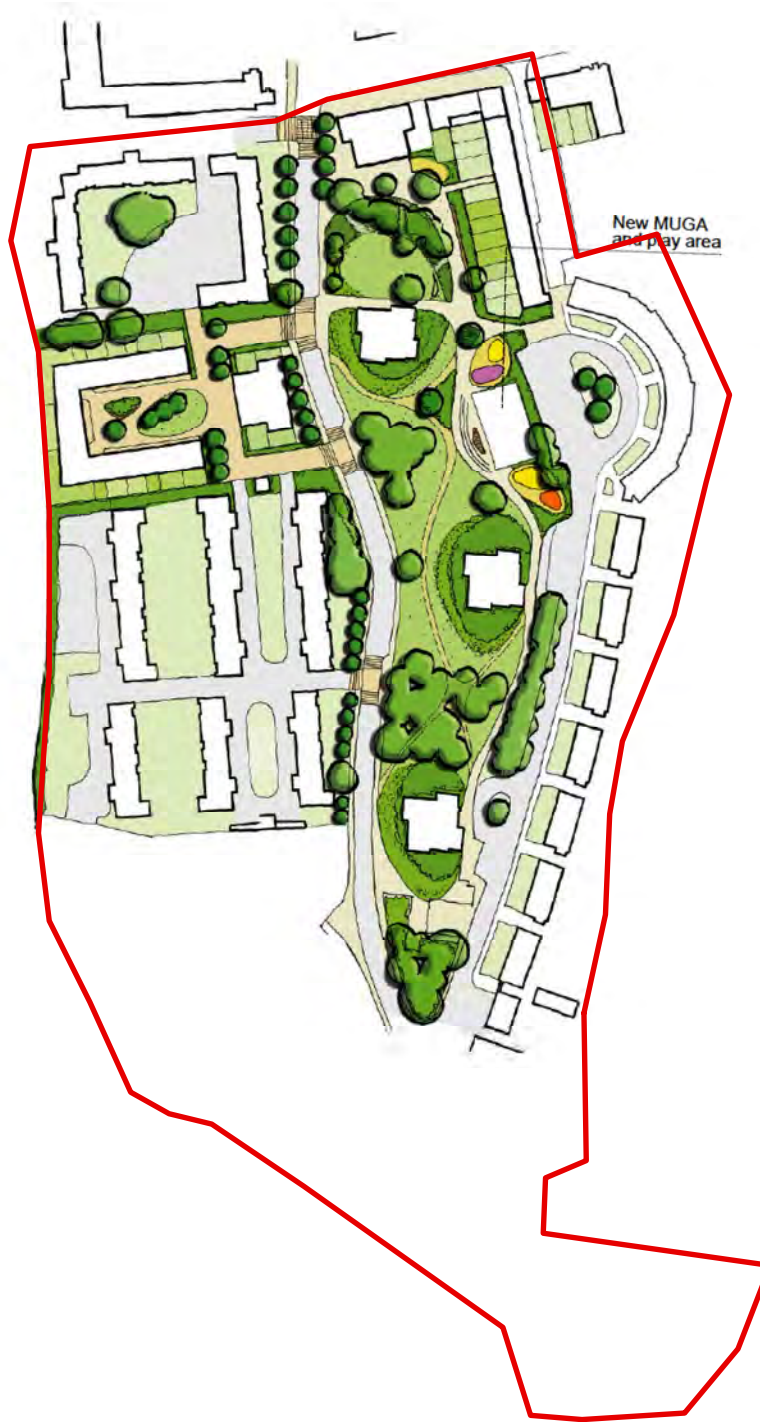
Figure No.
3

It is proposed to demolish the existing gym building, Aspen House, Tenants and Residents Association (TRA) Hall and garage blocks to enable the construction of four, five and six storey residential dwellings and a new TRA Hall. Landscaping will be altered. Plans of the proposed development options are shown in Figure 3, and Figure 4 shows the areas of the site proposed for demolition and construction.

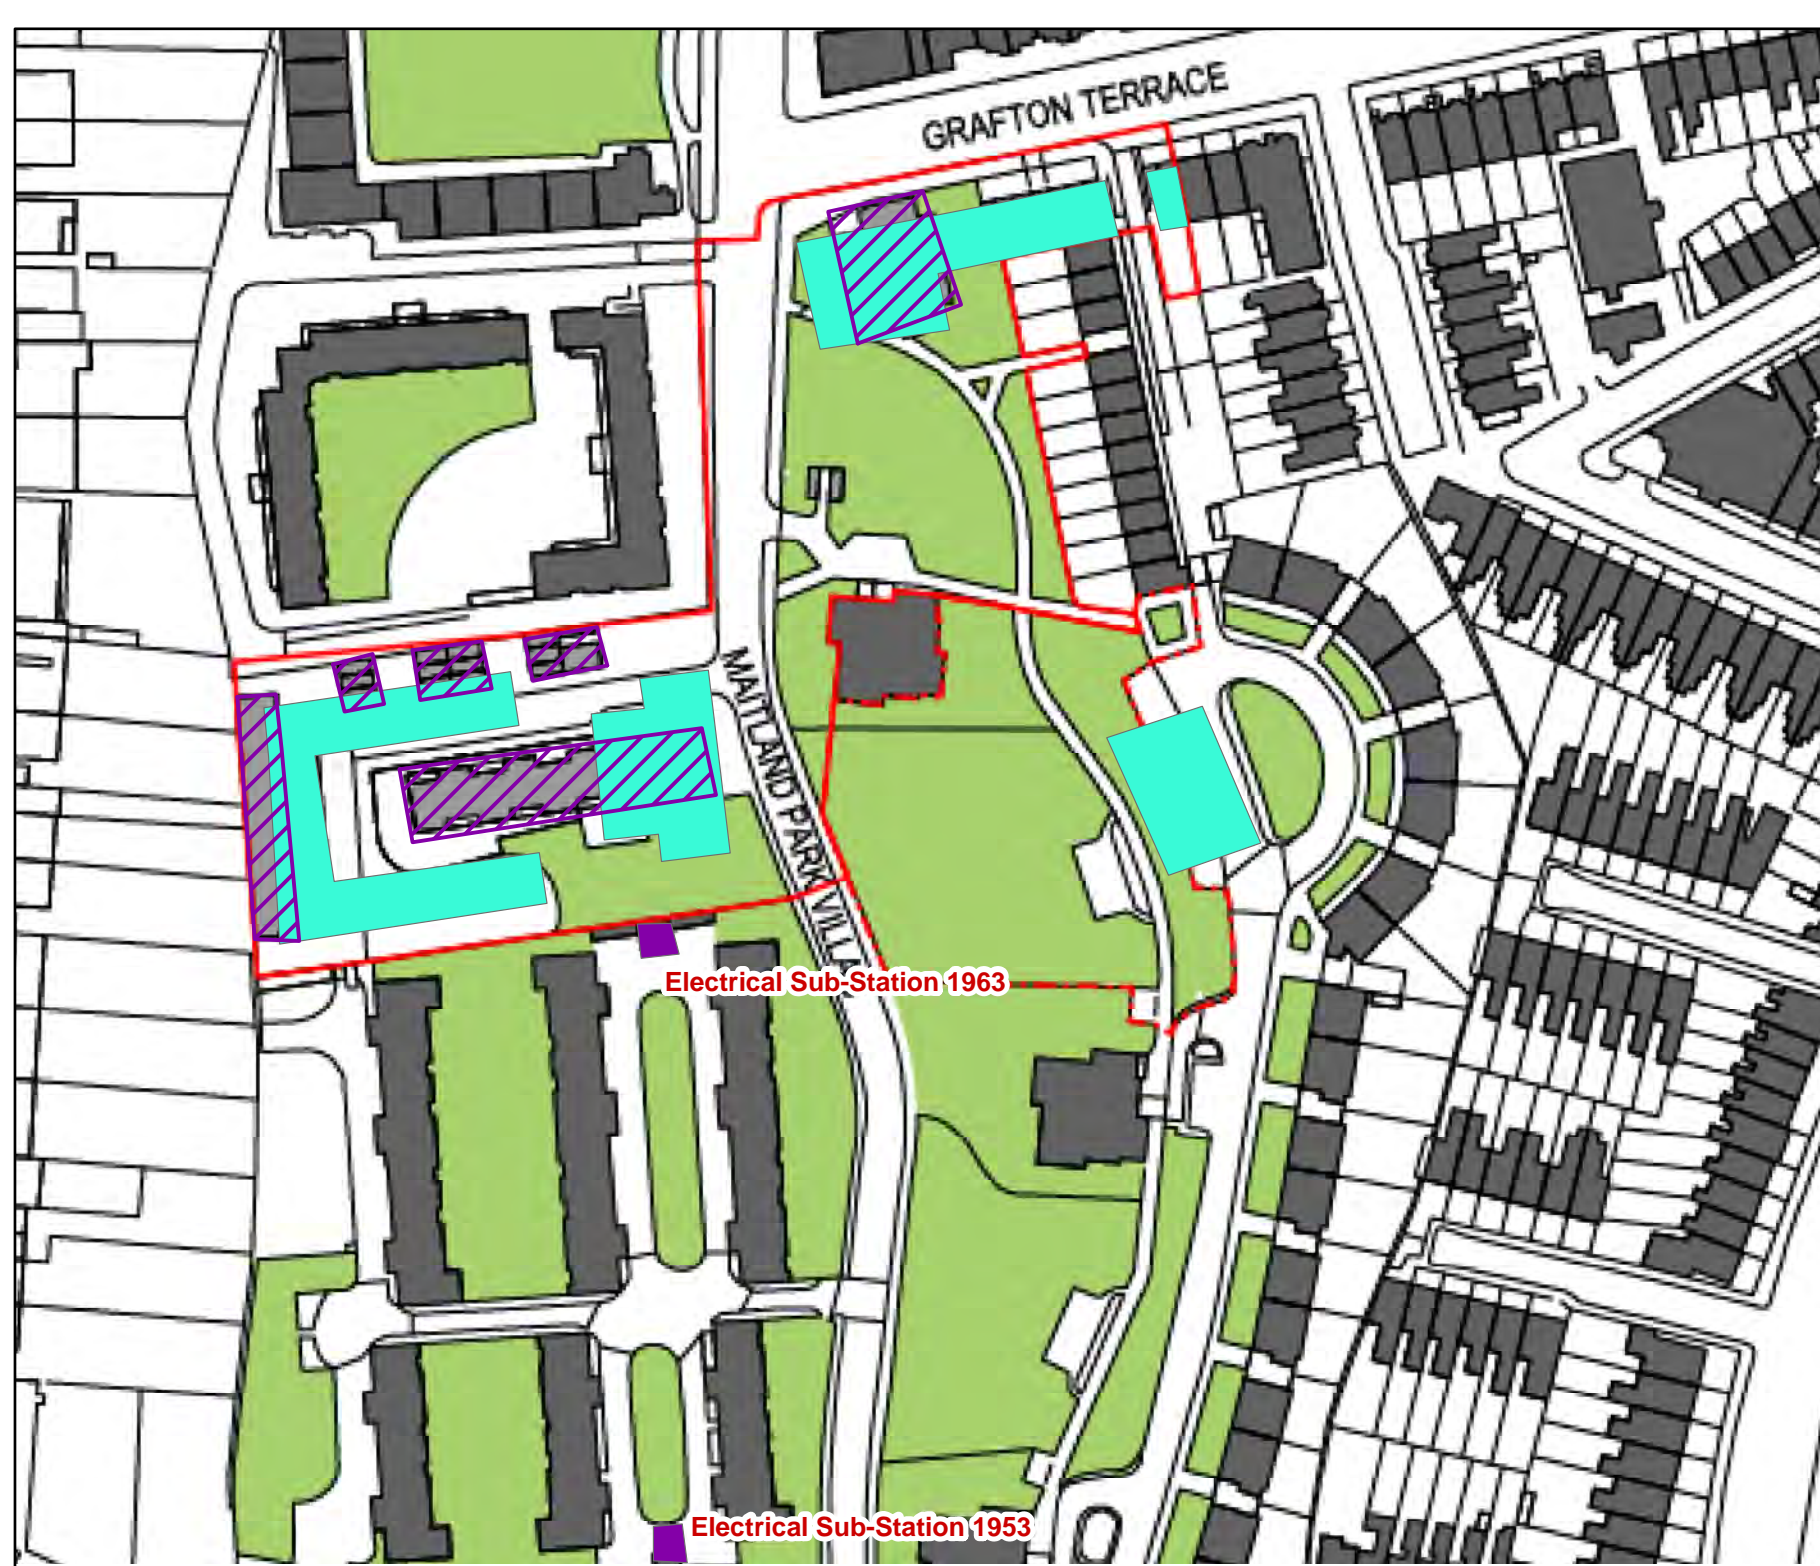
The locations of relevant historical features which could pose a potential risk to the proposed development are shown in Figure 4.

- Demolition
- Construction
- Allotments
- Potential Contamination Source

Review of available documentary sources indicates that there is the potential for contamination to occur on the site from the historic existence of two electrical sub stations. Their locations are shown on Figure 4. They are not located where demolition or construction is due to take place. The location of part of the proposed development is where buildings have been demolished in the past. There is therefore the potential in these locations for foundations or demolition rubble to be encountered. Due to the age of the buildings that existed, there is also the potential for asbestos to occur within that material.
