Heathside Preparatory School

76 Heath Street  
London NW3 1DN

Heritage Assessment DRAFT  
August 2014

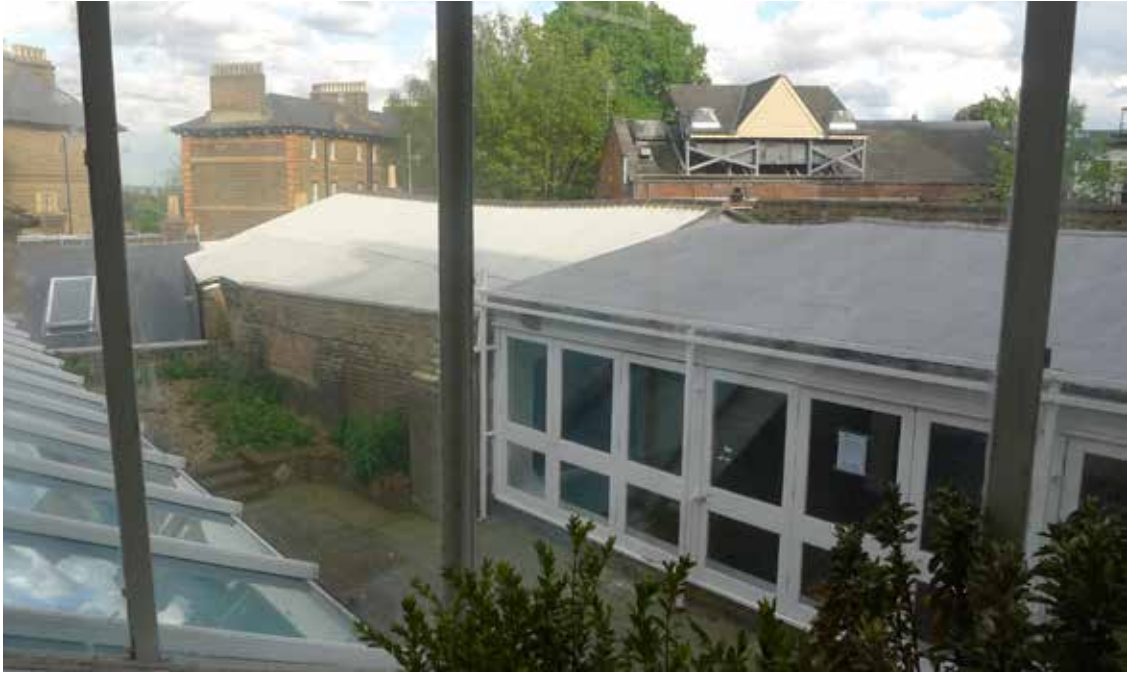
Part B - The middle building to the rear of 76 Heath Street

4.5.1 Yorkstone paving and low level brown brick walls form the landscape design. There are three infilled windows on the right of the middle building (B); one with a flat arch lintel, one with a failing solidier course lintel and one with the lintel removed.

4.5.5 At the upper level of the middle building, to the east of the 1972 glazed link, two brick piers and one corbelled column are evident. This wall is likely to have been the site boundary wall and appears in an extended format on the 1972 planning application drawings. It has had a number of interventions including three evident window openings.

4.5.6 A cill with curved bricks and flat brick arch is the highest quality window in this part of the building. The other openings are less considered, appearing ad hoc and poorly executed with a wobbly soldier course and roughly detailed brick cill.

4.5.7 Poor brickwork and mortar repairs detract from the quality and heritage significance of this wall.

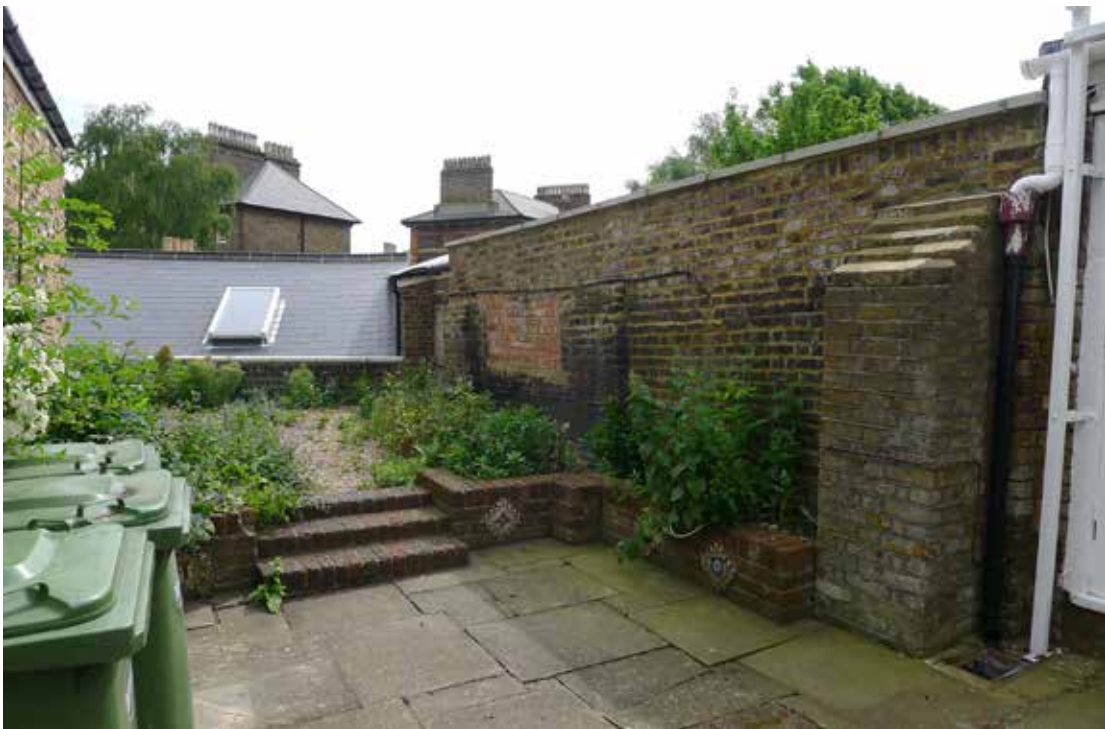
Part D - The open space courtyard to the rear of 74 Heath Street

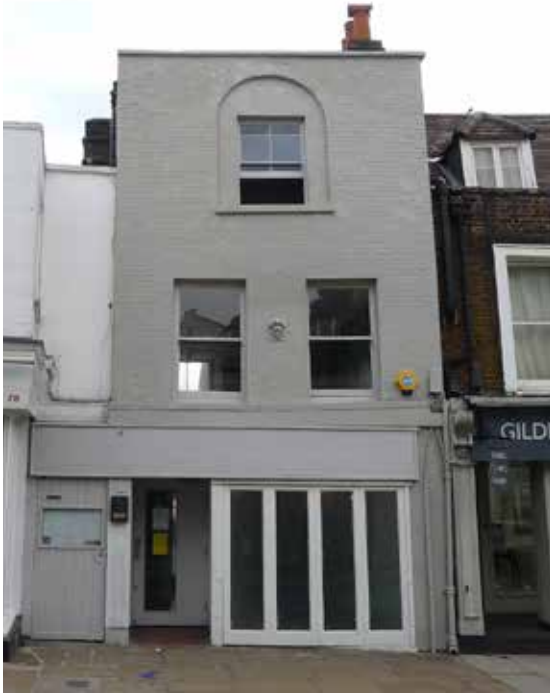
Part A - the principal, street front building showing 19thC facade, 21stC shopfront and alley way at left

4.2 Principal Elevation & Shopfront  
76 Heath Street is a three-storey, 18th century building, which is recognised within a group of four buildings as representative of the early era of development in Heath Street.

4.2.1 Its most significant architectural elements are the pantile roof and painted brick façade with parapet, gauged brick flat arches to recessed sashes and a distinctive shallow round-arched recess facing the street at second floor level.

4.2.4 The shop windows are painted timber framed, full height, bi-fold doors. The existing modern shop front at ground level detracts from its heritage significance and contribution to the streetscape.

4.2.5 The principal building is separated from 74 Heath Street by an alley way that leads to the existing courtyard behind 74 Heath Street. It is currently secured from the street by a timber door.

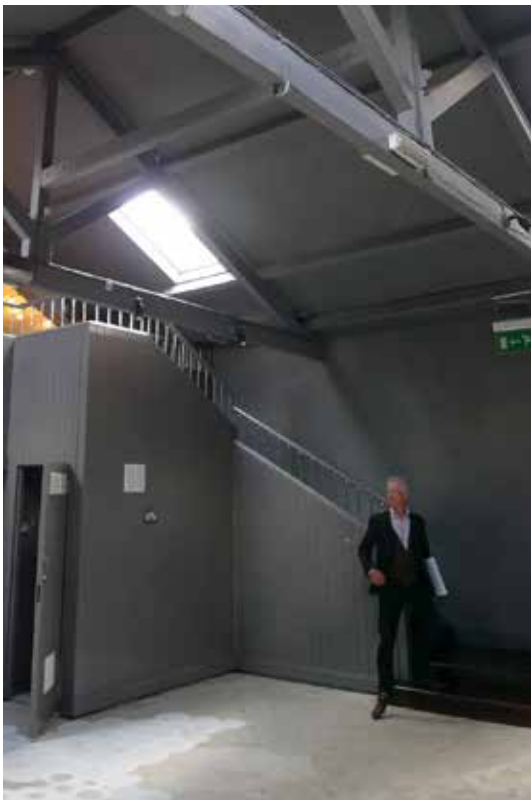
Part C - The auditorium to the rear of 74 Heath Street

4.5.2 To the rear, three steps leading up to the exterior landscaped area. Behind the outdoor garden, the auditorium roof is located with a low brick parapet forming the eastern edge of the garden.

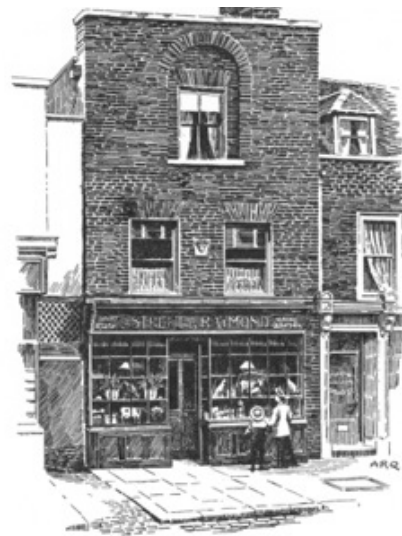
OLD HOUSE IN HEATH STREET, 1911.

Drawings from early 20th Century showing the shop front at 76 Heath St (right) and an unidentified series of shop fronts (below)

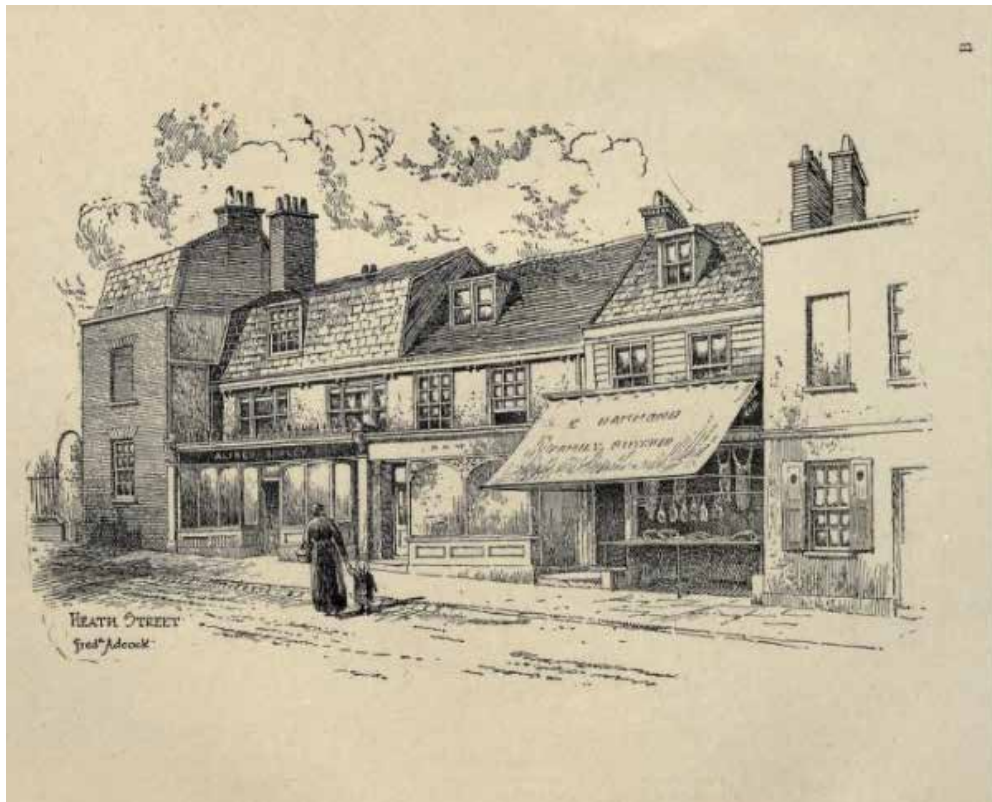
From an original drawing by A. E. Quinton in the Bell-Moor Collection.

The principal building is identified in the English Heritage listing as 18th century, however no primary source documentation has been found to confirm this. Likewise the street front elevation is thought to have been modified in the 19th Century. A drawing from 1909 shows it to be a similar configuration to what we find today.

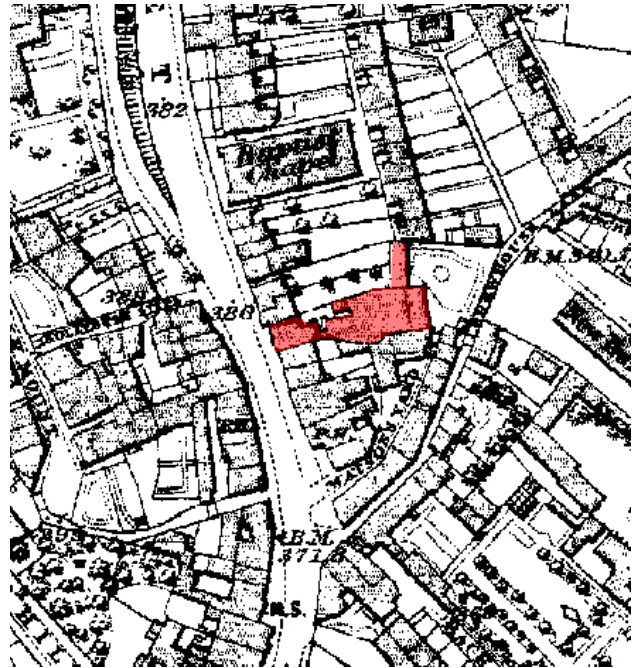
1879 OS map showing built form in similar arrangement to current configuration

5.1 Development of built form on the site  
 The 1879 OS map shows the principal building and closet wing in situ on Heath Street. A small open space is shown to the rear, but the remainder of the site is shown as built form bordering a large garden to the east which is the current location of Streetley Place.

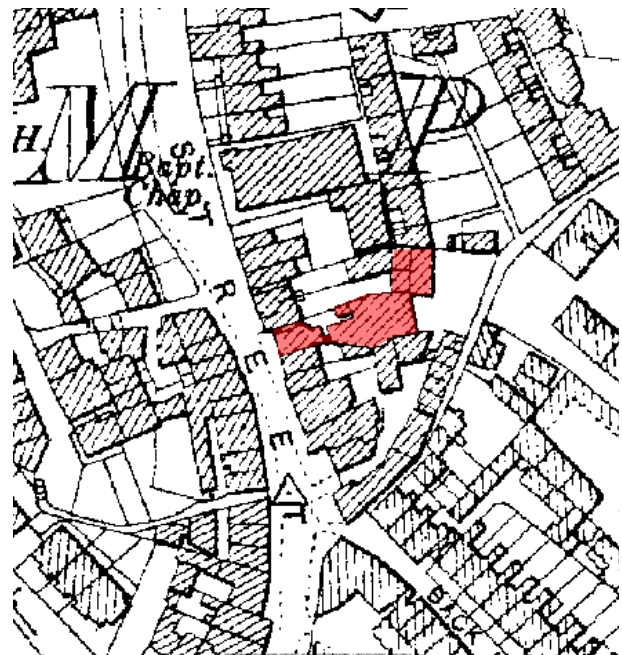
1896 OS map showing truncation of built form at east end of no. 76 and addition of built form to the east end of site at 72 and 74 Heath Street

5.1.1 The 1896 OS map repeats this format and shows a truncation of the built form at the east with an extension that matches the current location of the auditorium building.

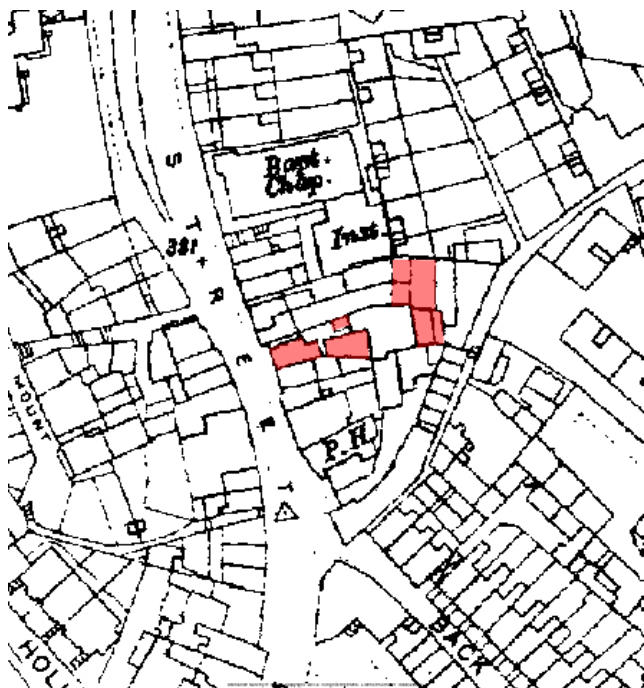
1915 OS map showing service buildings to the rear of 76 Heath Street; identification in 1903 plan as washing shed and stables

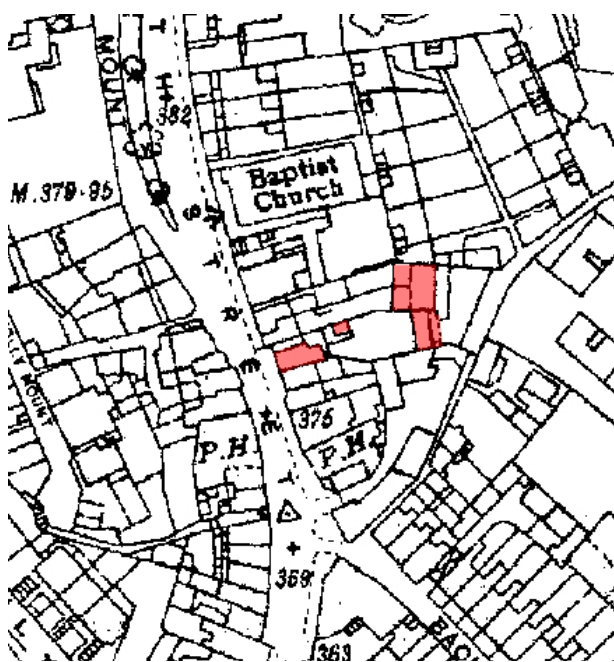
1934 OS map - Washing shed appears to be extended and possibly integrated into stables

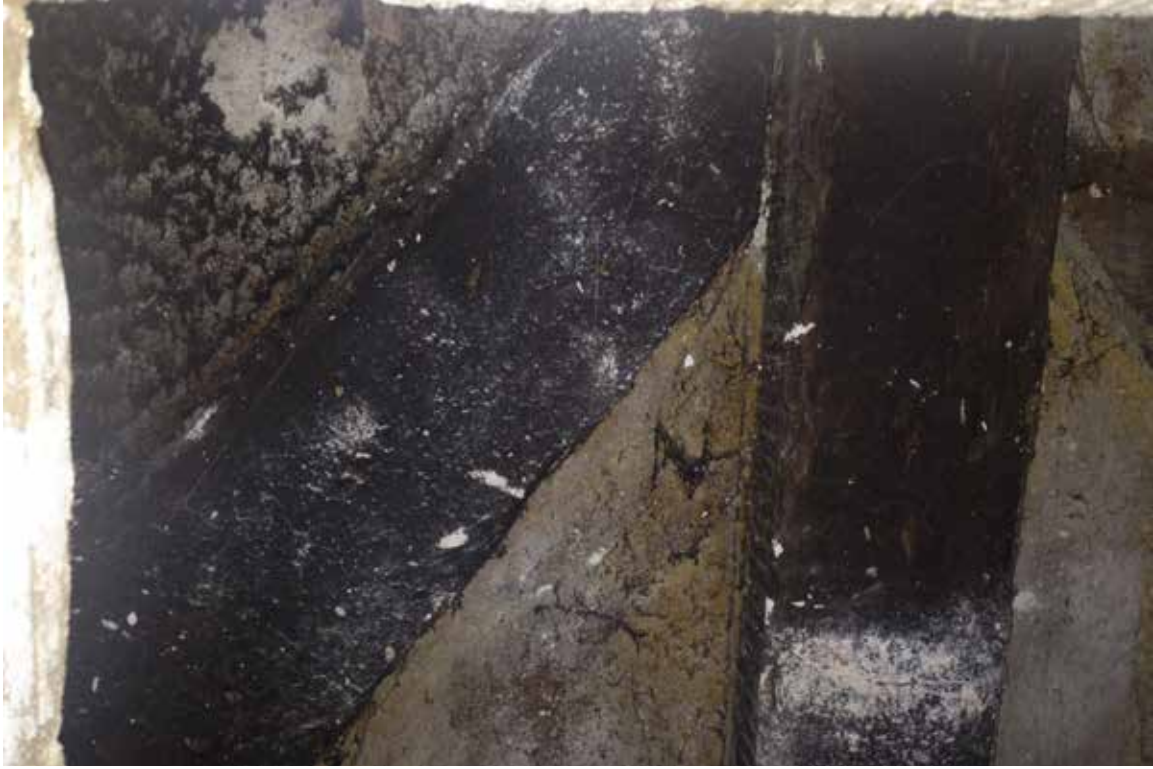
Fig 1: Investigation to the interior linings on the south boundary reveals old structural timbers with saw marks and hand-cut nails

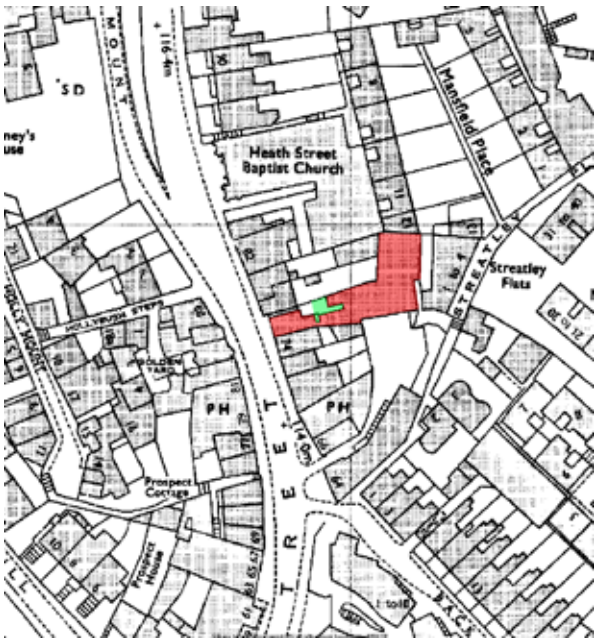
1974 OS map showing similar built form to existing

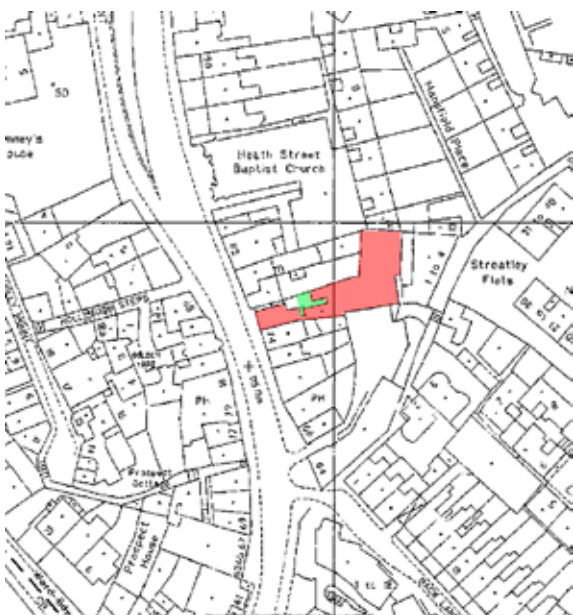
1991 OS map showing similar built form to existing

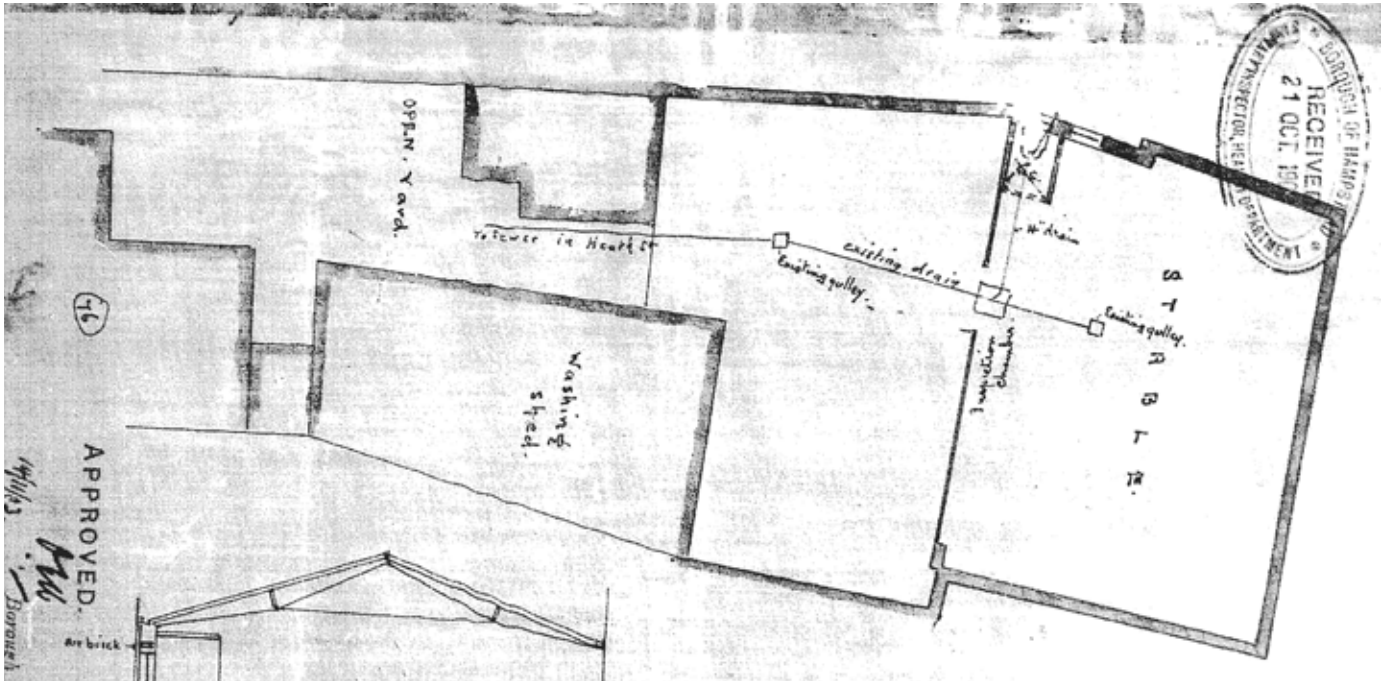
Fig xx: 1903 drainage plan showing open yard, washing shed and stables

5.1.2 The middle building offers a continuous, clear span on the interior with three layers of development that are gently articulated in the external building fabric, internal level changes and structural members. Built form is suggested in this location on the earliest OS map in 1879. However subsequent OS maps and the 1903 drainage plan show an open courtyard flanked by a washing shed, an outhouse and stables.

The Camden local studies archive holds a drainage drawing from 1903 which identifies the built form to the rear of 76 Heath Street as a washroom and stables.

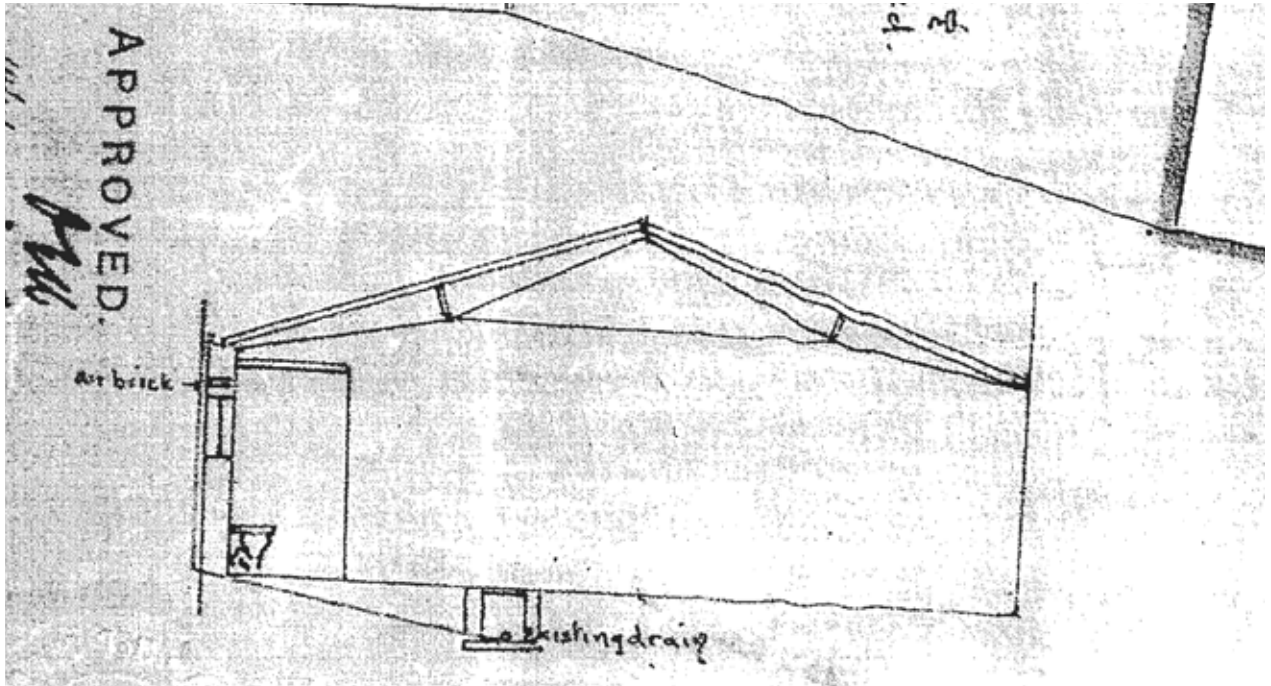
Fig xx: Detail of 1903 drainage drawing showing steel truss in same configuration as existing

5.1.3 A section drawing from the 1903 drainage plan also shows the existing rolled steel trusses with steel plates and suggests the middle window opening was introduced for a new WC in the original stables.

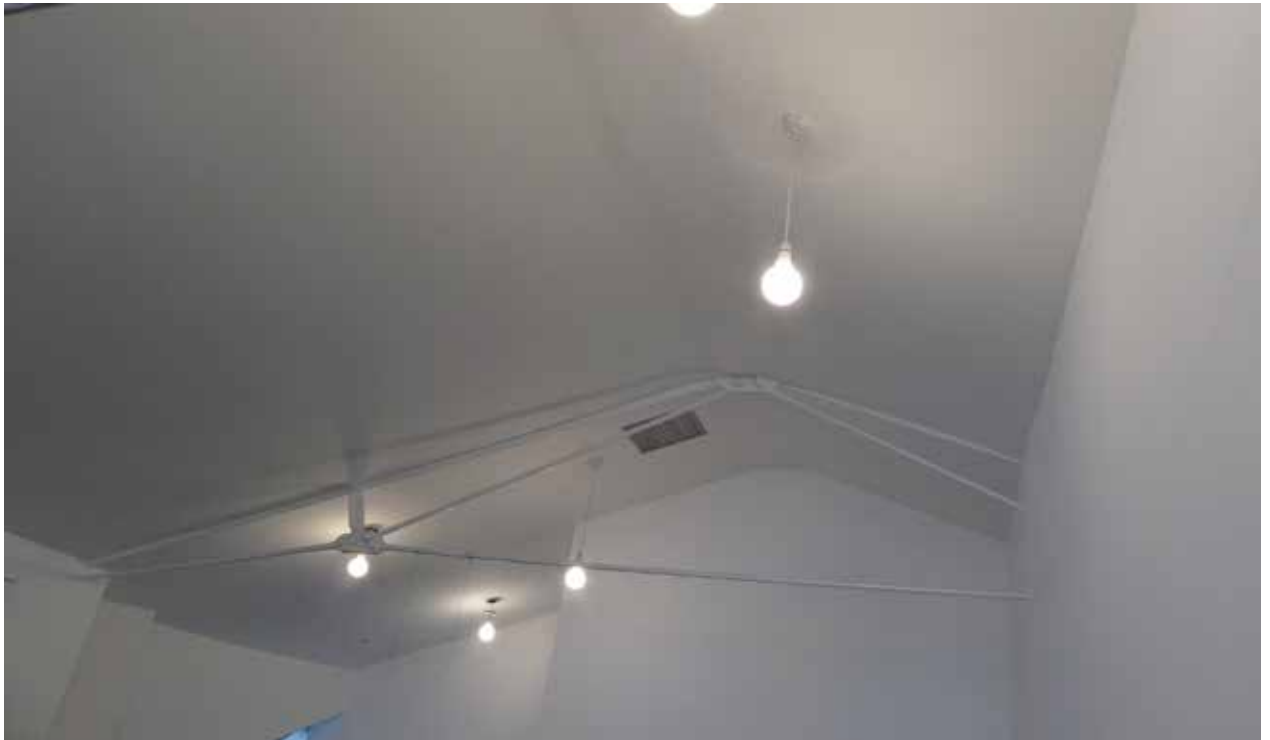
Fig xx: One of two existing steel trusses

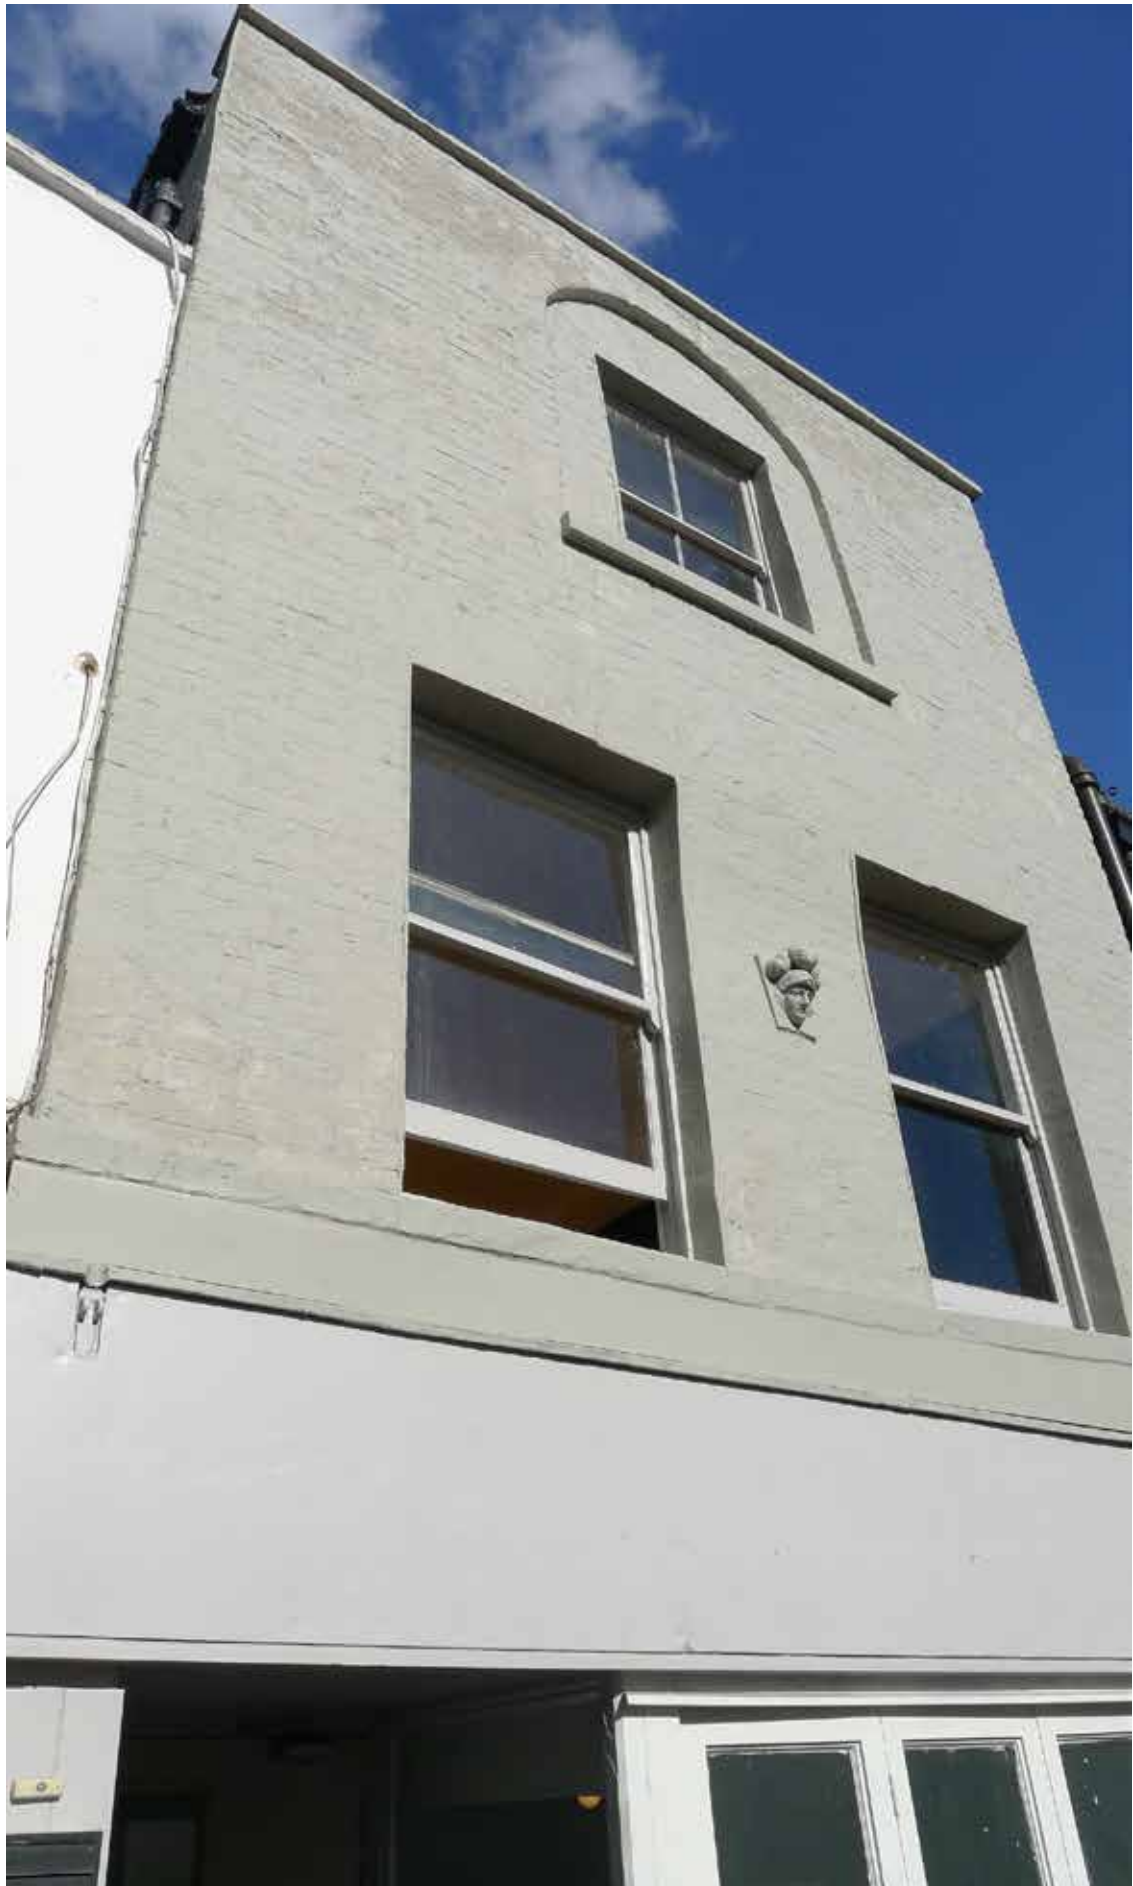
Fig xx: 76 Heath Street, principal facade above shop front shown distinctive window arrangement and limited decorative elements.
