Ecology Survey - Initial Bat Survey
'The Cottage', Spaniards Road, London, NW3 7JH

INITIAL BAT SURVEY

**THE COTTAGE, SPANIARDS ROAD,
LONDON**

Report Number: RT-MME-113683-02

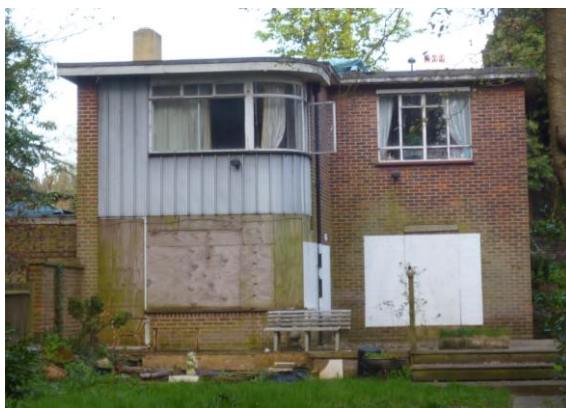
Plate 3.1: Rear of Building 1

This building was a two-storey building of brick construction with a concrete flat roof covered with felt (Plate 3.1). Soffit boxing was present in places around the building and was of wooden construction. The soffit boxing was generally in good condition. A few small gaps

The rear of the building had corrugated galvanised steel panelling attached to the walls (Plate 3.1). No features were noted around this panelling for bats to utilise and no bats or evidence of bats (such as droppings, feeding remains, or staining) was found.

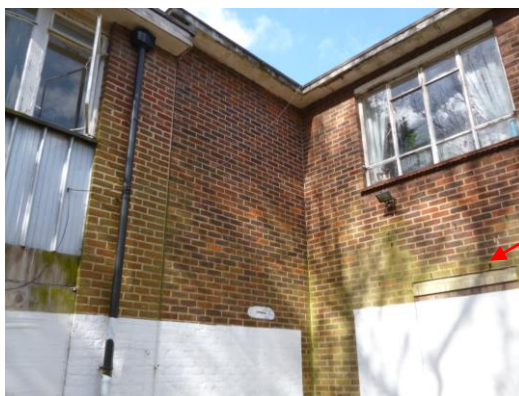
Plate 3.2: Example of weep holes (denoted by red arrow)

Weep holes were present above the windows on the ground floor of the building (Plate 3.2). Weep holes provide a potential access point into the cavity wall of the building which are suitable for use by crevice dwelling bats. These features were fully inspected using a ladder, torch and endoscope. The weep holes were found to be generally filled with dense cobwebs indicating that these features have not been recently utilised by bats as access points. No evidence of bats or bat activity was found in or around these features.

Only limited features suitable for use by roosting bats (comprising weep holes and small gaps in soffit boxing) were recorded during the assessment of this building. The weep holes were fully inspected with a torch and endoscope with no evidence of bats or bat activity identified. Whilst the gaps in the soffit box could not be fully inspected due to their height they were all heavily cobwebbed indicating no recent use by bats and no evidence of bats was noted below the features. As such it can be determined that bats are not currently using this building for roosting.

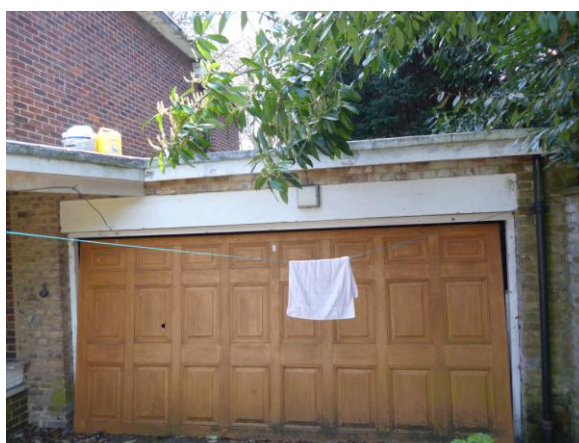
Plate 3.3: Garage

This building was a single-storey, flat roof brick building adjoining the southern elevation of Building 1 (Plate 3.3). No features suitable for bats to utilise were identified on this building. No evidence of bats or bat activity was found.

No features suitable for bats to utilise as either an access point or for roosting were identified on this building. As such it can be considered that no bats are currently using this building.

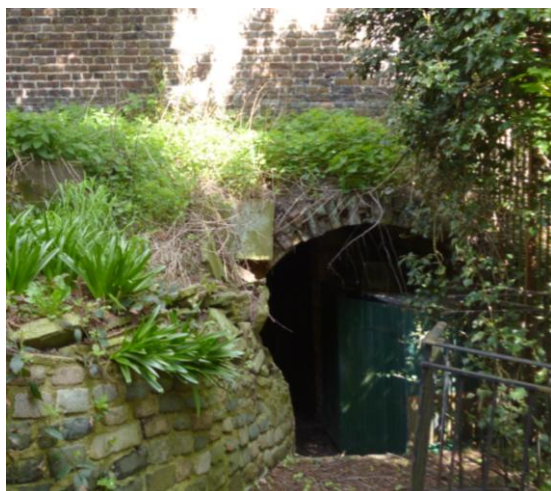
Plate 3.4: External view of tunnel

A tunnel was identified of brick construction (Plate 3.4 and 3.5), within which a number of cracks were present (Plate 3.6 and 3.7). Further to this missing mortar was present in a number of locations, with the potential to be utilised by bats. In the majority of locations the features were covered in thick cobwebs, indicating the lack of recent use by bats. All features were fully inspected using a torch and an endoscope no evidence of bats or bat activity was found.

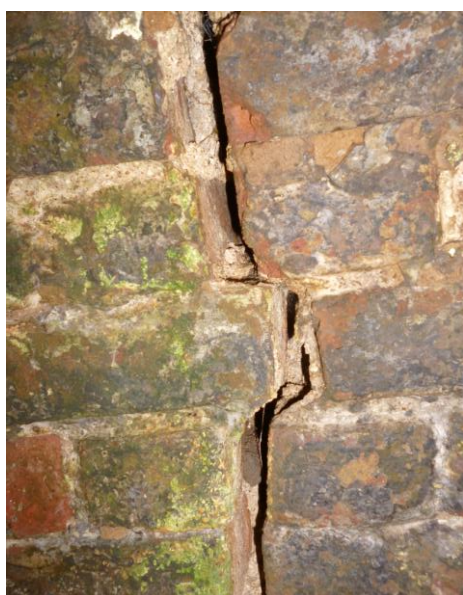
Plate 3.6: Example of cracks in the brickwork

Features were present such as cracks in the brickwork and missing mortar which could provide suitable roost locations for bats. However all features could be fully inspected at the

time of the survey and were found to be filled with dense cobwebs. This structure is therefore not considered to contain a bat roost at this time.

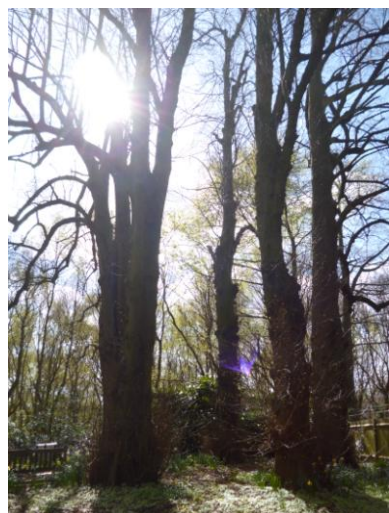
Plate 3.8: Group of lime trees

A group of 5 semi-mature lime *Tilia* sp., trees measuring up to 20 m in height were identified in the south-eastern part of the survey area (Plate 3.8). Rot holes, which can offer suitable roosting locations for bats were present on three of these trees (Plate 3.9). Due to the presence of such features these trees are considered to be Category 1 of the BCT tree index (Table 2.1). The features which could be reached using the ladders (up to 3.5 m) were fully inspected using an endoscope and torch. No bats or evidence of bats (e.g. droppings, feeding remains, scratch marks or urine staining) was identified. The rot holes present at heights greater than could be reached with the ladders were considered unsuitable for bats to utilise because they were open to the elements.

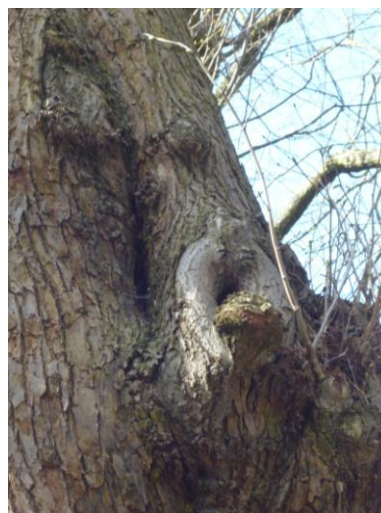
Plate 3.9: Example of rot hole in one of the lime trees

Three trees present within the survey area were considered to be Category 1 trees due to the presence of rot holes which may provide suitable roosting features for bats. However, all suitable features which could be accessed using the ladders were fully inspected using a torch and endoscope and no evidence of bats or bat activity was found. All features above this height which not be accessed using the ladders were considered unsuitable for bat to use because they were open to the elements. As such it was considered that no bats were currently using the trees for roosting. All other trees within the survey area were in good condition with no features suitable for use by roosting bats.
