Basement Impact Assessment
'The Cottage', Spaniards Road, London, NW3 7JH

Document type
Basement Impact Assessment

THE COTTAGE, SPANIARDS ROAD, LONDON BASEMENT IMPACT ASSESSMENT

Ref 61020760/GT/R01

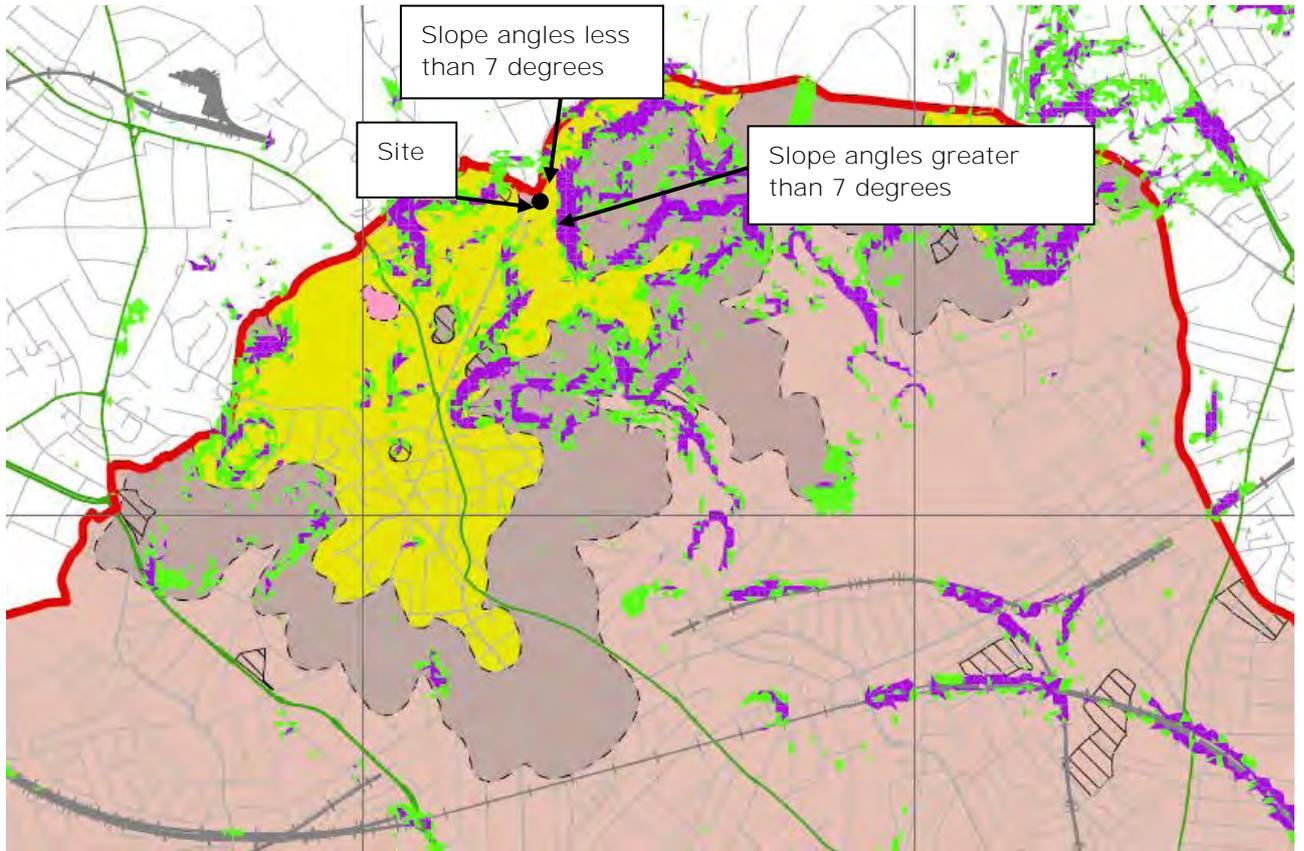
Figure 2 Extract showing slope angle of surrounding area

In a wider context the site lies on the shoulder of a hill that continues to extend up gently towards the south west to an elevation of approximately 140 mAOD. Figure 2 shows the site to lie within a hillside with a slope of less than 7°. Localised steeper slopes are shown north, west and immediately east of the site.

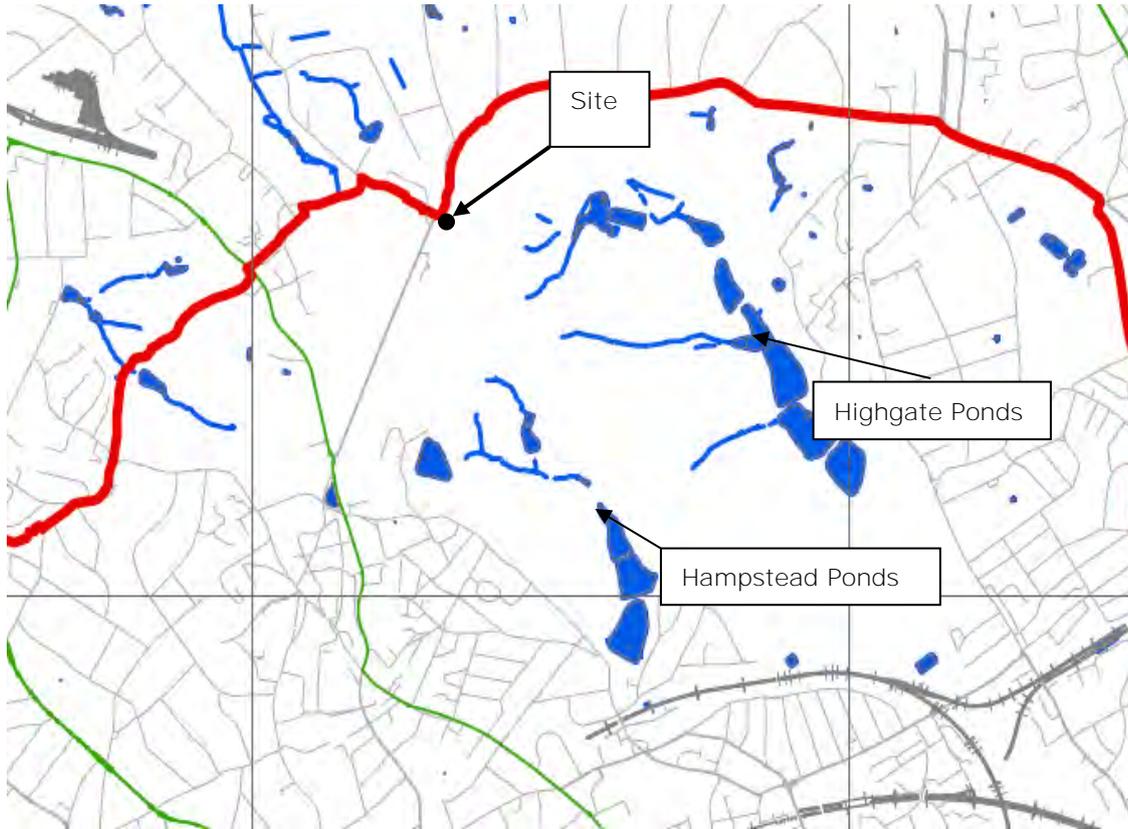
Figure 3 Extract showing Camden Surface Water Features and Pond Chains

An extract of the surface water features in the Camden area is shown in Figure 3. This shows that the site is not located adjacent to existing surface water features.

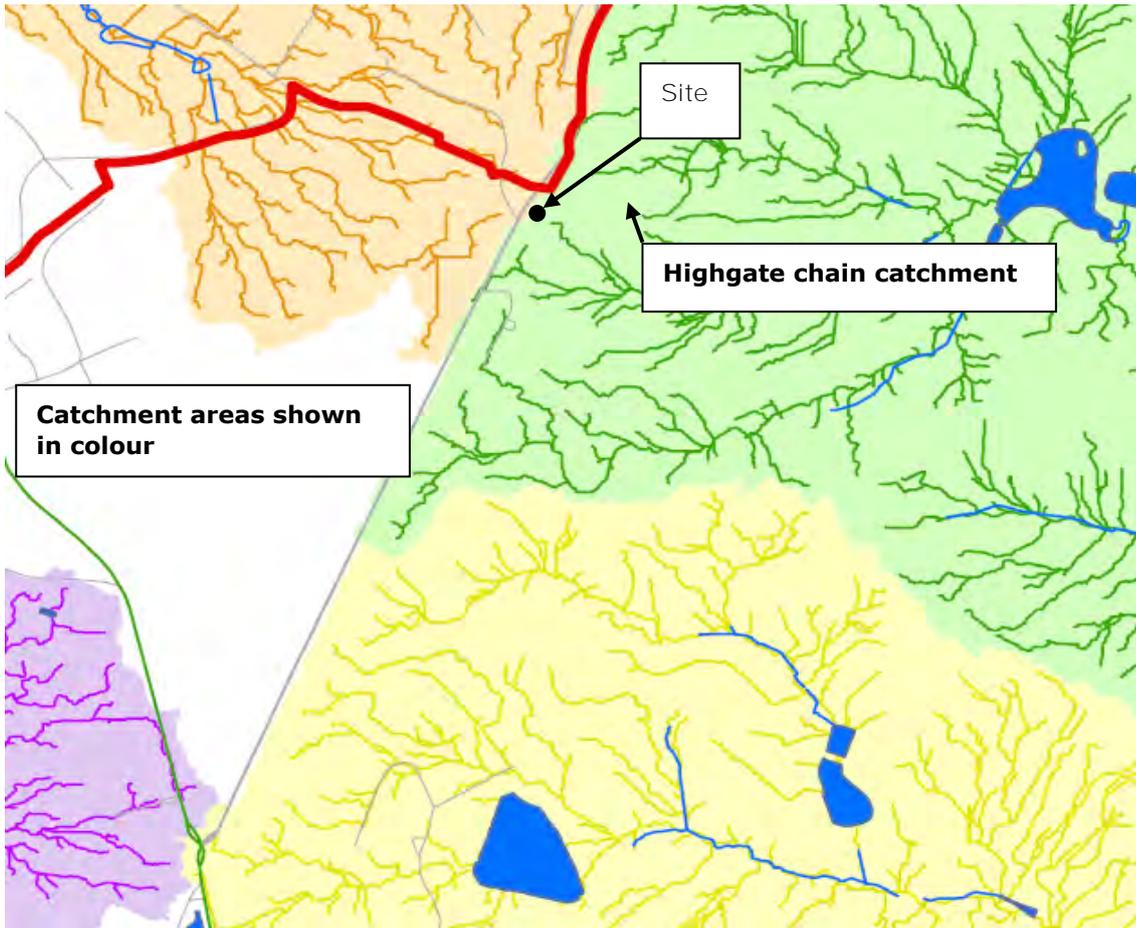
Figure 4 Extract showing Surface Water Catchment and Drainage

Figure 14 within the Camden Geological, Hydro-geological and Hydrological Study shows the site to lie within the Highgate Chain drainage and catchment area of the Hampstead Ponds. An extract showing the location of the site with respect to the surface water and drainage catchment areas is presented in Figure 4.

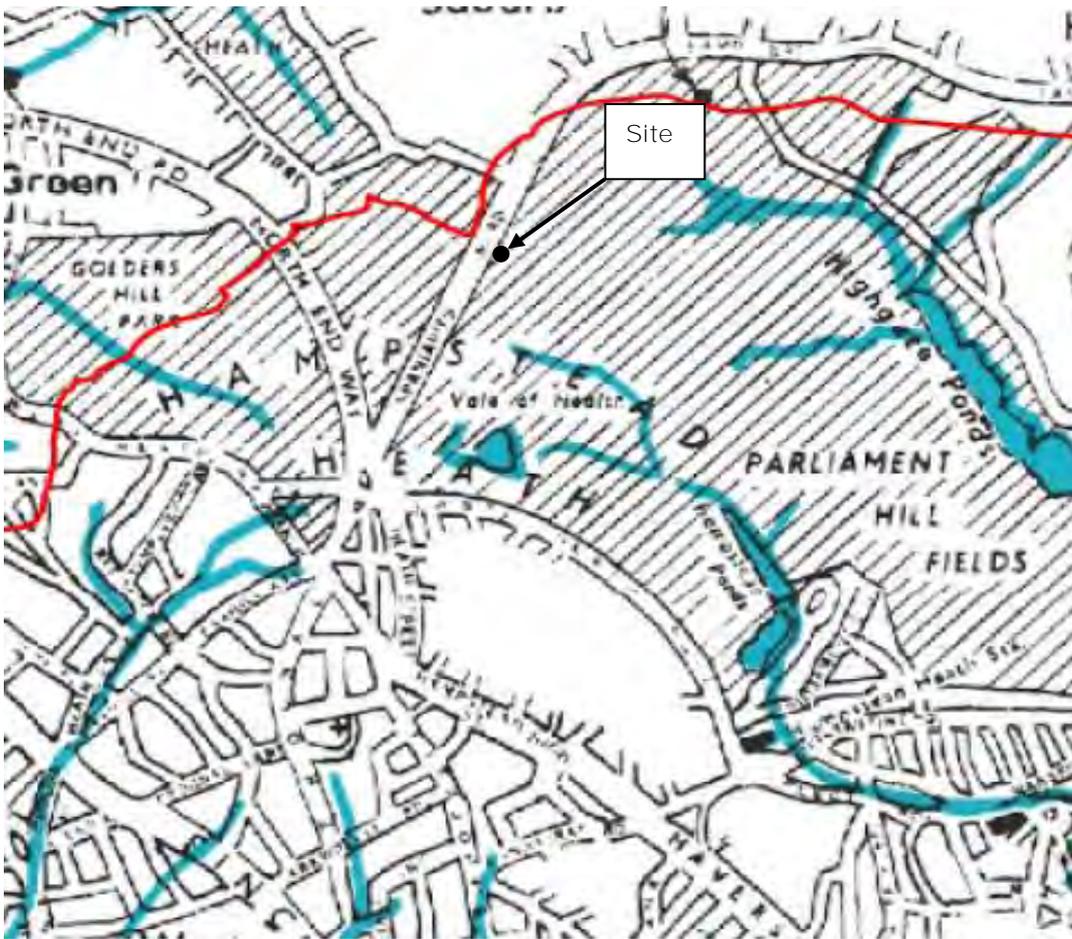
Figure 5 Extract showing Watercourses (source - Lost Rivers of London)

Based on the information available there are no watercourses associated with the Lost Rivers of London adjacent to the site. An extract showing the location of the lost rivers relative to the site is presented in Figure 5.

As shown in Figure 5 one of the tributaries of a Lost River of London is situated to the south east of Spaniards Road. The direction of flow of the tributary is in an easterly to south-easterly direction into the Hampstead Ponds, which were created in the 17th Century to increase the London water supply. From here the flow continues towards Kentish Town to join the River Fleet.

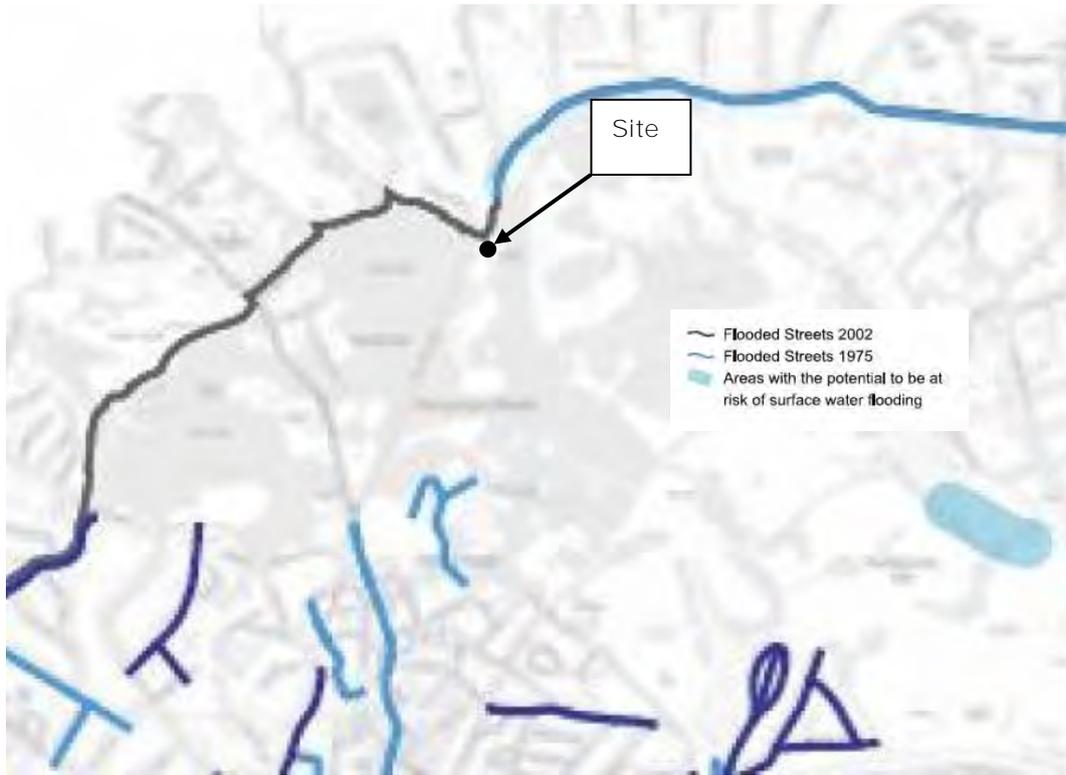
Figure 6 Extract showing locations of Historic Flooding

Figure 15 within the Camden Geological, Hydro-geological and Hydrological Study and Map 22 of North London Waste Plan shows Spaniards Road approximately 50 metres north of The Cottage to have had street flooding in 1975. However, the road at this location is at a lower level than the site. This information has been reproduced and presented in Figure 6.

Figure 9 within the LBC Guidance for subterranean development by Arup (dated Nov 2010) and the North London Strategic Flood Risk Assessment (SFRA), Map 22 by Mouchel (dated Aug 2008) suggests that the northern end of Spaniards Road may have been subject to flooding in 1975. This is reported as being a result of localised surcharge within the public sewer due to a one in one hundred years storm event. An extract showing the streets where floods have been recorded is shown in Figure 6.

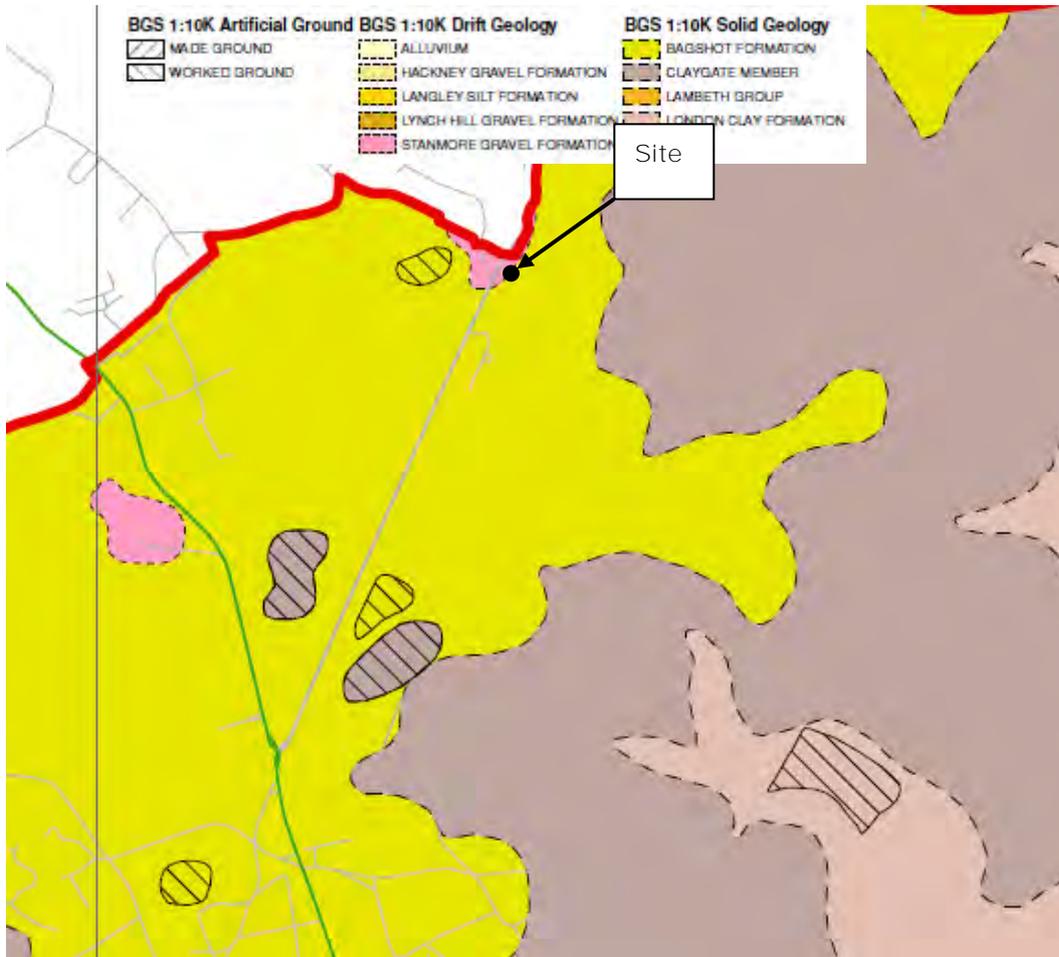
Figure 7 Extract showing the Geology of North Camden

The published British Geological Survey (BGS) 1:50,000 geological map sheet 256 : North London (solid and drift), shows the site to be underlain by the Bagshot Formation which overlies the Claygate Member which in turn overlies the London Clay Formation. The boundary between the Bagshot Formation and the Claygate Member is approximately 50 metres to the east of the existing property. A small deposit of Stanmore Gravel lies approximately 10 metres to the west of the site. The digital geological map at a scale of 1:10,000 shows an area approximately 100 metres west of the site as previously worked ground. Similar features are common in the area and are typically where Bagshot Formation materials have been excavated. An extract of the digital geological map at a scale of 1:10,000 showing the site location is shown in Figure 7.

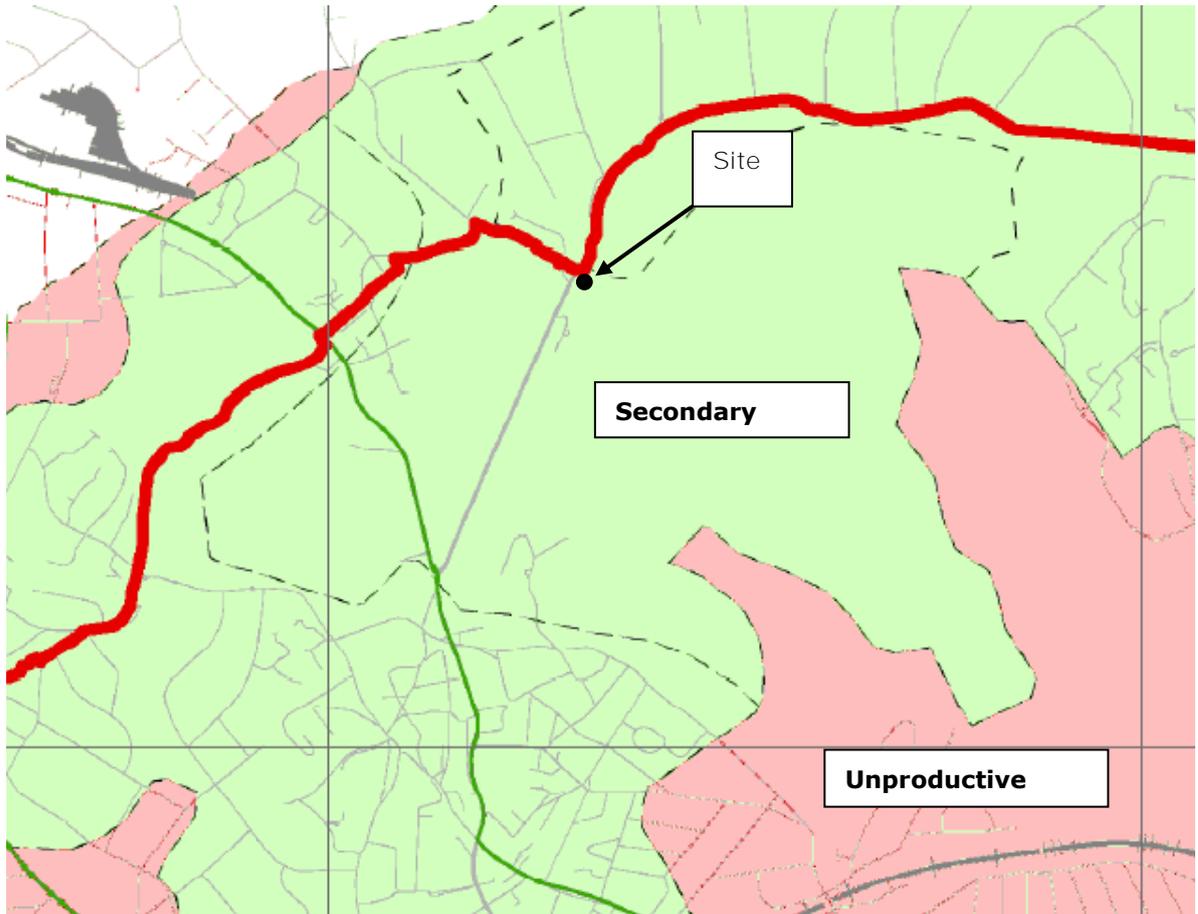
Figure 8 Extract showing Camden Aquifer Designation

An extract of the aquifer designation map showing the site location is presented in Figure 8 and shows the site to be in a designated Secondary A (or Upper) Aquifer. This is consistent with the Bagshot Formation encountered at shallow depth in the ground investigation. The chalk (or Lower) aquifer is at considerable depth below the site; it is estimated based on the geological map that the top of the chalk aquifer is at least 90 metres below the site. The proposed development therefore is likely to affect the upper aquifer but not the lower aquifer.

As indicated in Figure 8 the site is underlain by strata that are considered a secondary aquifer which may form the base flow to a river.

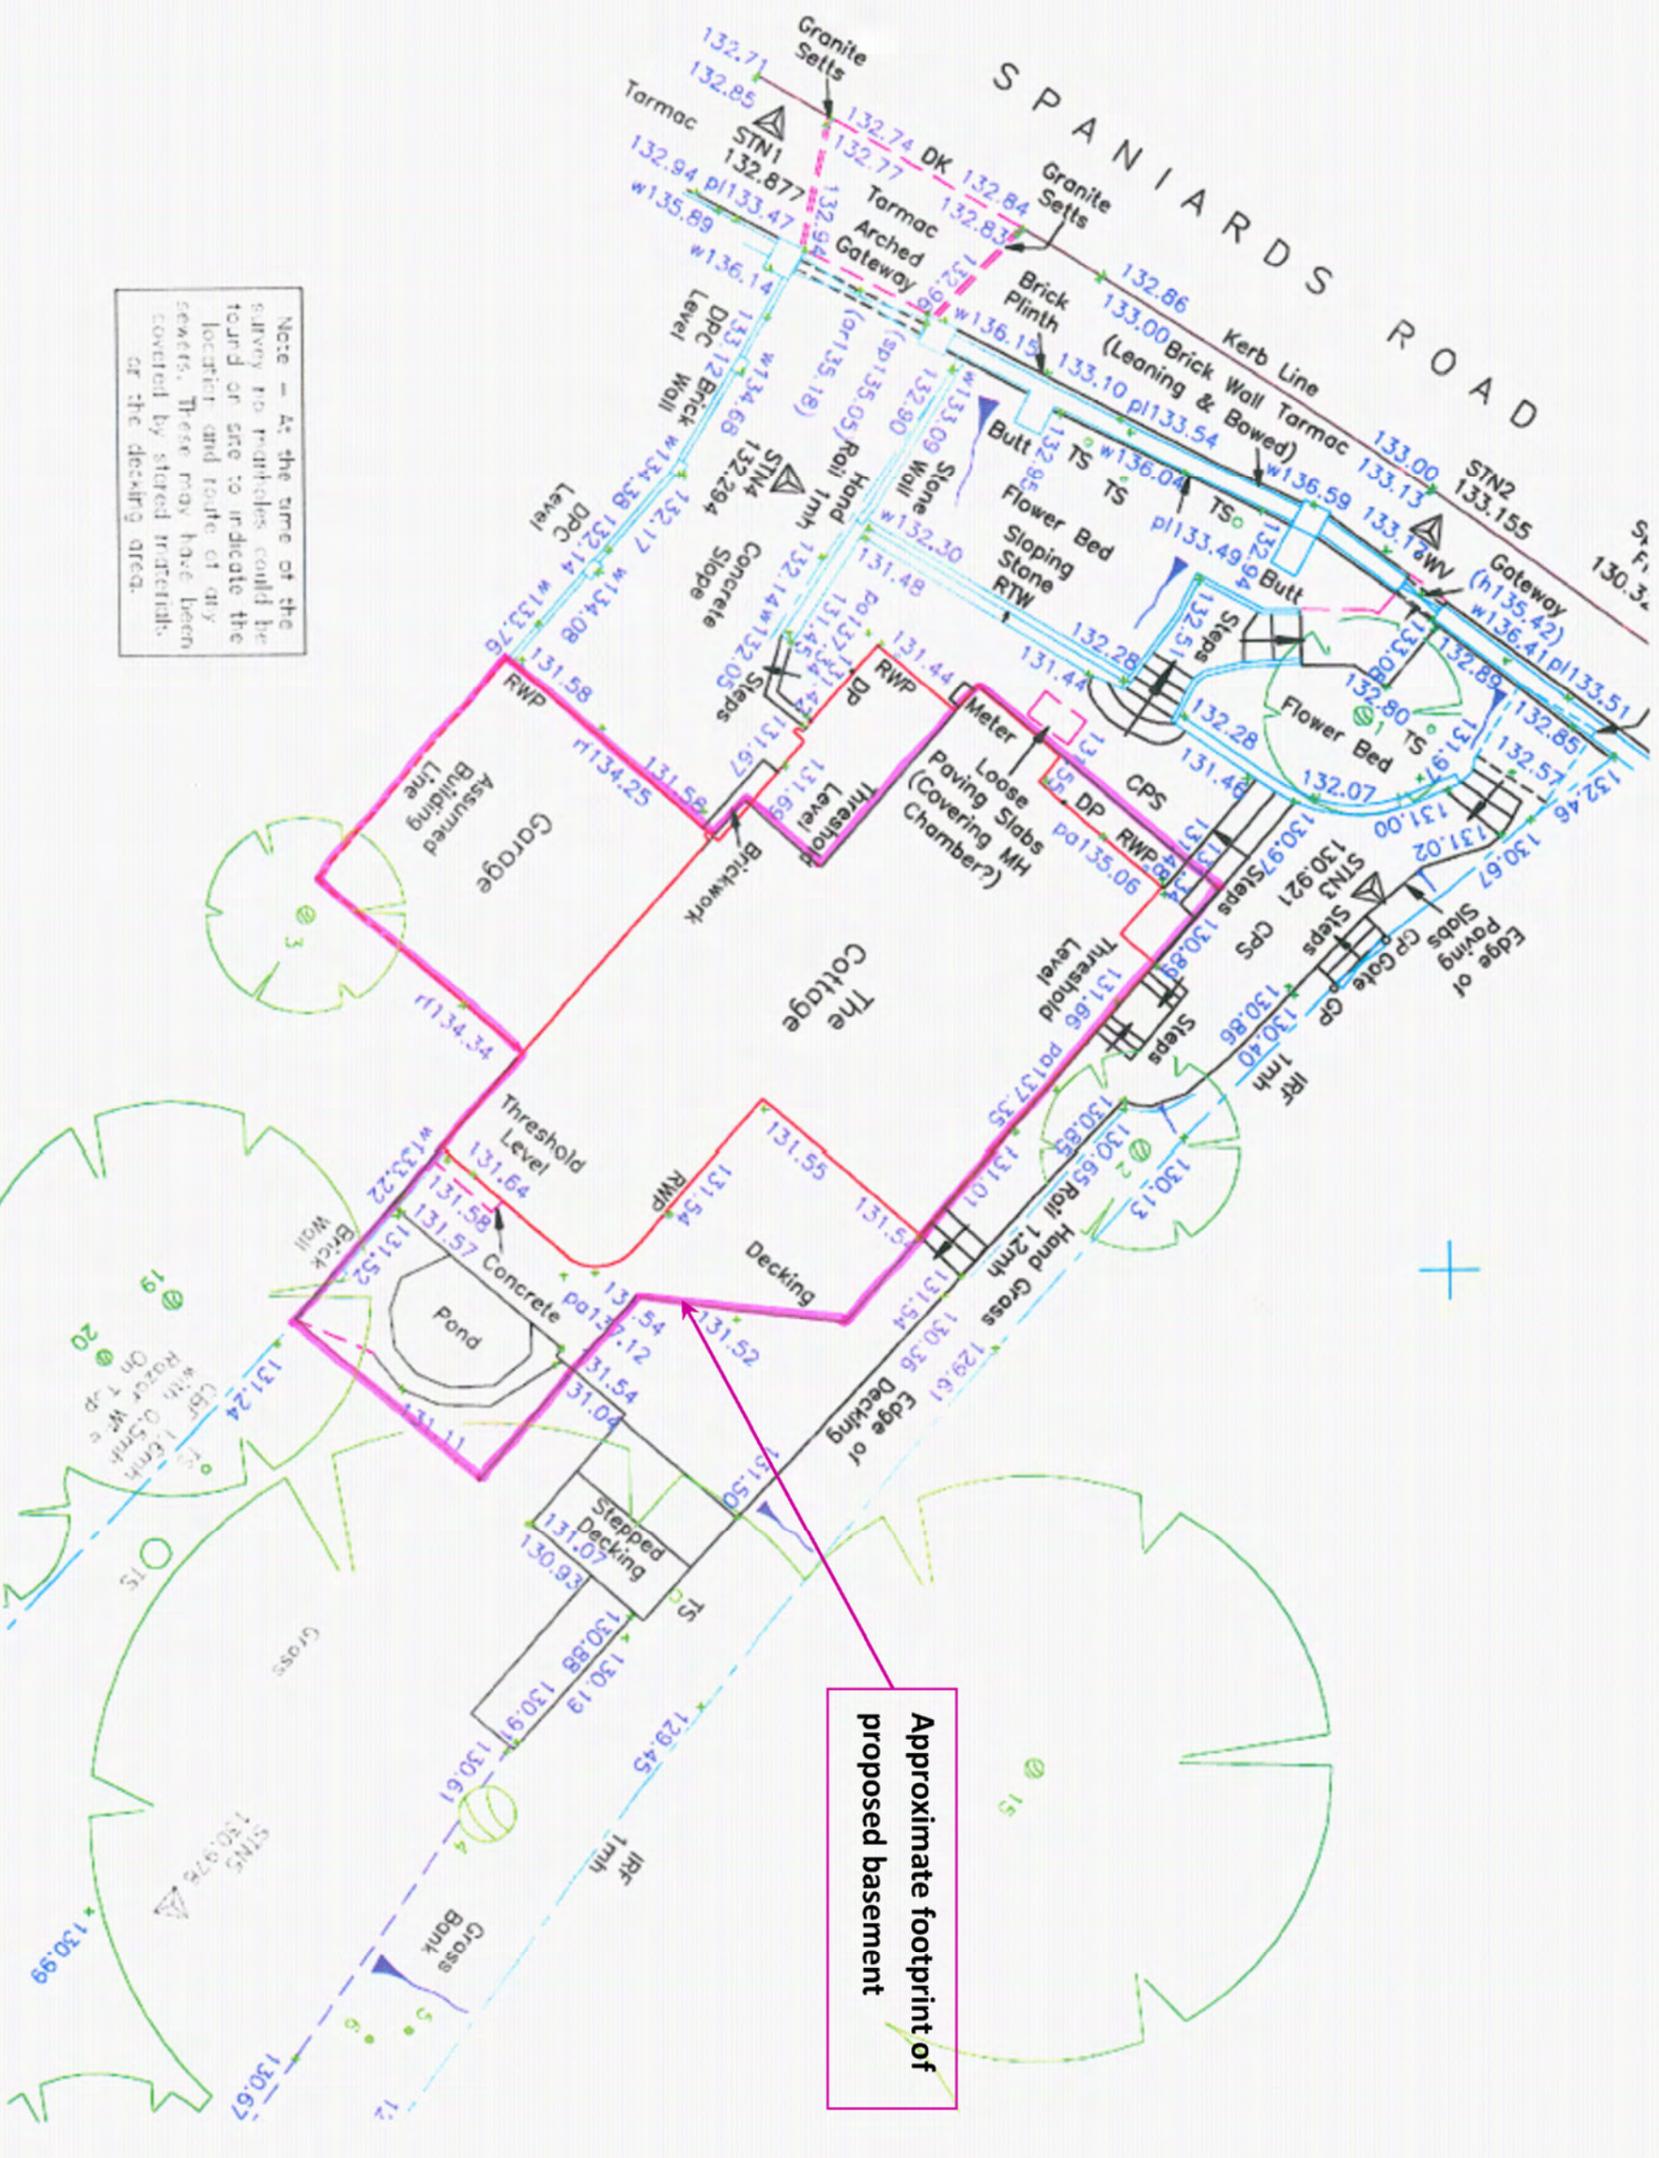
20760-GT-001 PLAN OF EXISTING BUILDING WITH PROPOSED BASEMENT FOOTPRINT

Note - At the time of the survey no markers could be found on site to indicate the location and route of any sewers. There may have been covered by stored materials or the decking area.

Approximate footprint of proposed basement

A plan view of the site is shown in Appendix A. The elevation of the site varies between 132.9 metres above ordnance datum (mAOD) and 129.3 mAOD; the highest elevation is to the west where the site adjoins Spaniards Road. The south east area of the site which consists of the garden is at a lower level and typically at an elevation of 131 mAOD. The north and east perimeter of the garden slopes steeply from 130.7 mAOD to 129.3 mAOD.

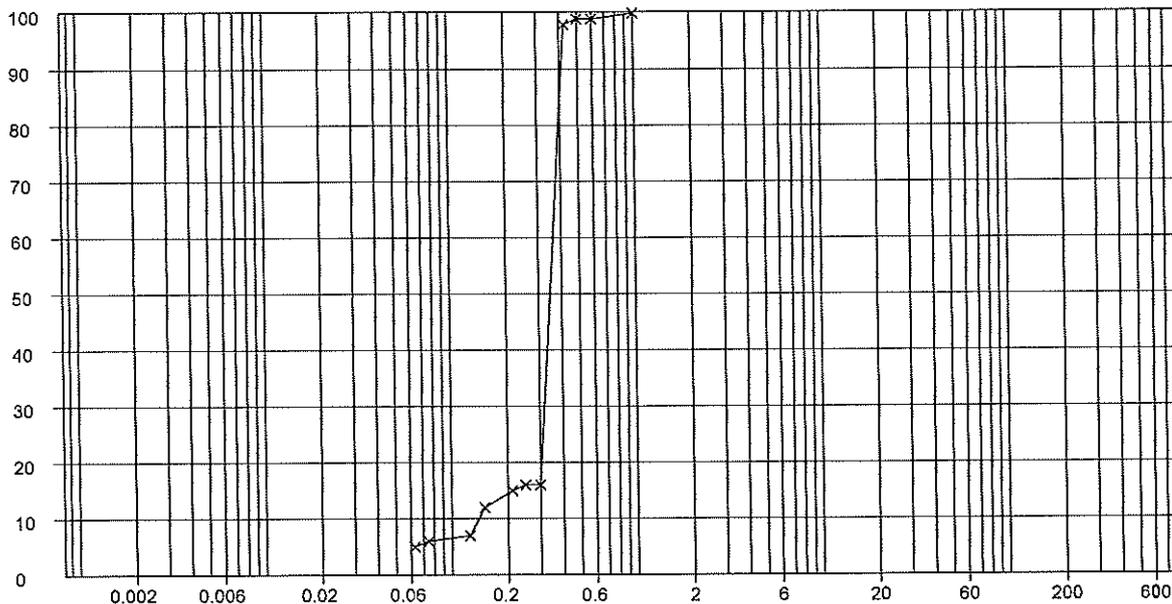
Borehole / Trial Pit	Depth (m)	Sample	Description
BH1	2.50	D7

Sieve / Particle Size	% Passing
1 mm	100.0
600 µm	99.0
500 µm	99.0
425 µm	98.0
300 µm	16.0
250 µm	16.0
212 µm	15.0
150 µm	12.0
125 µm	7.0
75 µm	6.0
63 µm	5.0

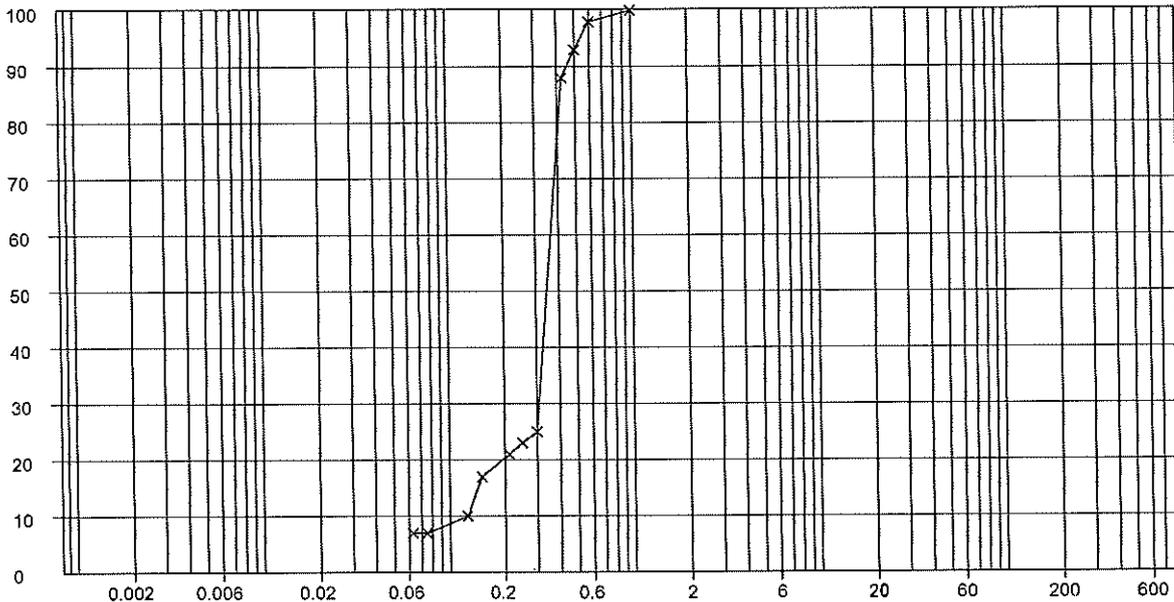
Borehole / Trial Pit	Depth (m)	Sample	Description
BH2	2.00	D6

Sieve / Particle Size	% Passing
1 mm	100.0
600 µm	98.0
500 µm	93.0
425 µm	88.0
300 µm	25.0
250 µm	23.0
212 µm	21.0
150 µm	17.0
125 µm	10.0
75 µm	7.0
63 µm	7.0
