65 SWINTON STREET LONDON WC1

Further to our site survey carried out on 7 February 2014, we are writing to comment on the condition of the external walls of the two storey back extension. Directional terms are used in this report as if looking at the extension from the rear. Please also refer to the appended photographs.

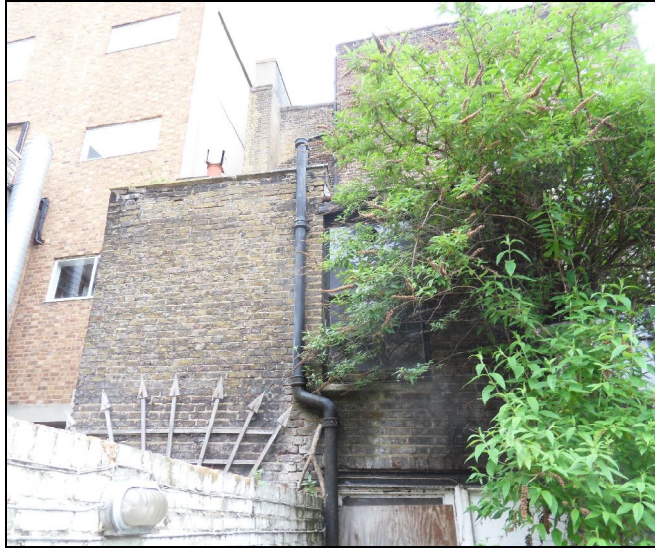
Viewed internally, it is evident that the right hand wall is bulging outwards severely, and there are large cracks at both ends of the rear wall. In our opinion this damage is most probably due to disturbance of the walls by the shrub root growth and the 'levering out' of the broken roof joists.

BACK EXTENSION REAR WALL - UPPER STOREY

The refurbishment proposals for the building include the construction of an extra storey on the back extension, and hence raising the existing external walls. As a result of the current damage, these walls are not structurally sound and it will not be safe to increase their height. We recommend that they should be taken down and rebuilt from ground level (on new foundations if necessary) in order to provide a suitably robust structure.

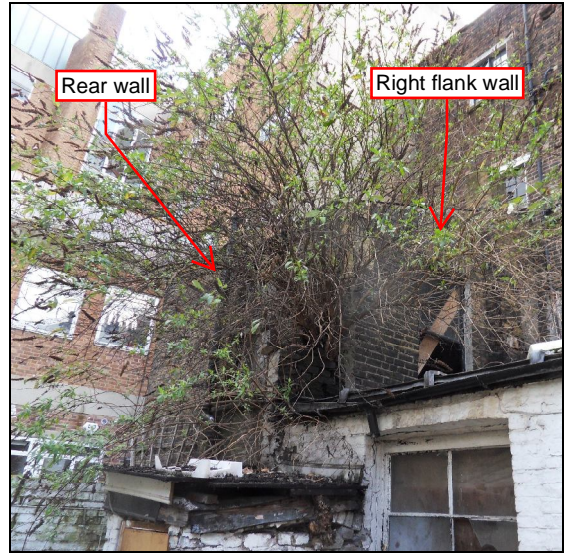
The external walls are of 215mm thick solid brickwork, and support the timber joists of the first floor and the monopitch roof of the extension, together with the timber joists of the flat roof over an adjoining single storey addition on the right hand side. As can be from the photographs, a massive shrub is rooted in the fabric of the walls in the rear corner at first floor level, and the adjacent flat roof joists have rotted and broken at mid-span which has left them 'cantilevering' out of the right hand wall.

BACK EXTENSION - REAR AND RIGHT HAND WALLS

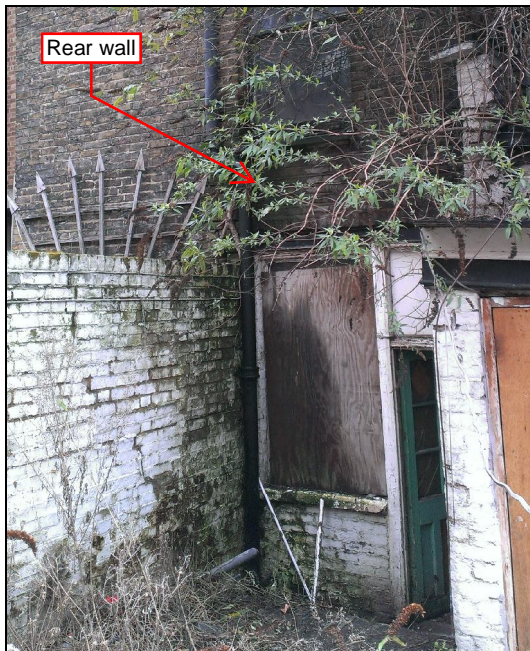
BACK EXTENSION REAR WALL - LOWER STOREY

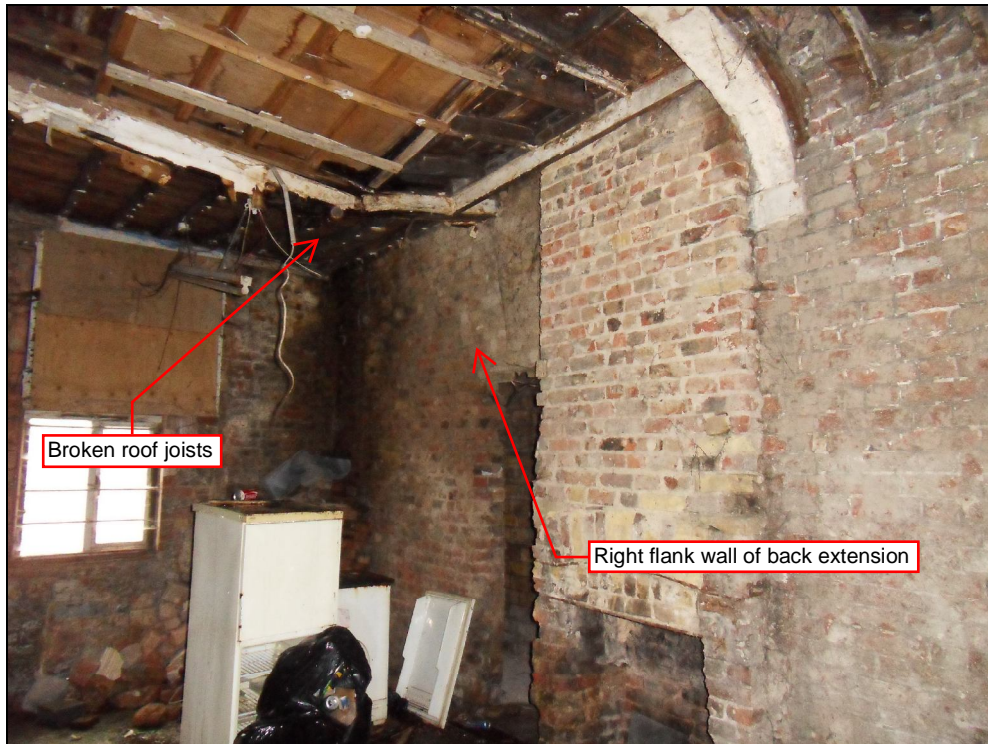
INTERNAL VIEW IN SINGLE STOREY ADDITION – VIEW TO REAR
