## D Phase 1 Preliminary Risk Assessment

**50 AVENUE ROAD,  
CAMDEN, LONDON NW8 6HS**

## PHASE 1 PRELIMINARY RISK ASSESSMENT

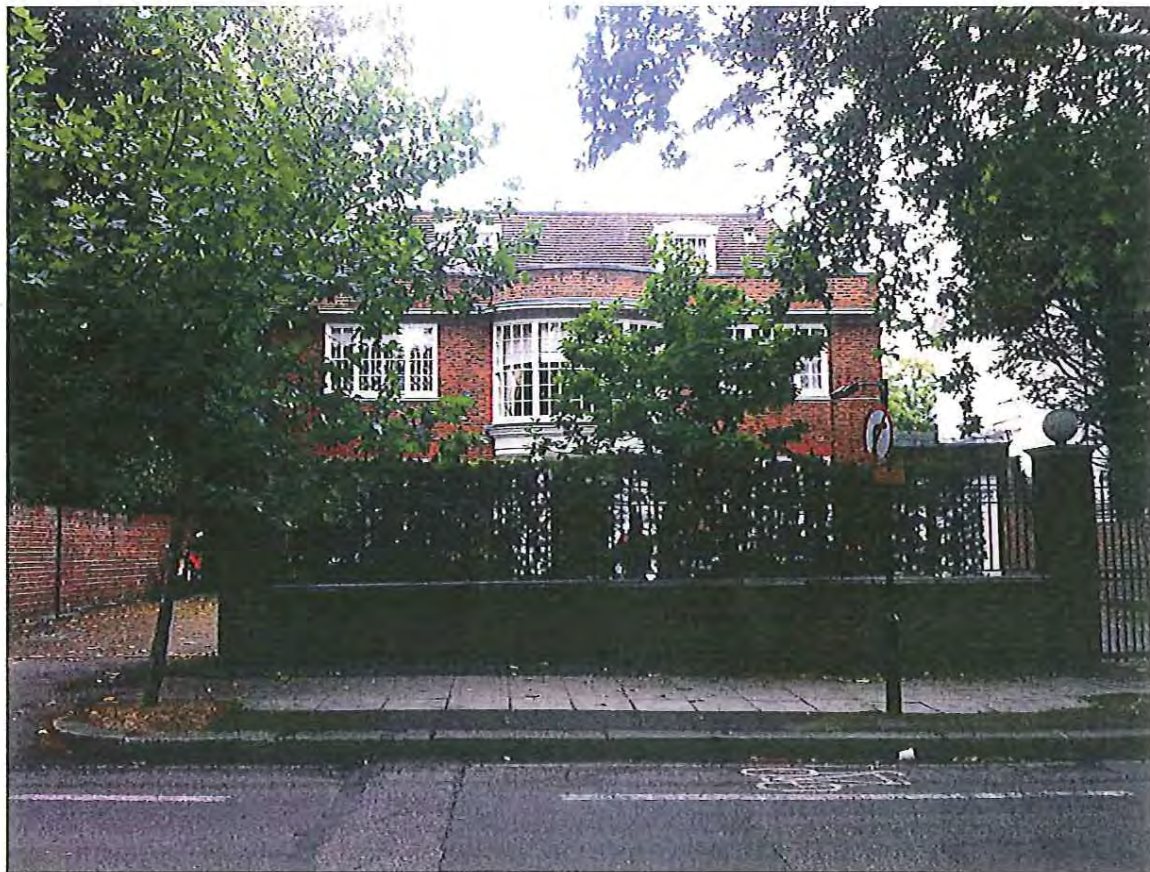
Photo 1- The property as viewed from Avenue Road

The site comprises of an extensive three-storey detached house with a large rear garden and gated driveway from Avenue Road. The rear garden is mainly set to lawn space and flower beds and small shrubs. The garden is bordered by a low brick wall with some large trees present at the end of the garden. A small wooden summer house is present at the end of the garden. The main house has a large gated driveway at the front, including a small raised lawn and hedge.

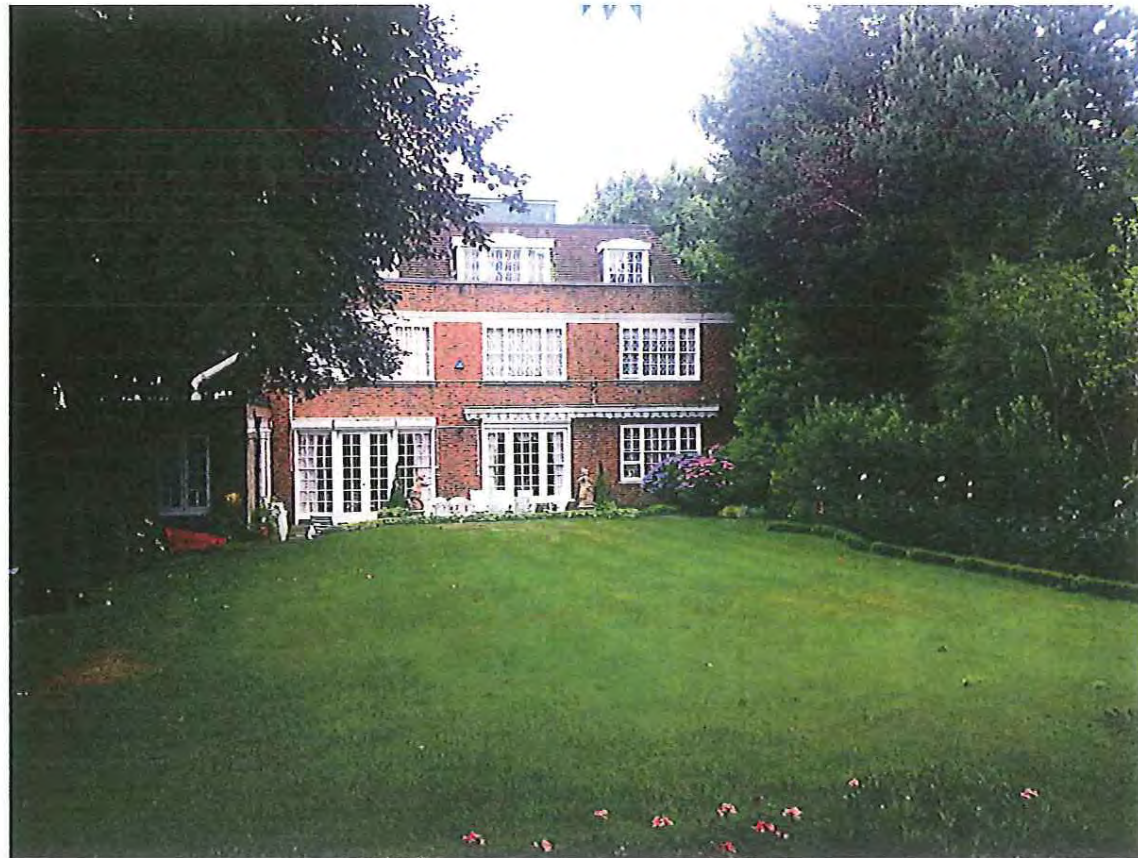
Photo 3 – Large rear garden and lawn

There were no potentially contaminating activities on the site and the house and garden appeared to be well managed.
