Stage 1: Desktop Study & Walkover Survey

53 Agar Grove,
Canteloves,
London,
NW1 9UE

Job No. 13.7883
December 2013

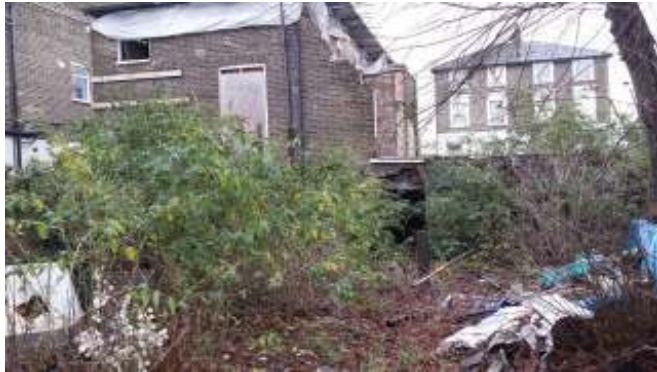
- A. Rear of property looking north.
- B. Rear of property looking north.
- C. Vegetation in back garden
- D. Access into site

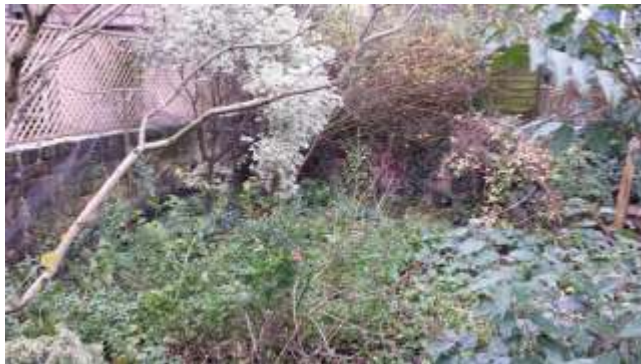
C.

The gardens to the rear, separated by a low brick wall, are largely over grown with buddleia, brambles, ivy and several small trees. Construction materials/waste was also present within the garden area generally consisting of bricks and timber.

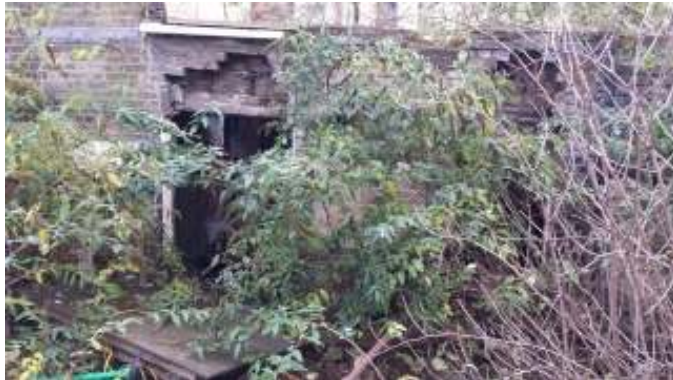
The site consists of two semi-detached residential properties of which the western house is in a state of disrepair and as such it is surrounded by wooden hoarding. There are garden areas to the rear (the north) and what appears to be an area that was previously patio slabs to the front (the south).

- E. Vegetation and damage to property.
- F. Rear of property looking east.
- G. West flank of property
- H. Southern flank of property

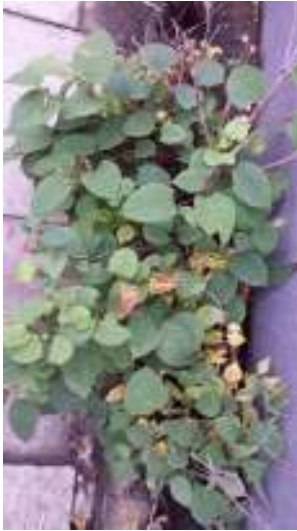
It is understood that the area to the front of the properties previously had Japanese Knotweed growth, however, at the time of the walkover this had been cut back with only stumps remaining which had been painted blue. It was noted that a small growth was present on the street side of the hoarding.

- E. Japanese knotweed on pavement side of hoarding.
- F. South property, cleared Japanese knotweed
- G. South of property
- H. Looking north from front of property

Japanese knotweed has not been considered further reflecting the fact that it was noted to be undergoing treatment at the time of the site walkover. The knotweed should be eradicated before any construction works are undertaken. It should be noted that no intrusive site investigations should be undertaken in the vicinity of the Japanese knotweed due to the potential for disturbing the roots and spreading it further.
