## Basement Impact Assessment & Site Investigation Report

Site: 36 Redington Road, London NW3

Report Date: September 2014

Project Reference: J11894

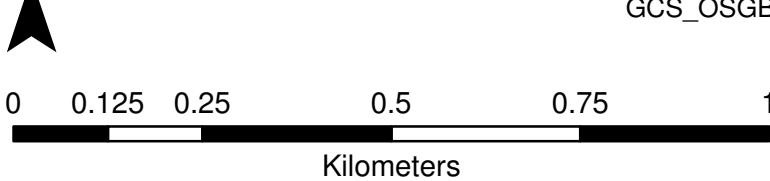
**Camden Geological, Hydrogeological  
and Hydrological Study**

**Hampstead Heath Surface Water  
Catchments and Drainage**
