Camden Stables Market
London
NW1
United Kingdom

**Camden Stable Market
Provender Stores**

Drawing Title
**PROVENDER STORES
UNAUTHORISED REMEDIAL WORKS**

October 2014 Drawing No B-WP-01

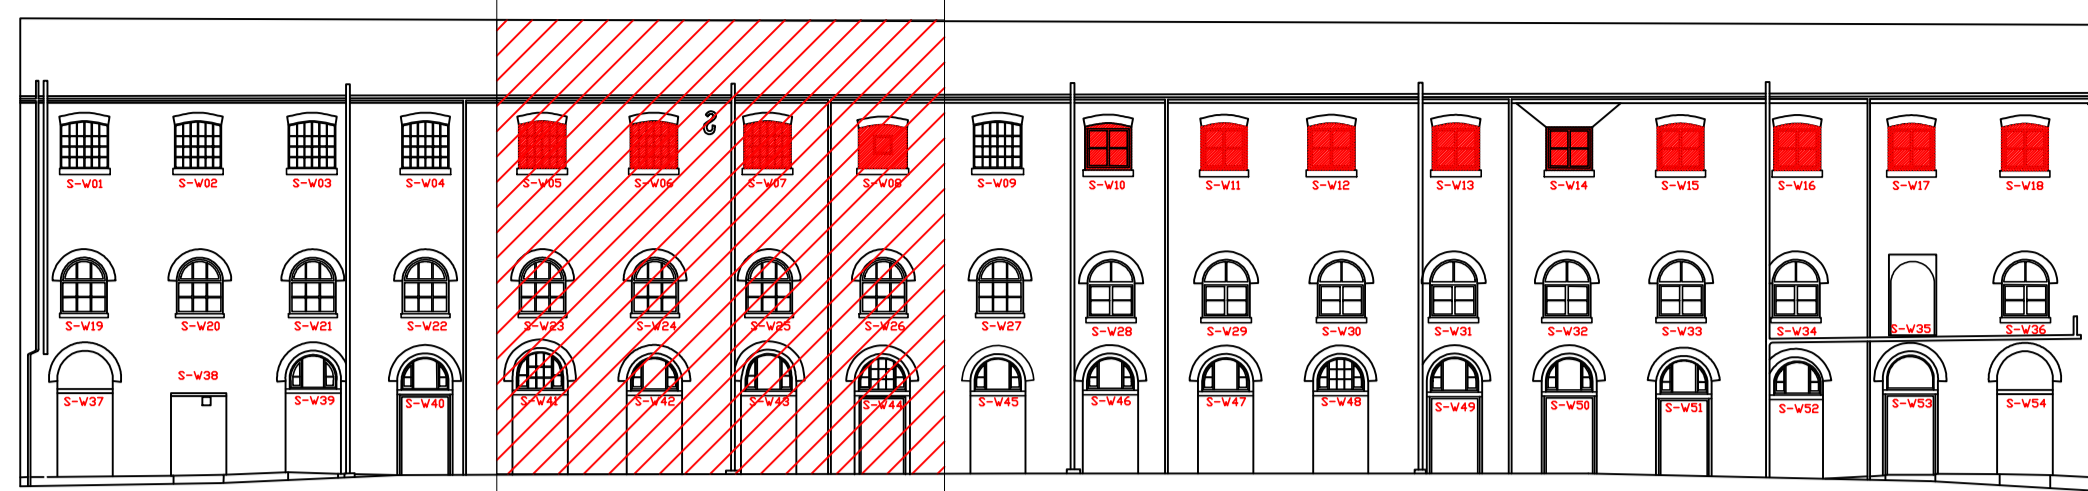
SOUTH ELEVATION

Windows of this type highlighted in red are proposed to be replaced. Those not hatched are to be refurbished. The hatched area is that part of the building affected by fire damage.

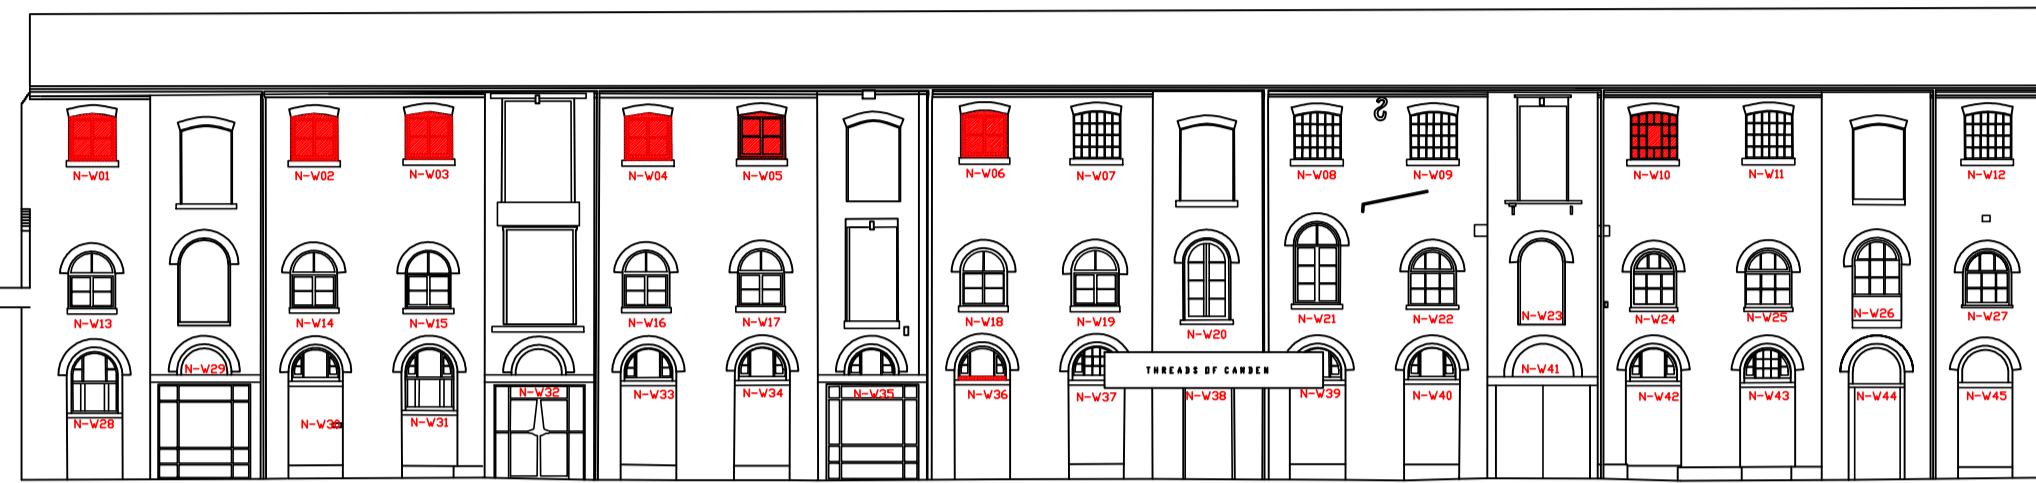
NORTH ELEVATION

Windows of this type highlighted in red are proposed to be replaced. Those not hatched are to be refurbished.

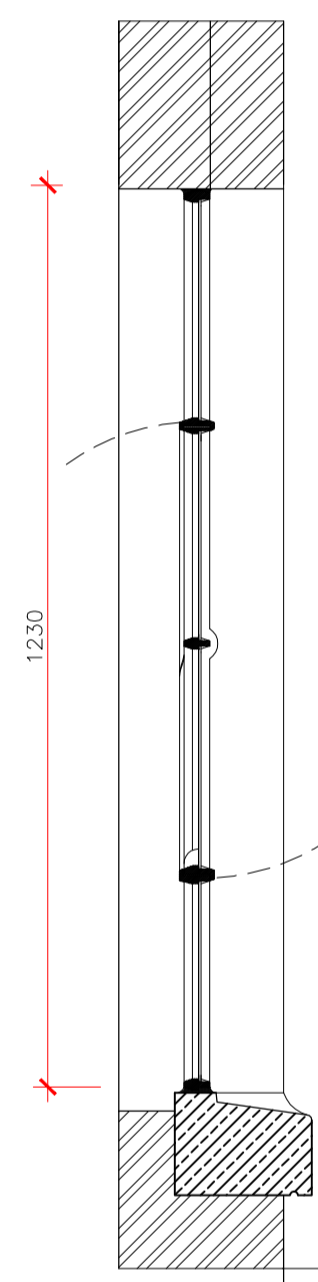
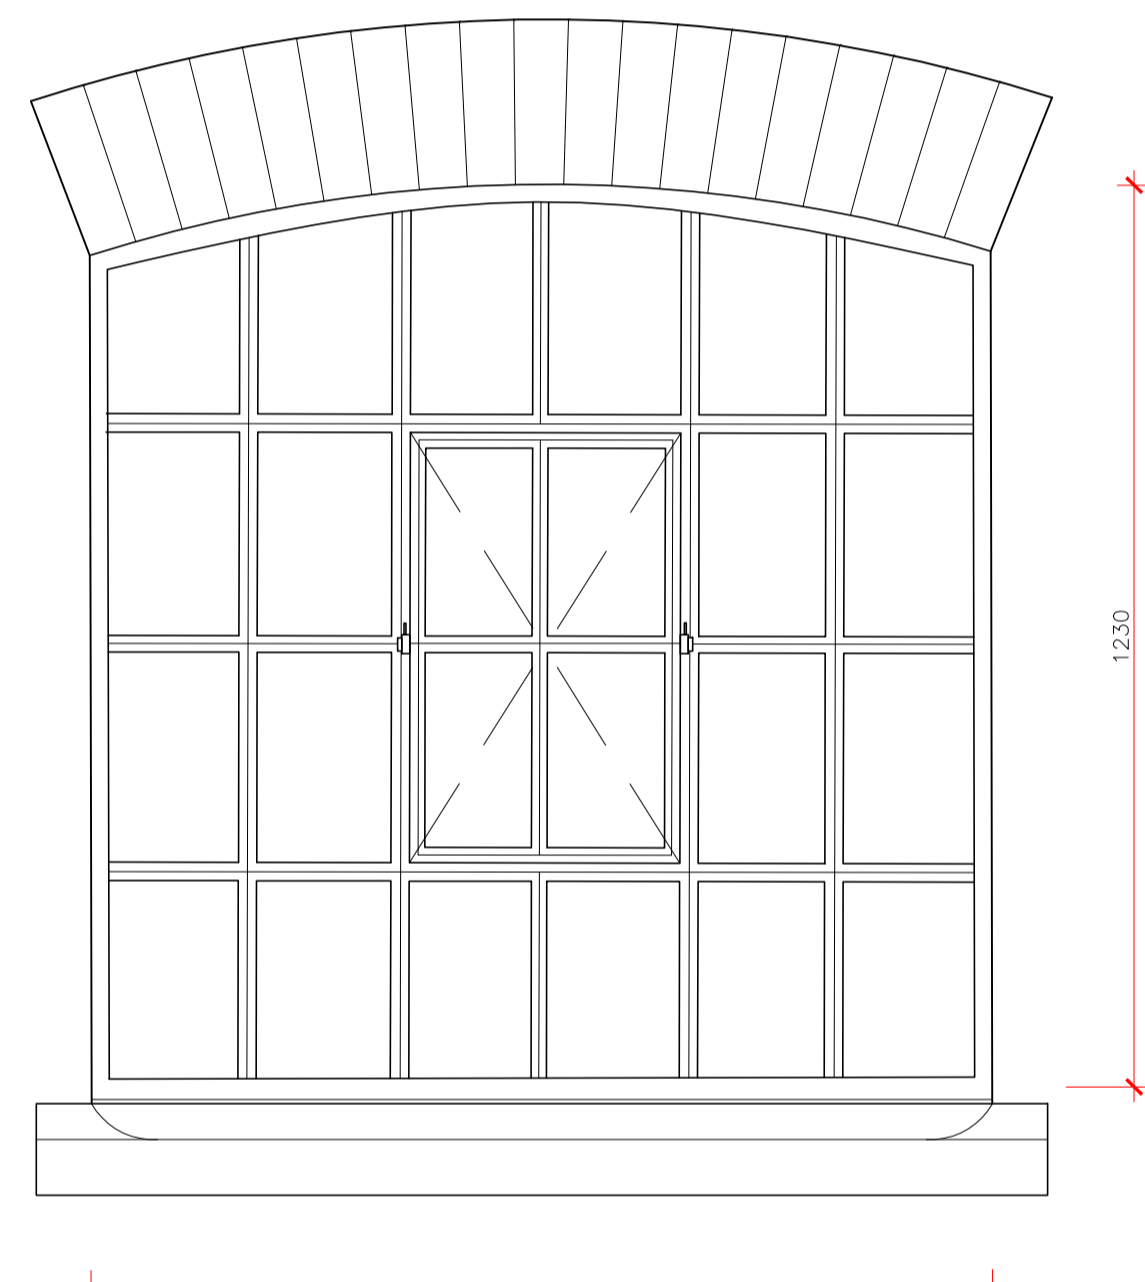
Section

Elevation

Existing cast iron window with central pivot light - Scale 1:10

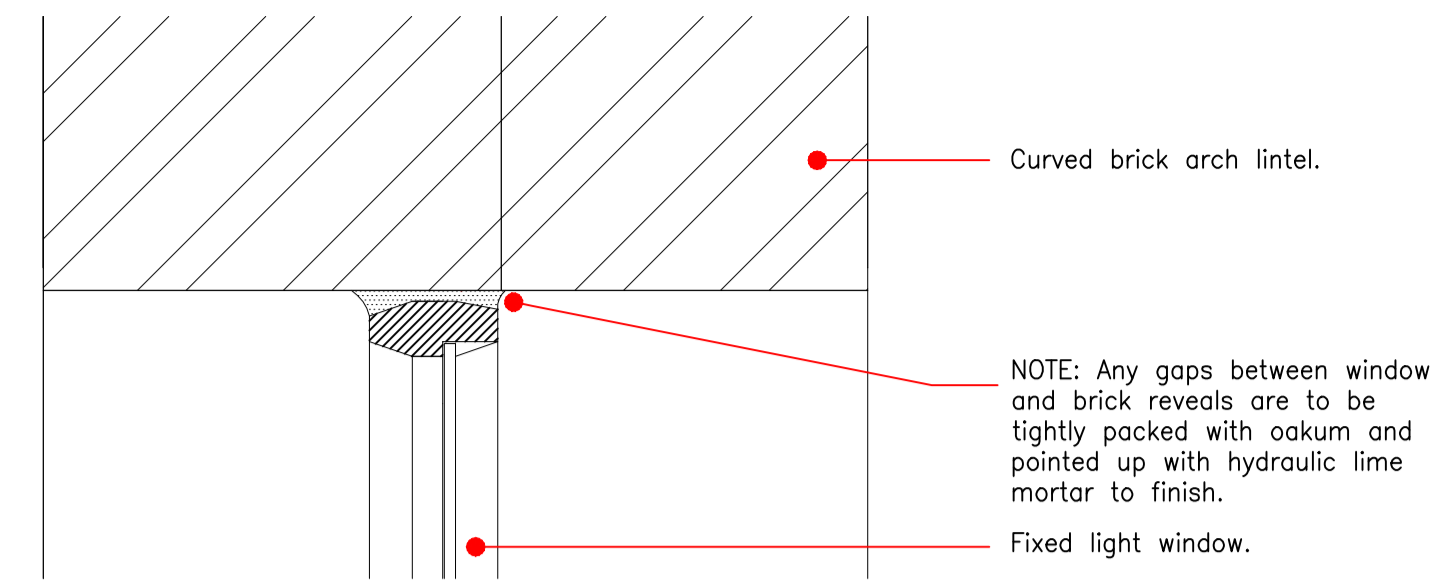
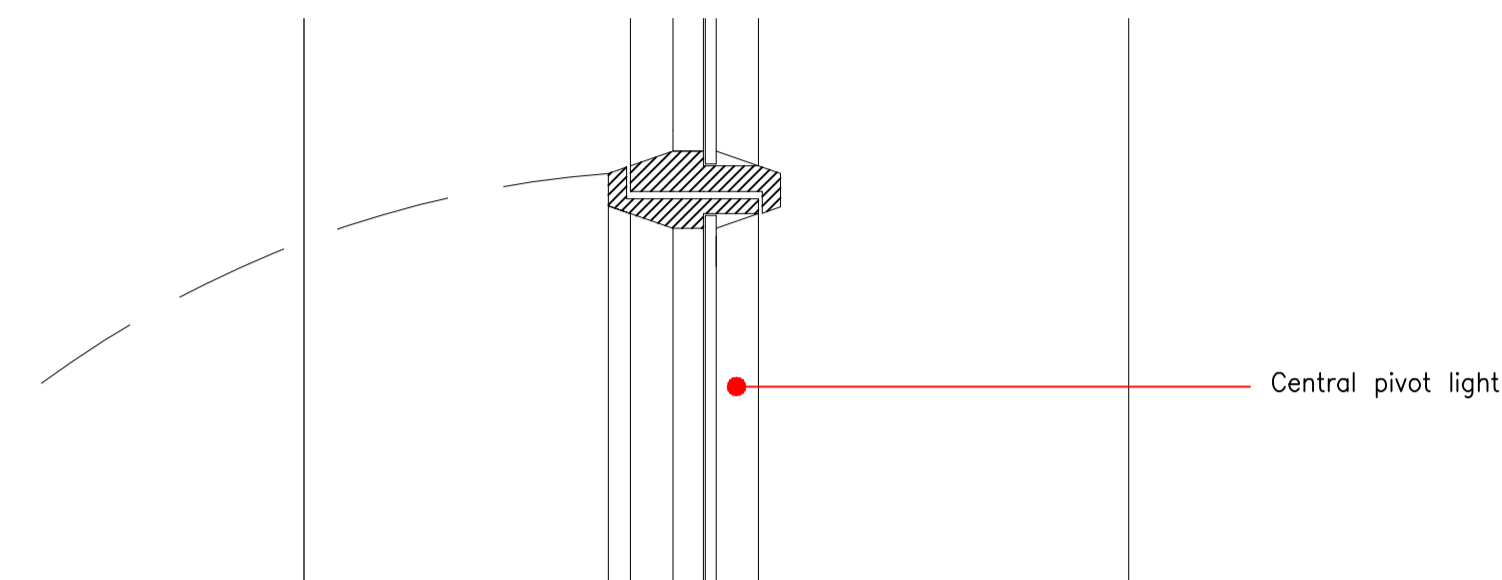
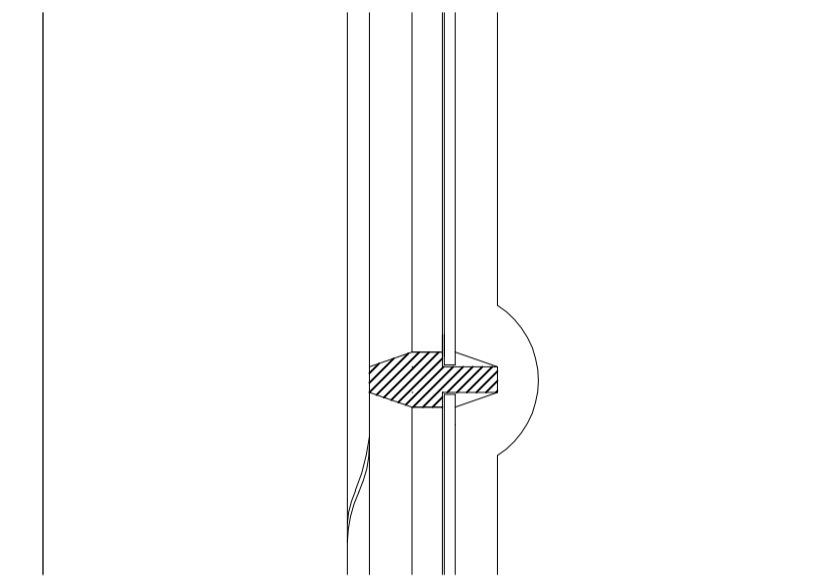
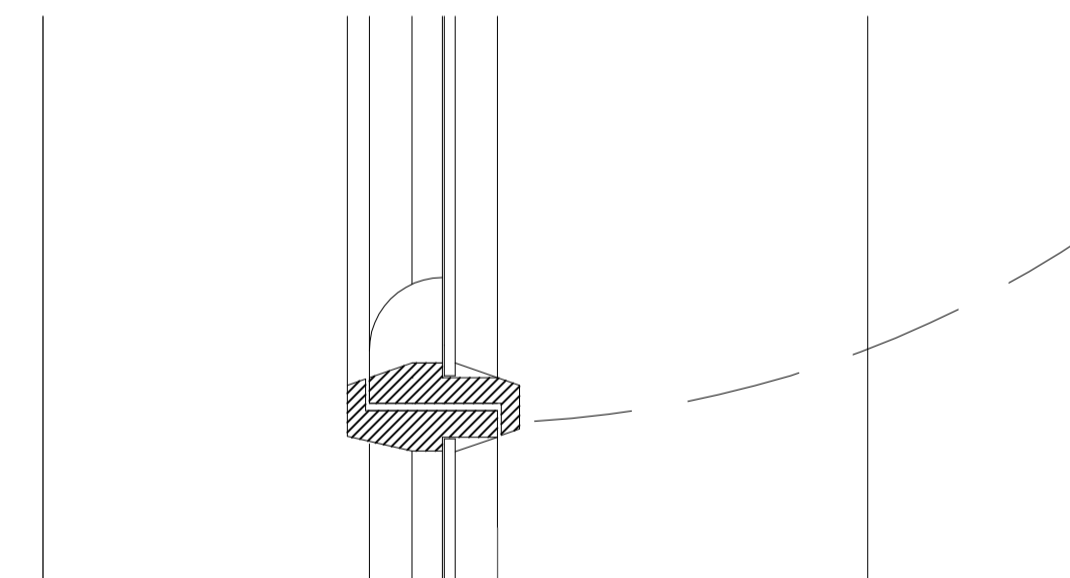
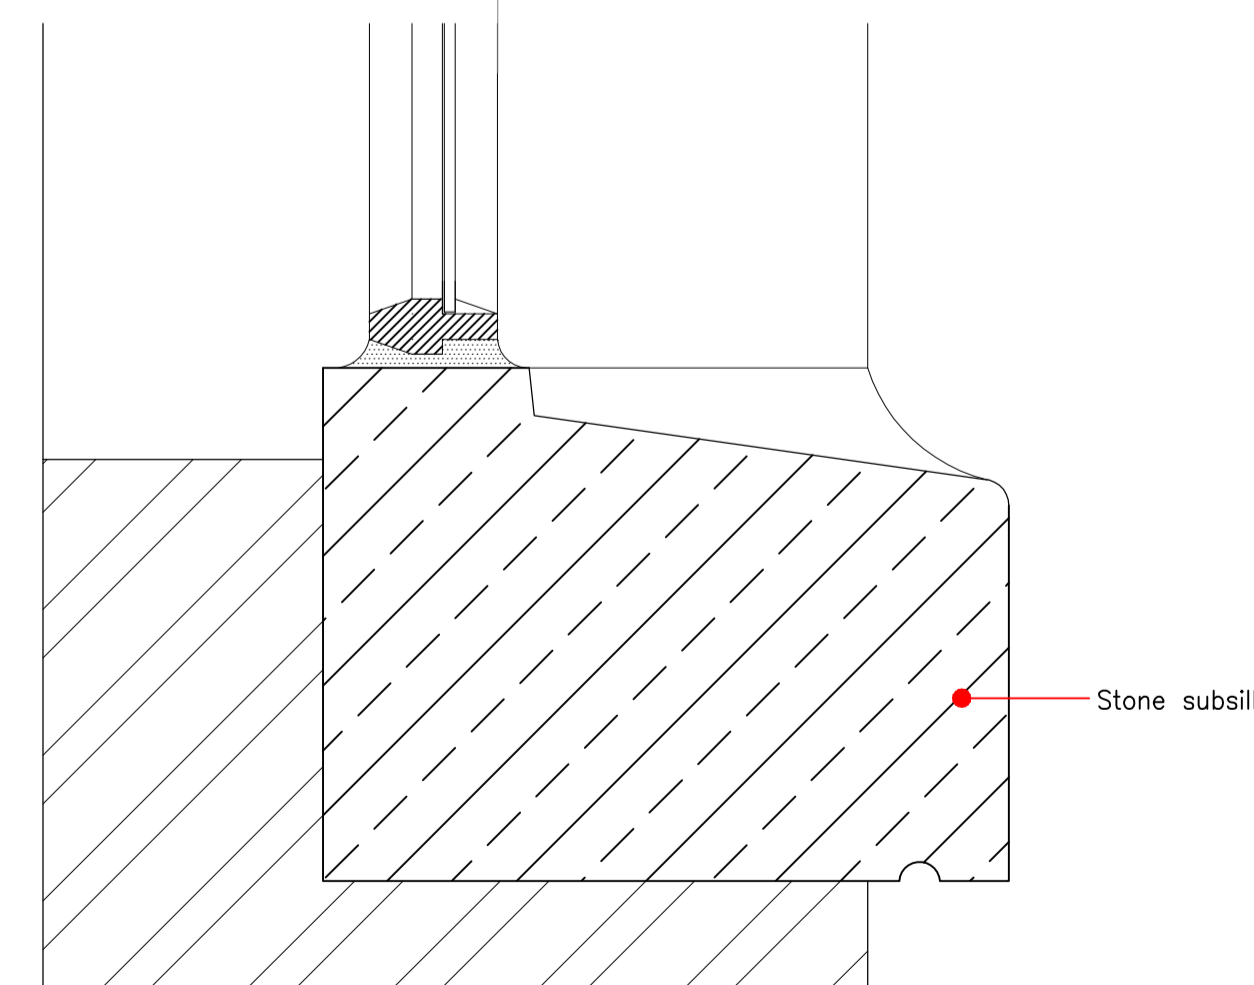
Existing cast iron window with central pivot light - section Scale 1:2

Curved brick arch lintel.

NOTE: Any gaps between window and brick reveals are to be tightly packed with oakum and pointed up with hydraulic lime mortar to finish.

Fixed light window.

Central pivot light.

Stone subsill.
