**Camden Stable Market
Provender Stores**

Drawing Title
**PROVENDER STORES
UNAUTHORISED REMEDIAL WORKS**

October 2014 Drawing No
B-WP-02

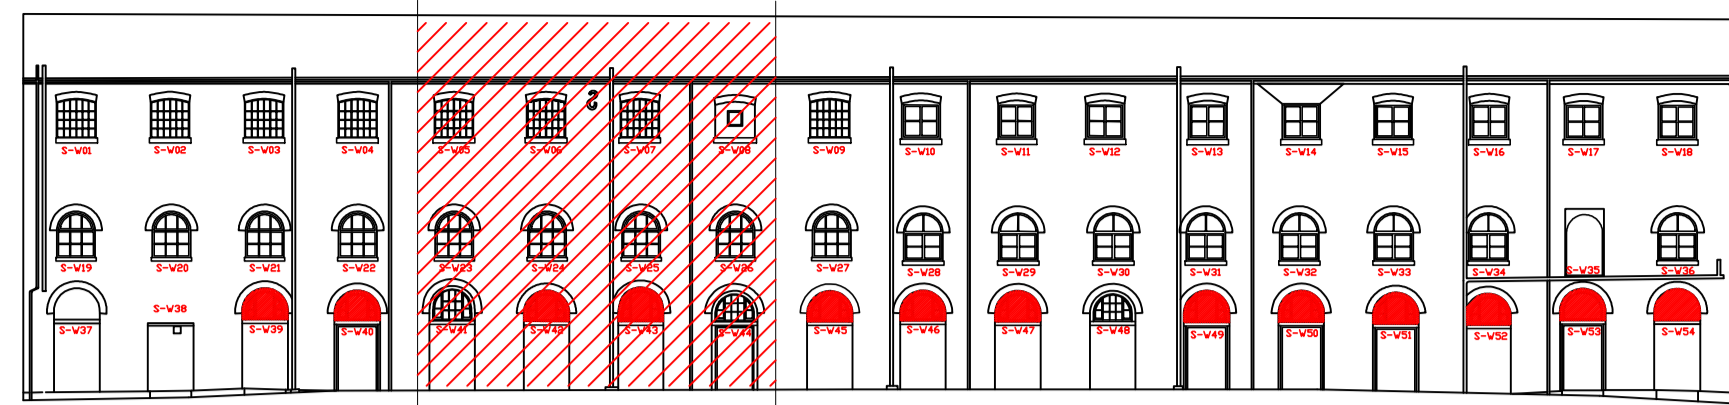
SOUTH ELEVATION

Windows of this type highlighted in red are proposed to be altered as part of this application. Those not hatched are to be refurbished. The hatched area is that part of the building affected by fire damage.

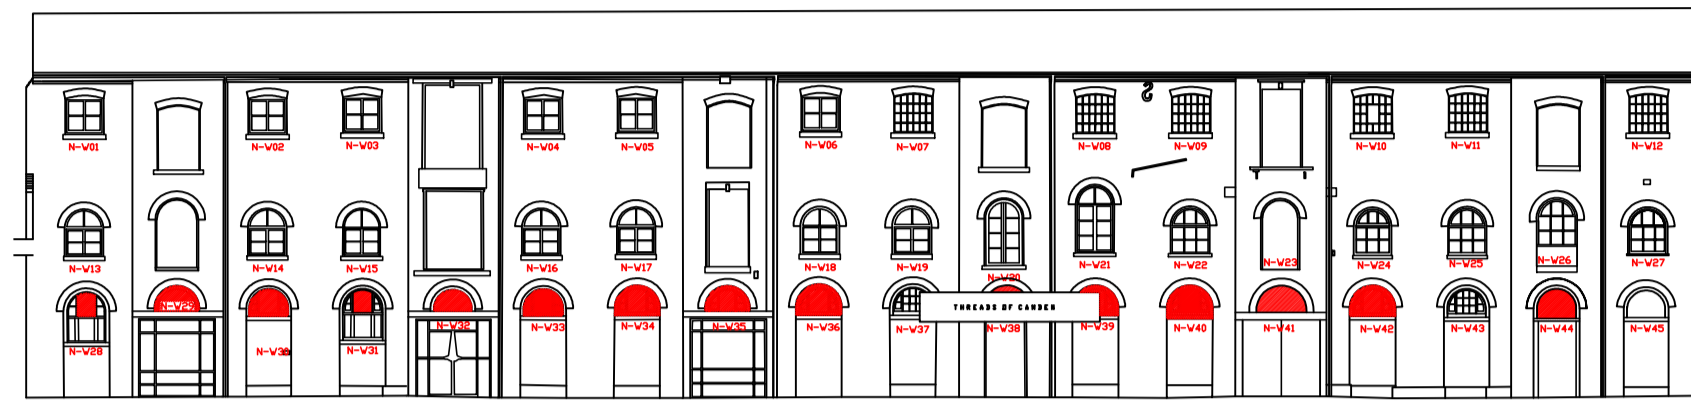
NORTH ELEVATION

Windows of this type highlighted in red are proposed to be altered as part of this application. Those not hatched are to be refurbished.

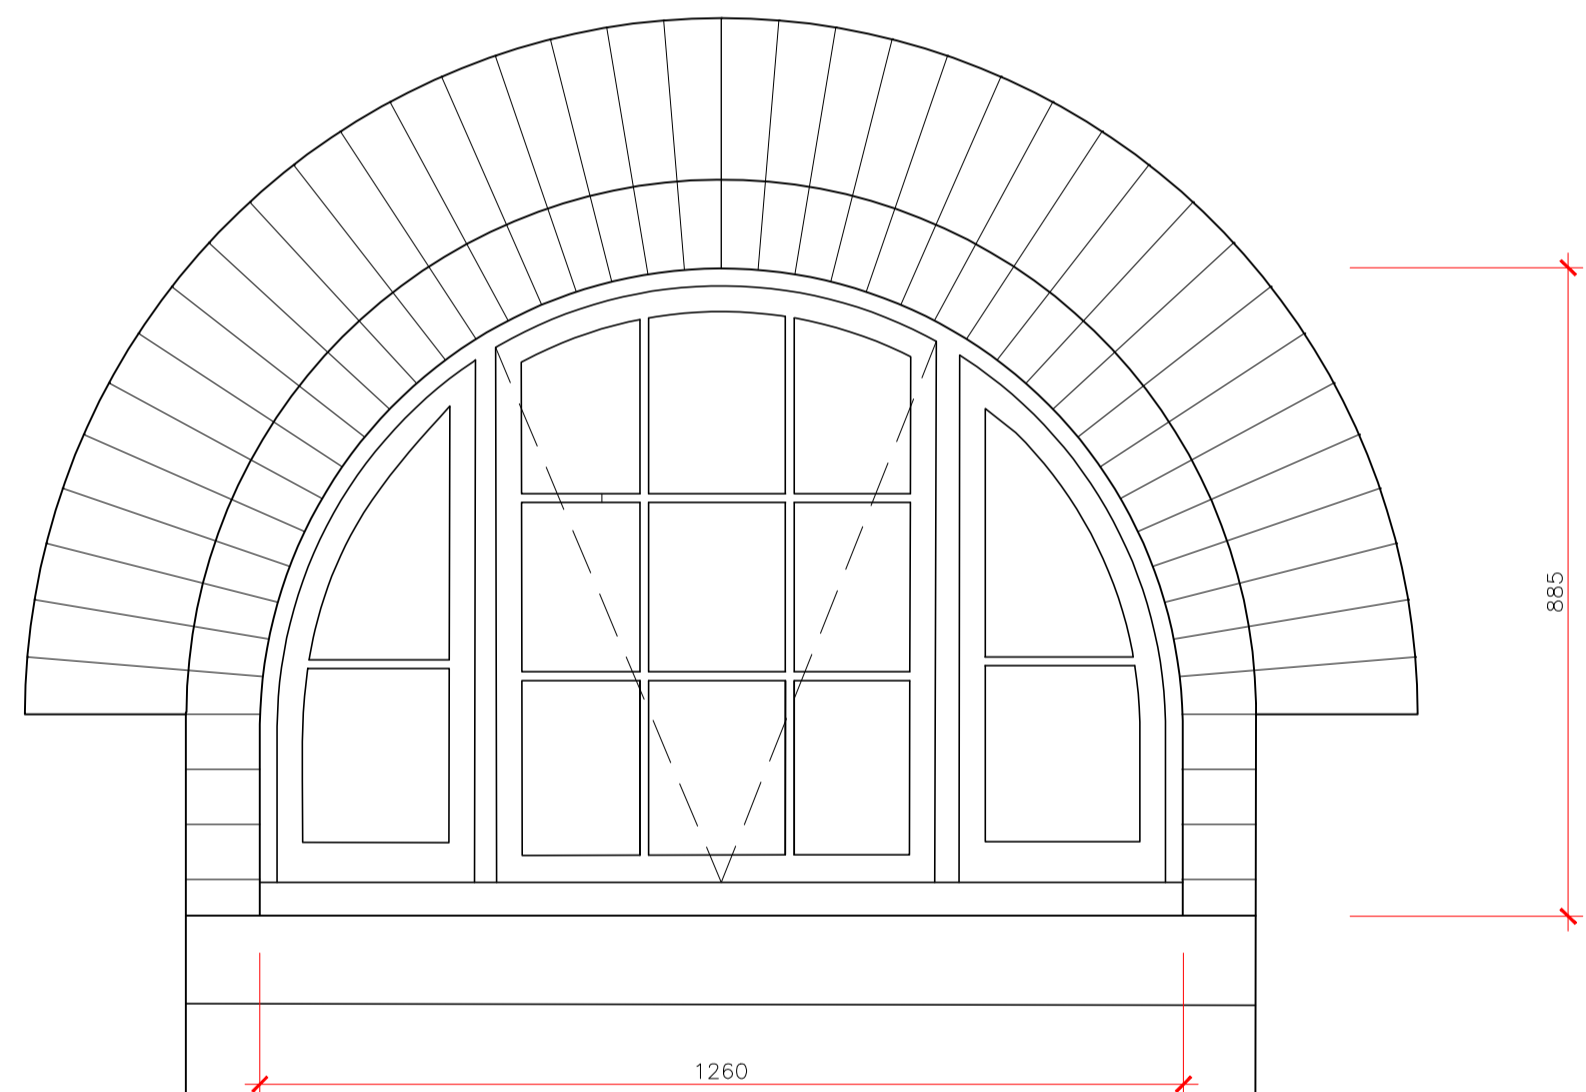
Elevation

**Existing fixed light / opening casement timber window -
Scale 1:10**

Note:
Window profiles are to match existing and to be agreed by design team prior to any manufacture following stripping of existing windows.

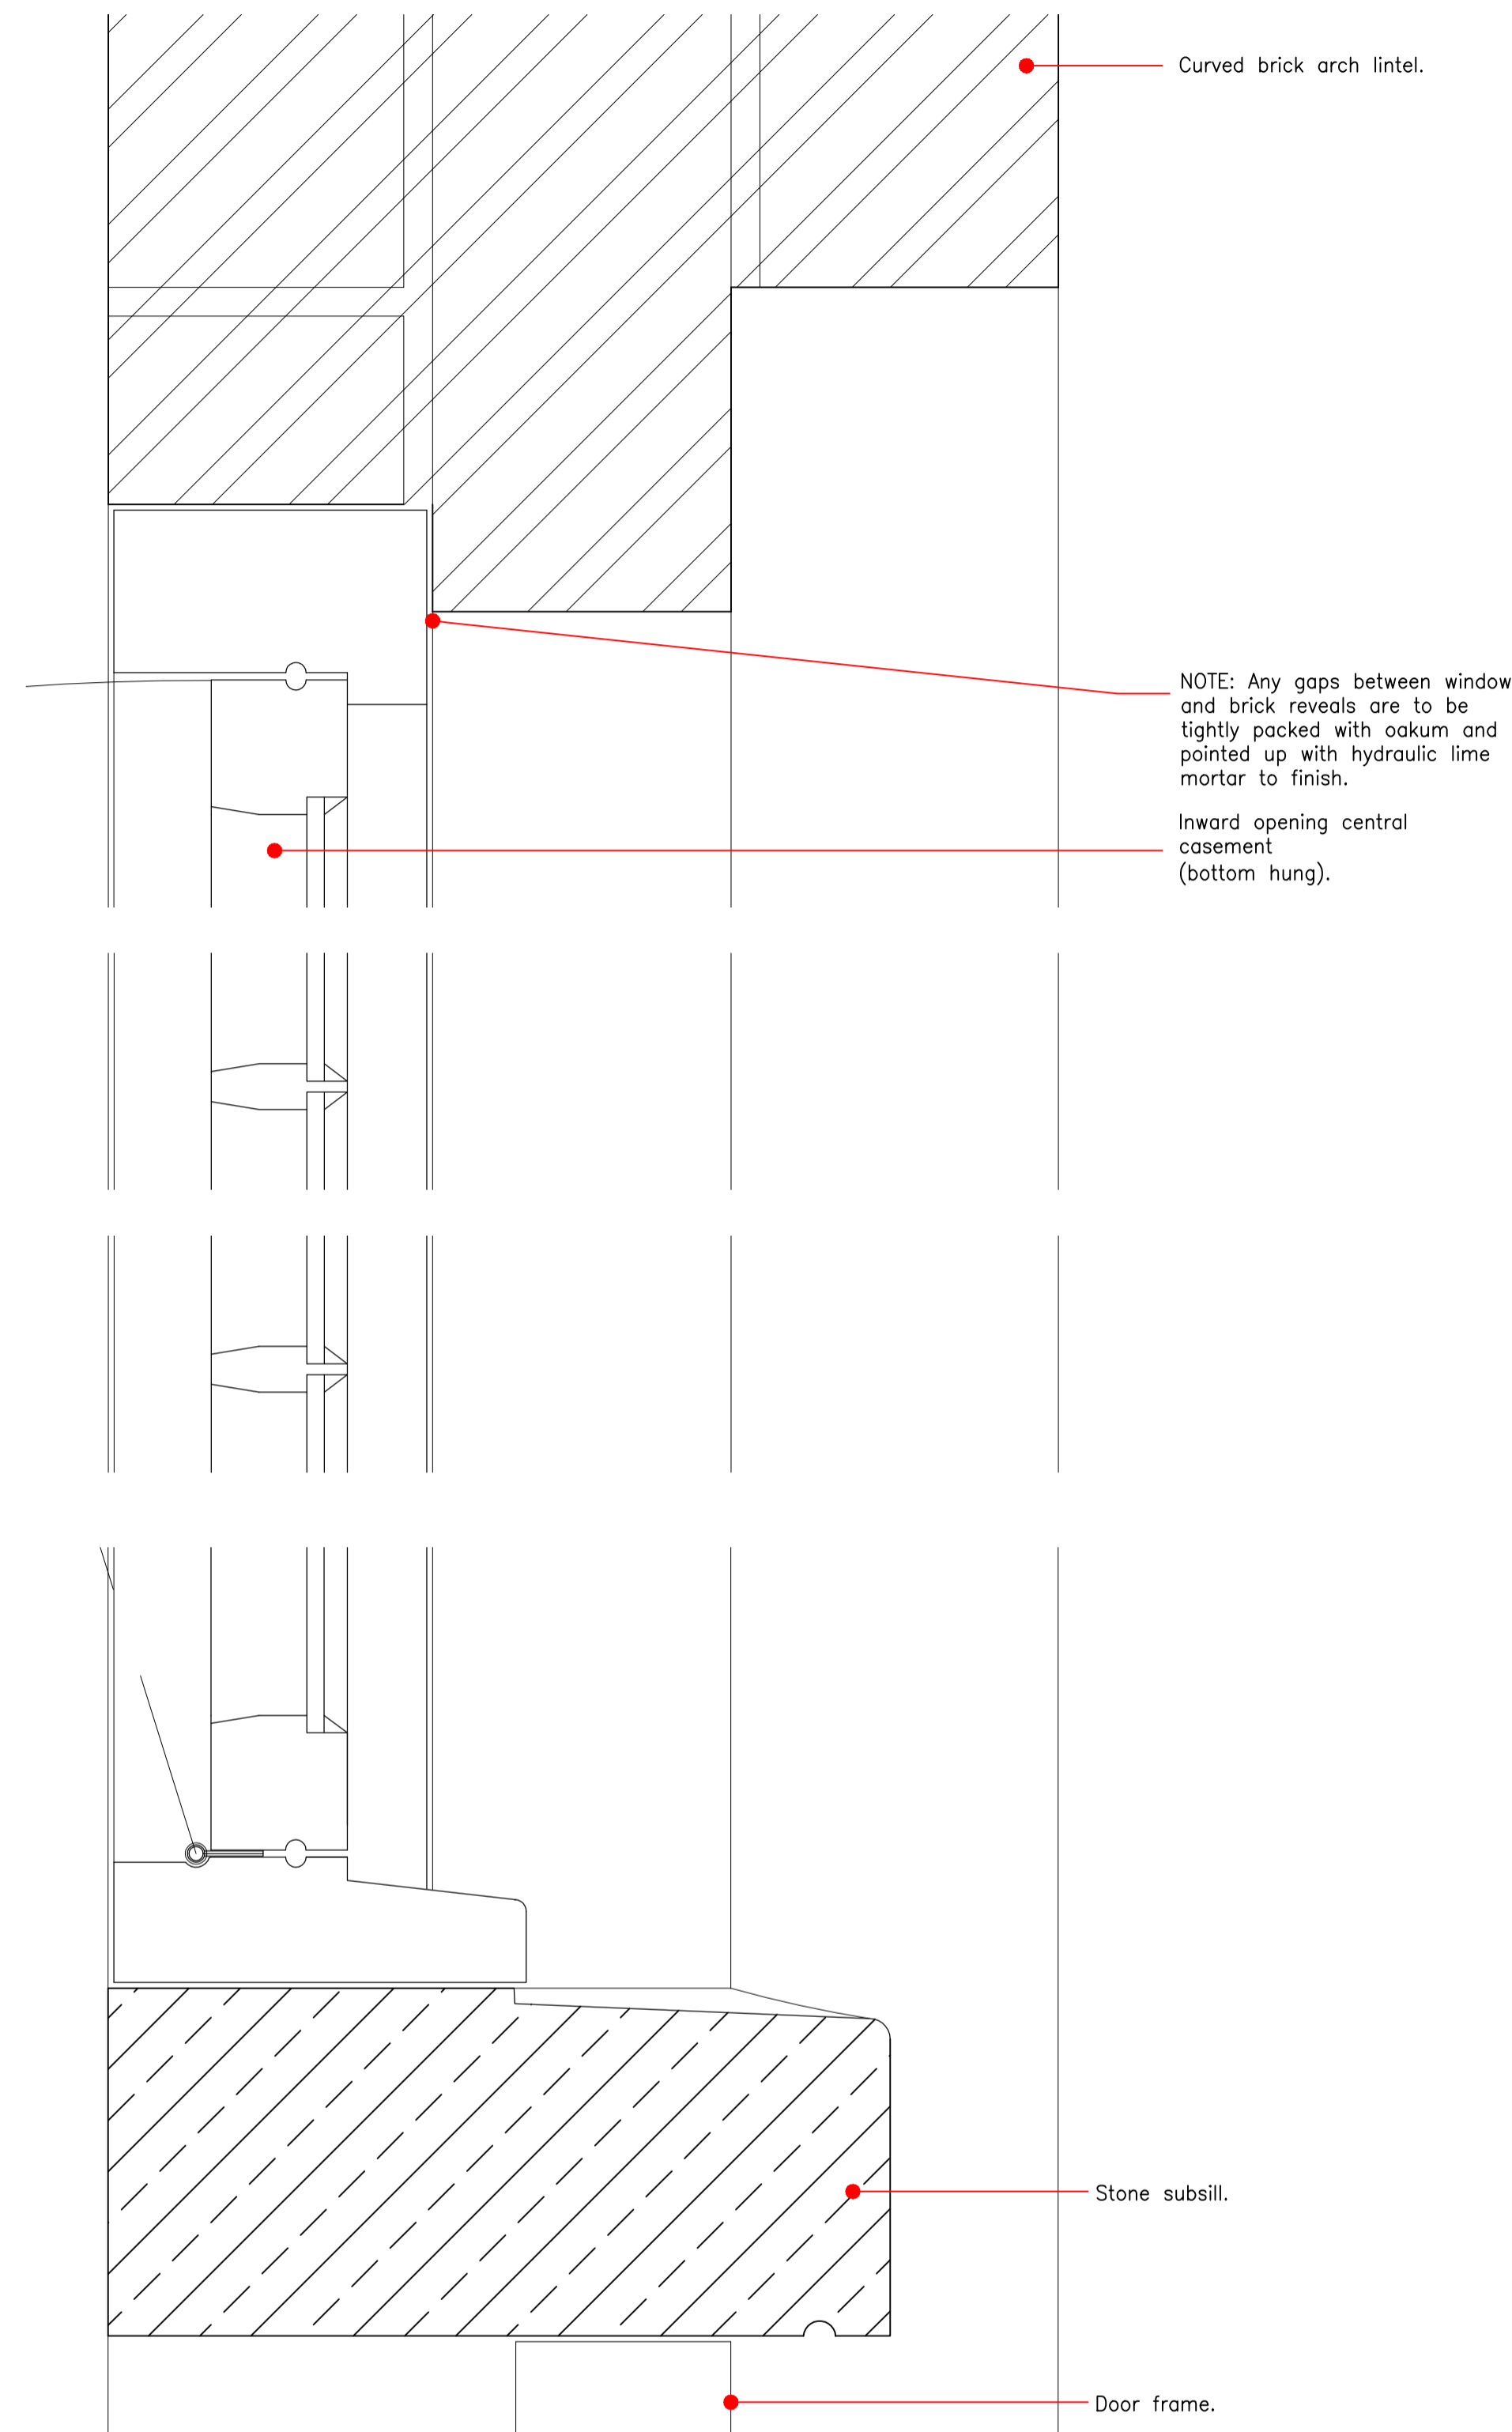
**Existing fixed light / opening casement timber window - section
Scale 1:2**
