Document type
Desk Study

KILN PLACE GEOTECHNICAL AND ENVIRONMENTAL DESK STUDY

Revision **2**
 Date **14.10.2014**
 Made by **Oli Mills, Design Engineer, Geotechnical**
Wendy Fergusson, Principal Environmental Scientist
 Checked by **Steve White, Senior Engineer, Geotechnical**
Karen Allso, Senior Environmental Consultant
 Approved by **Stephen West, Technical Director, Geotechnical**
Paul Stubbington, Project Director, Environmental
 Description **Geotechnical and Environmental Desk Study**
 Ref 61031879-KP-GE/EV-RPT-001

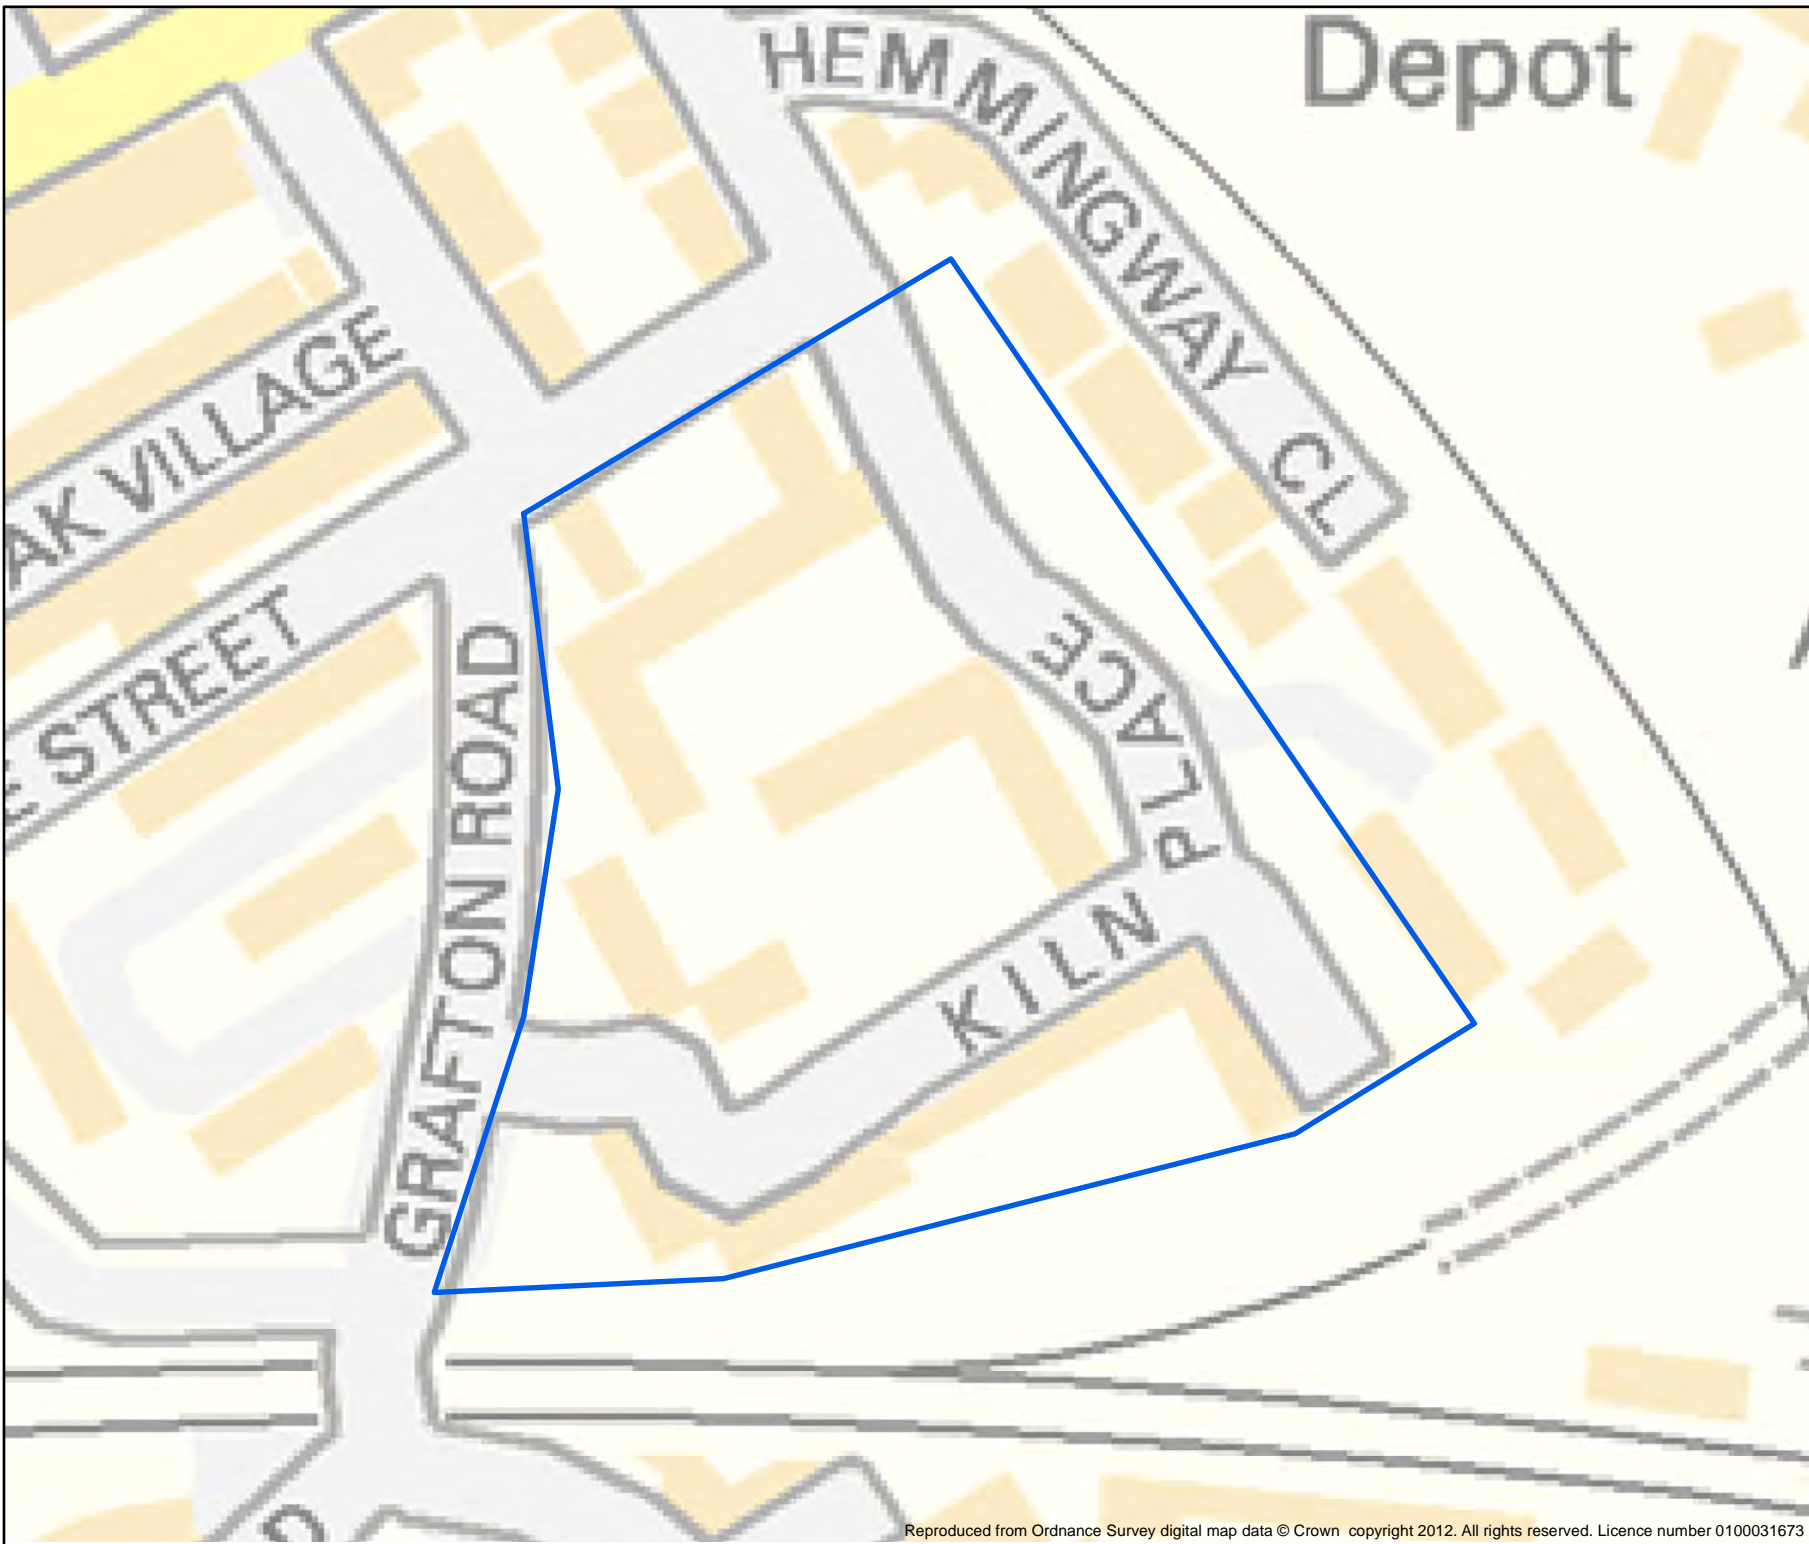
Figure No.	2	Revision	-
------------	---	----------	---

The site is centred at National Grid reference TQ 28331 85485 (post code NW5 4AJ) and covers an area of approximately 15,300 square metres (1.53 ha). A plan showing the site location is provided in Figure 1. The site is currently occupied by residential dwellings, car parking and green, open communal areas which includes a play area. Surrounding land comprises mixed uses, including residential dwellings, industrial land and railway. The current layout of the site is shown in Figure 2.

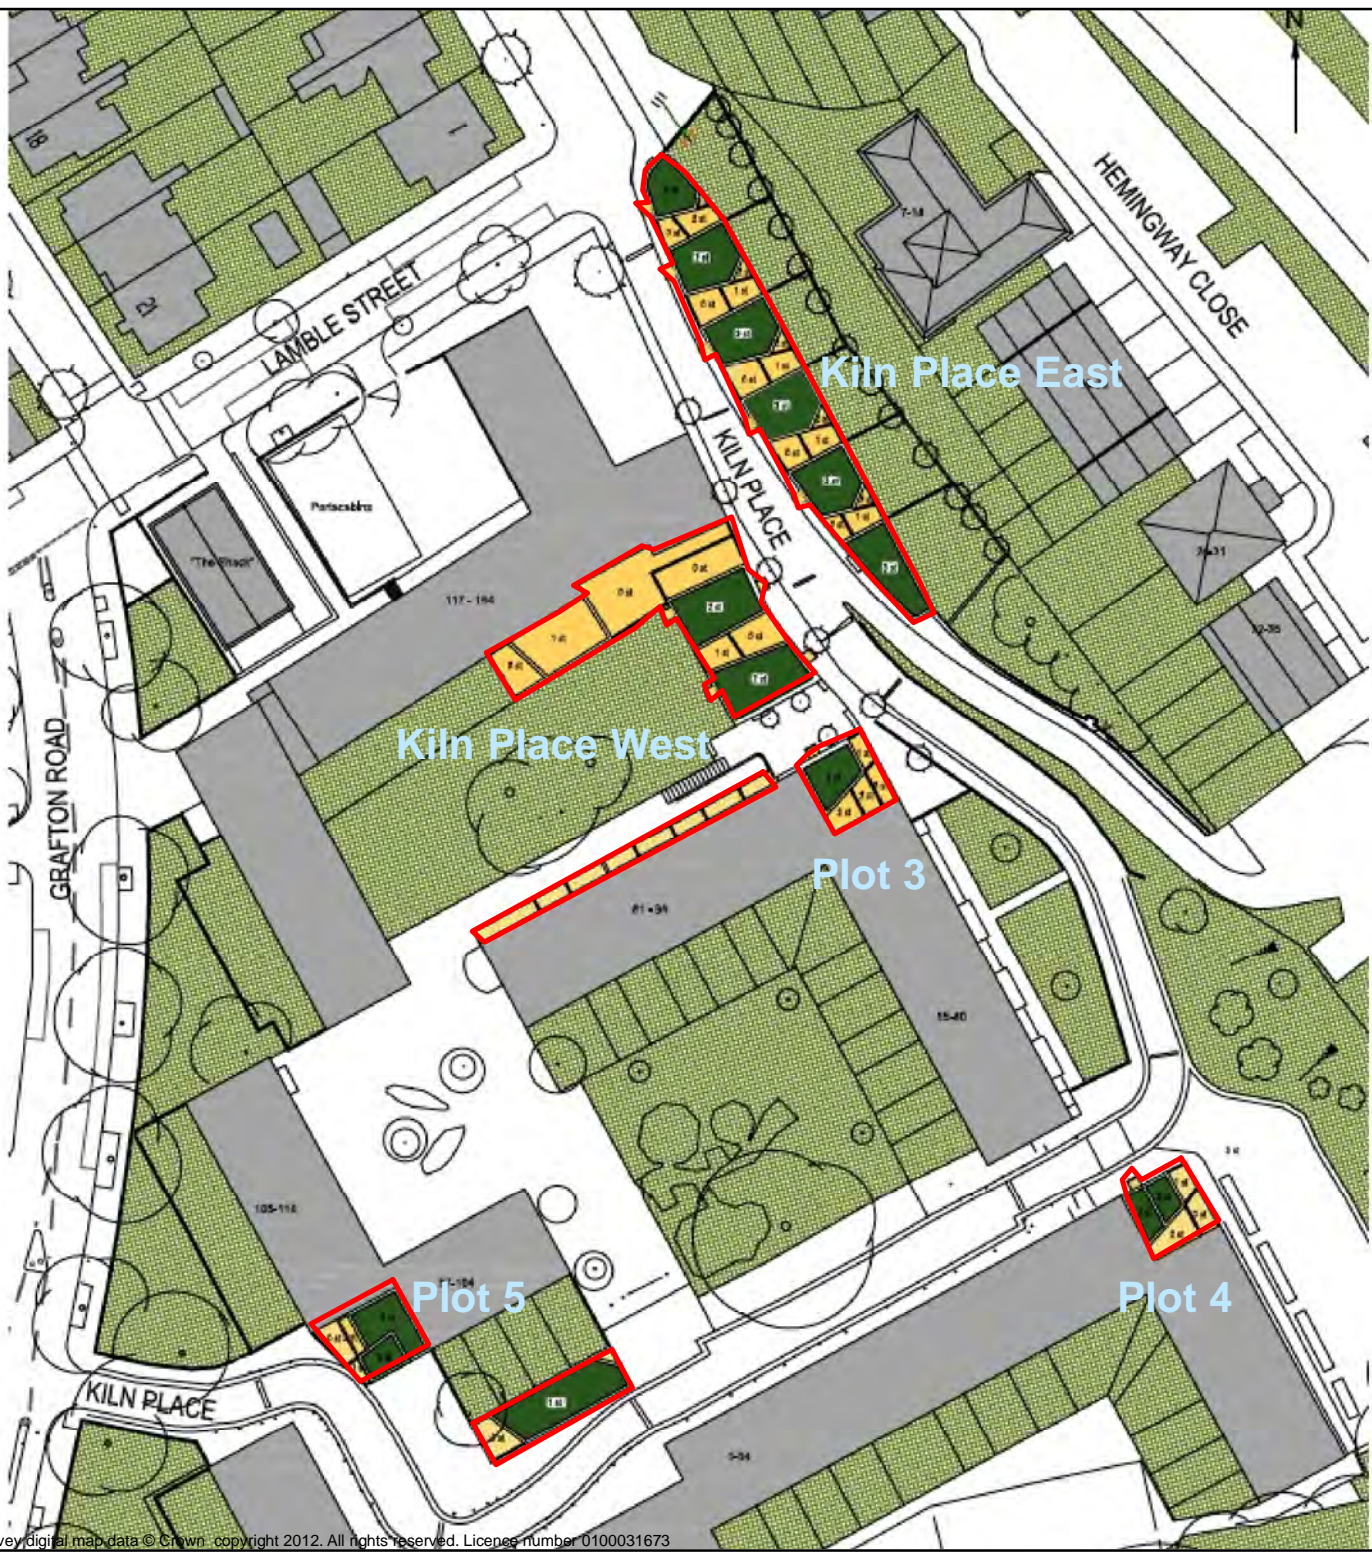
Following the issue of Rev 0 of this document, the proposed development has been updated to accommodate an underlying Thames Water sewer and the addition of proposed dwellings. As a result of the sewer main it is proposed to construct a series of cantilever residential dwelling of up to four storeys as detailed on the latest layout drawing 116_P_01P Rev E. Plans of the proposed development options are shown in Figure 3.

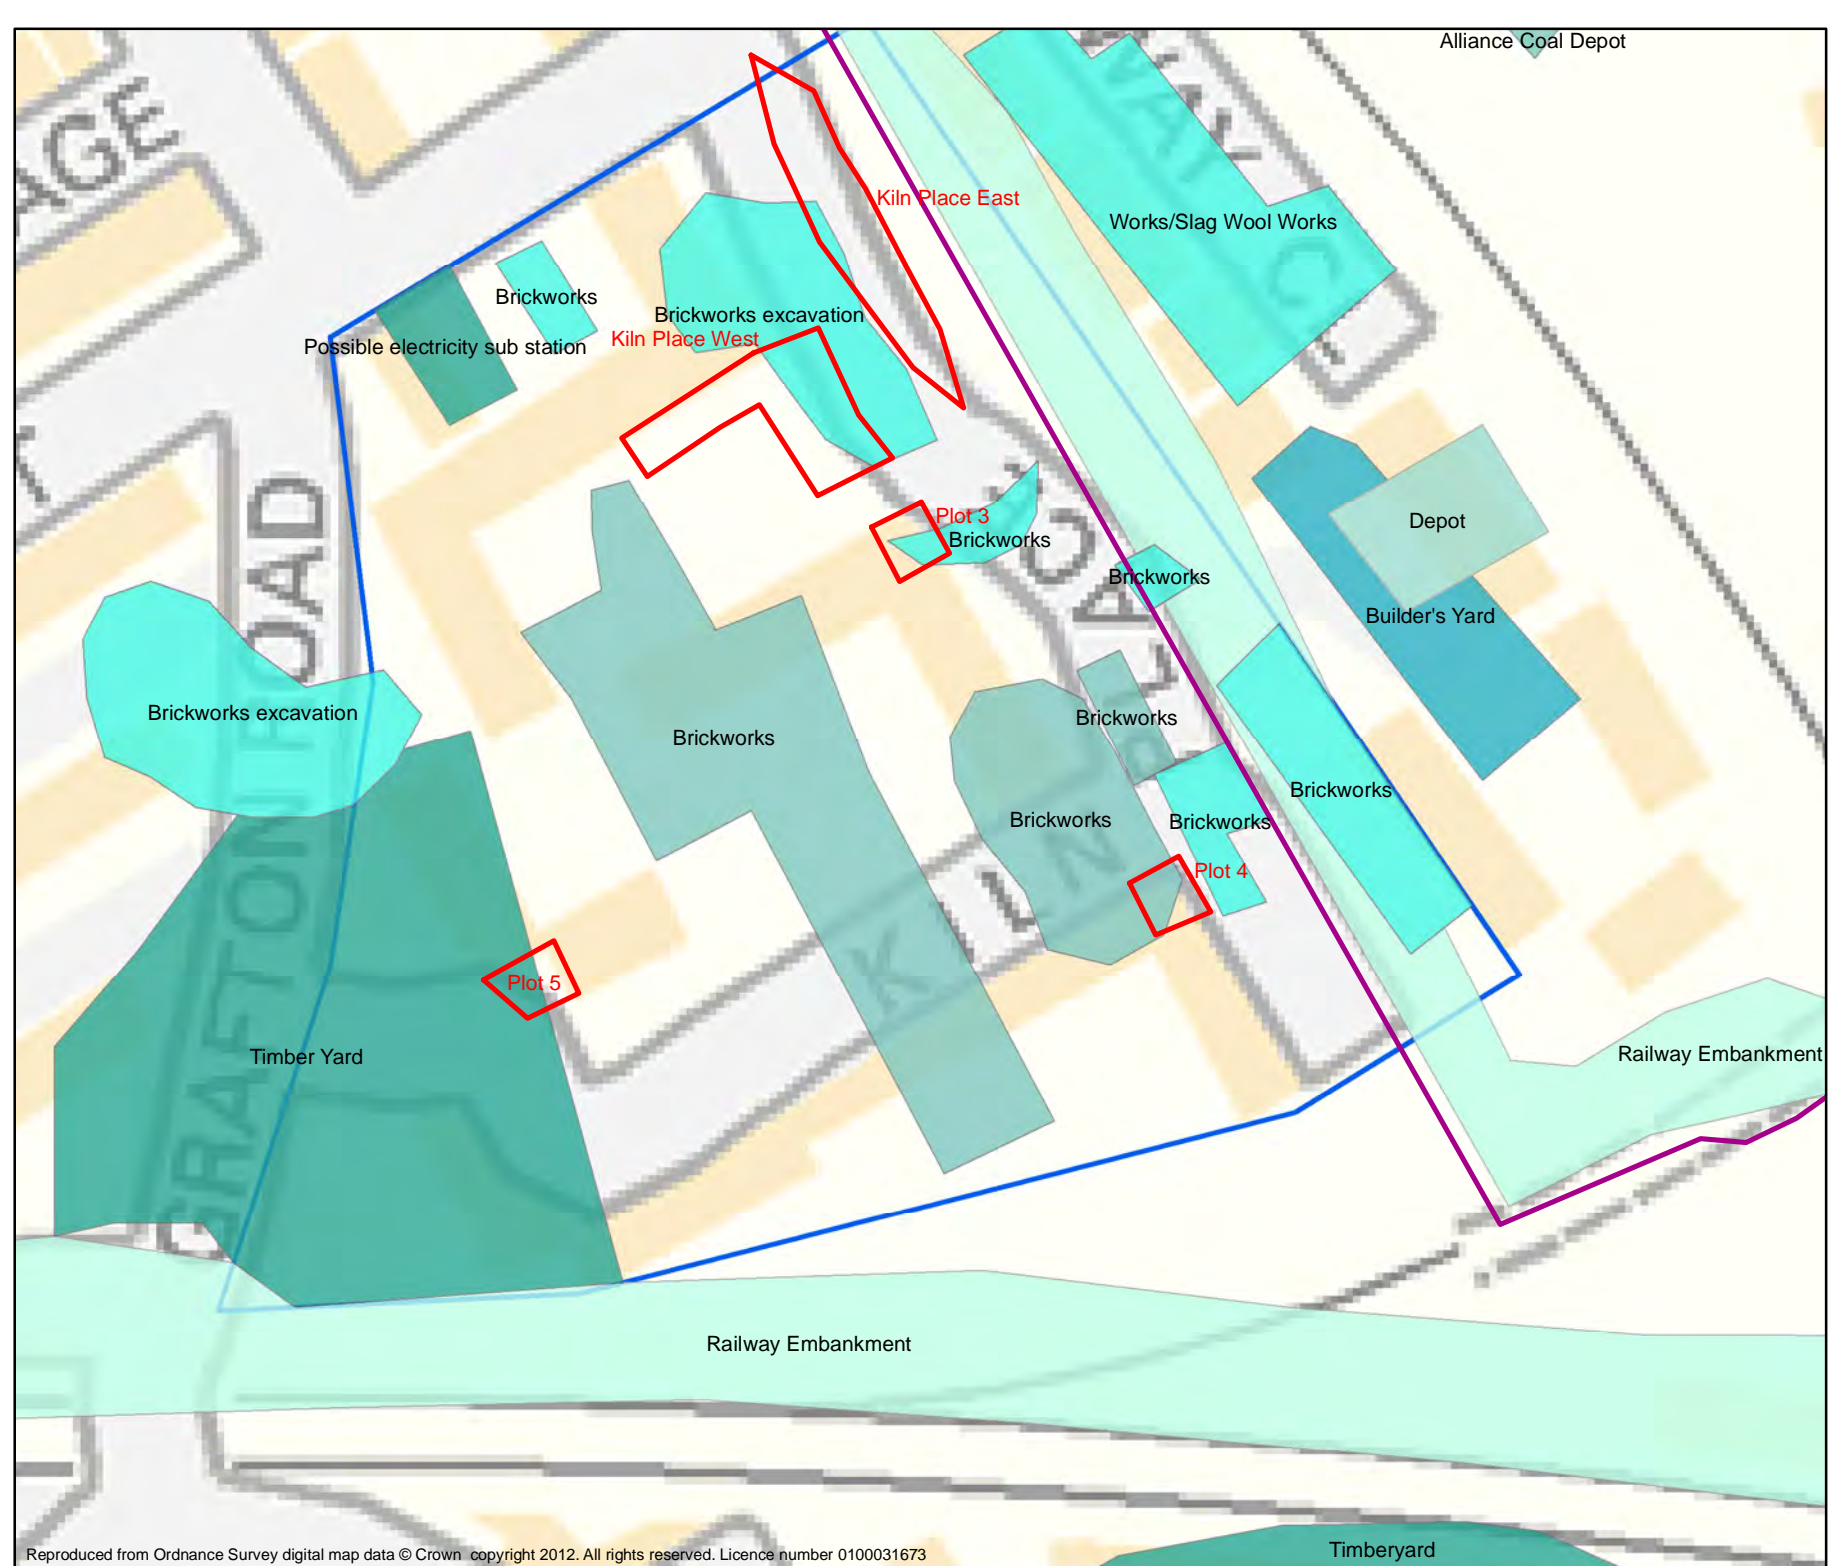
Figure 5 – Historical Uses

- 1860s drain
- Development Plots
- 1863
- 1894
- 1916
- 1954
- 1970
- 1980
- Site Boundary

By 1894 – 1896 Gospel Oak Brickworks has been constructed on the site. The area surrounding the brick works is shown as fields. The embankment along the eastern boundary still remains, however the drain is no longer shown and has possibly been culverted. Immediately south of the site, the Tottenham North line of the Midland Railway has been constructed and enters a tunnel under the L & N.W.R.

By the 1916, the Gospel Oak Brickworks has expanded and altered in building layout. There are areas of excavation with water both on site and to the west of the site. The embankment along the eastern boundary still remains, with buildings constructed immediately to the east.

By 1954, the majority of the buildings, pits and ponds associated with the brickworks have gone and the kiln is shown as disused. The embankment along the eastern boundary still remains and the buildings immediately to the east are named as Slag Wool Works. The south western corner of the site is now a timber yard.

By 1968, the site has been redeveloped and Kiln Place housing estate constructed. Grafton Road has been constructed and forms the western site boundary. Houses have been constructed on the **land to the west of the road. The Slag Wool works has been redeveloped and named 'works'** with a depot. The embankment which forms the eastern boundary appears to have been widened and possibly increased in height.
