**192 HAVERSTOCK HILL**

**BELSIZE PARK  
LONDON**

**BAT SITE ASSESSMENT**

**2012**

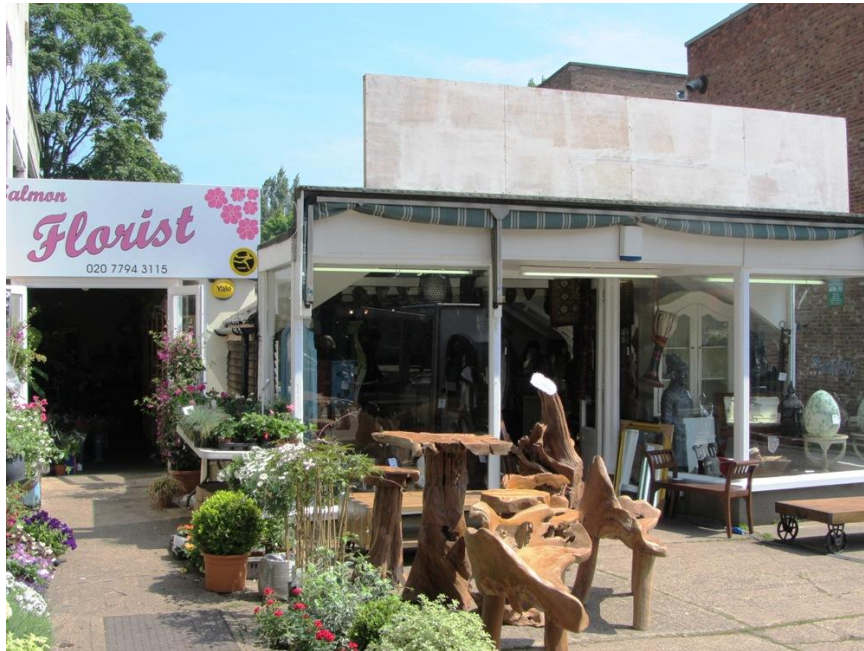
The site, located adjacent to Belsize Park Underground Station, comprises two units. The main building is occupied by the Hampstead Emporium, with a smaller adjoining unit that is currently tenanted by Salmon Florists.

Photograph 1: Front elevation

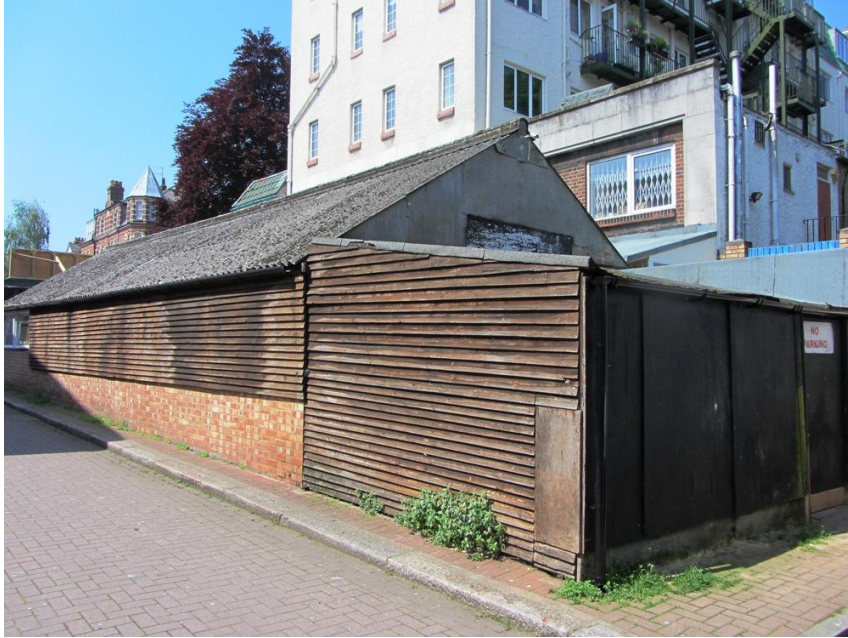
The adjoining florist unit has a sloping roof, with no internal loft void, and wooden panelled walls. There is also a rear extension, comprising a felt roof that is also lacking a loft void, with chipboard walls.

Photograph 2: Side and rear elevation

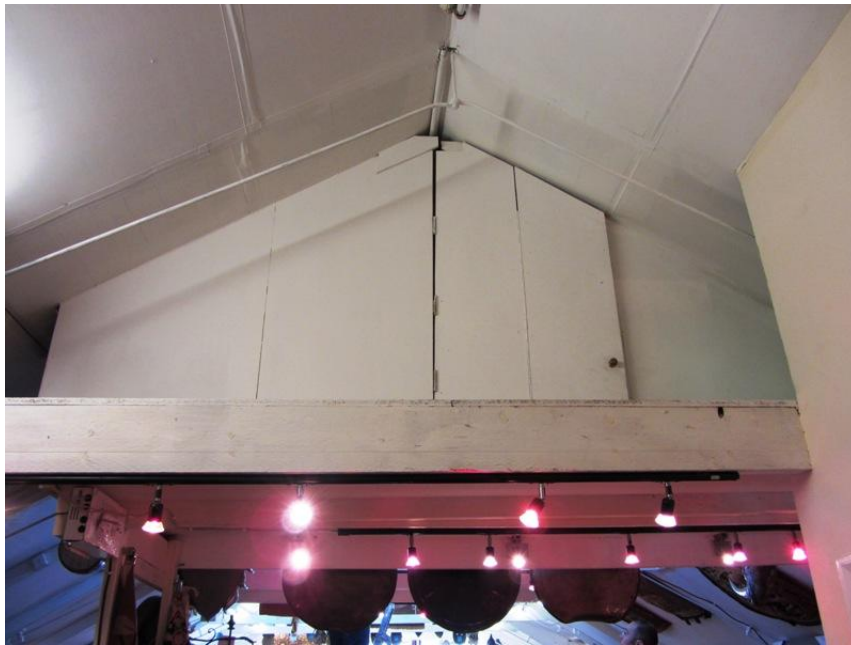
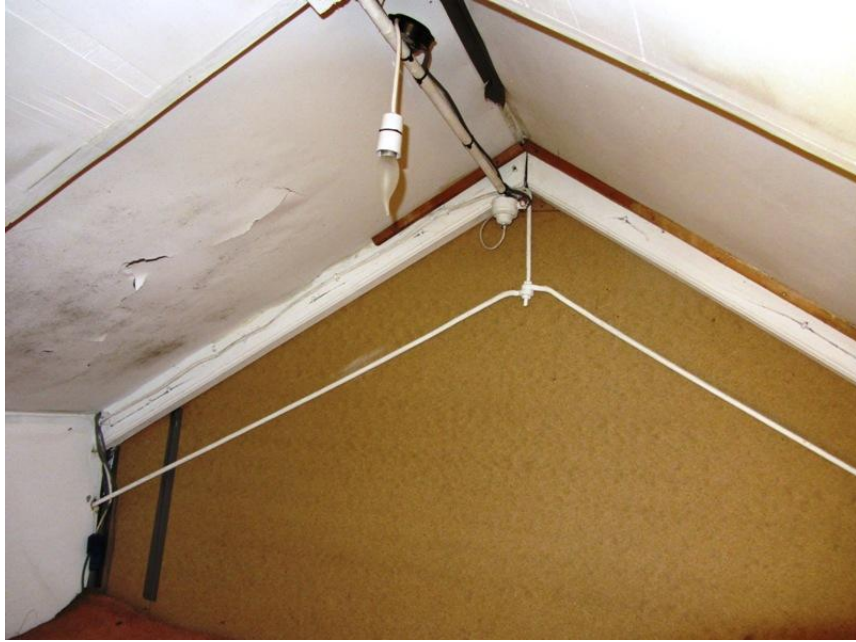
The main unit is a single-storey, timber-framed building with half brick – half wooden side walls. It has a pitched asbestos roof that is wooden-lined throughout. There are two small loft voids (see photographs 3 – 6 below).

The rear void is empty, wooden panelled and lined with carpet and with a main electric light. It is less than 2 metres in depth and less than 2 metres in height. The front void, also with a mains electric light, is slightly larger and has been used for past storage. It is of the same construction as the rear void. There is a rear extension with wooden walls that is used for storage. It has a sloping felt roof that is lined with boarding and no loft void.

Photograph 3: Loft void – 1

Photograph 4: Loft void - 1

No evidence of any past bat occupancy was found during the internal inspection of the two small roof voids in the main unit.

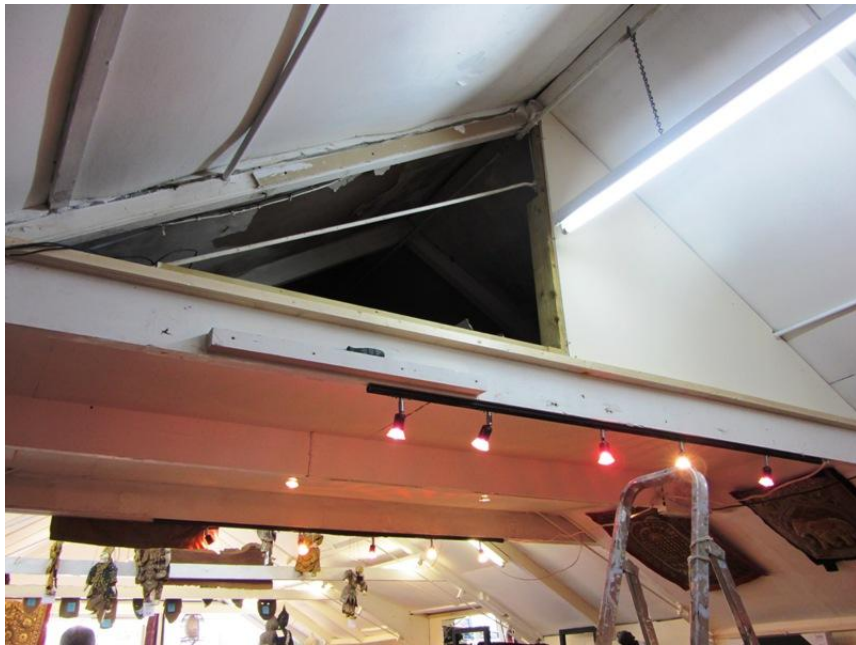
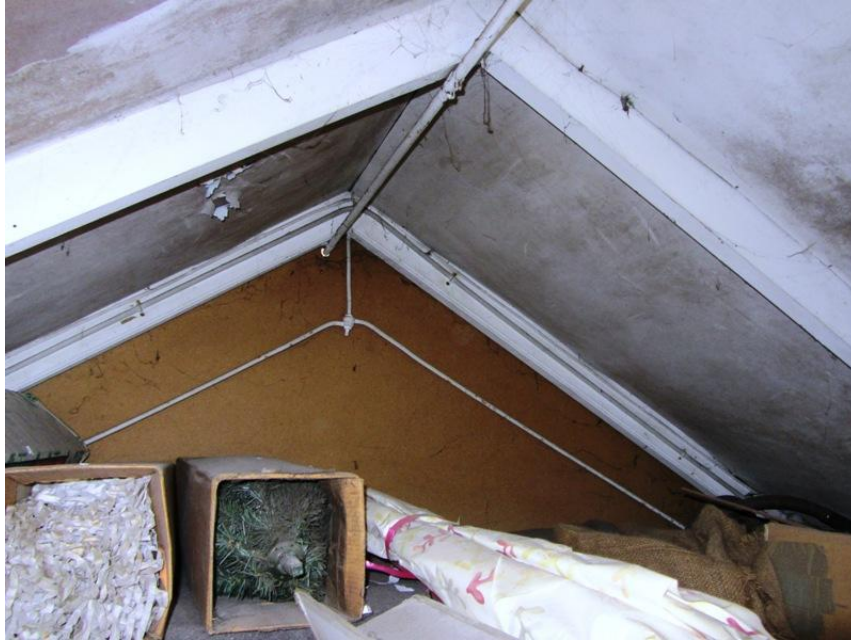
Photograph 5: Loft void - 2

Photograph 6: Loft void - 2
