Phase II Ground Contamination Report Midland Crescent

Stadium Capital Holdings 2 Ltd

February 2012 – Final v1

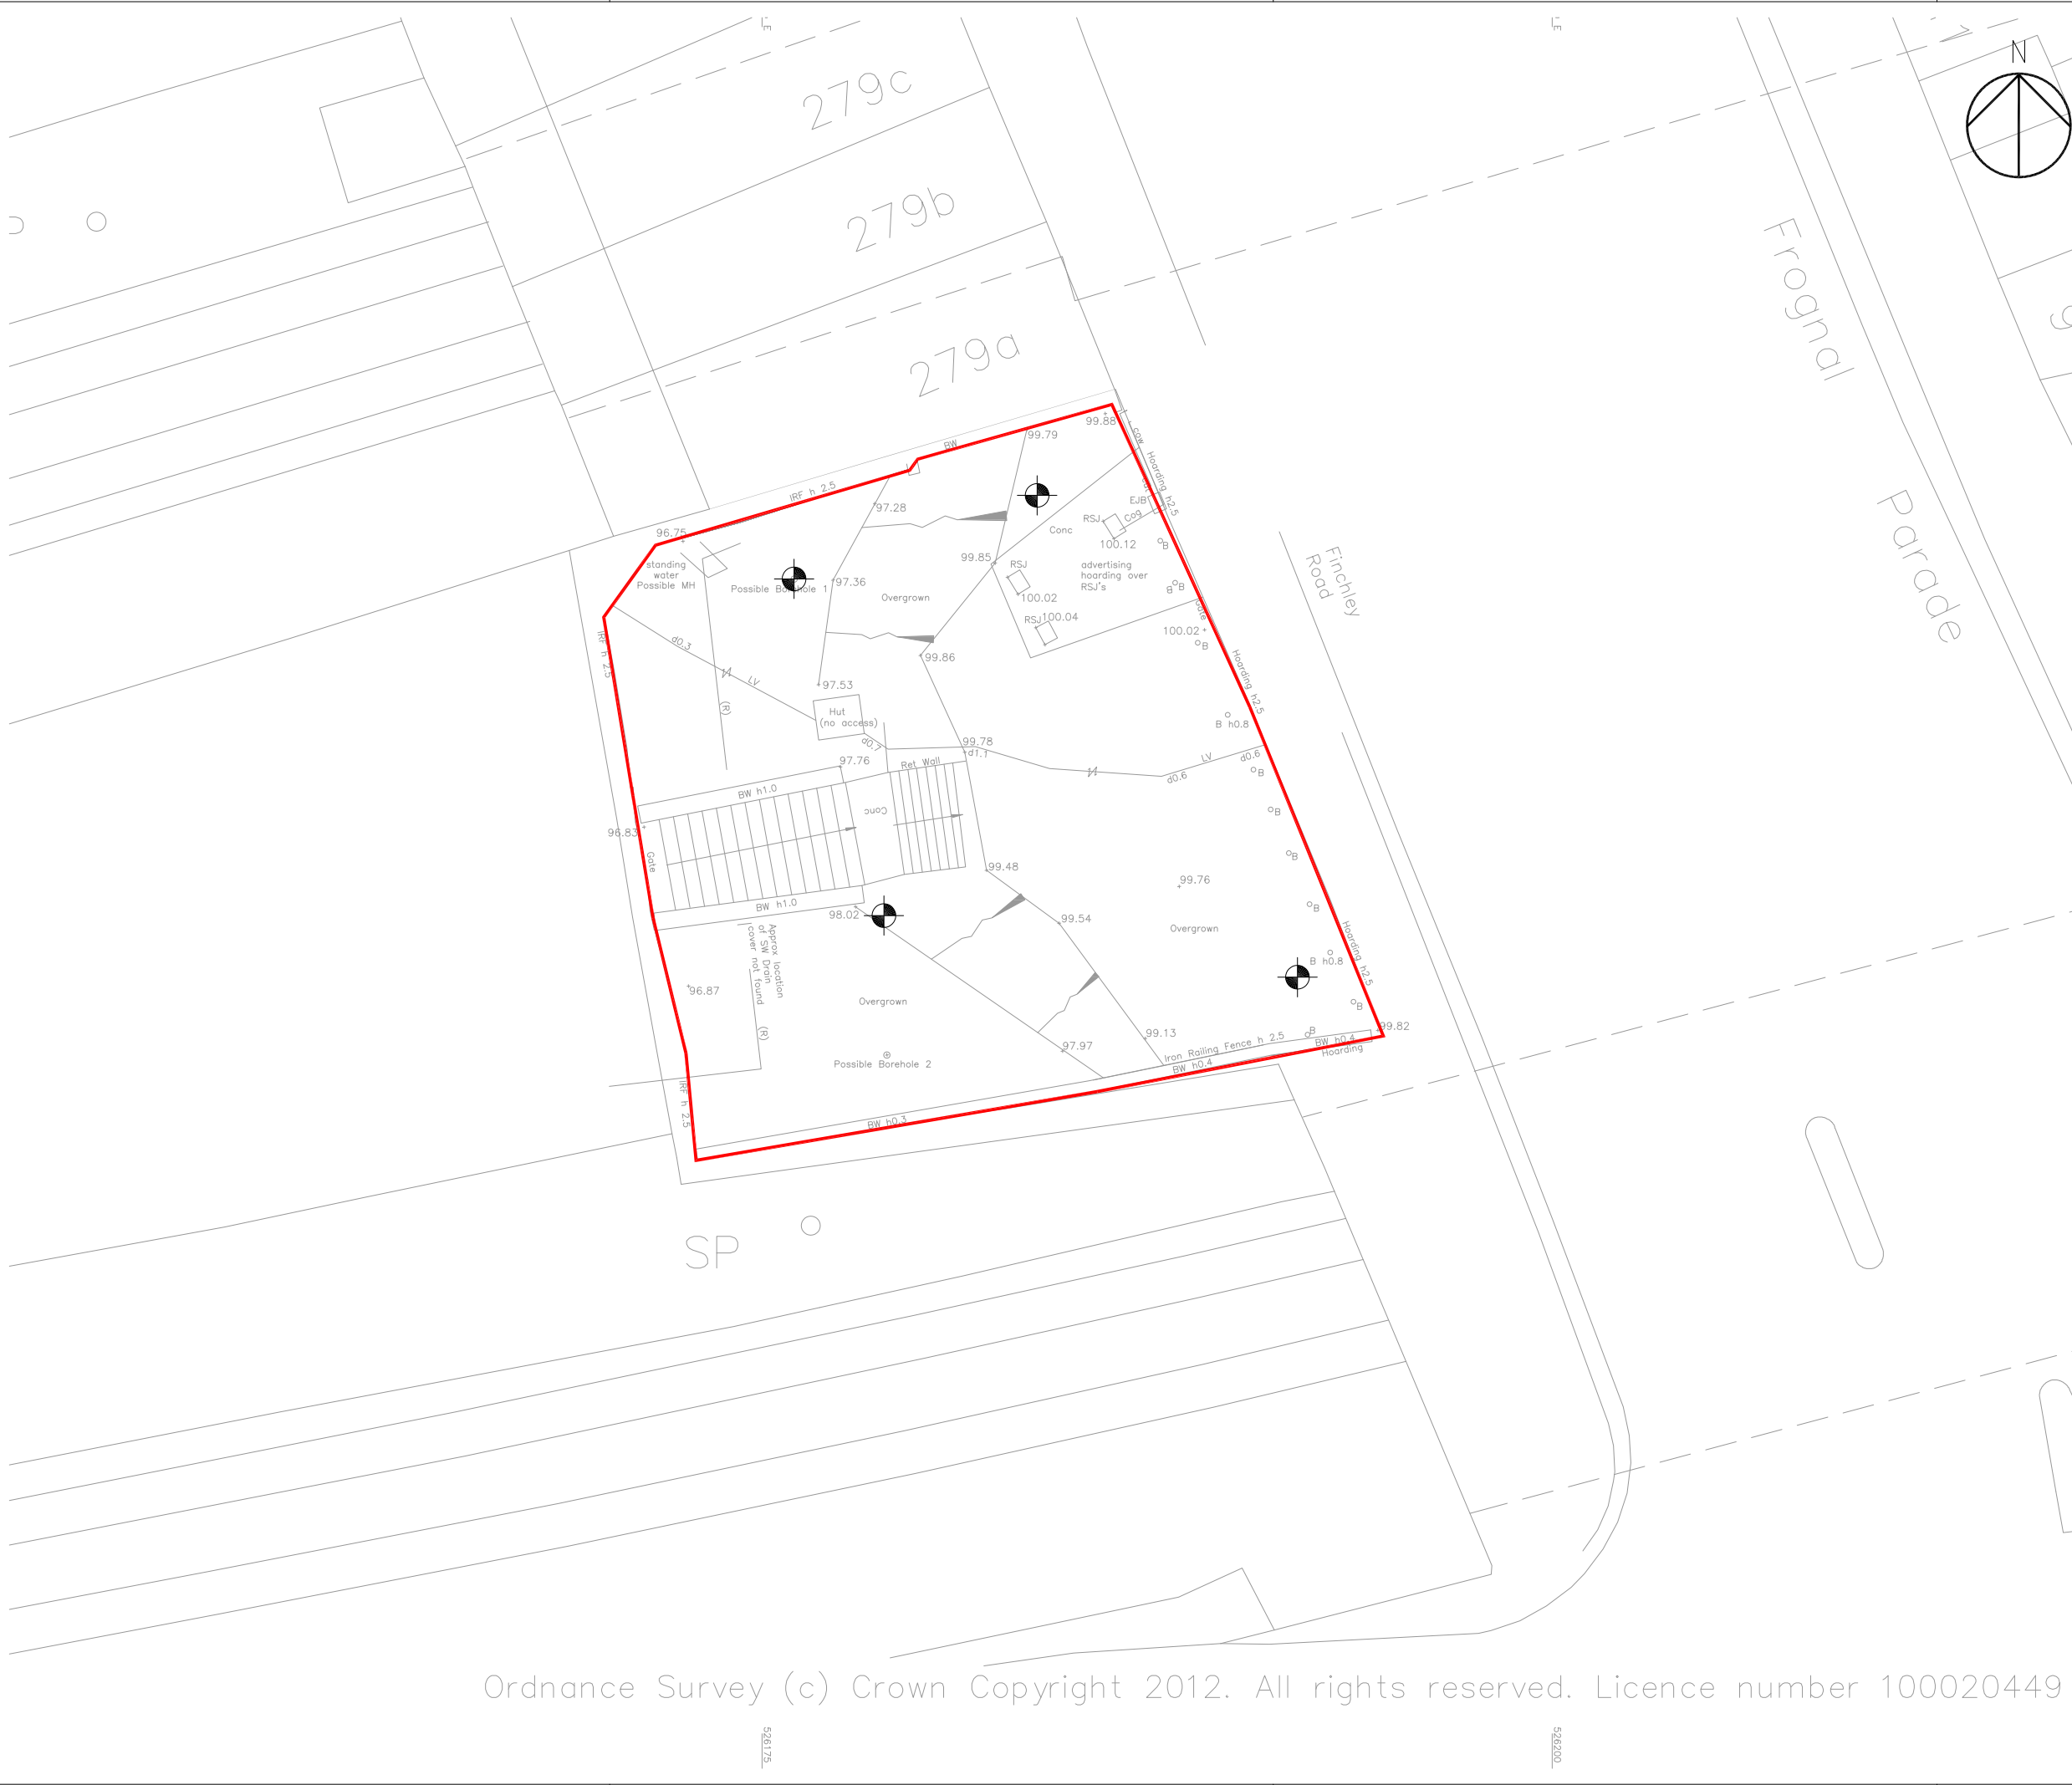
- 2.3 A Capita Symonds consultant undertook a site walkover on the 24th January 2012 as part of the Phase II Ground Contamination Report, to confirm the findings of a previous Phase I Desk Study. A site layout plan is provided as Figure 2.
