# BS4142 Noise Assessment

Report No: 3172-R1 – CO-OP, Camden Parkway, London, NW1 7AH – 20/10/2014

For: Wellsfield Associates

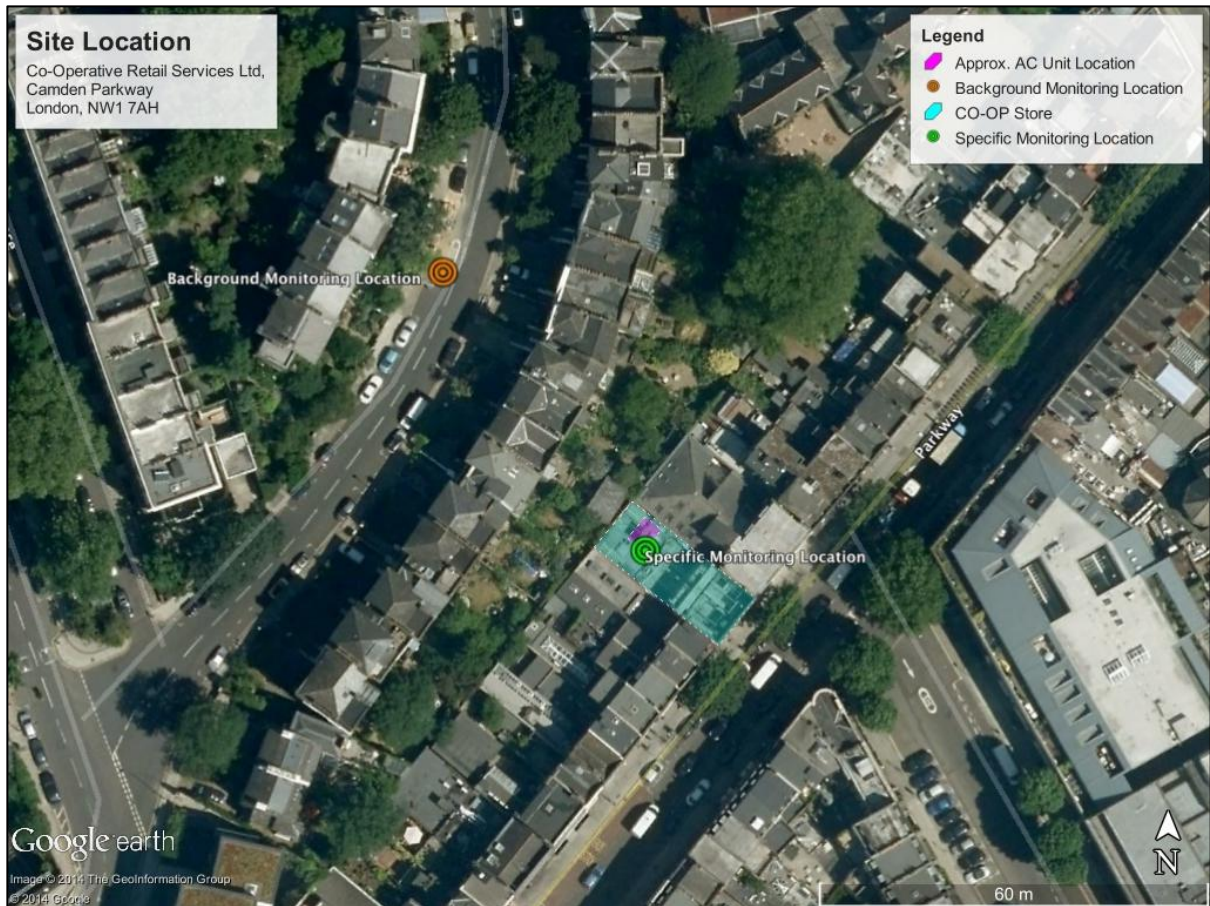
Figure 1 – Site Location

The Co-operative store is located on Camden Parkway, London on the ground floor of a mixed commercial and residential environment. The equipment has been installed on a flat roof outrigger of the building with the nearest sensitive receiver approximately 8 meters from the installation on the 1<sup>st</sup> floor of the same building. This is identified on the location plan in figure 1.

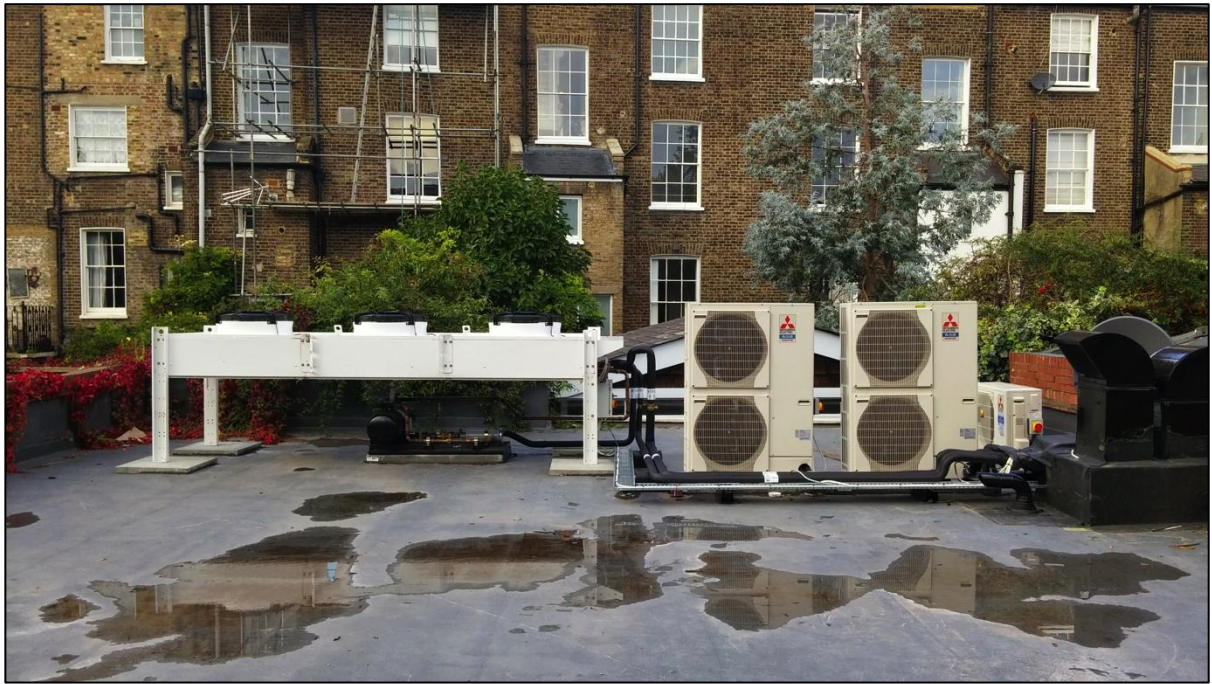
Figure 3 – View of Newly Installed Equipment

The installation consists of refrigeration fans, ventilation fans and air conditioning units. Pictures of the installation are available in the Appendix. Measurements were taken of the units in operation and the following levels were recorded at the nearest sensitive receiver.

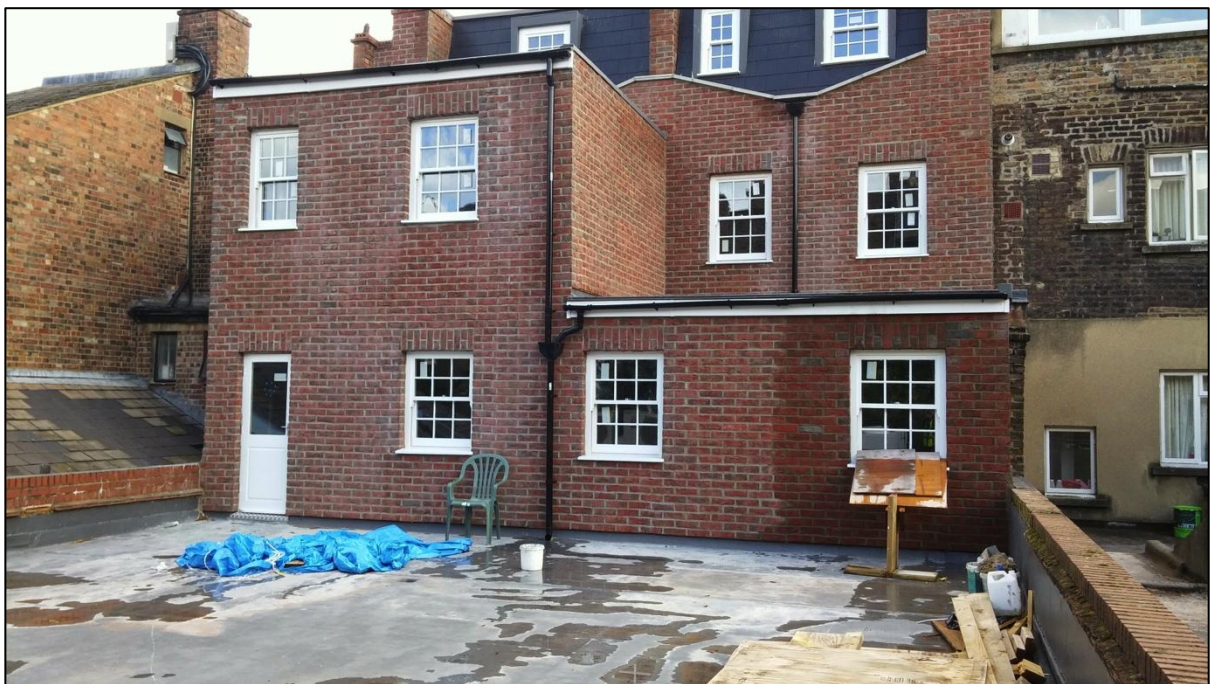
Figure 4 – View of Nearest Sensitive Receivers

The nearest sensitive receivers identified to the south-east approximately 8m from the installation; distance attenuation can be calculated using the following formula which would predict a distance attenuation of -18dB:
