Basement Impact  
Assessment: 156  
Goldhurst Terrace

**(Surface Water and  
Groundwater)**

**Report reference:** 62584R1rev1, July 2014  
**Report status:** Final Report

**GROUND INVESTIGATION REPORT**

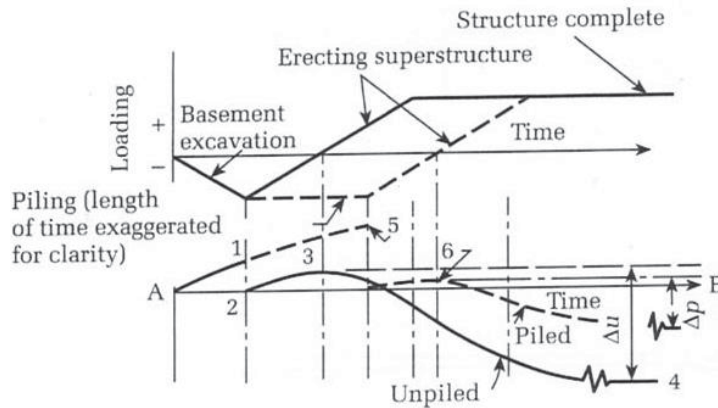
Figure A: Comparison of settlement/heave associated with piled and unpiled basements

The net downward movement resulting from the algebraic sum of heave, reconsolidation, and further consolidation will be lower for the piled basement than for an unpiled basement. This is illustrated in the Figure A below.

In the case of the piled basement, the excavation will generally remain open and unconcreted for a longer period until all piles have been installed. After completion of piling (Point 5) the soil is trimmed off to the specified level and the floor slab is constructed. There will be some continuing upward movement of the basement level as the soil around and beneath the piles continue to swell, but if the piles are long in relation to the width of the building such movement will be very small. When the superstructure loading reaches the original overburden pressure (Point 6) reconsolidation will take place. The net downward movement ( $\Delta p$ ) will be less, since the swelling is less and the consolidation due to net additional super-structure loading will also be less since the piles have been terminated in soil of lower compressibility.

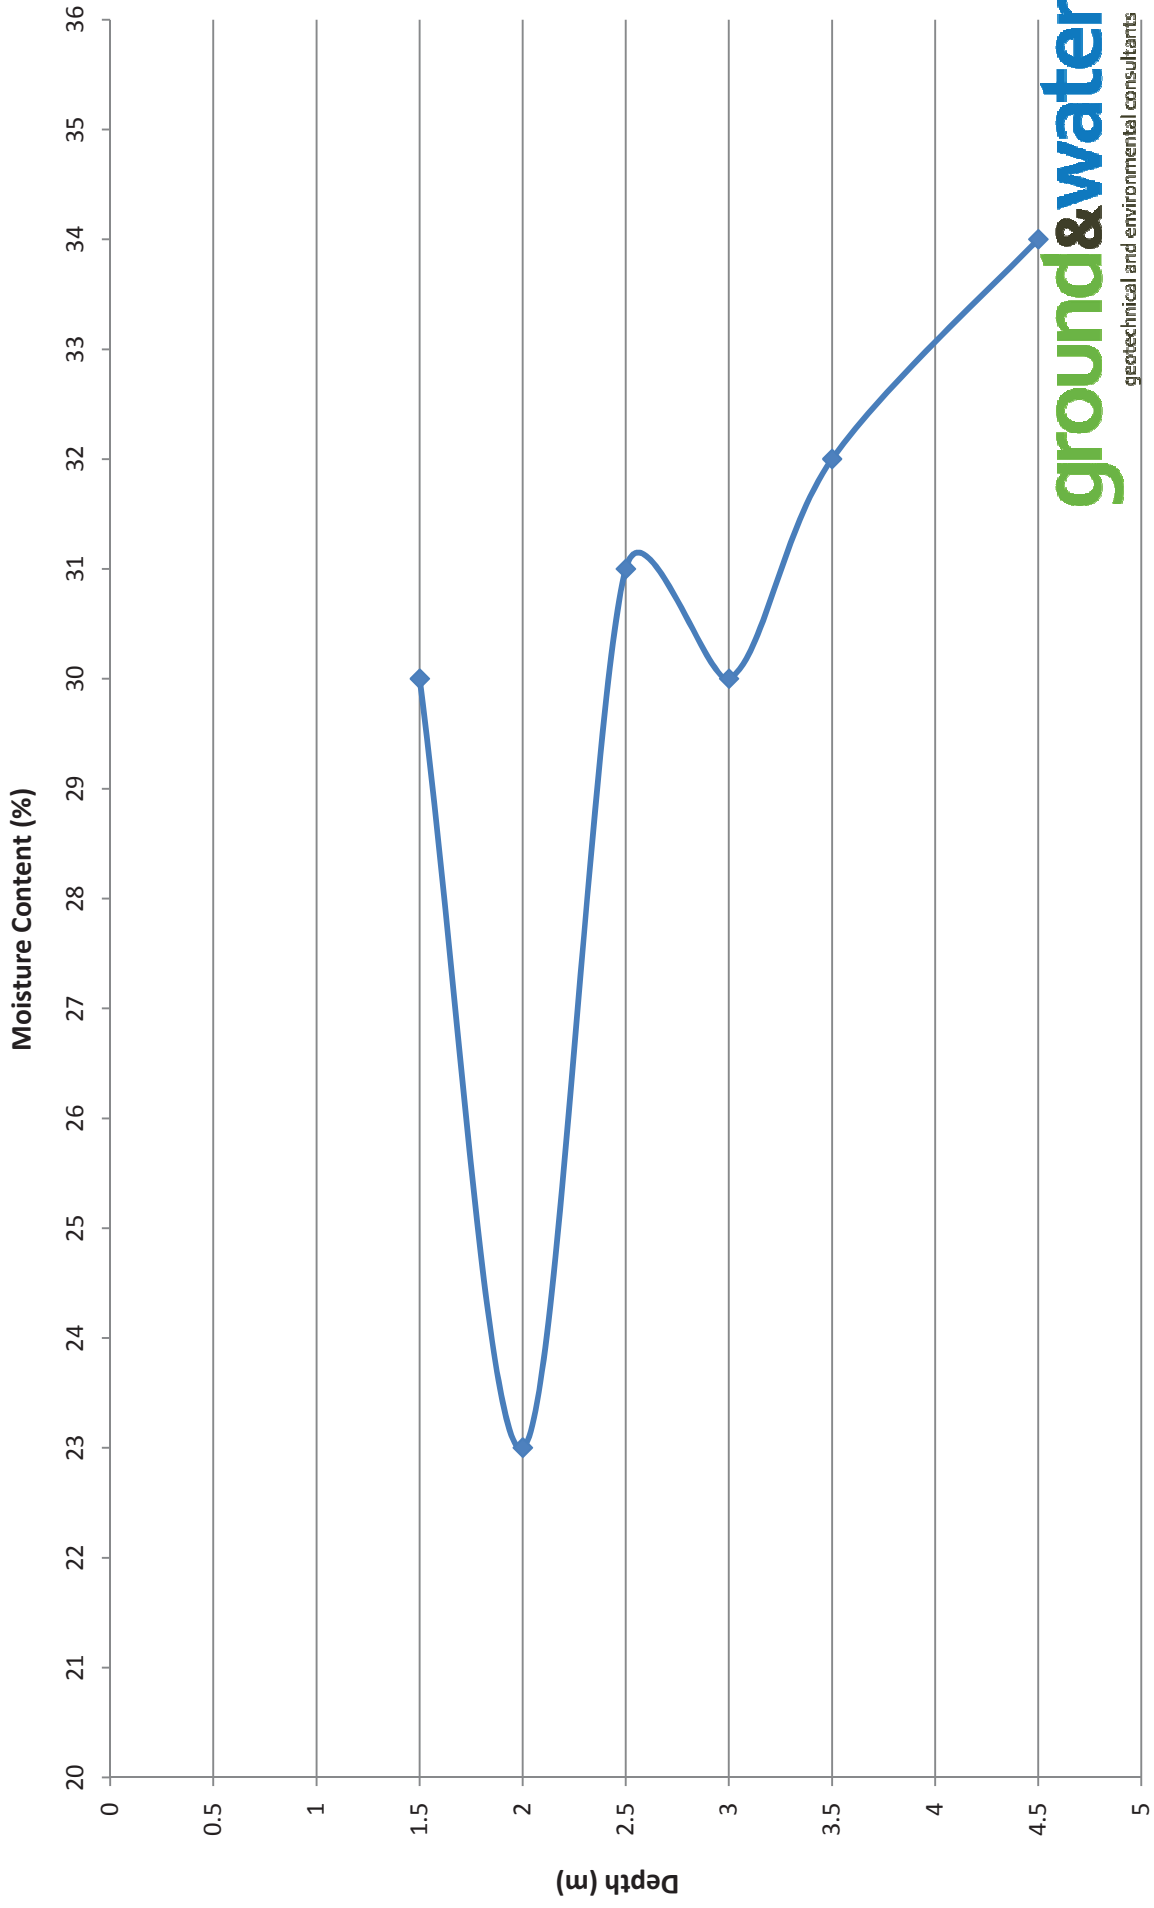
**Figure 7: Change in Moisture Content With Depth Within WS1**

Figure 7 & 8 show a possible moisture deficit in both at 2.00m bgl due to a lowering of the moisture content of the sample of the Head Deposits from that depth. Roots were noted to a depth of 1.50m bgl in WS1 and to 4.00m bgl within WS2. The deposits were described as a gravelly silty clay.

Given the absence of roots within WS1 the lower moisture content was likely due to the coarse fraction (gravel content) rather than the moisture demand from nearby trees.

Moisture content versus depth plots for WS1 and WS2 can be seen within Figures 7 and 8.
