Design and Access Statement  
&  
Heritage Statement

Perimeter wall & associated works  
34 Brookfield Park  
London  
NW5 1ER

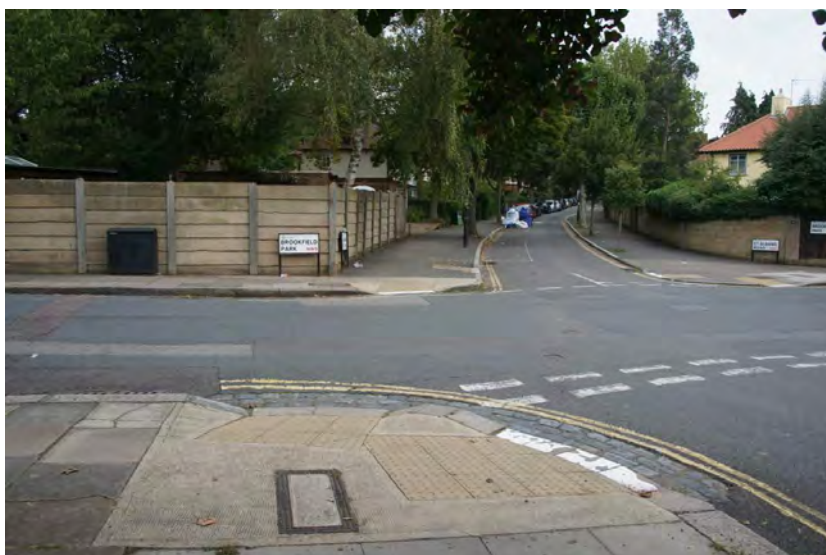
The wall around 38 Brookfield Park

Numbers 1 to 33 Brookfield Park are large semi-detached Edwardian houses, two storeys high, most having a mansard above. Numbers 35-37 Brookfield Park do not exist. After no 34, the next house on Brookfield Park is no 38, which is on the other side of St Albans Road from no 34. It is a detached three-storey house from about 1954. It, too, has a wall around the site, approximately 2.0m high.

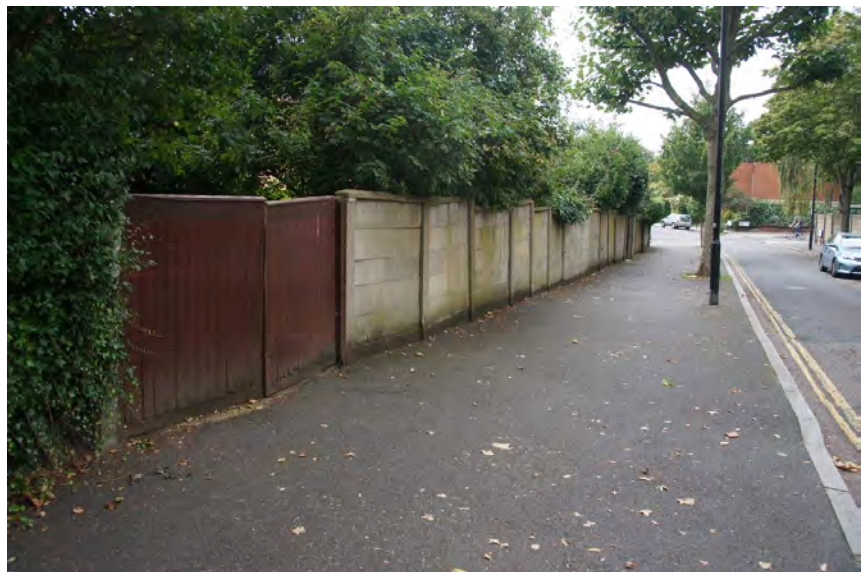
Pavement on St Albans Rd, adjacent to 34 Brookfield

Road is moderately wide and Brookfield Park slightly less so. The part of St Albans Road adjacent to 34 Brookfield Park has generously wide pavements, with the pavement on the side adjacent to 34 Brookfield Park being 3.7m wide at the point of its entrance gate, increasing to 4.25m at the point of its garage forecourt gate.

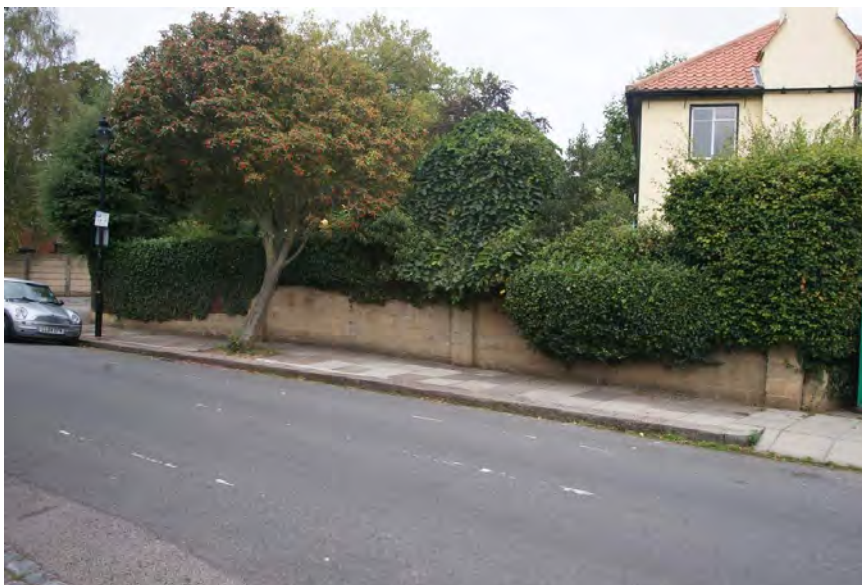
First section of the wall, with 32 Brookfield Park to the right edge of the photograph

Starting from where 34 Brookfield Park adjoins the neighbouring 32 Brookfield Park, the wall goes north-west along Brookfield Park, towards St Albans Road. This first section is made from unfinished concrete blockwork, some of which is obscured by

mature vegetation on the garden-side of the wall drooping over onto the street side.

- to retain the line and height of the existing garden perimeter wall,
- to retain the blockwork section of that wall, repointing and repairing where required,
- to replace the concrete post and panel sections with close-textured finish blockwork;
- to replace the wooden palings section of the existing wall with close-textured finish blockwork;
- to paint it an ivory colour with textured masonry paint; and
- to replace the existing swing gate with a sliding painted steel gate, remotely operated.

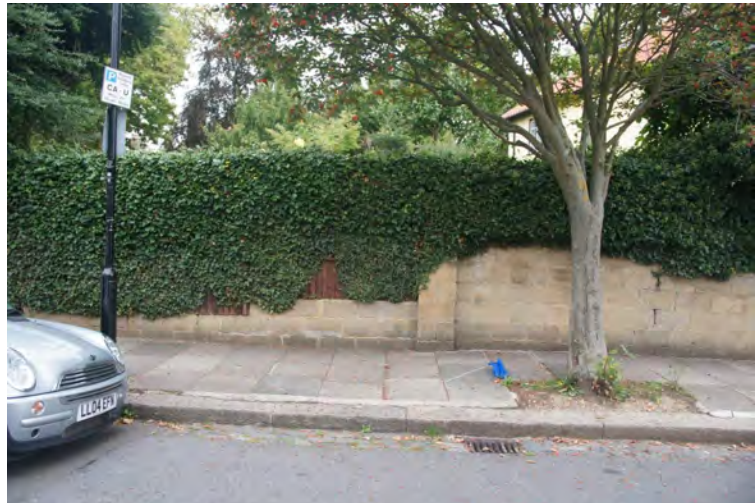
The second section of the wall, still in Brookfield Park but further north-west towards St Albans Road, comprises a short section comprising a lower layer of unfinished blockwork, varying in height between 350mm to 660mm, and an upper layer of dark brown painted wooden palings on top of the blockwork.

Second section of the wall, showing wooden palings on top of blockwork

Most of the wooden palings are covered with a vine which has its roots in the garden.

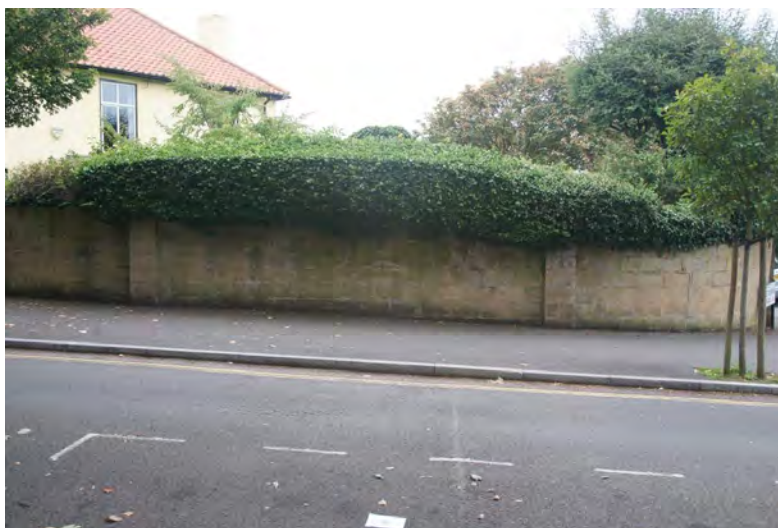
The third section of the wall is a resumption of the unfinished concrete blockwork,

Third section of the wall, from St Albans Rd

some of it appearing to be more recent than the remainder (having a more uniform grey colour than the rest). This third section curves around into St Albans Road and continues in a north-easterly direction up St Albans Road until it gets to the entrance gate to 34 Brookfield

Park. Mature, dense foliage from the garden of 34 Brookfield Park sits on top.

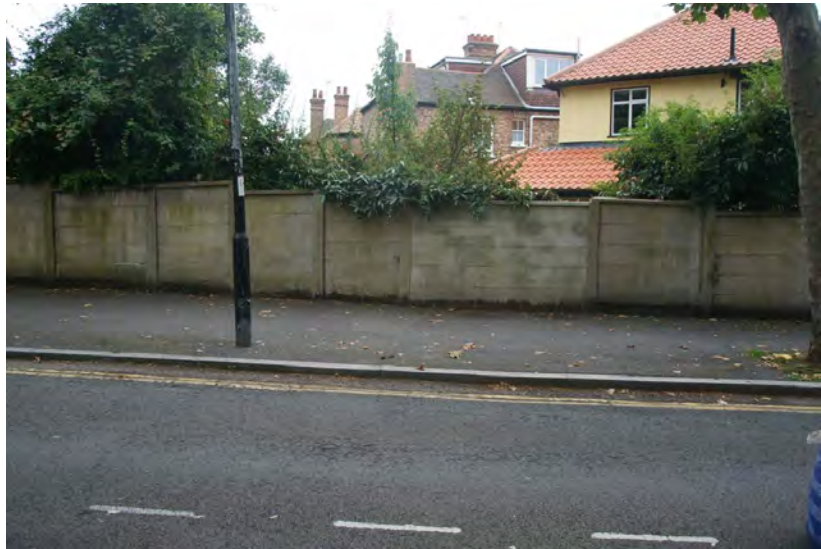
The fourth section of the wall runs in a north-easterly direction along St Albans Road from the entrance gate to 34 Brookfield Park to the gates leading to the forecourt and detached garage of 34 Brookfield Park. Along this section, the wall is made from slotted concrete posts into which horizontal pre-cast concrete panels spanning between the posts have been inserted. The spans between the concrete posts are uneven, varying from 1.23m to 1.71m (measured between posts). Between one of the sets of posts the panels have been replaced with rendered blockwork.

Fourth section of the wall, including the section made from rendered blockwork.

The wall adjacent to St Albans Road does not quite form a straight line and the unevenness is made more pronounced by differing amounts of leaning of the posts and of the panels within them. The lean of the posts has caused some of the panels to come out of their slots. So far none have fallen out, but pedestrian safety is becoming an issue.

As a matter of safety, both to the public using the footpath on St Albans Road and to occupiers and visitors to 34 Brookfield Park, the slotted post and panel sections of the wall need replacing. This is evident from the photographs. The concrete panels are very heavy and are capable of inflicting considerable injury. It is unlikely that they will give any warning before collapsing.

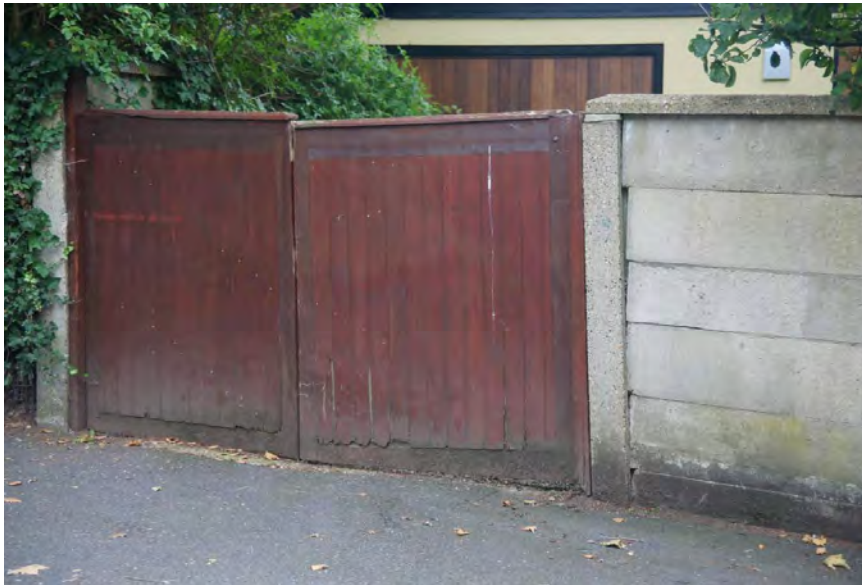
At the north-east end of fourth section of the wall there is a double wooden hinged gate, allowing access to the garage and standing in front of it. Each gate is attached to a slotted concrete post.

The gates are in an advanced state of decay.

Gates leading to forecourt and garage

The material and colour of the replacement gate to the garage are intended to complement those of the house (the black wooden frames to the steel casement windows contrasting with the light-coloured render). The simple linear design avoids embellishment with unnecessary features, consistent with the design of the house. The sliding gate is the same height as the wall, thereby continuing the line of the wall as well as enabling better use of the garage forecourt (as there is little room to close swing gates with a vehicle in the forecourt area). The opening mechanism will comply with all safety requirements (pressure strips, 24V operation and photocells).

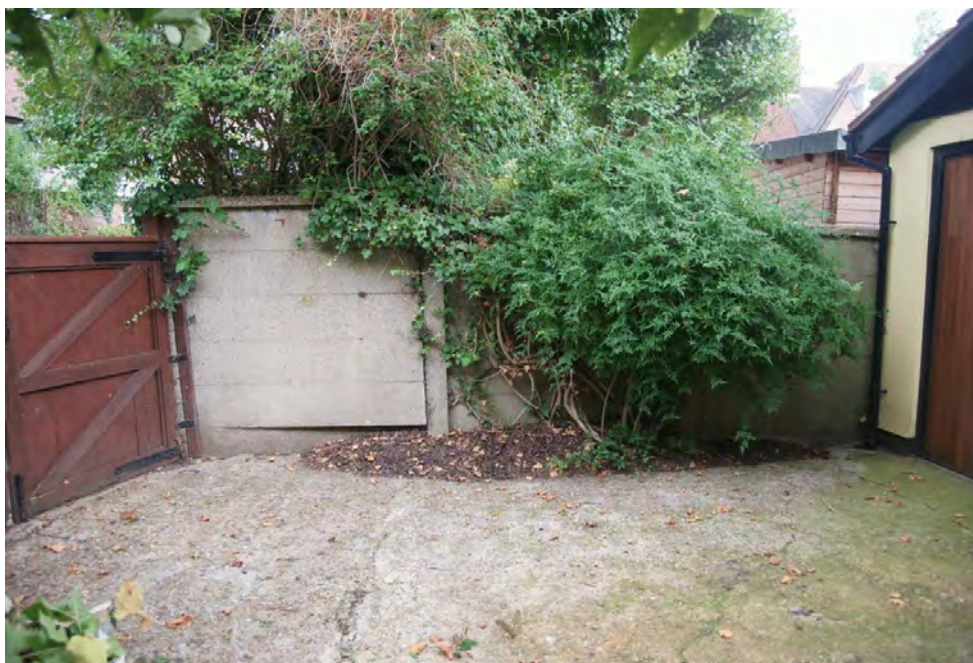
Fifth section of the wall, St Albans Rd to left, garage to right

application, the last section) of the wall is a section that separates 34 Brookfield Park from the property at 47 Kingswear Road (owned by LB Camden) until it reaches the

garage on 34 Brookfield Park. This section of the wall is also made from concrete posts and panels. It is partly covered by foliage.

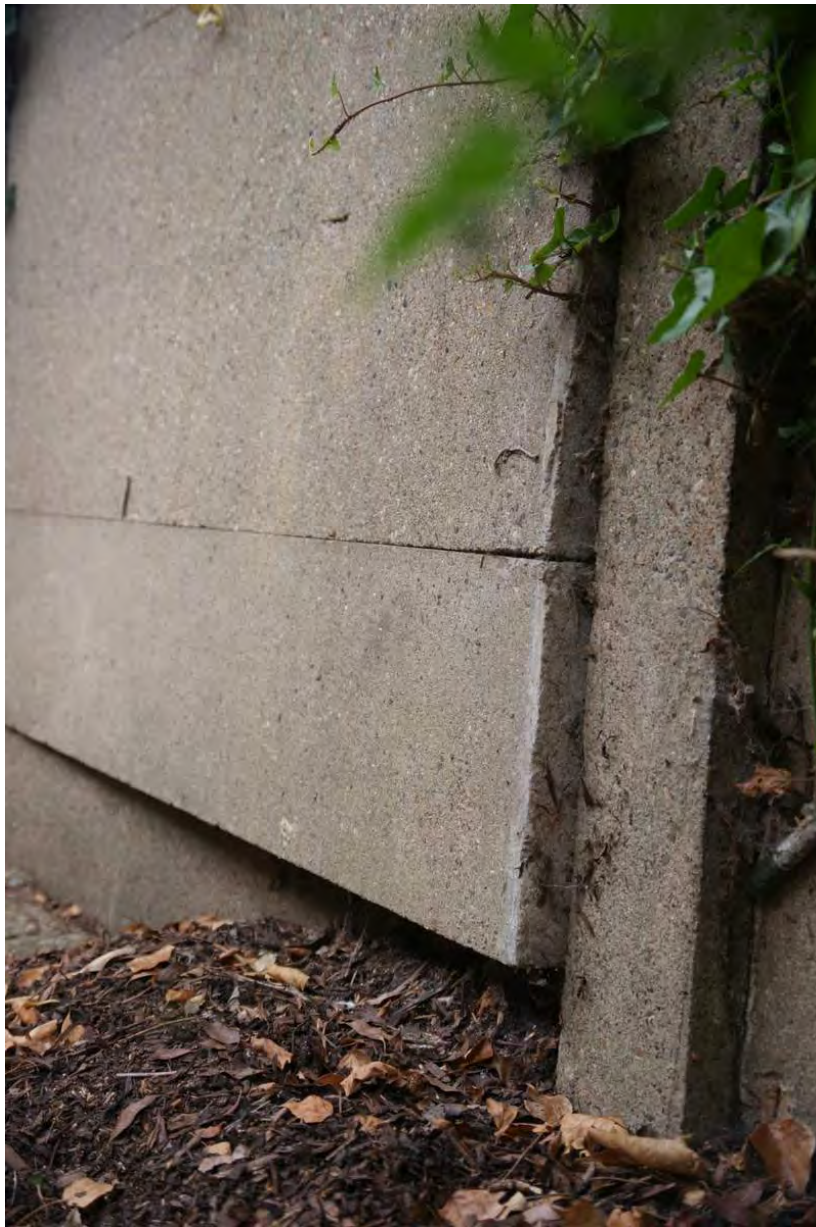
The fifth section of the wall is also leaning considerably, with a number of concrete

panels well out of their slots and jutting beyond the face of the posts. Occupier safety is an issue.

Panels on the fifth section of wall clear out of slotted post

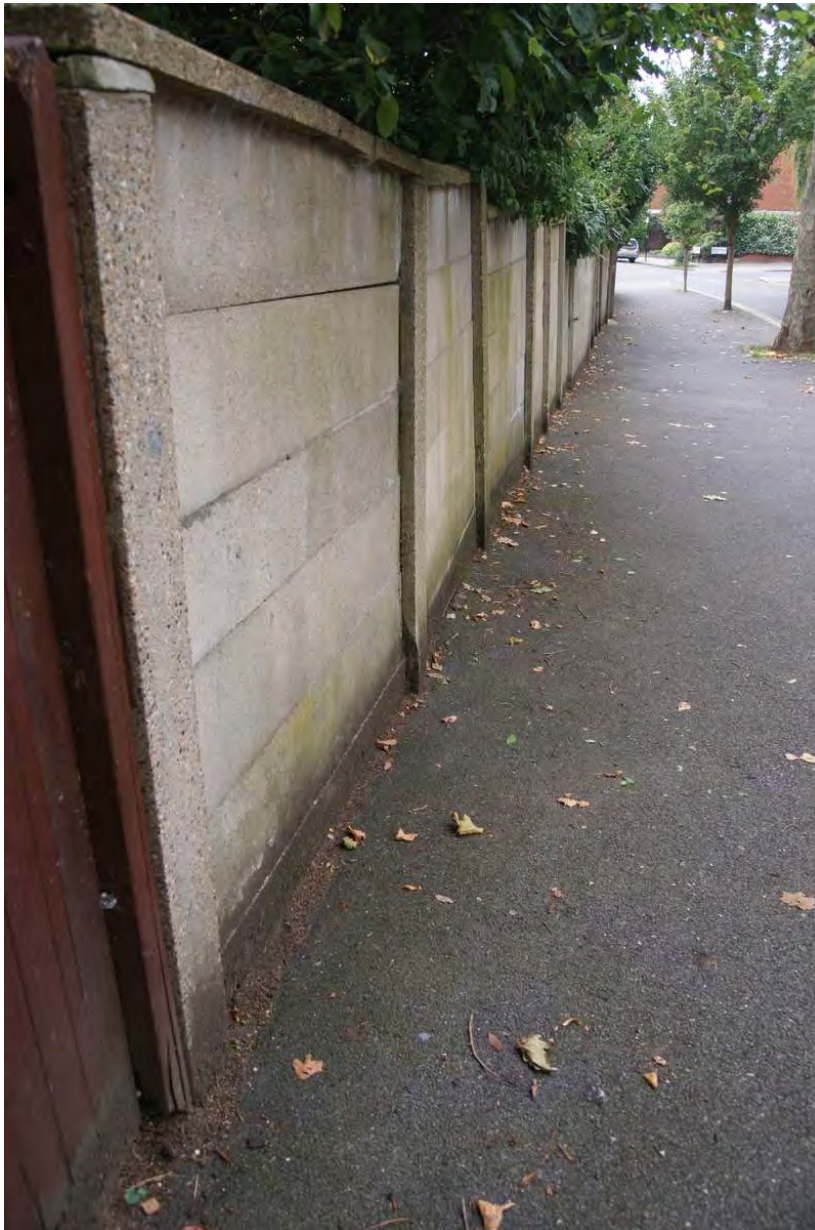
As is apparent from the above, there is no uniform style to the materials or appearance

of the wall. The drab and rough materials are in contrast to house itself, which is rendered neatly, and the garden wall's appearance is only softened because of the dense, mature foliage which grows over and above it, supported in part by trellises.

The wall looking down St Albans Rd towards Brookfield Pk

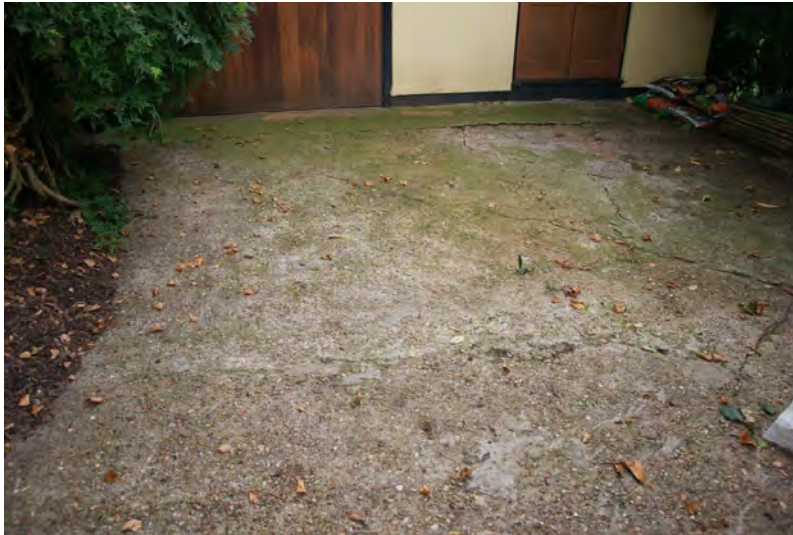
The forecourt to the garage is made from rough, unscreeded, in-situ concrete in an

advanced state of deterioration, with significant cracking and spalling evident

Garage forecourt

- to replace the existing concrete in the forecourt of the garage with granite sett paving; and
- to re-build to the same dimensions and in the same approximate position the composting containers.

These are both minor works of improvement. At the moment, the garage forecourt is made from cracked rough concrete area and is undrained. The replacement will be level, a superior surface and drained into the garage system (rather than across the pavement into the gutter, as at present). Both materials and drainage will be an enhancement. The replacement compost bins will be properly ventilated to ensure rapid decomposition.

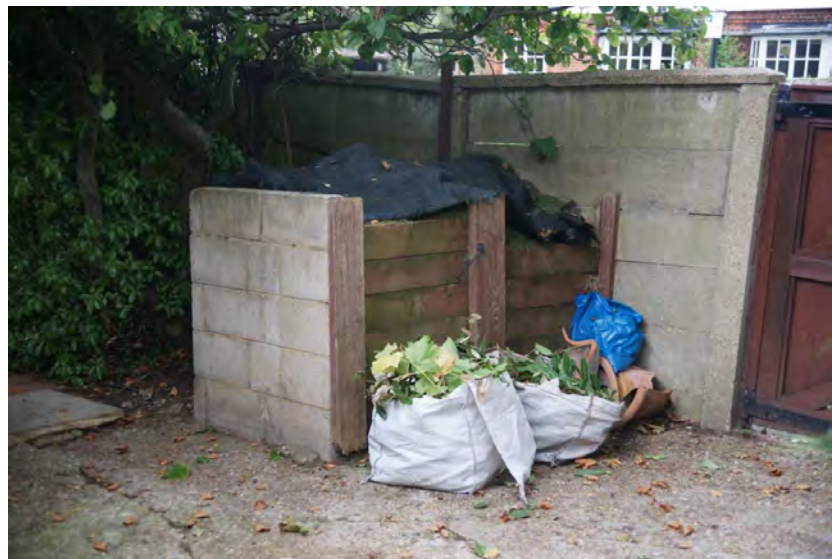
There is a double compost bin made from concrete blockwork adjacent to the wall where it meets the gate.

Compost bins
