**75 Bayham Street
Camden Town
London
NW1 0AA**

Contaminated Land Desk Based Assessment

November 2014

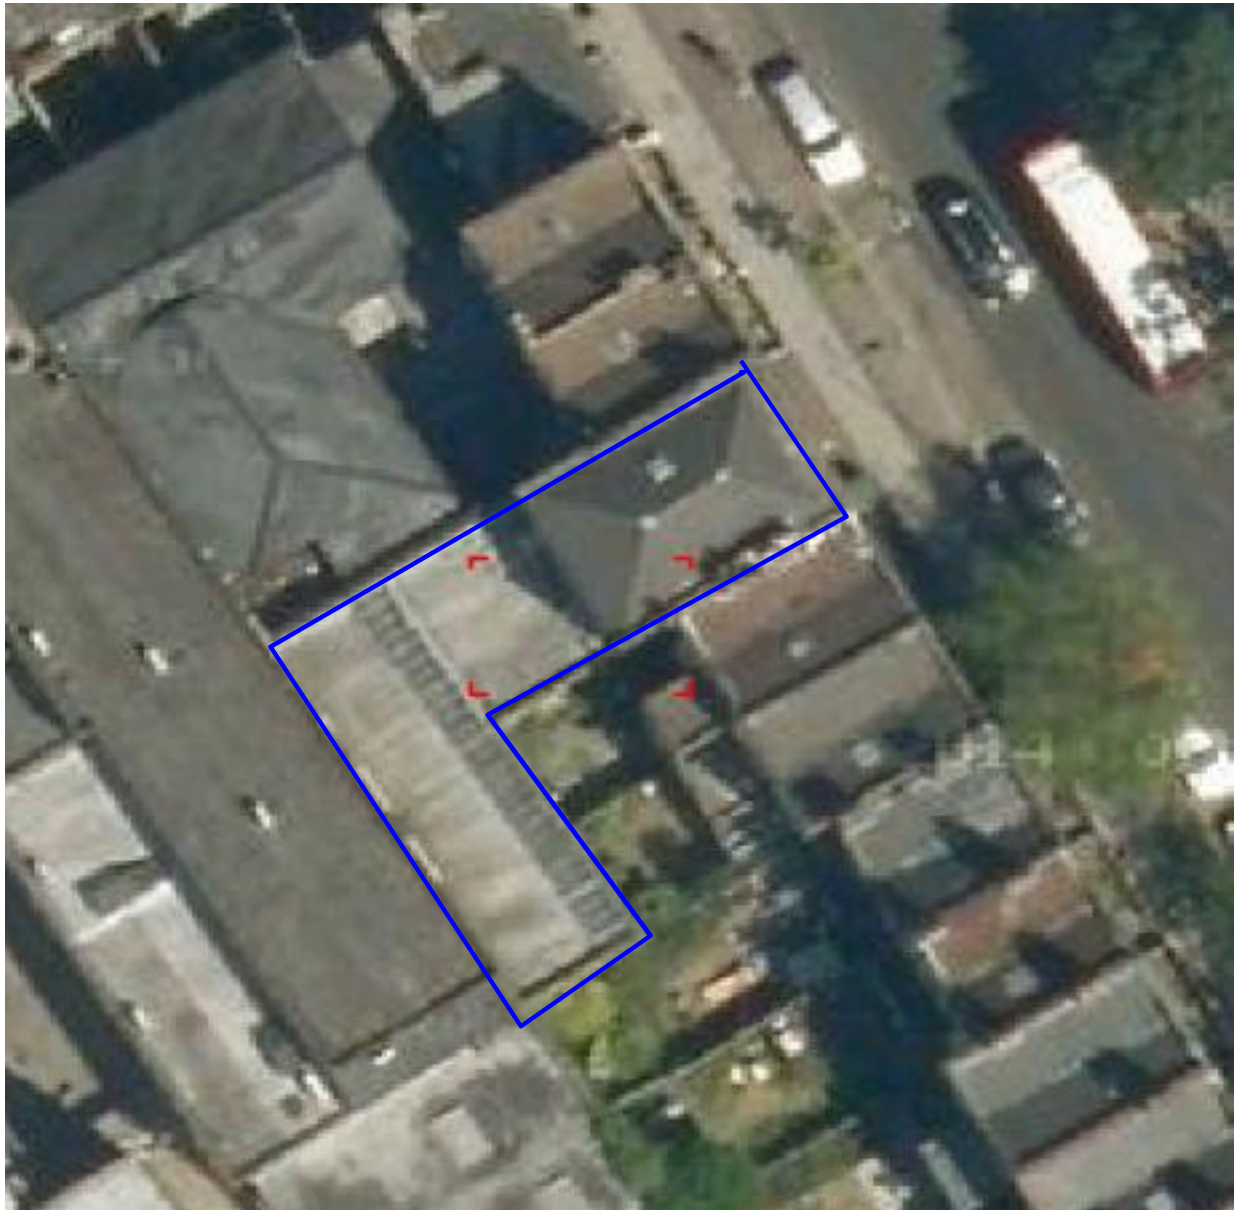
The site boundary has been defined using the boundary indicated on the unreferenced plan provided by WYG Planning on the 23rd October 2014 (Figure SK02).

A site walkover was undertaken by WYG on 20th November 2014. The site occupies an 'L' shaped area as shown on the layout drawing SK02. The selected site photographs identified in the text below are provided in Appendix C.

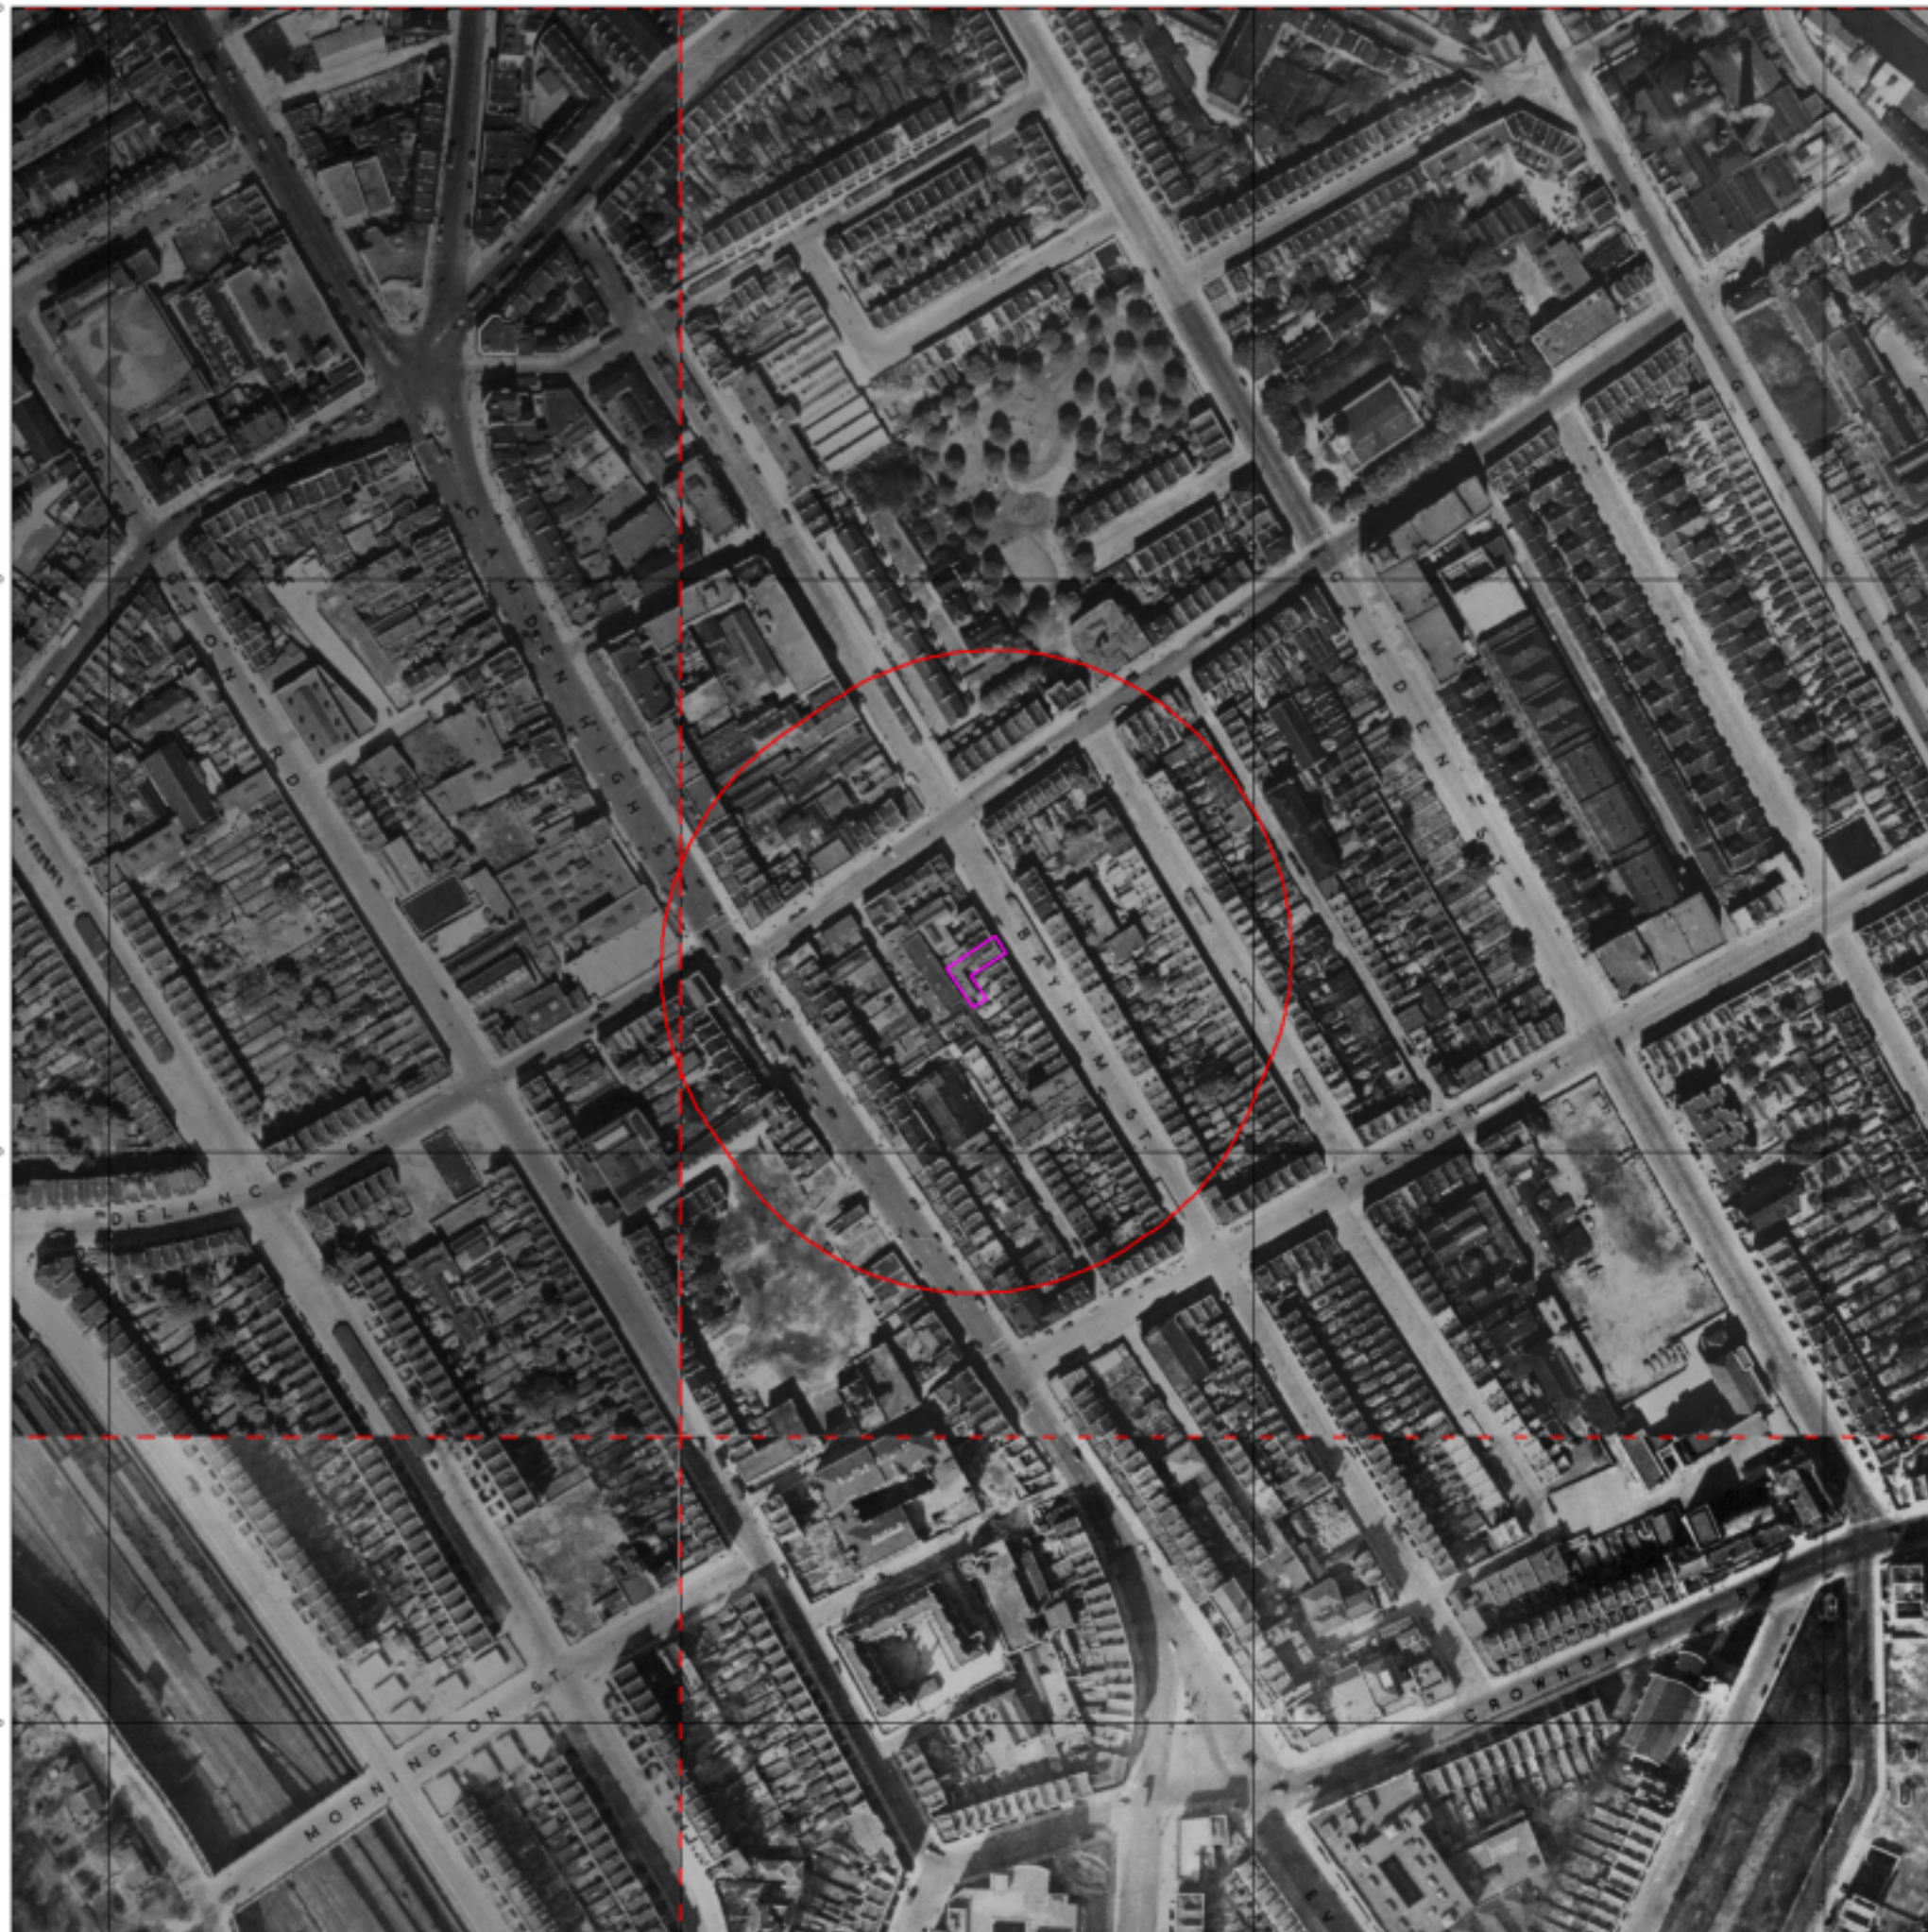
The Historical Aerial Photos were produced by the Ordnance Survey at a scale of 1:1,250 and 1:10,560 from Air Force photography. They were produced between 1944 and 1951 as an interim measure, pending preparation of conventional mapping, due to post war resource shortages. New security measures in the 1950's meant that every photograph was re-checked for potentially unsafe information with security sites replaced by fake fields or clouds. The original editions were withdrawn and only later made available after a period of fifty years although due to the accuracy of the editing, without viewing both revisions it is not easy to spot the edits. Where available Landmark have included both revisions.
