23 DOWNSIDE CRESCENT

APPENDIX B – SITE INVESTIGATION REPORT

Desk Study and Ground Investigation Report

**23 Downside Crescent
London NW6**

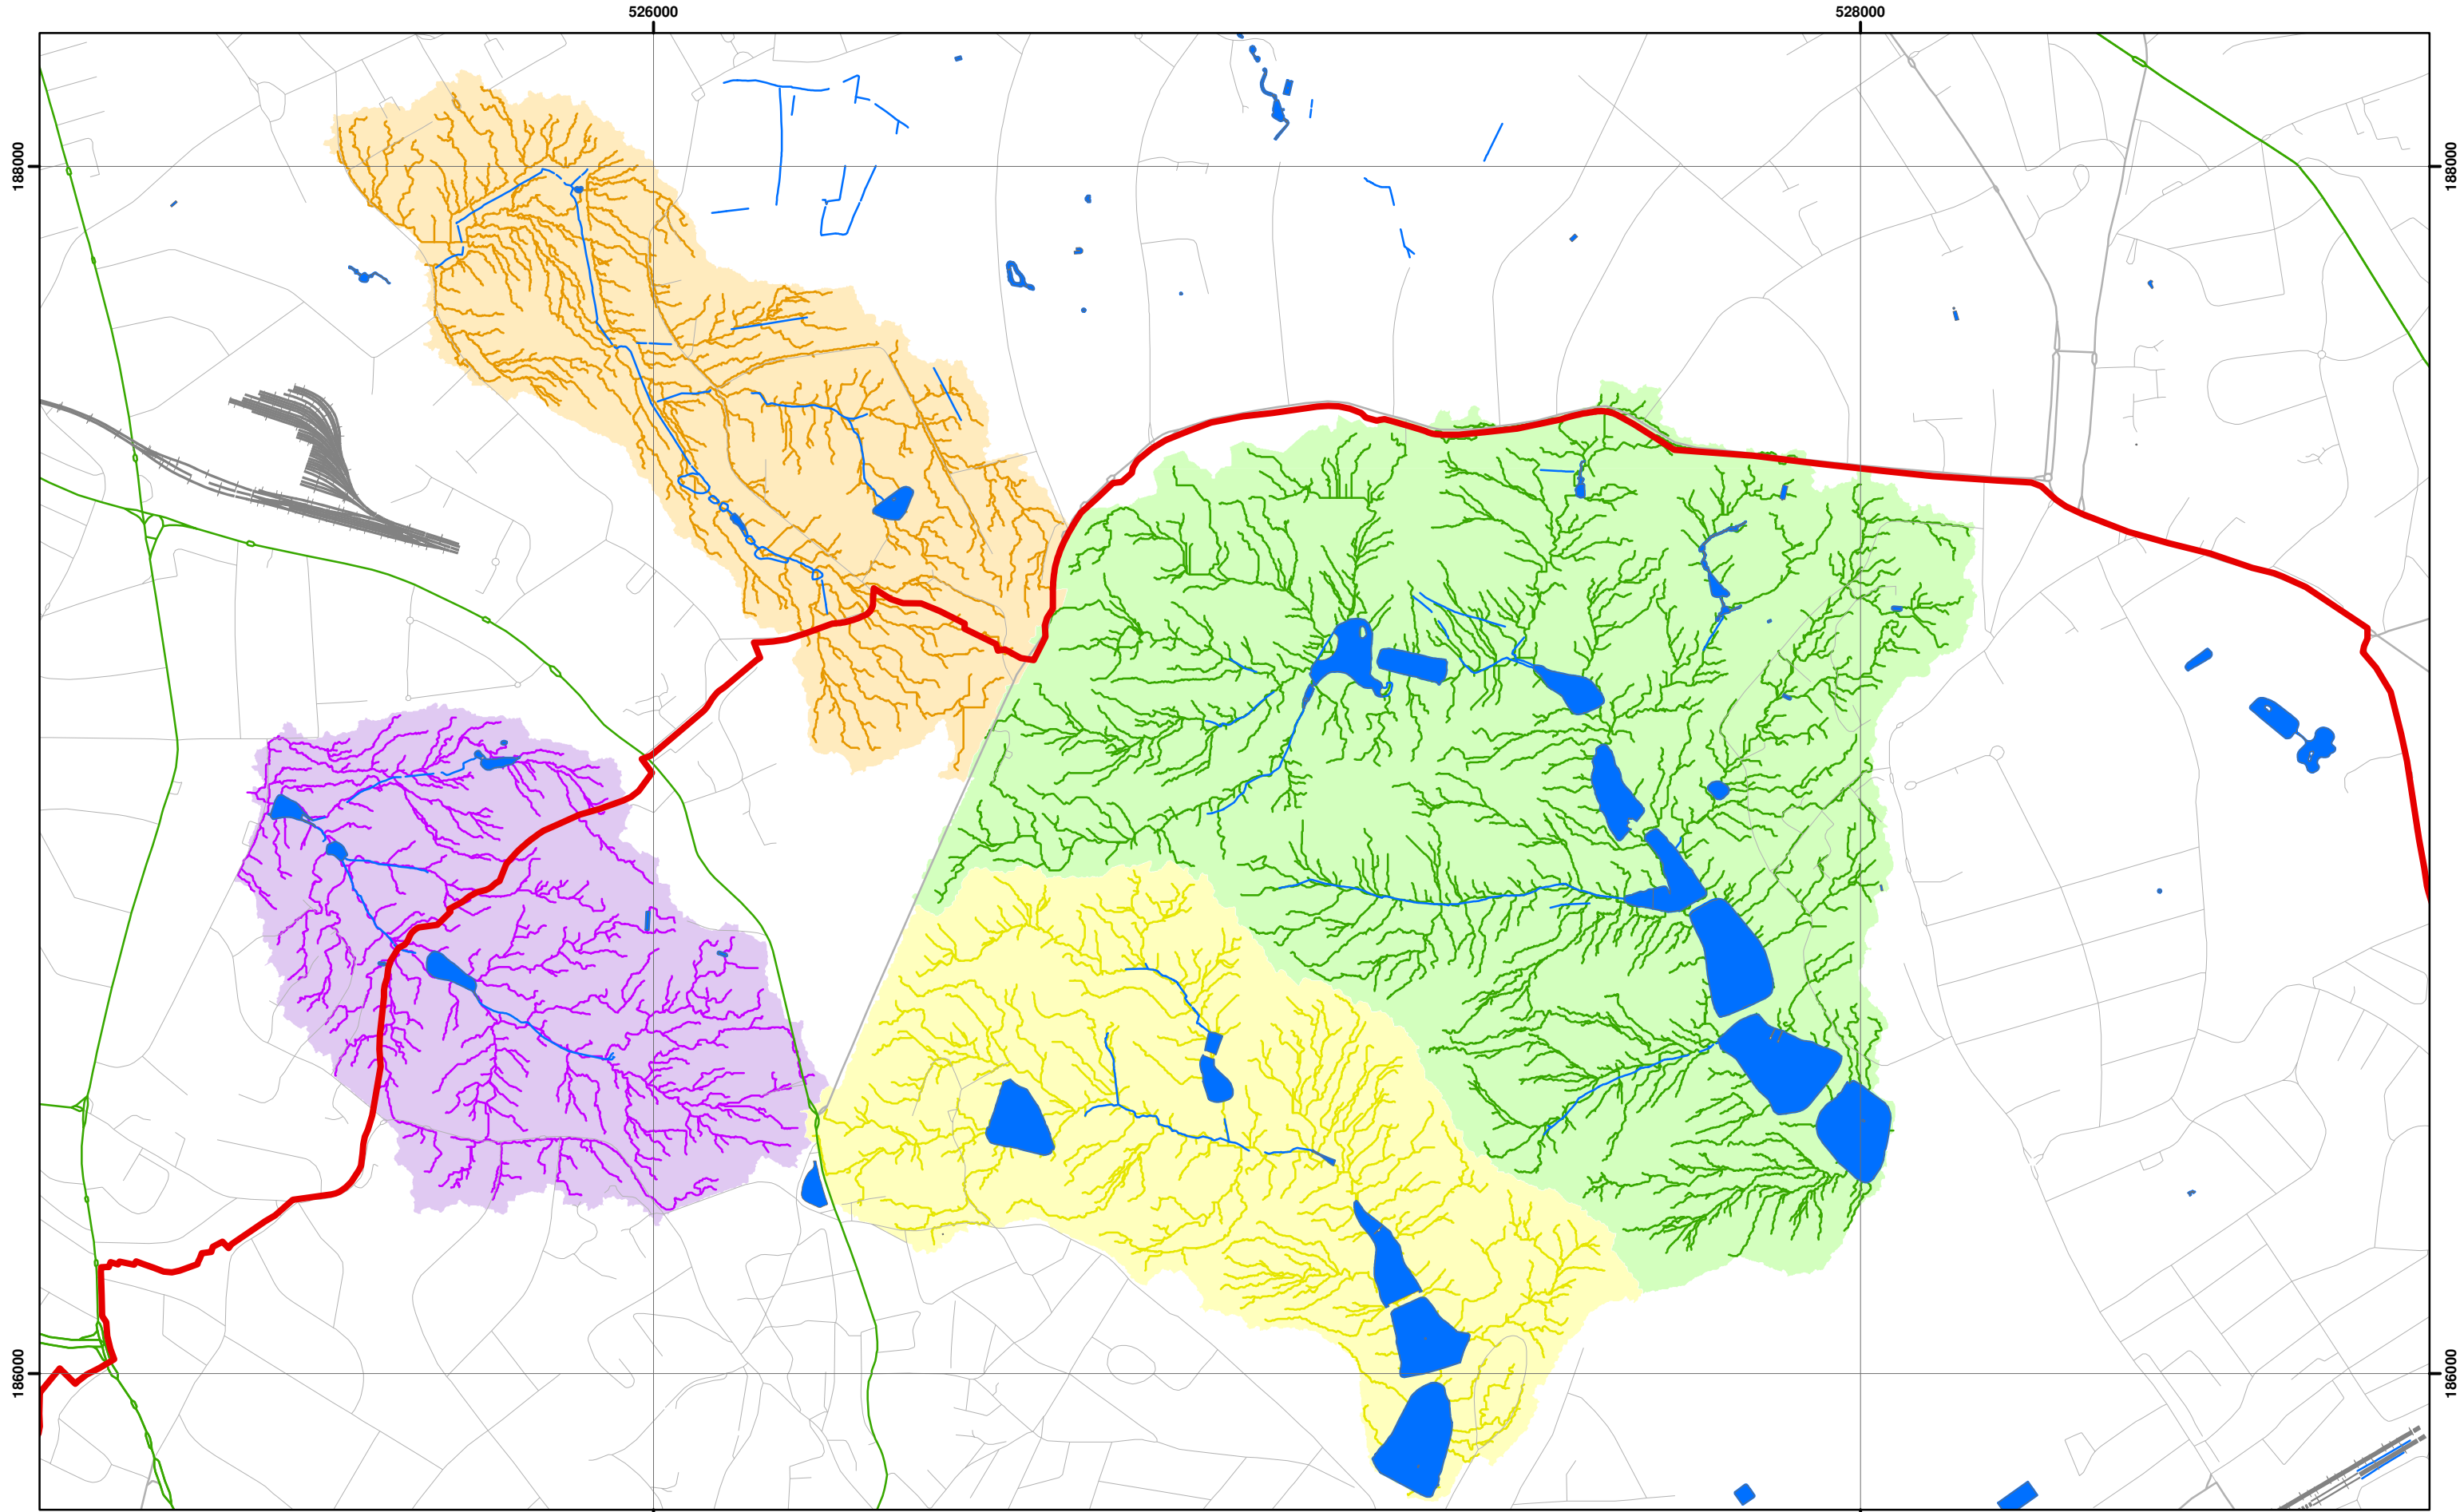
FIGURE **14**

Catchments and Drainage after Haycock, 2010

Hampstead Heath Surface Water
Catchments and Drainage

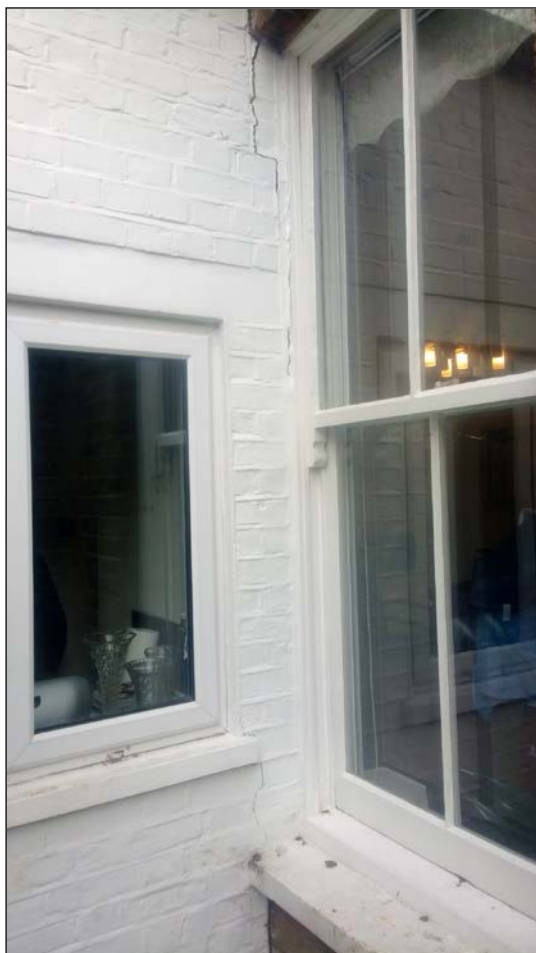
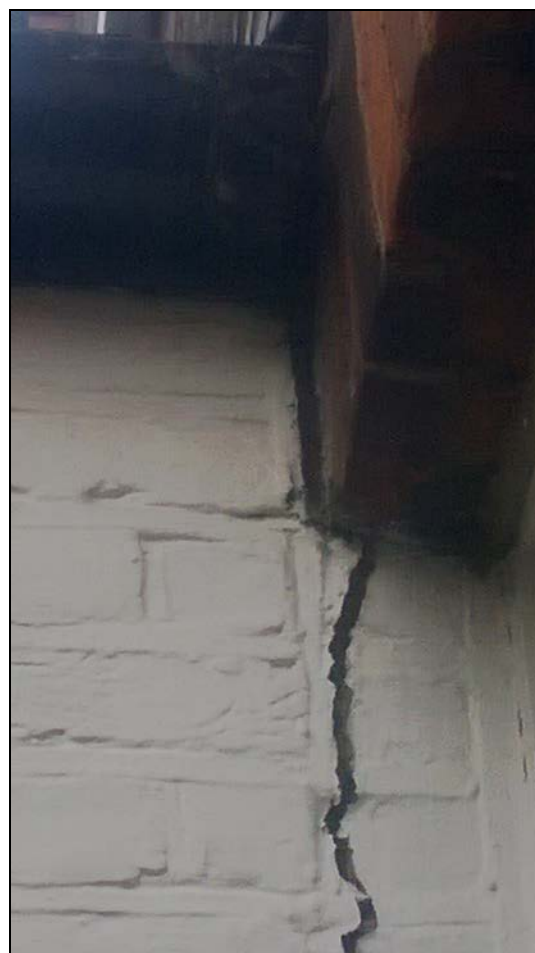
The property is showing some indications of movement, with 5 mm to 20 mm wide cracks present between the extension and main house which suggest rotation towards the rear where the extension appears to be suffering from subsidence. The rear garden is laid to lawn with hedges, flower beds and 8 m to 10 m tall semi-mature deciduous trees, and a 22 m tall mature deciduous tree outside the rear of the property. The front garden has a surface covering of gravel with flower beds around the perimeter. The level of the ground floor level and rear garden level is approximately 1.00 m above street level and the local topography slopes gently down towards the northeast.

During the site walkover, it was noted that it appears that the single storey extension is suffering from subsidence, and cracks of between 5 mm and 20 mm in width are present between the main house and the rear single storey extension, becoming widest at the top (see photos below). The pattern of cracking is indicative of rotation of the extension away from the house, and the presence of cracking in the wall of the main section of the house suggests that the extension is pulling the wall from the main house with it.

It was noted during the site walkover that it appears that the rear extension is suffering from movement, which could be as a result of desiccation due to tree roots, although more information is required to make a judgment in this respect. The rear extension will need to be underpinned to mitigate the effects of further subsidence, but further investigation of possible causes of the movement will be required to determine the depth of underpinning required.

It appears from the site walkover that the single storey extension is suffering from subsidence, and cracks 5 mm to 20 mm wide are present between the main house and the rear single storey extension, with the pattern of cracking suggesting rotation away from the main house.

There are additional factors such as the presence of tunnels and nearby construction work that could have resulted in movement of the property. At this stage it is considered that the effect of trees is likely to be a contributory cause.

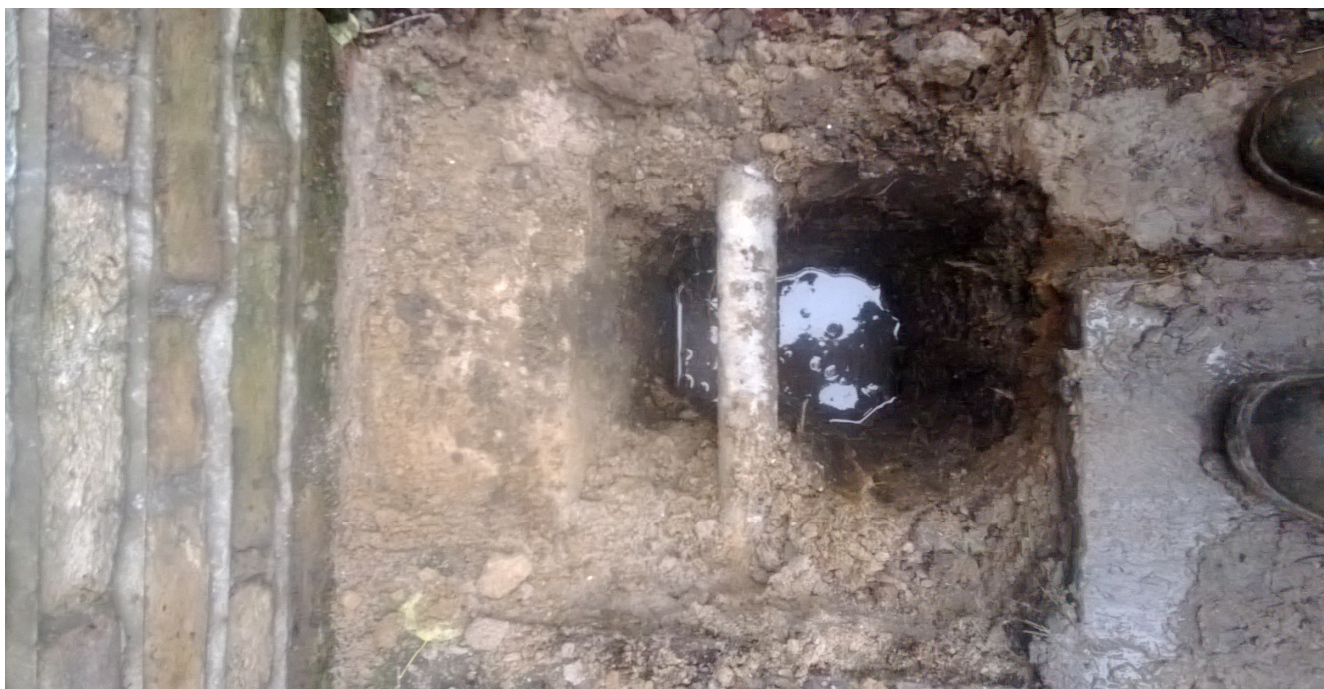
In Trial Pit No 1, rare subrounded flint cobbles less than 120 mm were found in the London Clay, and in Trial Pit No 2, black clay pockets and roots were encountered.

Trial Pit No 1 was excavated adjacent to the shared wall with No 21 within the rear garden, and found the wall to be supported by a concrete footing bearing on London Clay at a depth of 1.20 m.
