**NO.3 DOWNSHIRE HILL, HAMPSTEAD  
ARBORICULTURAL IMPACT ASSESSMENT  
TREE RETENTION AND PROTECTION – METHOD STATEMENT  
Revision 01: Date; 13<sup>th</sup> November 2014**

- 1.4 The Tree Retention and Protection Proposals at No.3 Downshire Hill comprise the following;  
*LLD622 / 02 – Tree Protection Plan;*  
*LLD622 - Arboricultural Impact Assessment and Method Statement;*  
*Appendix No. 1 - Site Photographs.*

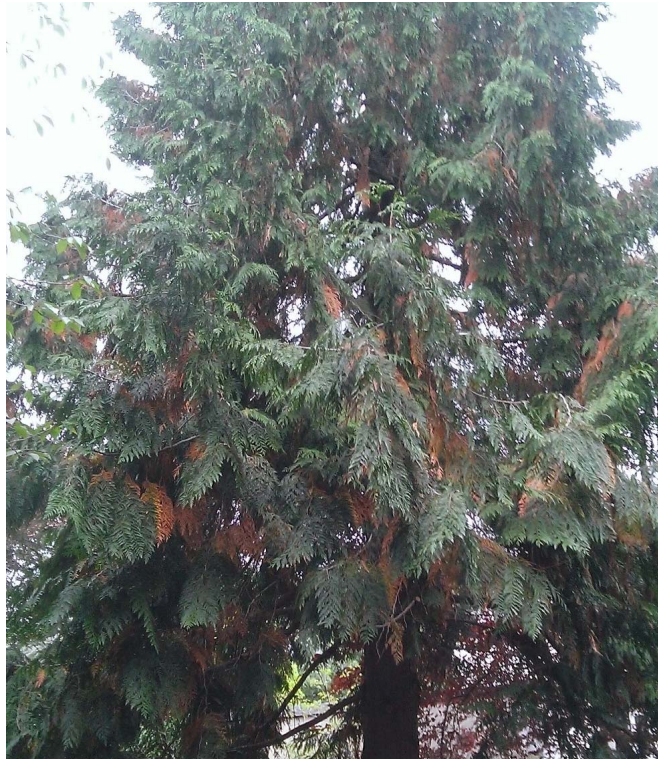
**Photograph No. 01 - T 01 - *Thuja plicata* - Mature Western Red Cedar tree to the northern garden area. The tree is single-stemmed, tall, and upright.**

- 2.1 A detailed tree survey within No. 3 Downshire Hill, Hampstead was undertaken on the 11<sup>th</sup> October 2013. There are 2 no. mature trees species of coniferous and deciduous tree species located within the northern garden area. *T01 – Thuja plicata (Western Red Cedar Tree)* is a single stemmed Western Red Cedar tree which is tall and upright with pendulous lower branches. The tree has been crown-lifted to 4.0 metres height through tree surgery works. The needles are showing signs of minor browning to the ends of the branches. The tree is tall and upright with long pendulous branches arching down into the garden area. The tree dominates the northern garden area (*Refer to Photographs No. 01, 02, and 03 – Appendix No. 1*).

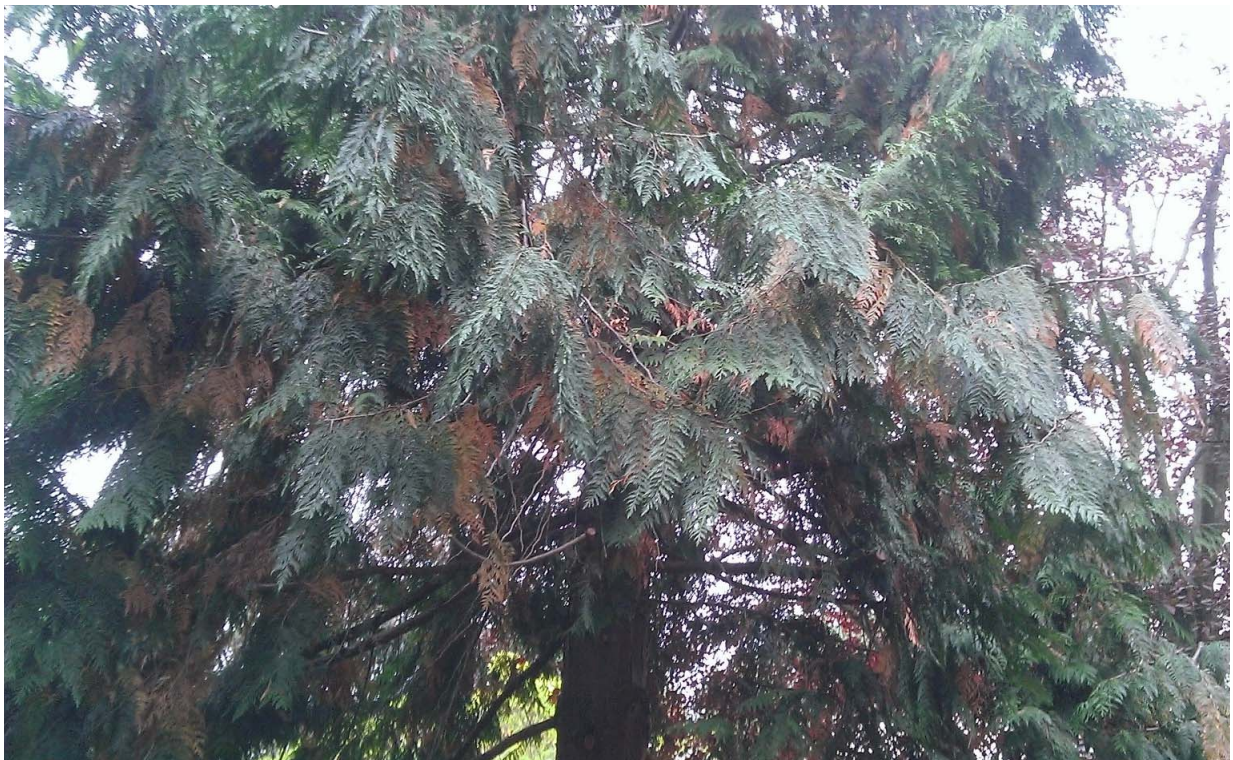
**Photograph No. 02 - T 01 - *Thuja plicata* - Mature Western Red Cedar - The tree has pendulous hanging branches and needles; with minor browning to the end of the branches.**

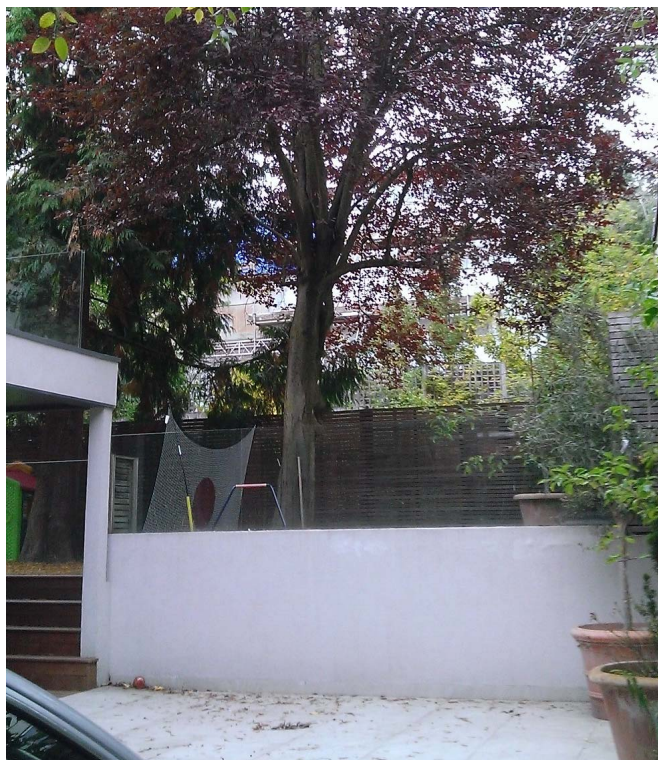
**Photograph No. 06 - T 02 - *Prunus cerasifera* 'Pissardii' - The cherry plum tree is located above the car park area retaining wall of 0.95 metres height.**

- 2.2 *T02 - Prunus cerasifera (Cherry Plum)* is a single stemmed purple plum tree which forks at 2.5 metres height into 4 - 5 no. conjoined leaders. The branches are included and conjoined with multiple stems to approximately 4.0 metres height. The stems are thick, tall, and upright. The lower outer branches are pendulous and ascending into the rear garden area. The tree has a good spreading feathery tree canopy form (*Refer to Photographs No. 04, 06, and 07 – Appendix No. 1*).

- 3.1 The existing mature trees within the northern garden area at No. 3 Downshire Hill are located above the existing dwelling house within the site. The property has been excavated and cut into the existing ground and is located at a finished floor level of approximately 1.0 metres beneath the level of the northern garden area where the existing trees are located. This has been achieved with the use of retaining walls, and structural walls within the property which create a retaining structure against the existing garden area. In creating these retaining structures the existing tree roots would have already been cut within the specified tree root protection areas of these existing mature trees (Refer to Photographs No. 04, 05, 06 and 07 – Appendix No. 1).

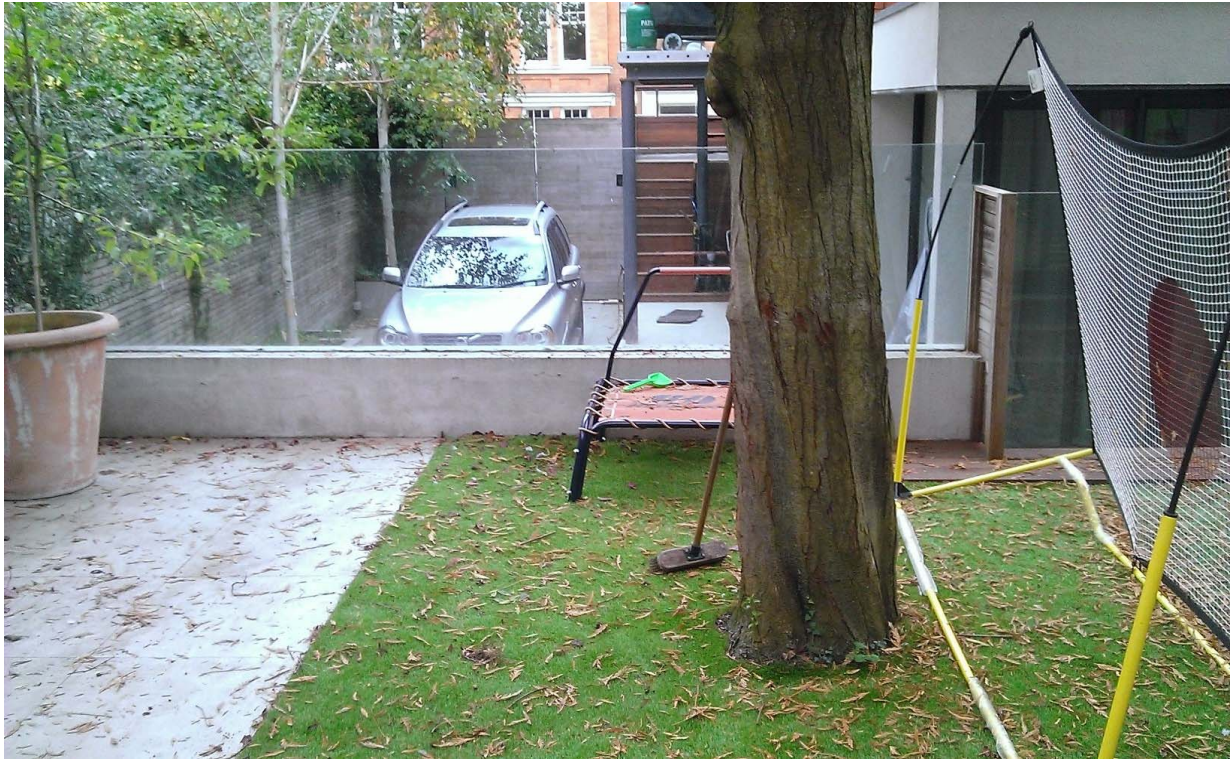
**Photograph No. 07 - T 02 - *Prunus cerasifera* 'Pissardii' - The single stemmed cherry plum tree is located above the car park area retaining wall of 0.95 metres height.**

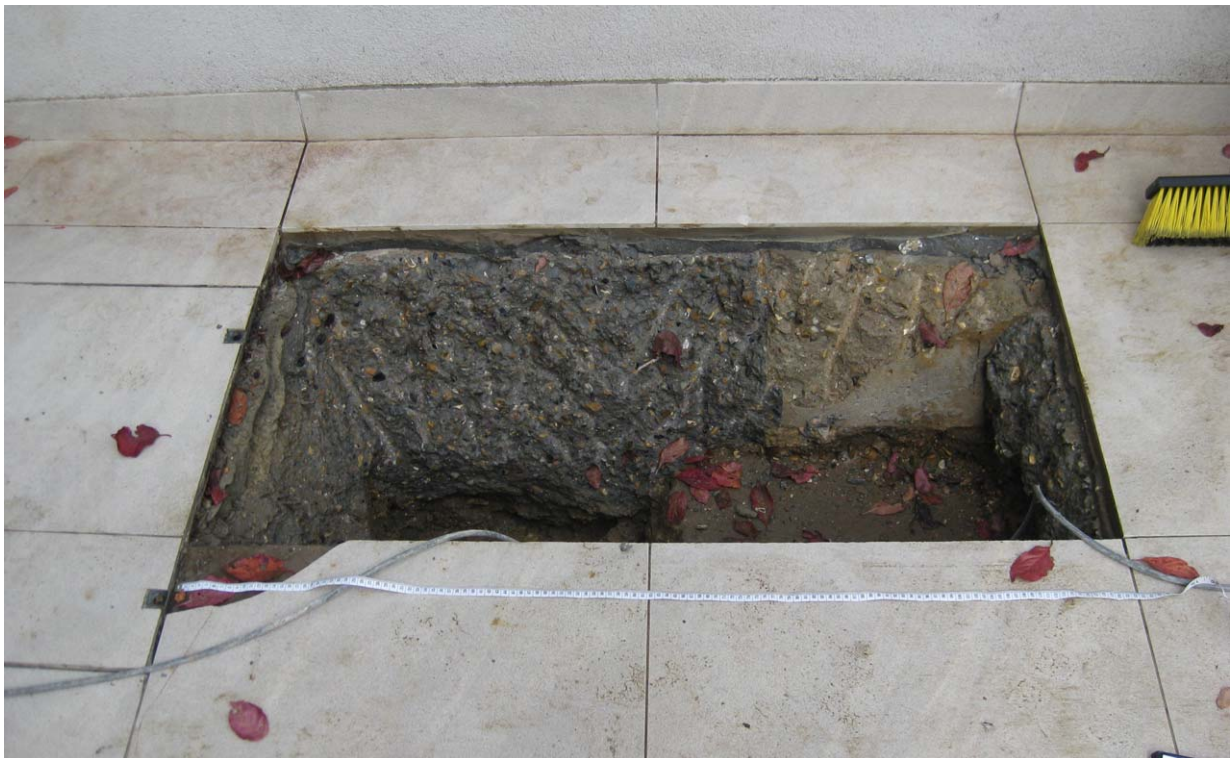
- 3.4 Trial Holes No. 1 to the western edge of the existing terrace was dug within the root protection area of T01 – *Thuja plicata* and T02 – *Prunus cerasifera ‘Pissardii’*. The trial holes was implemented to the following dimensions; 1220mm length x 610mm width x 850mm depth (Refer to Photograph No.s 08, 09, and 10). The trial hole demonstrates the depth of the sub-base construction beneath the existing retaining walls adjacent to the existing property, and the significant depth of concrete footing beneath the existing paving. The occurrence of the existing topsoil / subsoil layer was located extremely deep beneath the concrete footing. At this depth only very fine, small, and fibrous tree roots of the adjacent conifer tree were found in this trial hole. There were no significant tree roots found in close proximity to the development proposals.

**Photograph No. 08 - *Trial Hole No. 1* - The trial hole demonstrates the depth of concrete sub-base beneath the existing paving area. The existing topsoil / subsoil layer is located at a significant depth below the paving surface.**

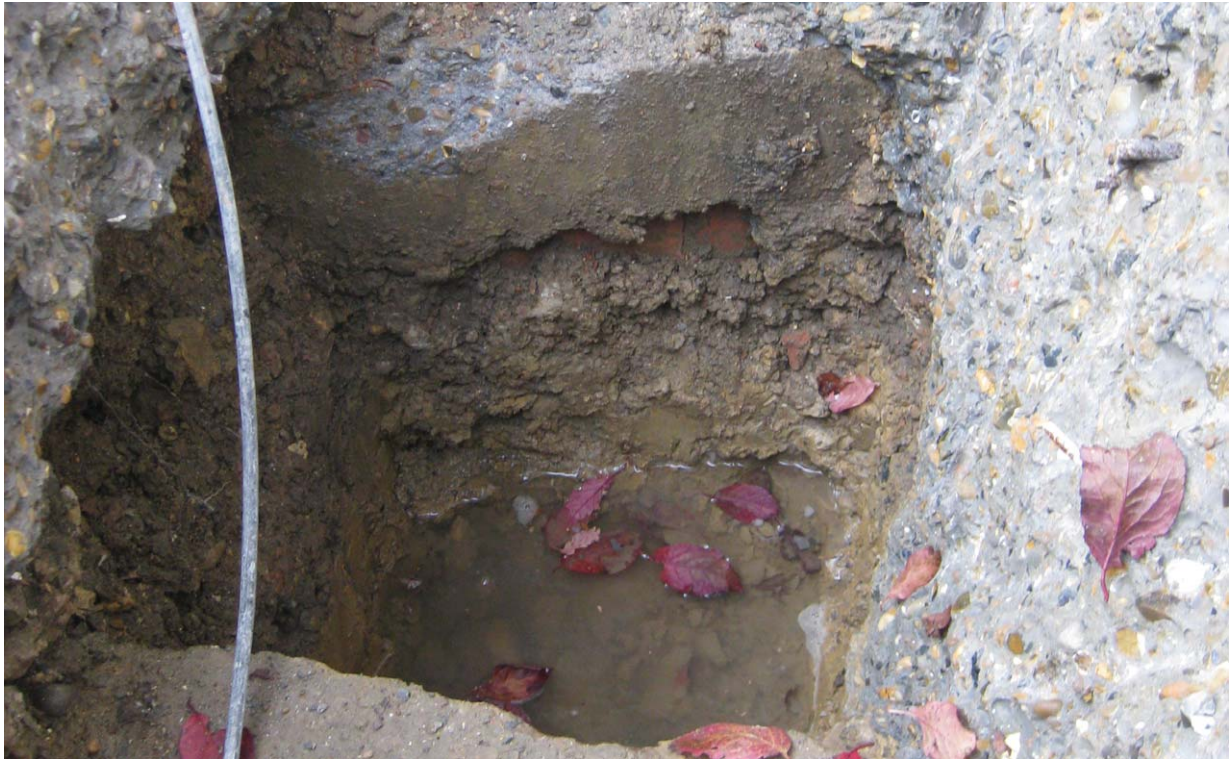
**Photograph No. 09 - *Trial Hole No. 1* - The trial hole demonstrates the depth of concrete sub-base beneath the existing paving area. The existing topsoil / subsoil layer is located at a significant depth below the paving surface.**

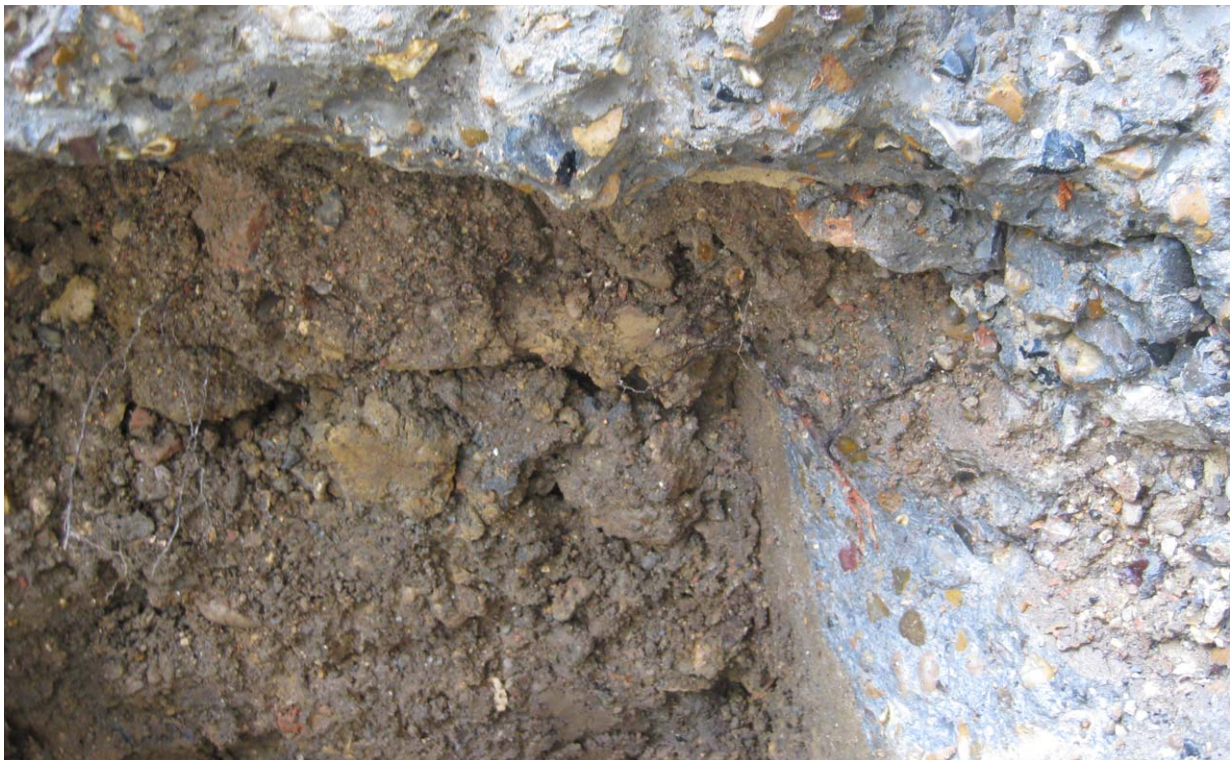
**Photograph No. 10 - *Trial Hole No. 1* - There were no significant tree roots found within the trial hole, only small fibrous tree roots beneath the concrete sub-base layer of the adjacent conifer tree.**

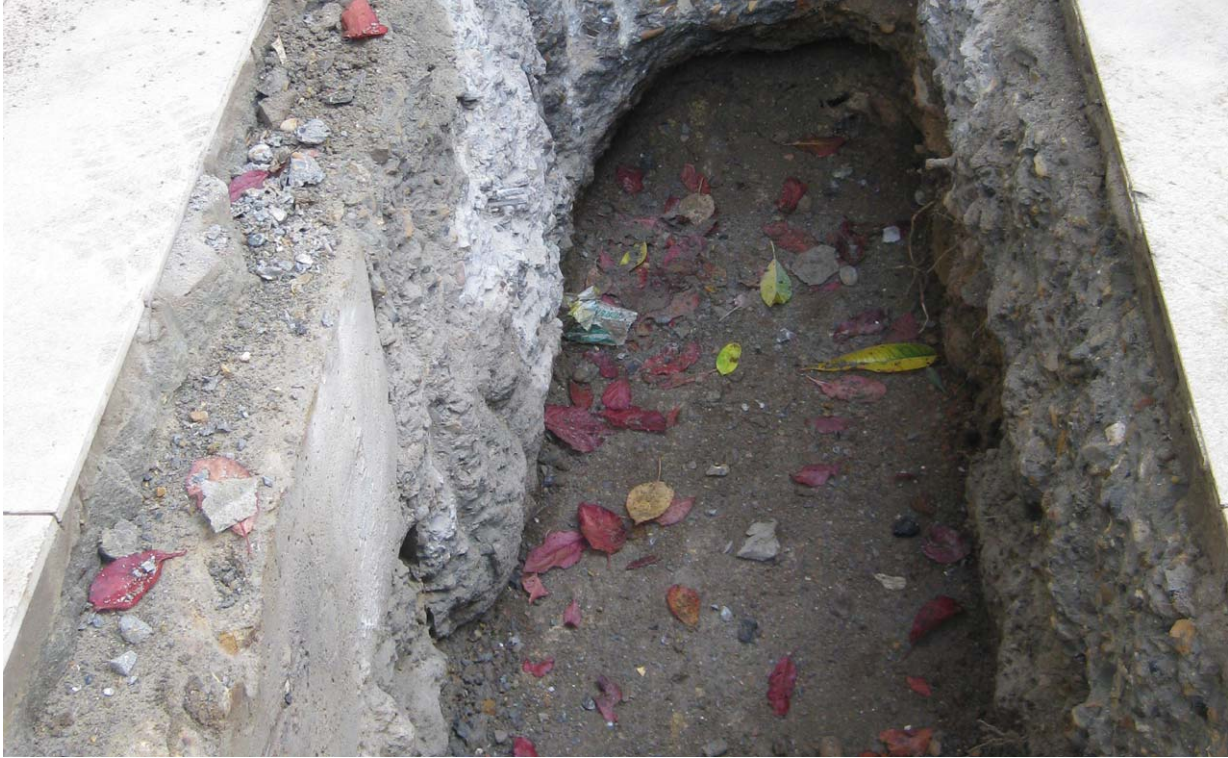
3.5 Trail Hole No. 2 to the eastern edge of the existing terrace was dug through the existing paving area within the root protection area of T02 – *Prunus cerasifera 'Pissardii'*. The trial hole was implemented to the following dimensions; 1600mm length x 400 width mm x 600mm depth (Refer to Photograph No.s 11, 12, and 13) Again, the trial hole demonstrates the depth of the sub-base construction beneath the existing retaining walls adjacent to the existing property, and the significant depth of concrete footing beneath the existing paving. The occurrence of the existing topsoil / subsoil layer was located extremely deep beneath the concrete layer into the trial hole. At this depth only very fine, small and fibrous tree roots of the adjacent plum tree were found in this trial hole around the existing drain. There were no significant tree roots of the adjacent tree found in close proximity of the development proposals.

**Photograph No. 11 - *Trial Hole No. 2* - The trial hole demonstrates the depth of concrete sub-base beneath the existing paving area. The existing topsoil / subsoil layer is located at a significant depth below the paving surface.**

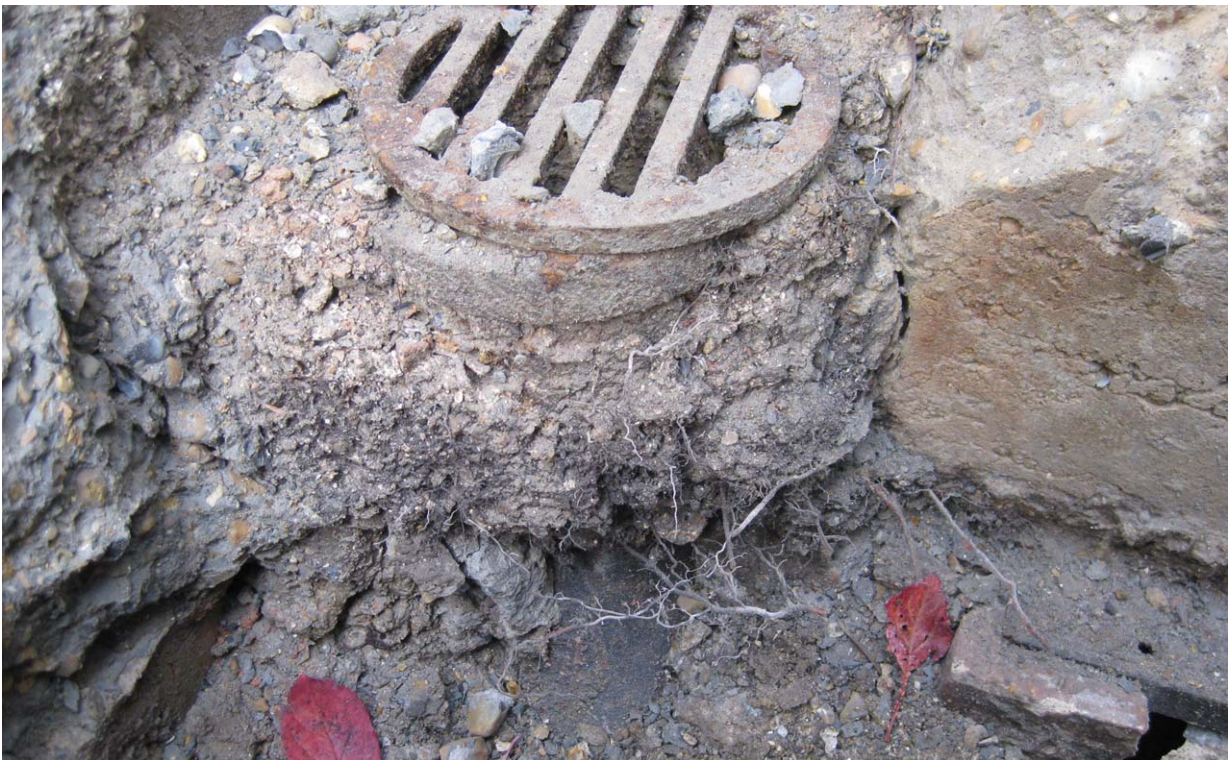
**Photograph No. 12 - *Trial Pit No. 2* - There were no significant tree roots found within the trial hole, only small fibrous tree roots beneath the concrete sub-base layer of the adjacent plum tree, surrounding the drain cover.**

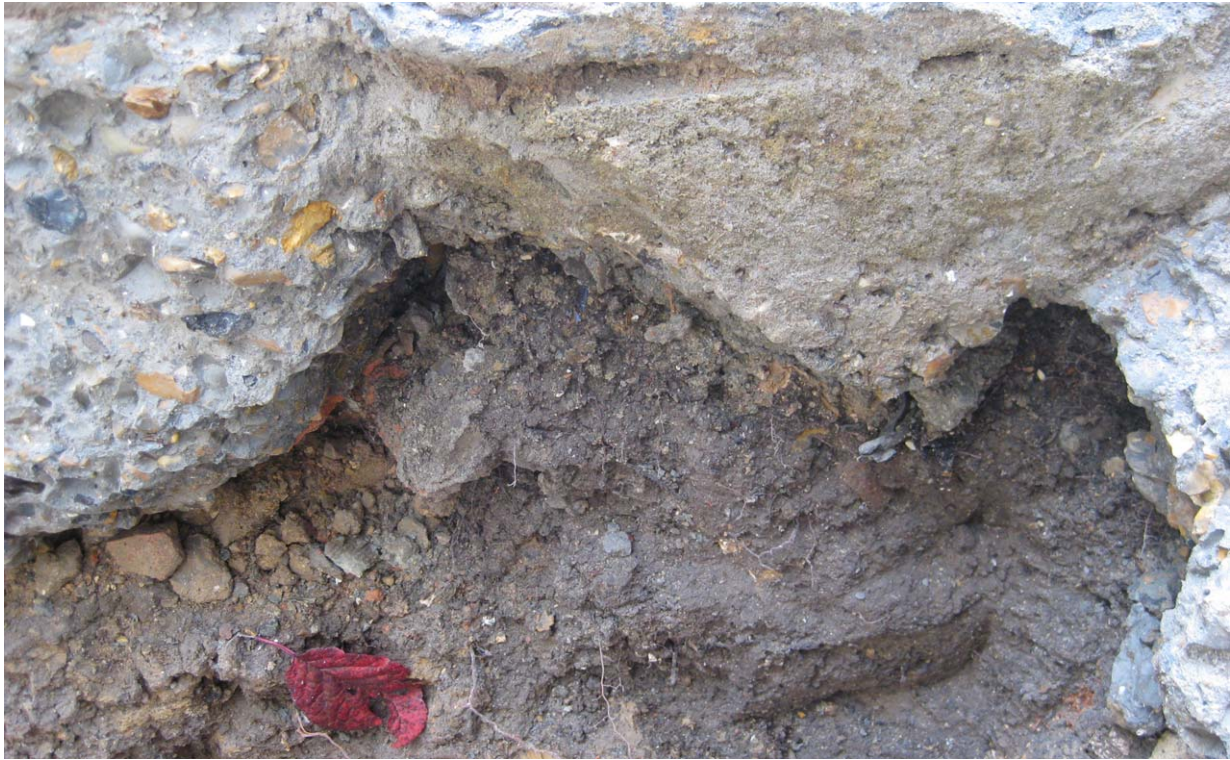
**Photograph No. 13 - *Trial Pit No. 2* - There were no significant tree roots found within the trial hole, only small fibrous tree roots beneath the concrete sub-base layer of the adjacent plum tree.**
