# Expansion of Kingsgate Primary School and Redevelopment of Liddell Road

## Aboricultural Impact Assessment

Submitted in support of  
Application 01 for Phase 01  
Application 02 for Phase 02  
December 2014

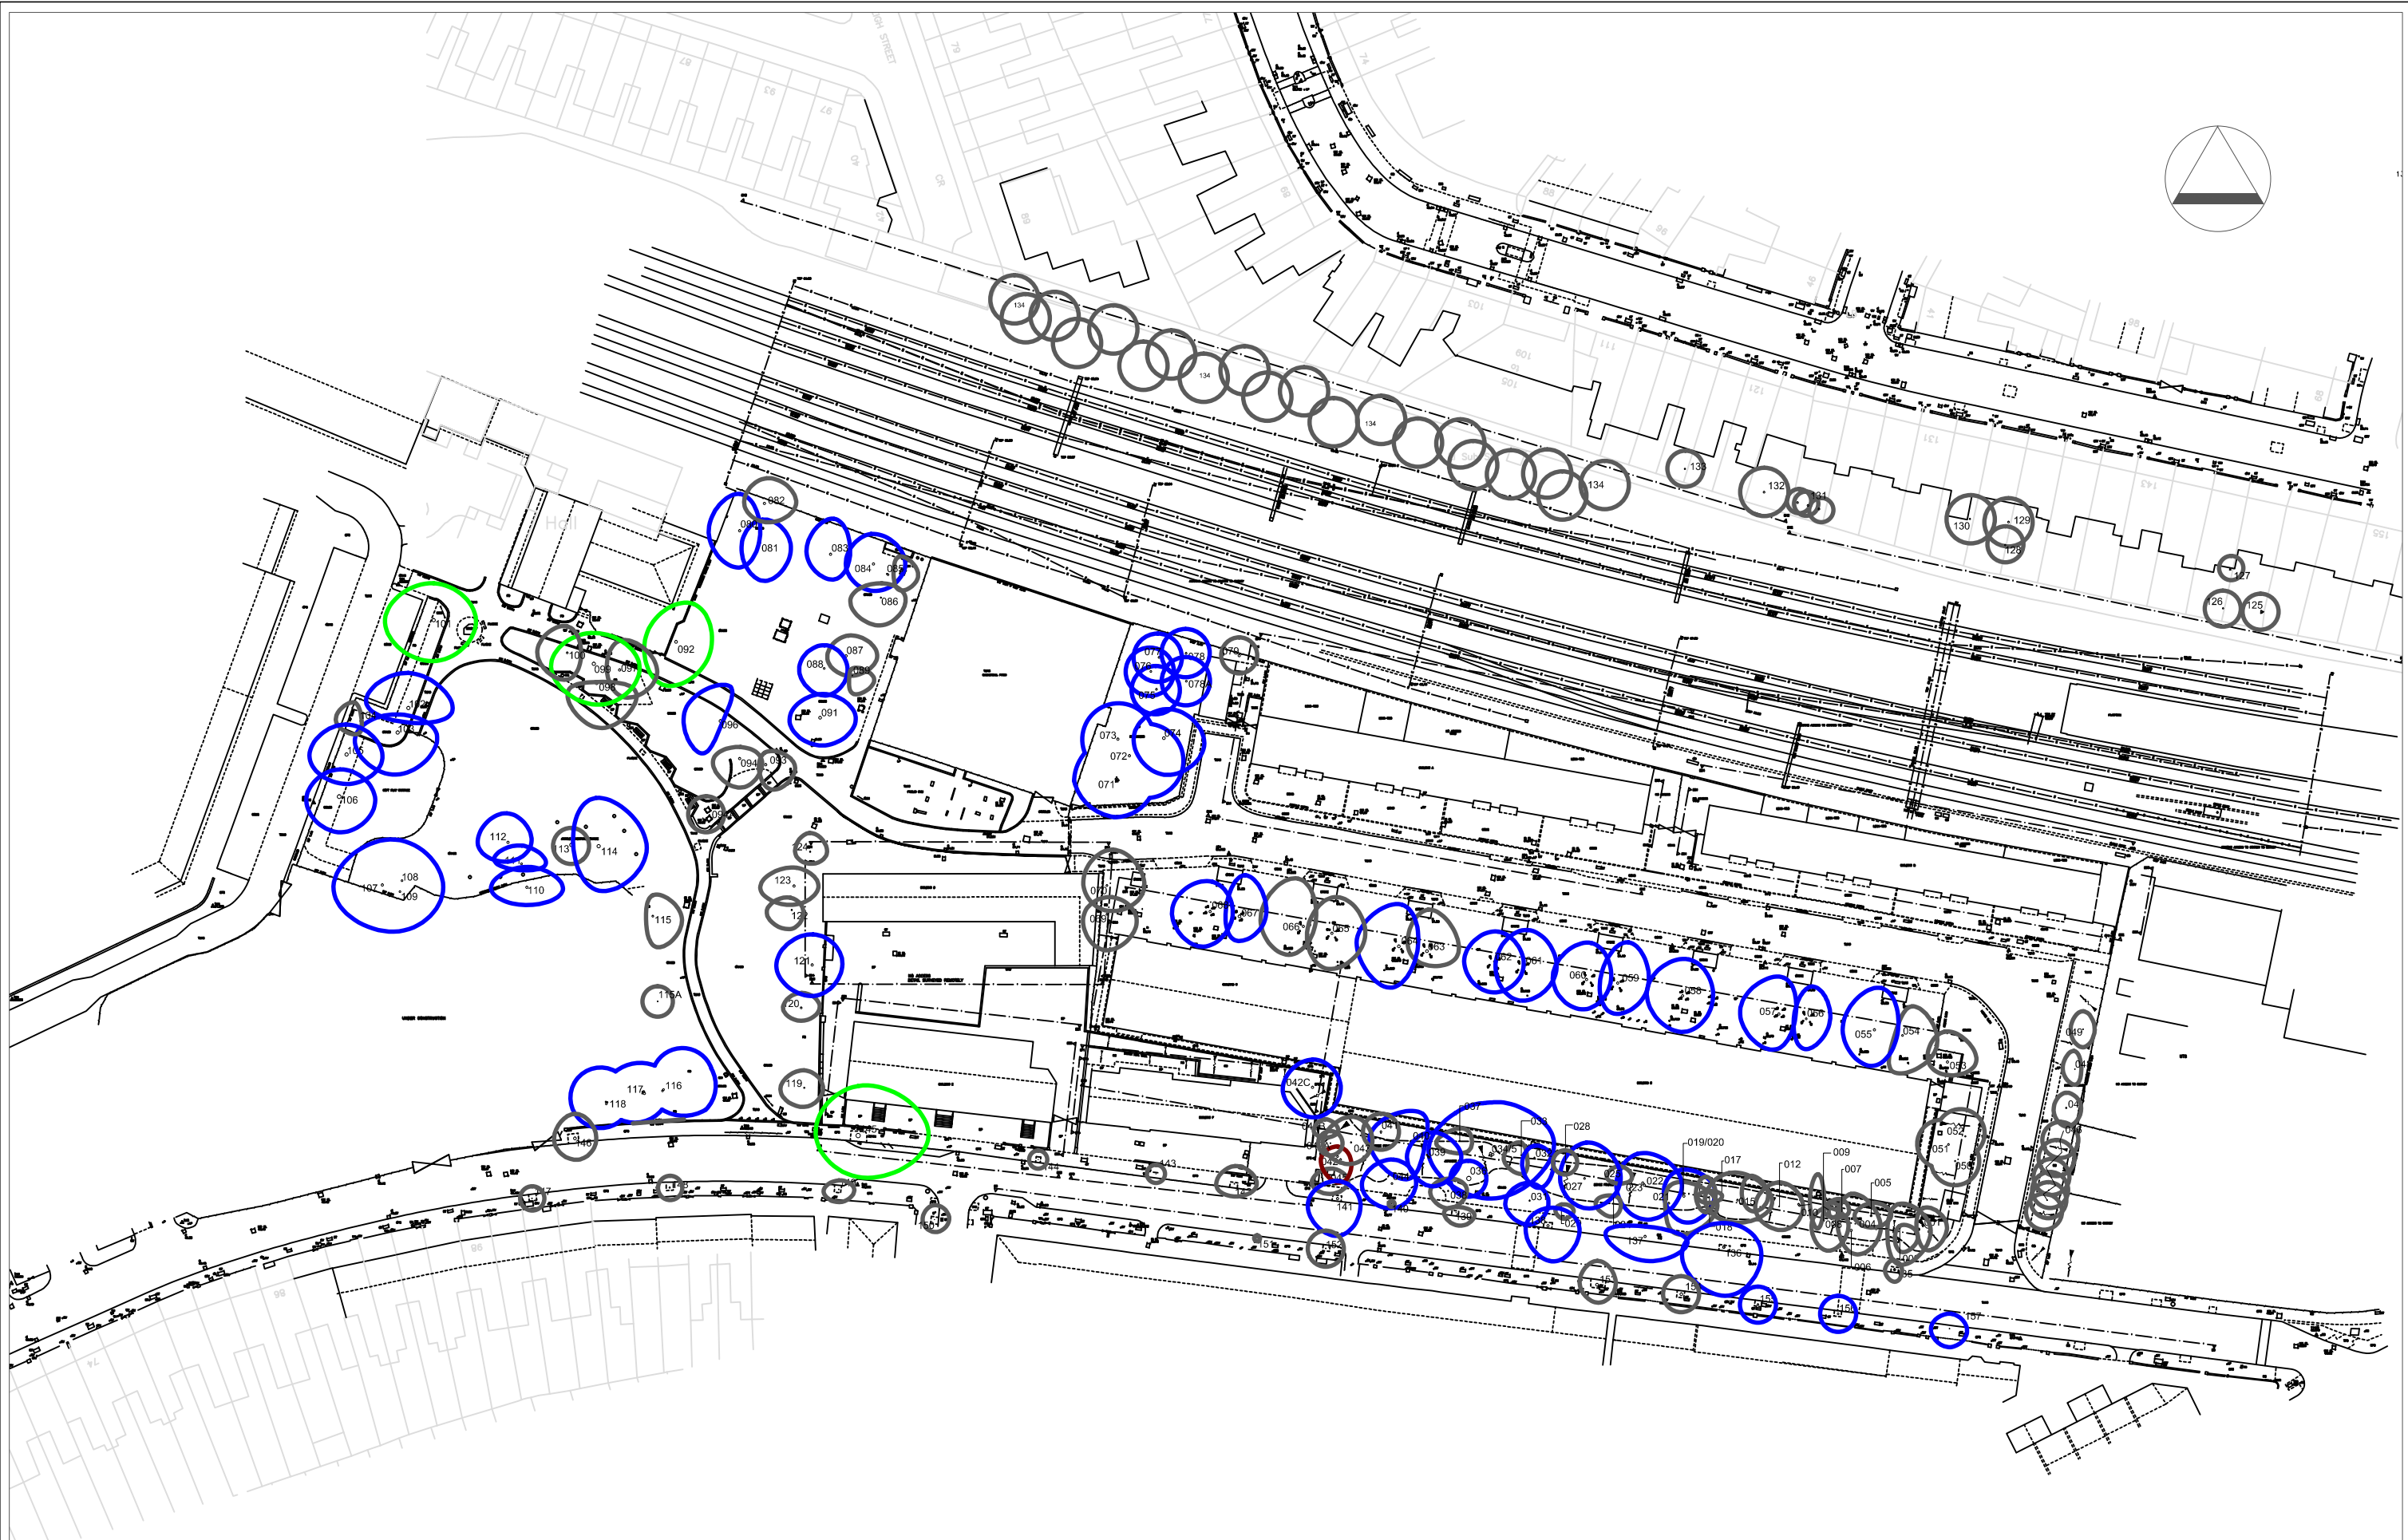
2.1.2 The **Tree survey plan** in **Appendix a**, which is based on the full topographical survey referred to in 1.9 above, shows tree locations under existing conditions.

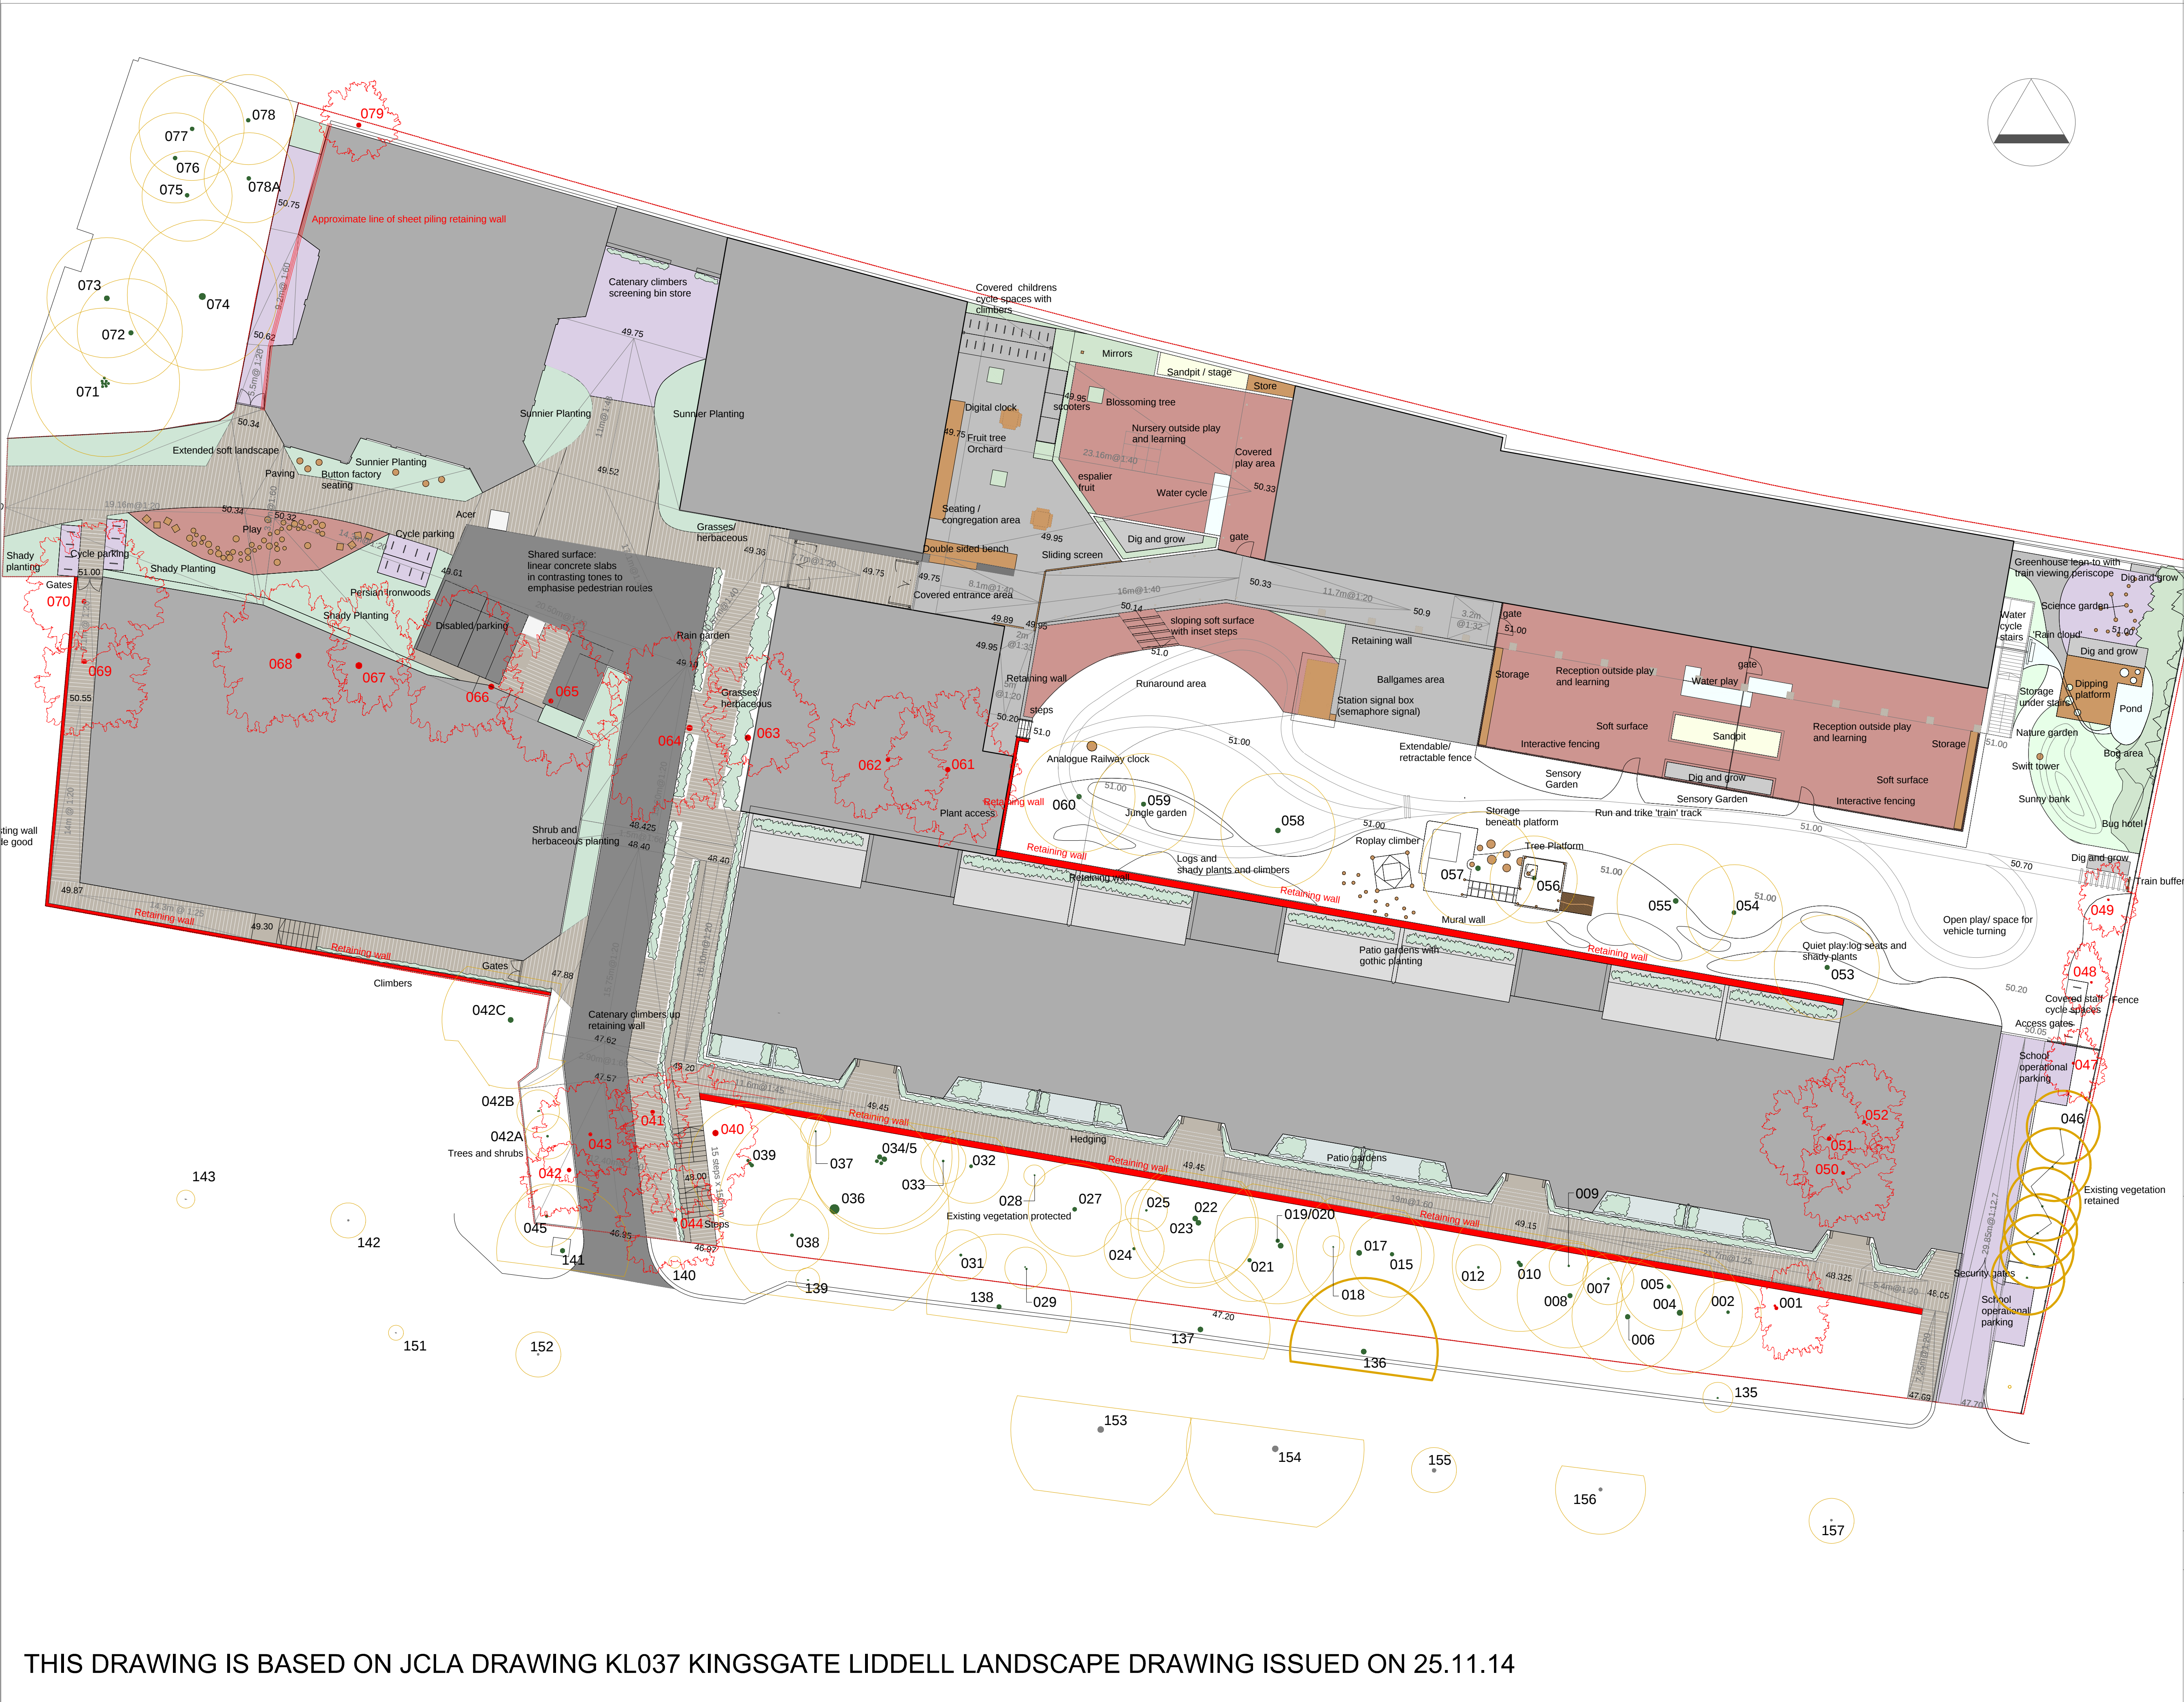
ROOT PROTECTION AREA as defined in BS5837 2012  
Trees in relation to design, demolition and construction - Recommendations

TREE TO BE REMOVED
