**PARLIAMENT HILL SCHOOL, CAMDEN**

**PERS AUDIT**

**Project No. 13-255**

**Report. 13-255-03**

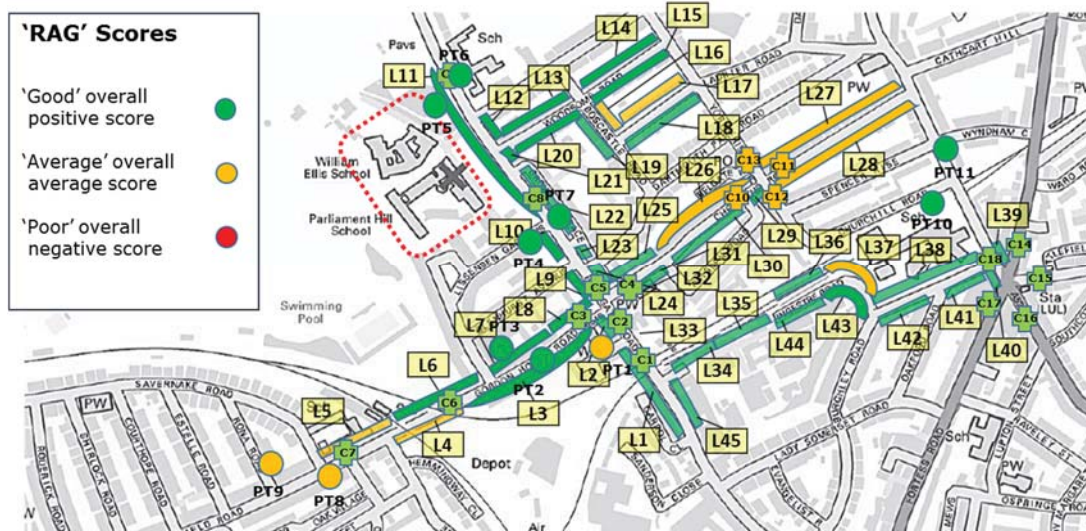
**Figure 4.1 – Summary of PERS Audit Results**

4.3 A summary of the results for all of the audited areas can be seen in **Figure 4.1**. Each area is coloured according to its assigned ‘RAG’ colour.

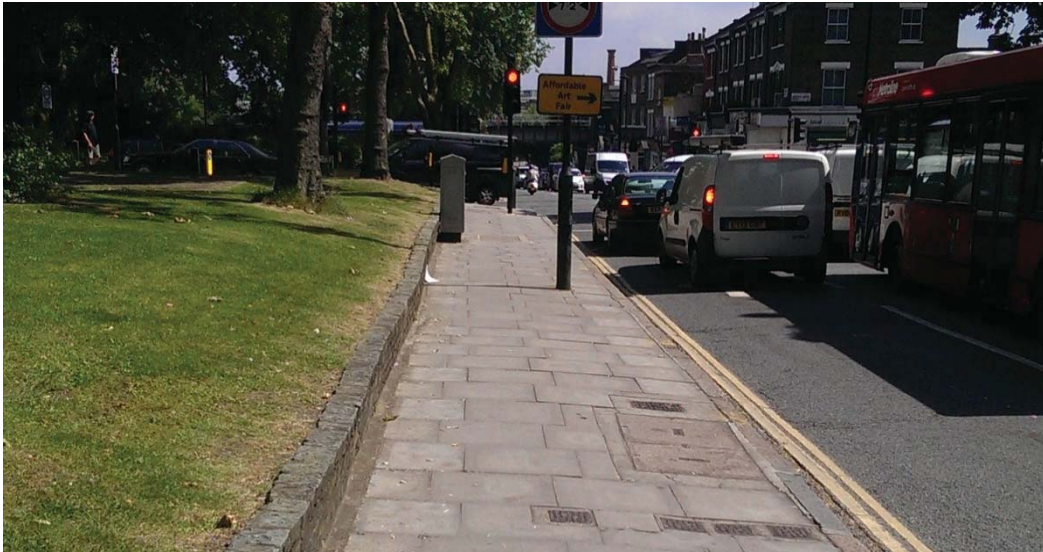
**Photo 1 – Western Side Footway, Highgate Road (Southbound)**

5.4 Many of the links benefit from wide accessible footways which are well lit, and which accommodate dropped kerbs and tactile paving at crossing points. **Photo 1** shows a typical footway along the western side of Highgate Road in the vicinity of the site, whilst **Photo 2** shows the footway on the eastern side of Highgate Road with clearly defined user markings.

5.5 The photos shown above represent the 'typical' conditions of the links along Highgate Road which the majority of pedestrians will use when moving to and from the development on the routes identified in **Table 3.1**.

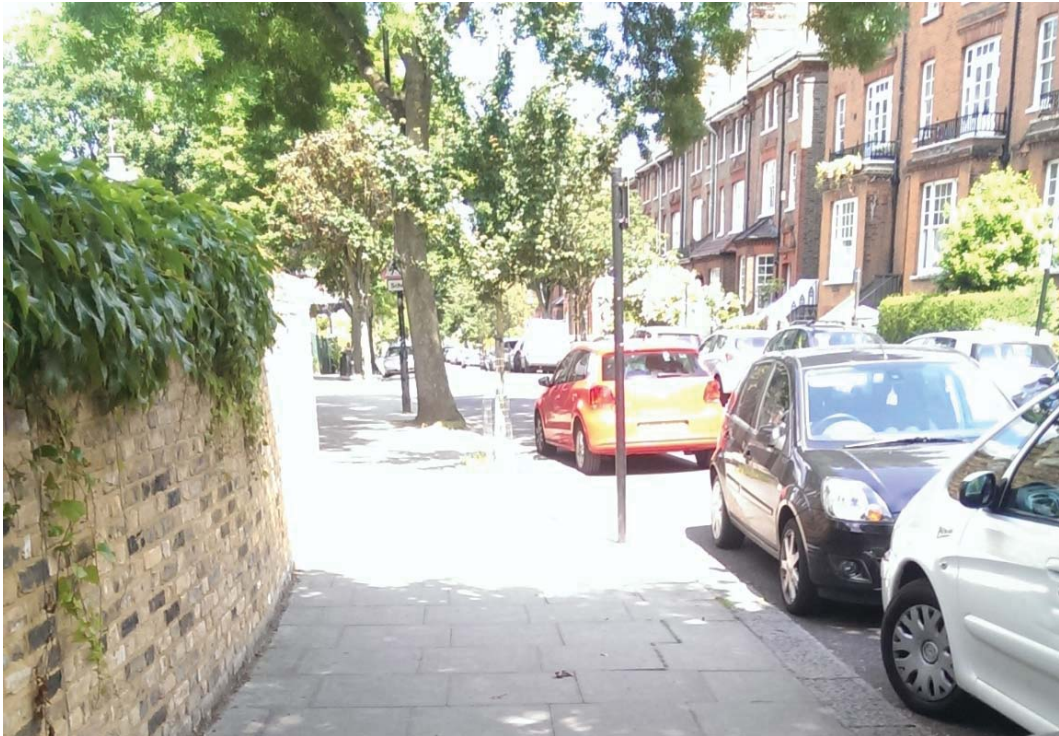
**Photo 3 – Northern footway, Woodsome Road (Eastbound)**

5.6 **Photo 3** shows a typical footway on nearby residential roads (Woodsome, Laurier and Boscastle roads) which both achieved overall positive RAG scores (although lower than the links on Highgate Road). The footways have widths varying between 2 – 3m, are well lit, and benefit from desirable gradients.

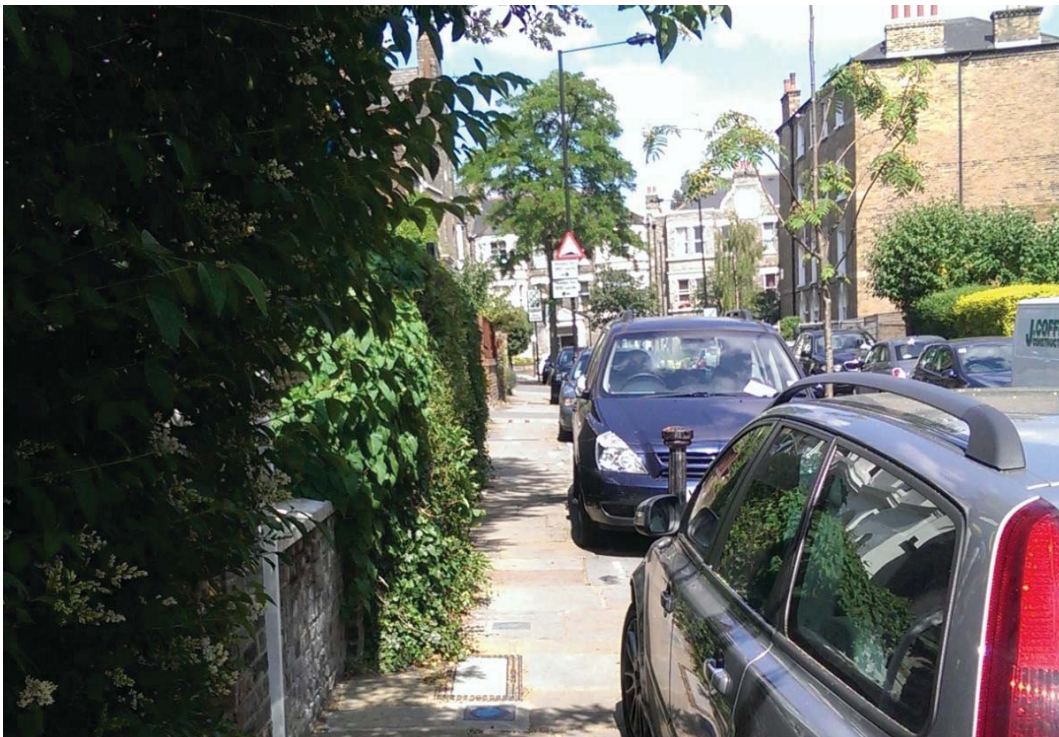
**Photo 4 –Northern footway, Chetwynd Road (Eastbound)**

5.7 **Photo 4** shows the footway on the northern side of Chetwynd Road. This link achieved an Amber ('Average') score due to the limited effective width provided for pedestrians, due to the number of obstacles (i.e vegetation and parked cars) and the steep gradient of the road discouraging pedestrians to use this route. Similar conditions were observed along the majority of Chetwynd road. **Photo 5** shows the pedestrian footway along the southern side of Chetwynd Road.

9.4 Whilst the majority of the links, crossings and public waiting areas achieved a 'Good' overall score, some sections of footway such as those along Chetwynd Road, as described in **Section 5.6**, were given an 'Average' score (Amber) on the basis of width constraints and obstructions which resulted in unfavourable environment for pedestrians.

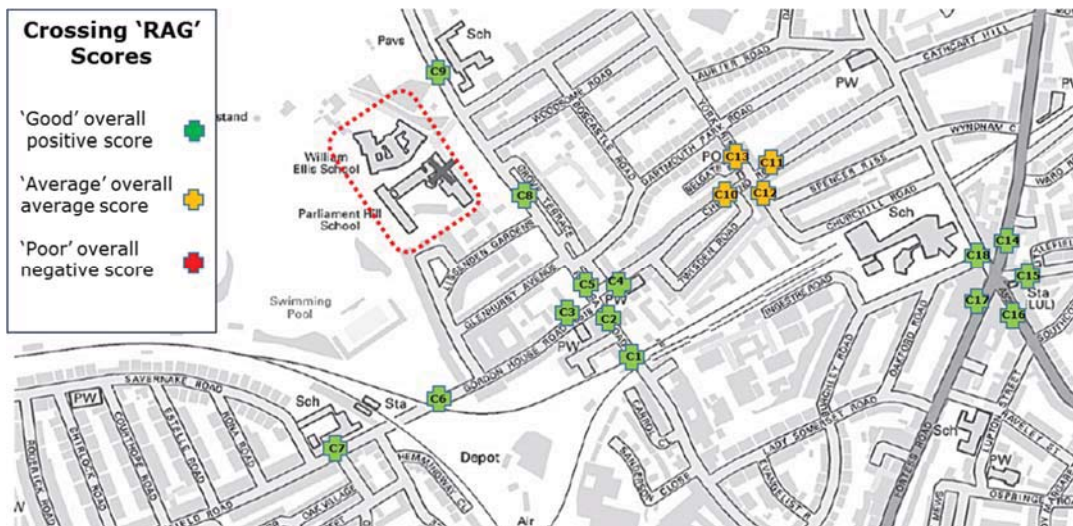
**Figure 6.1 – PERS Scores for Crossings**

6.3 **Figure 6.1** below summarises the locations of the crossings and their RAG Ratings.

6.4 The majority of the crossings within the audit area were rated as 'Good' (Green). These crossings were judged to display a suitable crossing type, incorporating appropriate tactile paving and dropped kerbs without deviation from pedestrian desire lines. There were no Red ('Poor') ratings for crossings along the assessed routes.

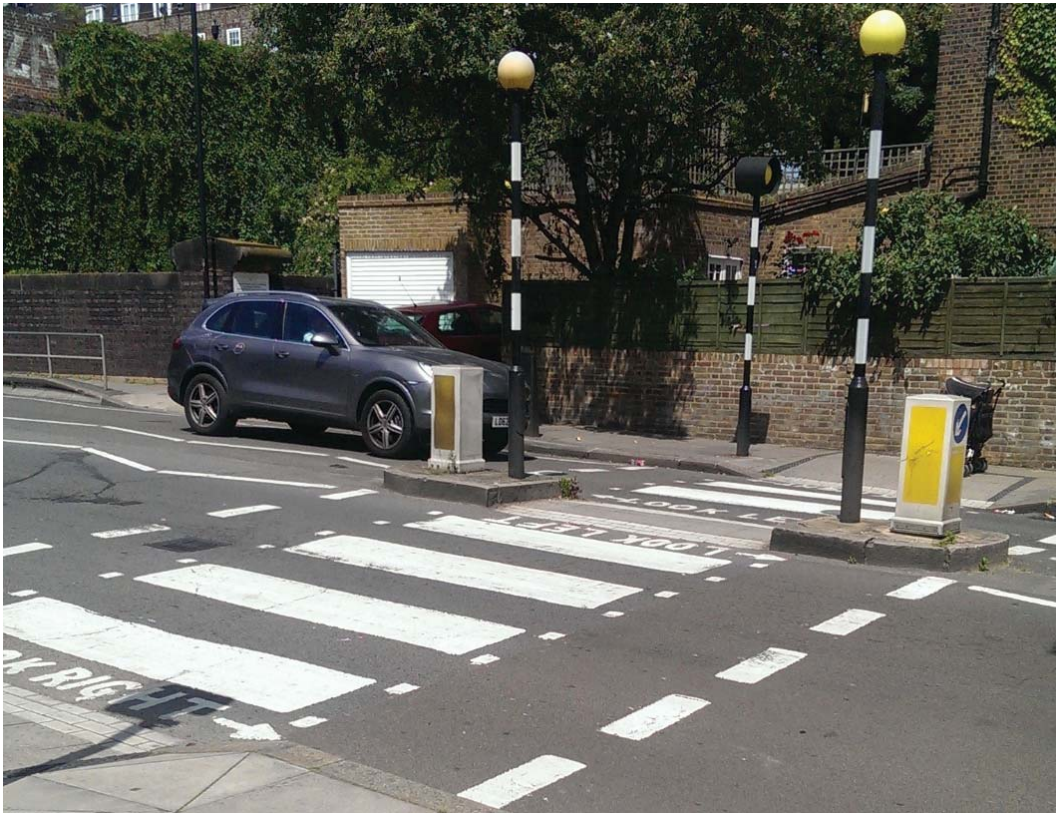
**Photo 6 – Pedestrian crossing at Highgate Road**

6.5 **Photo 6** shows the pedestrian crossing at Highgate Road (C1). As is evident, the tactile paving and dropped kerbs are fit for purpose, adequately maintained and are located along pedestrian desire lines.

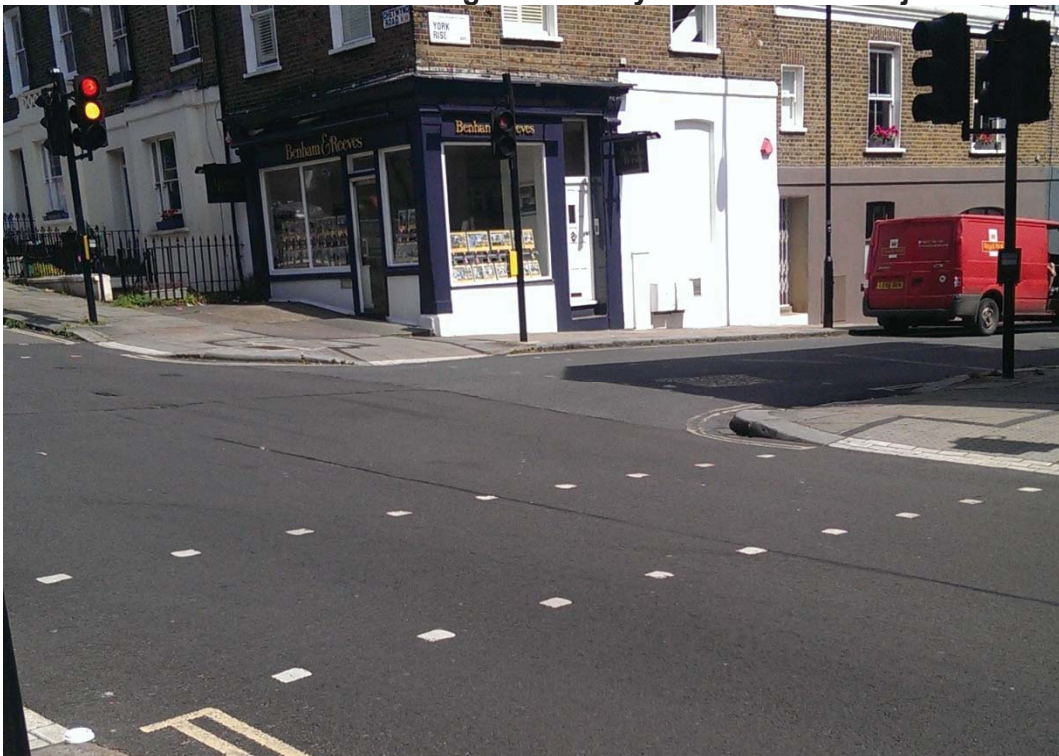
**Photo 7 – Pedestrian crossings at Chetwynd Rd/ York Rise junction**

6.6 **Photo 7** shows two of the pedestrian crossings at Chetwynd Rd/ York Rise junction. The legibility, surface quality and gradient of these crossings were poorly rated resulting to an average ('Amber') score for all the crossings at this junction.

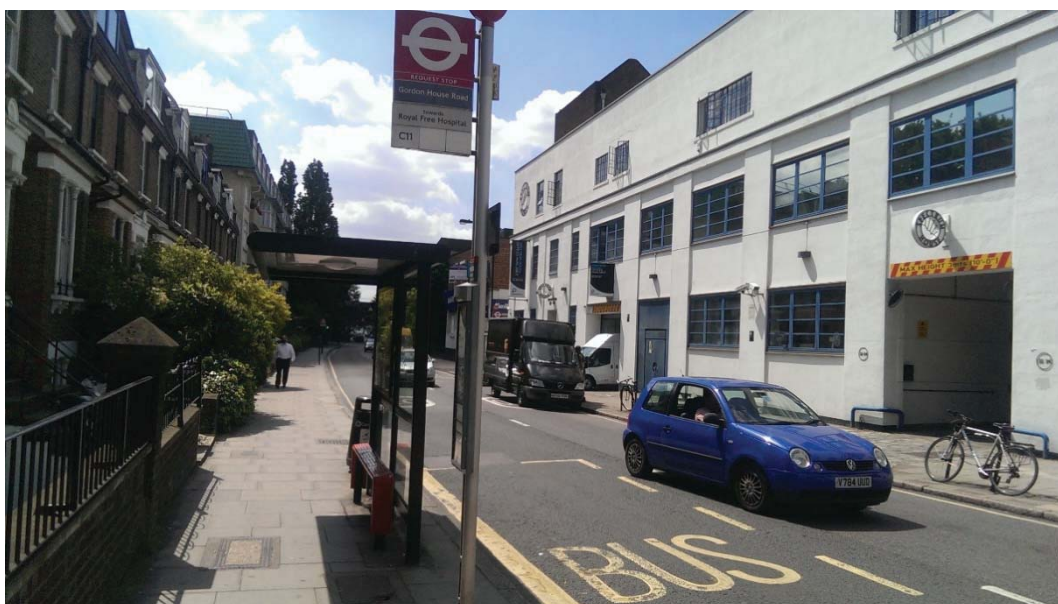
Photo 8 – Gordon House Road (Stop GZ)

7.5 The bus stop located on Gordon House Road as shown in **Photo 8**, is typical of the majority of the Public Transport Waiting Area's identified within this audit. **Photo 9** shows an example of a typical public transport waiting area located on the eastern side of Highgate Road (closest to the Site).
