### Monitoring Plus Report

Owners name	Mr Nighy & Ms Quick	Suspected cause	Root-induced shrinkage	Monitoring type	Levels
Address	13 Torriano Avenue  London  NW5 2SN	Principal area of damage	To be advised	Installed	31/01/2014
Home phone	[REDACTED]	Damage category	To be advised	No of visits / weeks	tbc @ 7.3
Work phone		Surface geology	To be advised	Completion date	tbc
Correspondence address		Feedback from last visit	21/10/14 - Pts 3 & 4 gone due to repairs. Pts 11 & 12 n/a. Support for cill in way.		
Comment	Max movement 0.0 Focal area 03/12/14 - results to date show small variations broadly consistent with soil swelling in winter (upwards) and shrinkage in summer (downwards)				
		Sketch showing location of monitoring points <p style="text-align: center;">Front Elevation</p> <p style="text-align: right;">Drain side of eebra crossing</p>

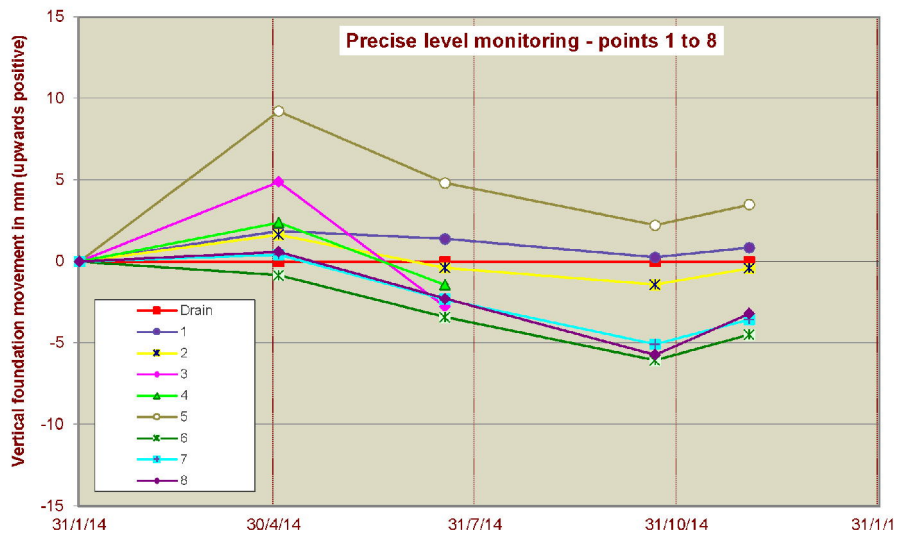
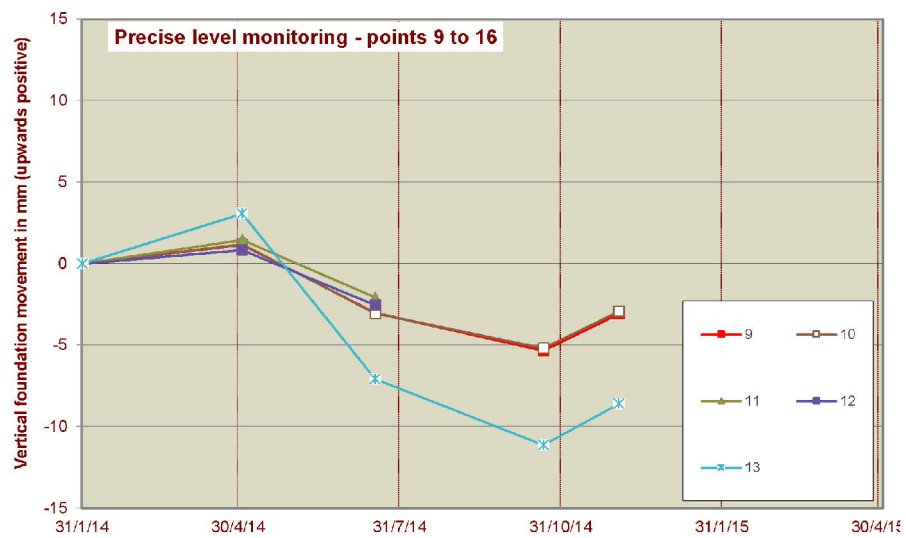
## Level monitoring results

Survey: By: Date: Point ID	1 JW 31/01/2014		2 PD 02/05/2014		3 JW 17/07/2014		4 PD 21/10/2014		5 RM 03/12/2014	
	levels	<i>chngs</i>	levels	<i>chngs</i>	levels	<i>chngs</i>	levels	<i>chngs</i>	levels	<i>chngs</i>
	mm	mm	mm	mm	mm	mm	mm	mm	mm	mm
<b>Drain</b>	1000.00	<b>0.0</b>	1000.00	<b>0.0</b>	1000.00	<b>0.0</b>	1000.00	<b>0.0</b>	1000.00	<b>0.0</b>
1	2326.76	<b>0.0</b>	2328.63	<b>1.9</b>	2328.14	<b>1.4</b>	2327.01	<b>0.3</b>	2327.61	<b>0.8</b>
2	2354.90	<b>0.0</b>	2356.53	<b>1.6</b>	2354.51	<b>-0.4</b>	2353.48	<b>-1.4</b>	2354.48	<b>-0.4</b>
3	2374.56	<b>0.0</b>	2379.45	<b>4.9</b>	2371.79	<b>-2.8</b>	gone	<b>#N/A</b>		<b>#N/A</b>
4	2488.38	<b>0.0</b>	2490.76	<b>2.4</b>	2486.94	<b>-1.4</b>	gone	<b>#N/A</b>		<b>#N/A</b>
5	789.03	<b>0.0</b>	798.25	<b>9.2</b>	793.84	<b>4.8</b>	791.25	<b>2.2</b>	792.52	<b>3.5</b>
6	754.30	<b>0.0</b>	753.45	<b>-0.9</b>	750.88	<b>-3.4</b>	748.23	<b>-6.1</b>	749.81	<b>-4.5</b>

7	835.26	<b>0.0</b>	835.67	<b>0.4</b>	832.93	<b>-2.3</b>	830.19	<b>-5.1</b>	831.71	<b>-3.6</b>
8	592.57	<b>0.0</b>	593.16	<b>0.6</b>	590.29	<b>-2.3</b>	586.84	<b>-5.7</b>	589.38	<b>-3.2</b>
9	586.20	<b>0.0</b>	587.35	<b>1.2</b>	583.17	<b>-3.0</b>	580.86	<b>-5.3</b>	583.12	<b>-3.1</b>
10	586.74	<b>0.0</b>	587.94	<b>1.2</b>	583.68	<b>-3.1</b>	581.55	<b>-5.2</b>	583.82	<b>-2.9</b>
11	-33.10	<b>0.0</b>	-31.63	<b>1.5</b>	-35.17	<b>-2.1</b>		<b>#N/A</b>		<b>#N/A</b>
12	-48.58	<b>0.0</b>	-47.75	<b>0.8</b>	-51.11	<b>-2.5</b>		<b>#N/A</b>		<b>#N/A</b>
13	-86.70	<b>0.0</b>	-83.63	<b>3.1</b>	-93.77	<b>-7.1</b>	-97.83	<b>-11.1</b>	-95.29	<b>-8.6</b>
