79 Fitzjohns Avenue, London NW3

APPENDIX C: Hydrogeological and Ground Movement Report

**79 Fitzjohn's Avenue,
Camden, London**
Basement impact assessment

December, 2014

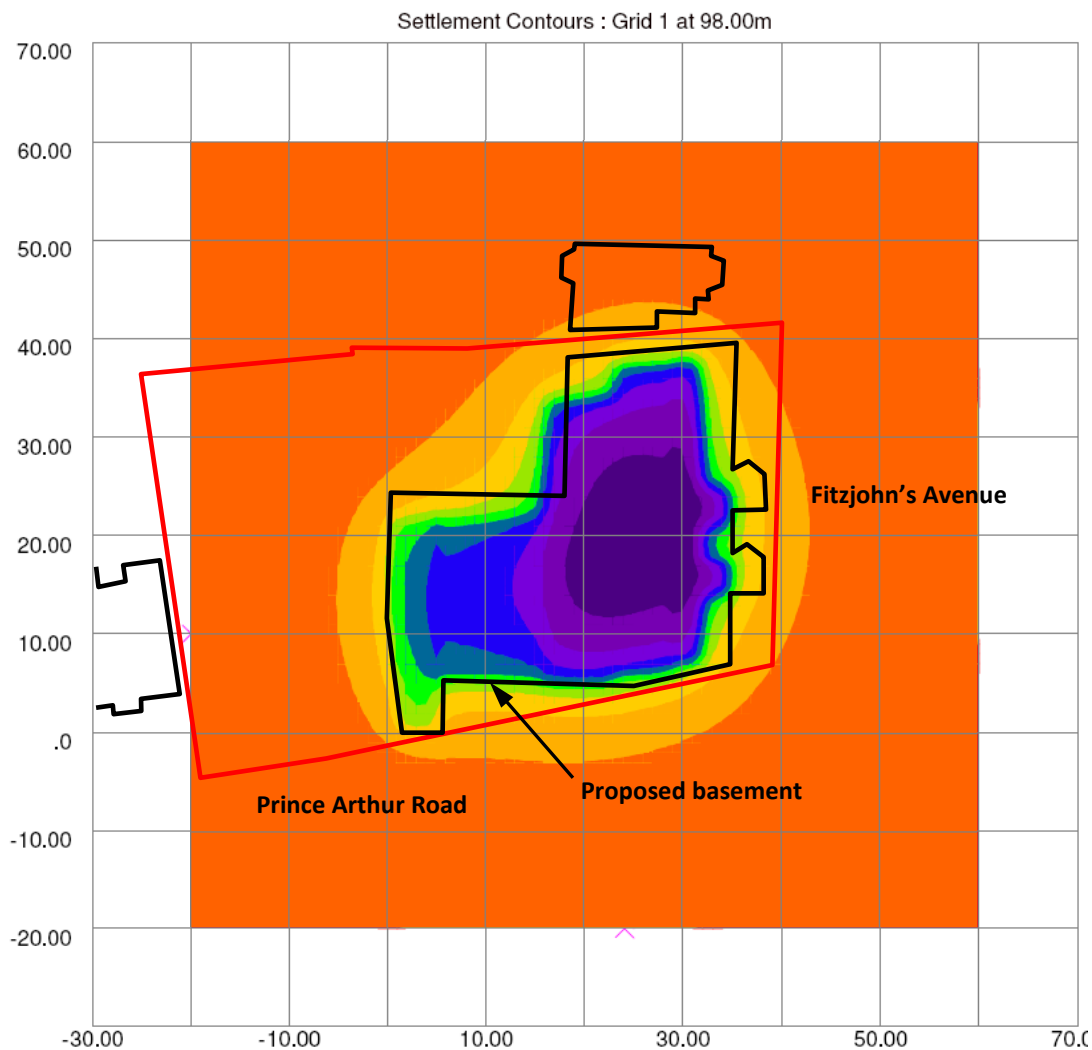
Figure 6

Total movement contour plot

Total heave is predicted to be approximately 45mm, occurring beneath the central region of the proposed basement, reducing to around 7mm around the basement perimeter and 5mm at the nearest foundation of the adjacent property on Fitzjohn's Avenue.

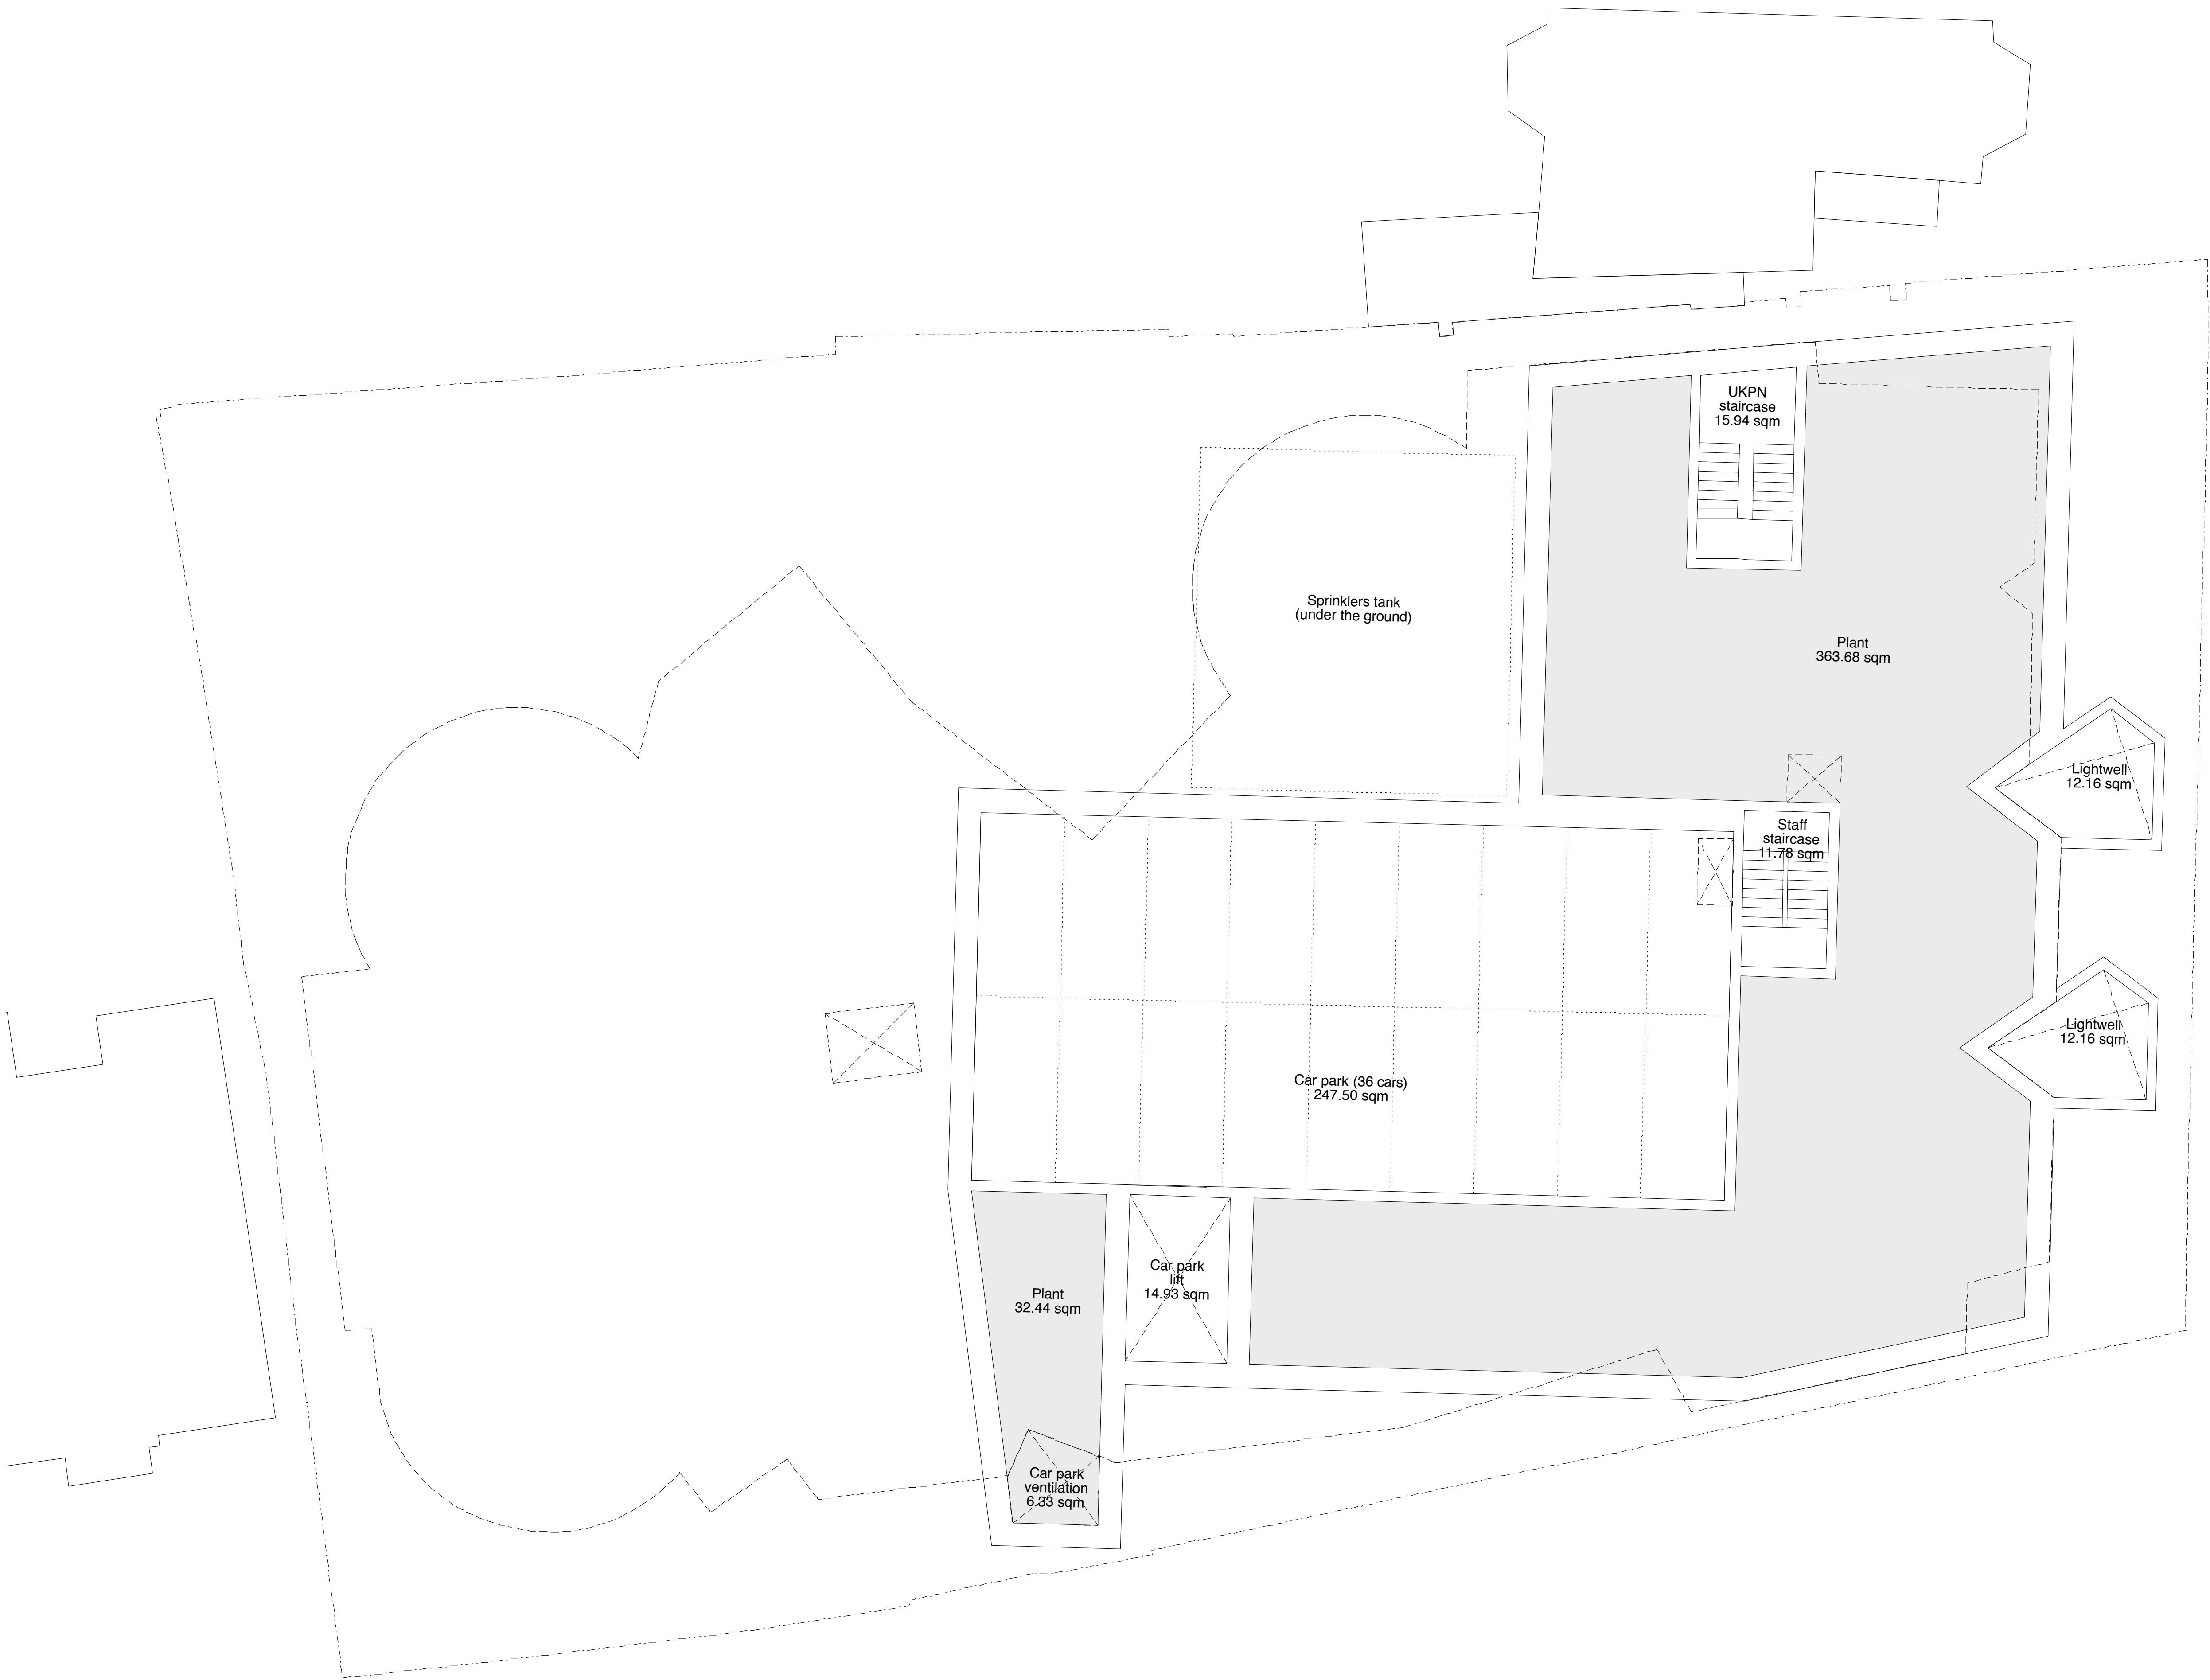
Sergison Bates architects ^{LLP}
Proposed basement - car park

The proposed development comprises the demolition of the existing structure and construction of a six storey complex of buildings with lower ground floor and basement levels. The basement footprint does not extent below the entire footprint of the proposed buildings, and occupies the northern side of the site only.

The basement will be formed at a level of approximately 98mOD and will be cut into the existing slope, with a retained height of around 8m along the north-western site boundary and 4m along the south-western side of the basement.
