Design & Access Statement

1.a Assessment

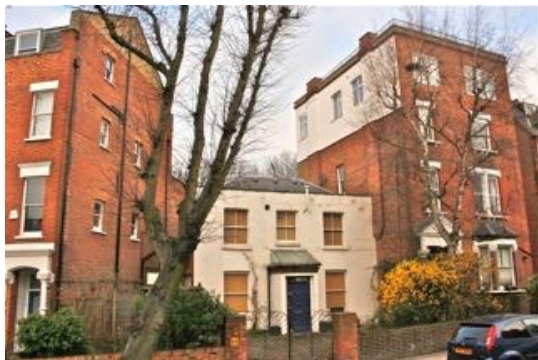
Note: The shape of the demise at 15a Parliament Hill is unusual and can be a source of initial confusion. As shown on the plan opposite the site is comprised of both the house on Parliament Hill and the large garden behind 15 Parliament Hill. A single room in the ground floor of 15 Parliament Hill is also part of the demise. This space of this room is physically with the rest of 15a and it provides a direct and convenient space and connection to the large rear garden of 15a Parliament Hill.x

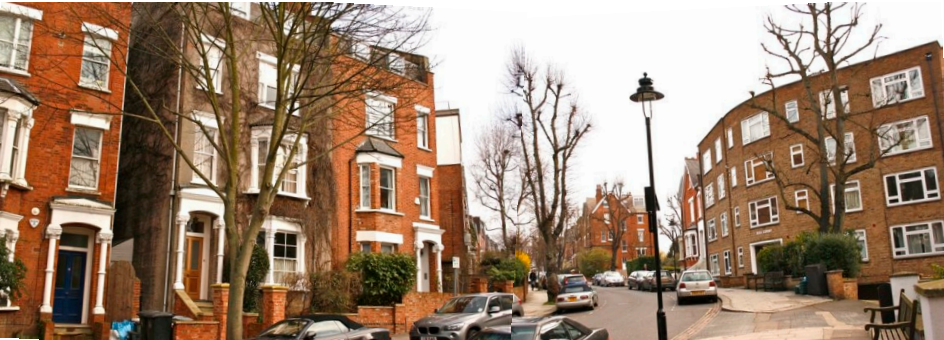
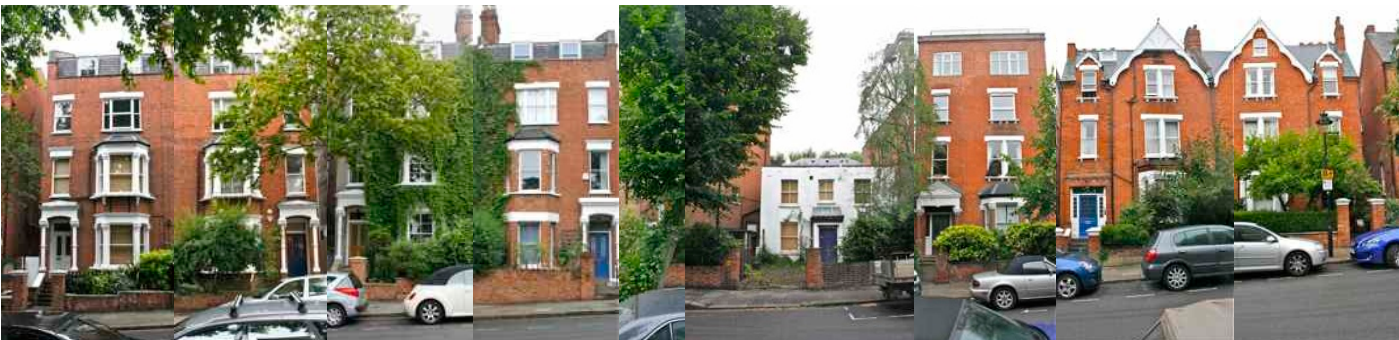
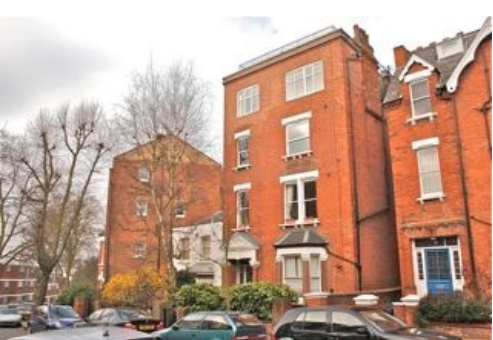
14 15a 15 Hill Court

*Bend in Parliament Hill at 15a
The characteristic continuation of
terraces around curves is
interrupted at 15a*

*The line of terraces is broken and
the exposed side walls dominate.*

The areas characteristic curving streets and corresponding faceted residential terrace elevations are arguably a logical consequence of the combination of topography and the island like circumstances of this community set within Hampstead Heath. The streets curve for level ground and double back at the perimeter with the Heath. The shape of the terraces follows.

The curved plan form of Hill Court is an appropriate contextual response although the fenestration, roofline, and material of the building are comparatively bland. The large and relatively blank side walls framing 15 Parliament Hill do not continue the larger pattern of curving terrace elevations within the conservation area. The set back, small scale, and white painted render of 15a are a break with the continuity of the larger streetscape.

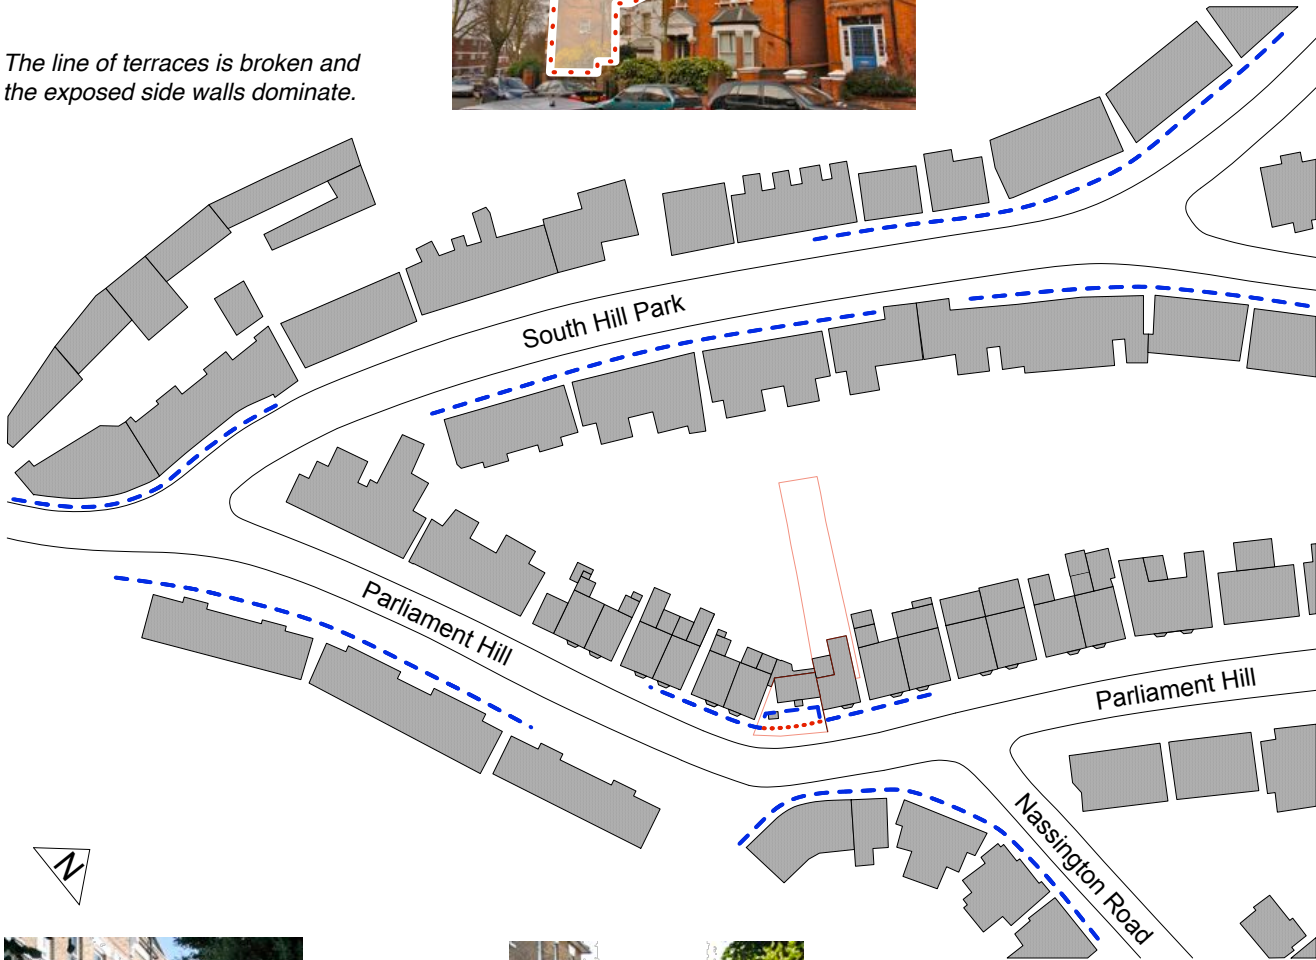
*Curving Streets and Elevations
The topography and island-
within-the-Heath setting of the
Conservation Area results in a
characteristic streetscape
across buildings of different
periods.*
