CAMDEN TOWN
HALL ANNEXE
EUSTON ROAD
WC1H 9JE

TREE REPORT

(Including Arboricultural Impact
Assessment and Method Statement)

Written By:	T Grayshaw
Checked By:	
Date:	18/12/2014
Revision:	
Ref:	PRI19554traia_ams

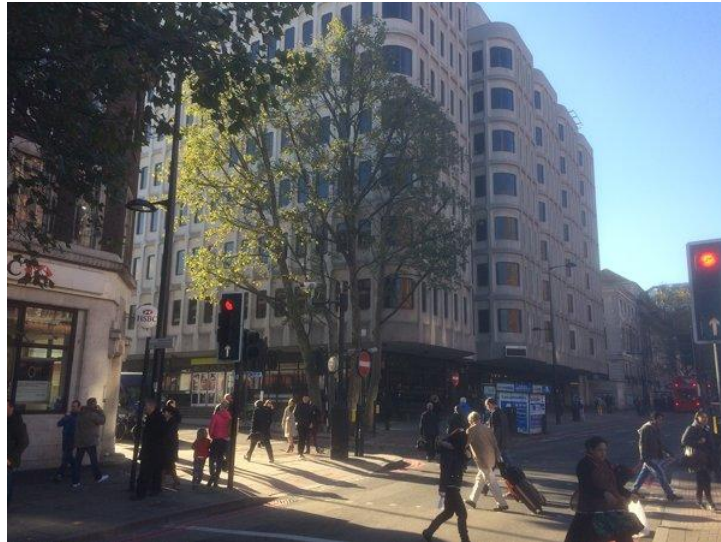
Trees 1 - 4

- 4.5. There are four B category London Plane trees on the corner of Argyle Street and Euston Road. These are closely planted at the base, and as a result have a shared canopy. The trees have been recently heavily reduced to previous pruning points, consistent with management on a pollard/reduction regime.

- 5.9. T1 - 4 have been recently reduced such that there is 2.5 - 3m between the canopies and the existing building. Scaffolding is to be erected off the pavement around the building as indicated with burgundy hatch on the Logistics Plan. It can be seen that due to the reduction works to the trees there will be no adverse conflict between the scaffolding and the canopies.

- 5.7. There will be no access to the site from Bidborough Street at the west of the site, and therefore no impact on T8 is expected.
- 5.8. Site hoarding is to be erected in the position shown on the 'Site Logistics Plan' on page 9 of the Knight Harwood Construction Management Plan for the duration of the development. This will ensure that there will be no construction impact on the stems of the trees. There is no excavation proposed within the RPAs of T1 - 4, or T8.

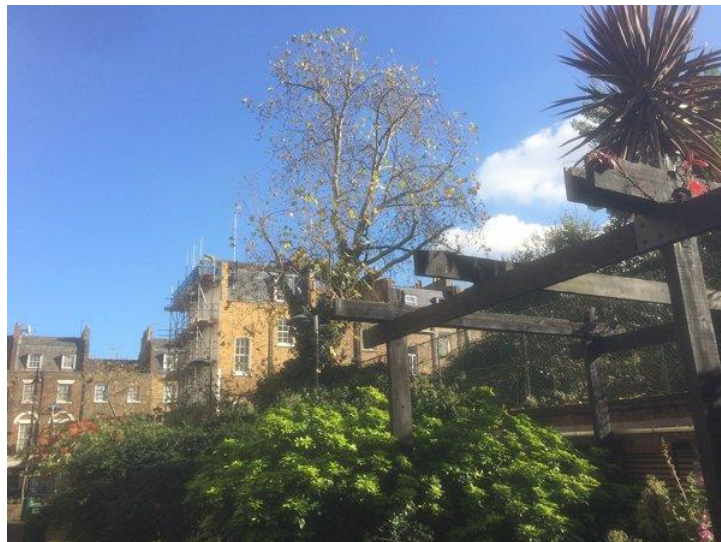
Tree 7 in garden area

- 4.7. T7 is a semi mature London Plane within the garden area. The tree is heavily ivy clad, and has an unbalanced crown shape. Although it is of a fair size, it is of low quality and should not represent a development constraint.

No.	Name	Ht (crown)	Dia (stems)	Canopy spread N E S W				Life stage	ERC	Comments & preliminary recommendations	BS Cat
T7	London Plane (Platanus X hispanica)	12 (3)	430 (1)	2	4	5.5	5	SM	20+	Ivy infested stem. Reduced away from north. One sided crown shape due surgery. Relatively poor crown architecture.	C2
T8	London Plane (Platanus X hispanica)	21 (5)	590 (1)	9	8.5	8	6.5	M	40+	High individual quality and landscape value as street tree. Bifurcates at 5m. Reduced away from building.	A2

- 5.6. Trees T5 - 7 are to be removed and mitigation planting provided as part of the landscape proposals for the scheme. T5 and T6 are currently planted in raised brick planters, and it would not be feasible to retain the trees without retention of the planters. T7 is currently ivy infested, and has been compromised by tree surgery, resulting in an uneven crown shape. All three trees are C category, and are not of a quality that would represent a constraint to development. A better long term result will be achieved for the garden area with the removal of the trees, and replacement planting being provided.

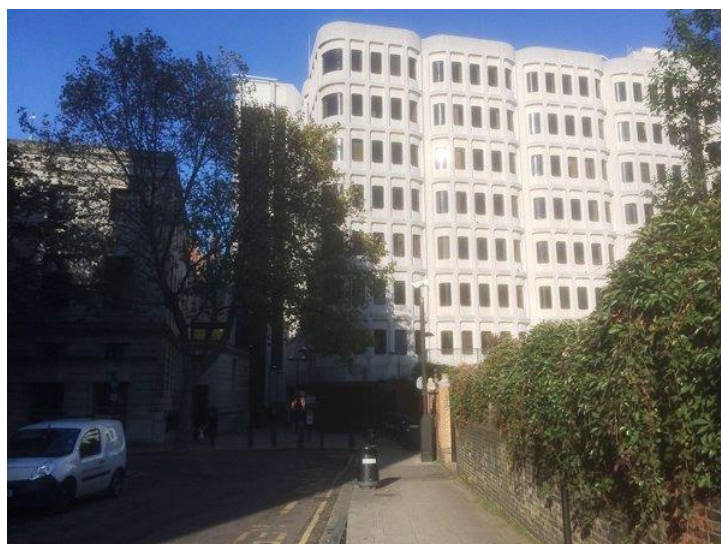
Tree 8

- 4.3. A total of eight individual trees with stem diameters of 75mm and above at 1.5m were surveyed and recorded.
- 4.4. One of the trees included in the survey is A category. This is a mature London Plane on nearby Bidborough Street of high individual quality and landscape value as part of the street scene.

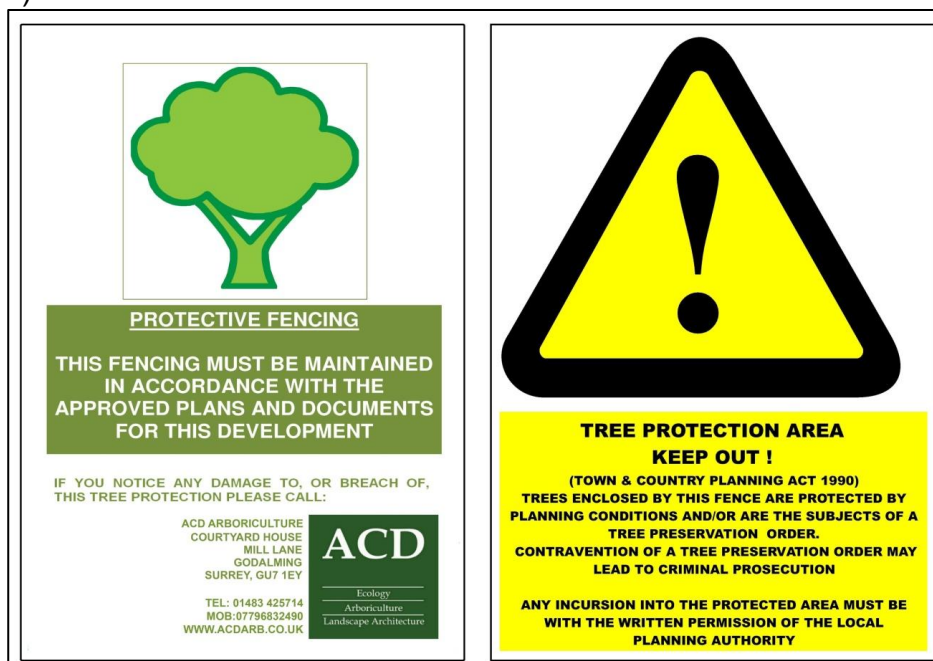
Figure 1: Tree Protection Sign (digital copies available for download at: www.acdarb.co.uk)

- 6.5.1. The Tree Protection Plan (PRI19554-03) appended below shows the alignment of the site hoarding, which is to be installed prior to any of the following taking place:
- Demolition
 - Plant and material delivery
 - Utility installation
 - Construction works
 - Landscaping
- 6.5.2. All weather notices should be erected on the hoarding (for example see figure below).
