Project H

Submission for partial removal of garden wall

4 September 2014

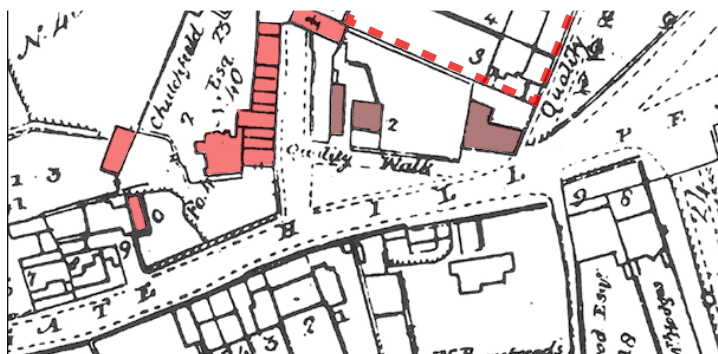
Figure 12: The Map of the Parish of St Pancras, produced in 1801 by John Tomson, showing the layout of the main house and the neighbouring Grove Bank buildings, which stood in the grounds of Witanhurst. (Camden Archives, Holburn).

1. The map of 1801 (Fig 12) indicated the original form of the 18th Century House with the stables building that abutted the Fox and Crown (now The Summit) – see Fig 13. There is no indication of a wall on the line of the current wall at this time, just edging to what was presumed to be the Stableyard, access to which can be seen on the photograph (Fig.6) of the old house.

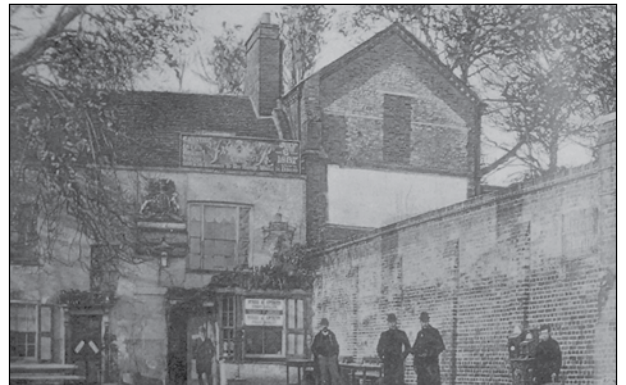
Figure 13: A late nineteenth century view of the Fox and Crown pub shows one of the buildings located on the Witanhurst estate, behind the wall to the left of the picture. This is likely to be a stable of barn mentioned in the later sales particulars.

3. The 1895 Town Map and the 1896 OS Map indicate a reduced footprint for the stables adjacent to the Fox and Crown (shown on Fig.13), but also indicates the wall in its current position. It appears to function in a retaining fashion for a belt of planting to its north and the newly laid out gardens of Parkfield, which are illustrated on the Sale catalogue for Parkfield of 1889 (Fig. 15).

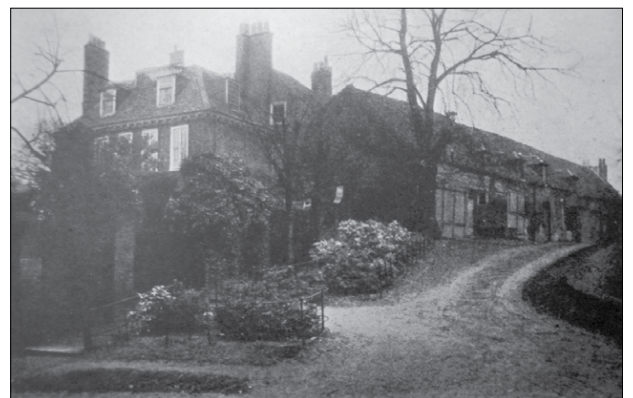
Figure 6: An historic photograph of circa 1880 showing the stable range and yard to the east of the original, 5 bay house. The buildings behind the house may be remnants of an older section of house, or a later addition; no other evidence survives to date them. (English Heritage, National Monuments Record).

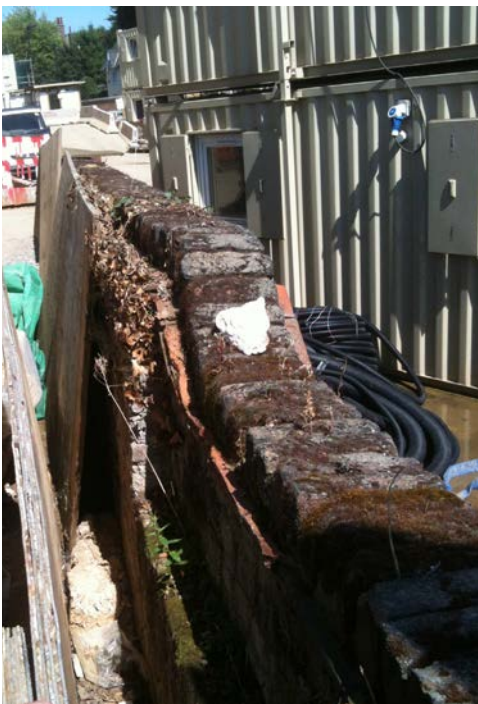
Photo 1: Looking along coping to the East.

9. Photos 1-3 indicate the current condition of the wall.

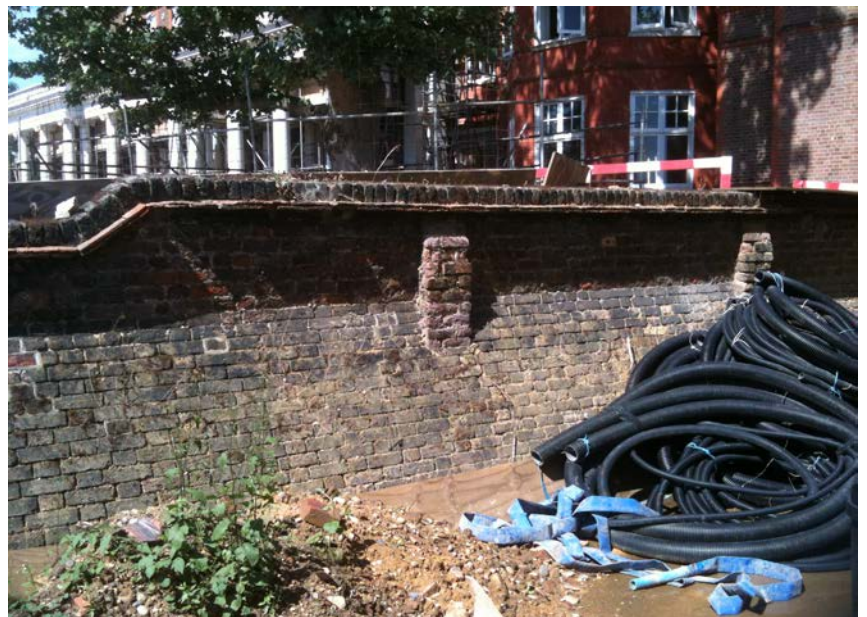
Photo 2: Looking North towards the house

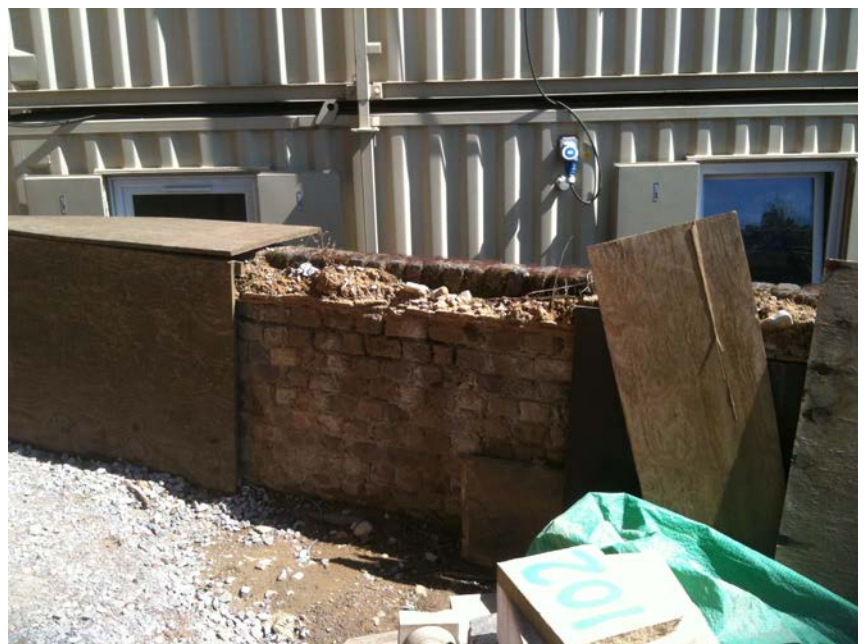
Photo 3: Looking South from the house side of the wall
